## **NATIONAL TRANSPORTATION SAFETY BOARD**

### **Factual Report**

# **METEOROLOGY**

ERA20FA118

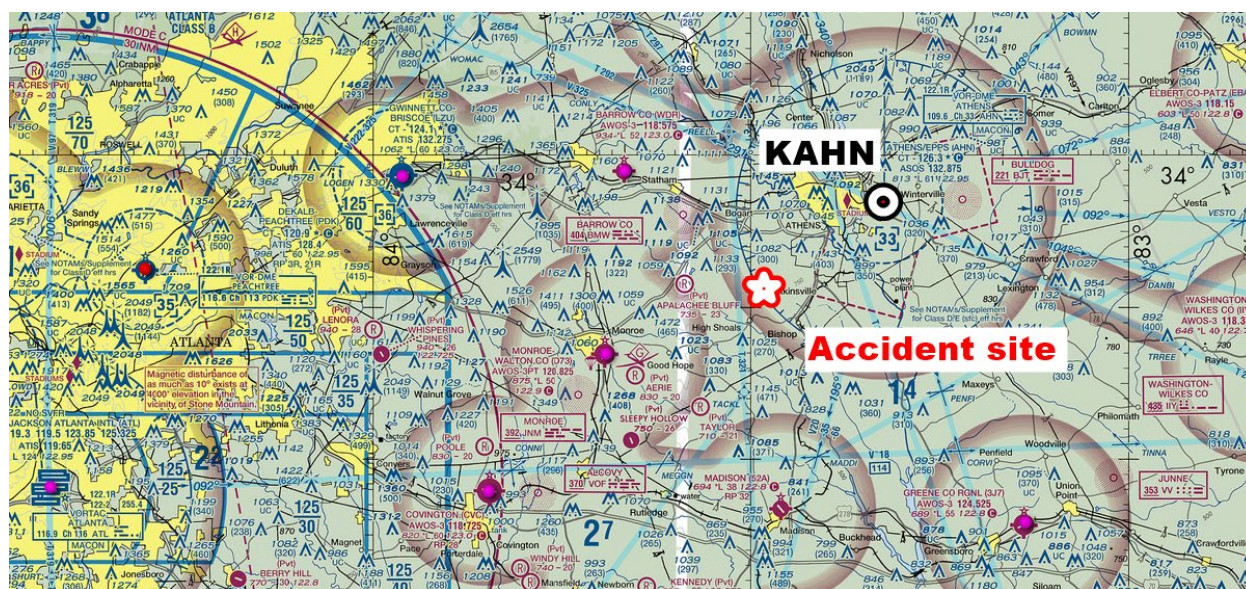
The area surrounding the accident site was documented using official Meteorological Aerodrome Reports (METARs) and Specials (SPECIs). The following observations were taken from standard code and are provided in plain language. Figure 10 is a local sectional chart with the accident site and the closest weather reporting location marked.

**Figure 10 – Sectional map of the accident area with the location of the accident site and surface observation site**

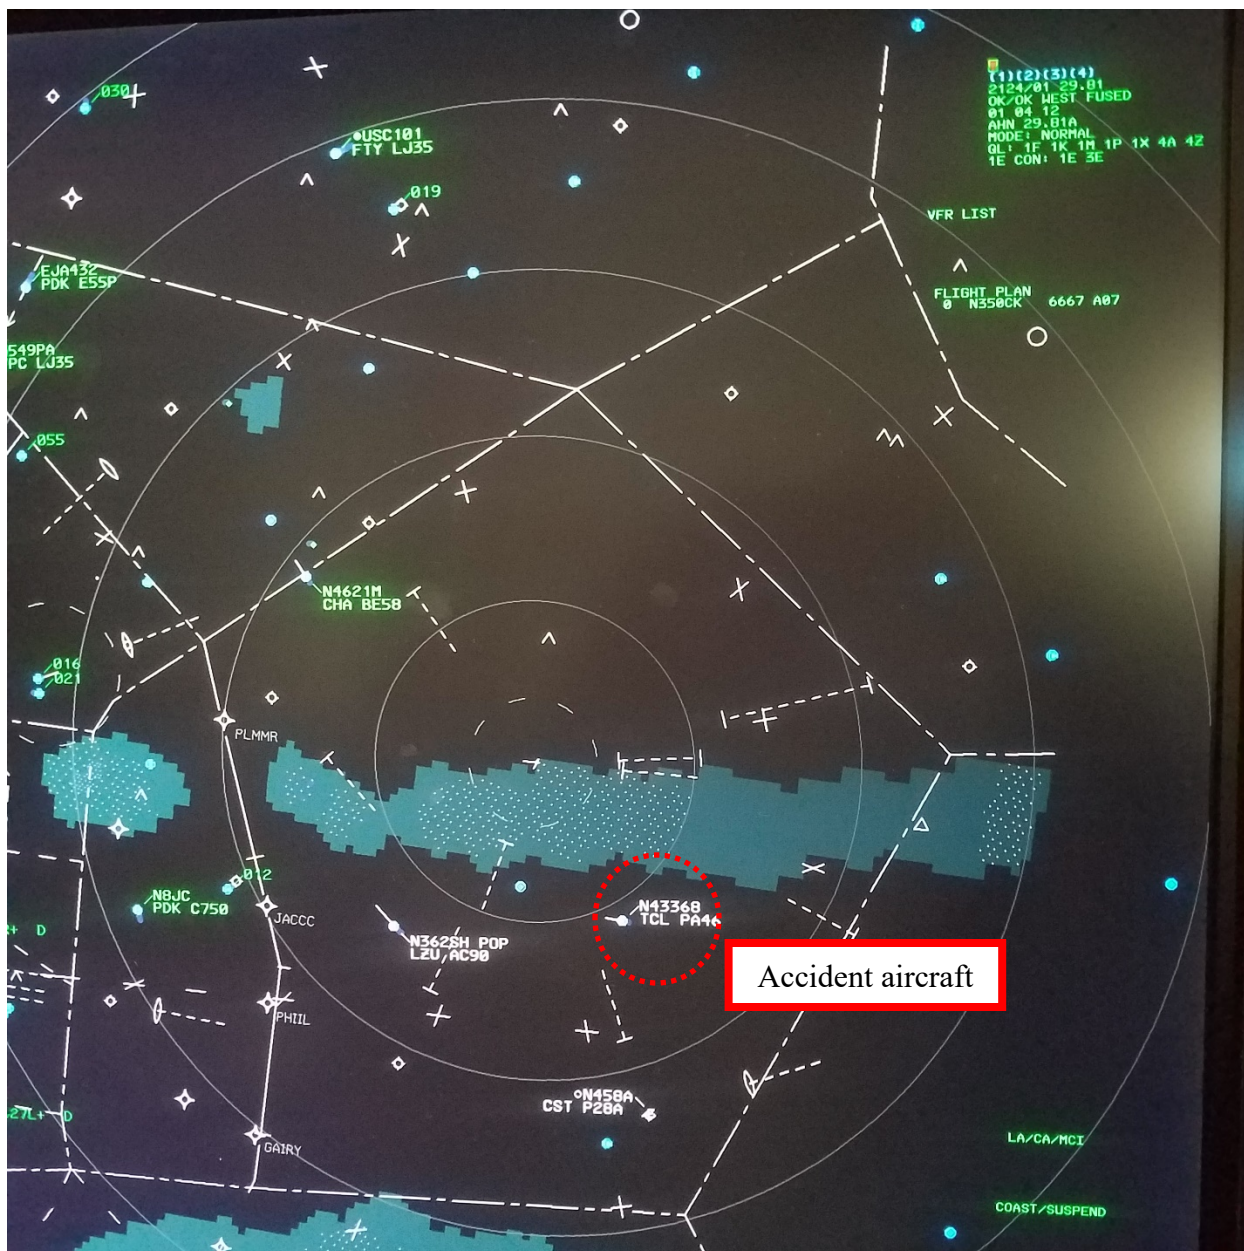
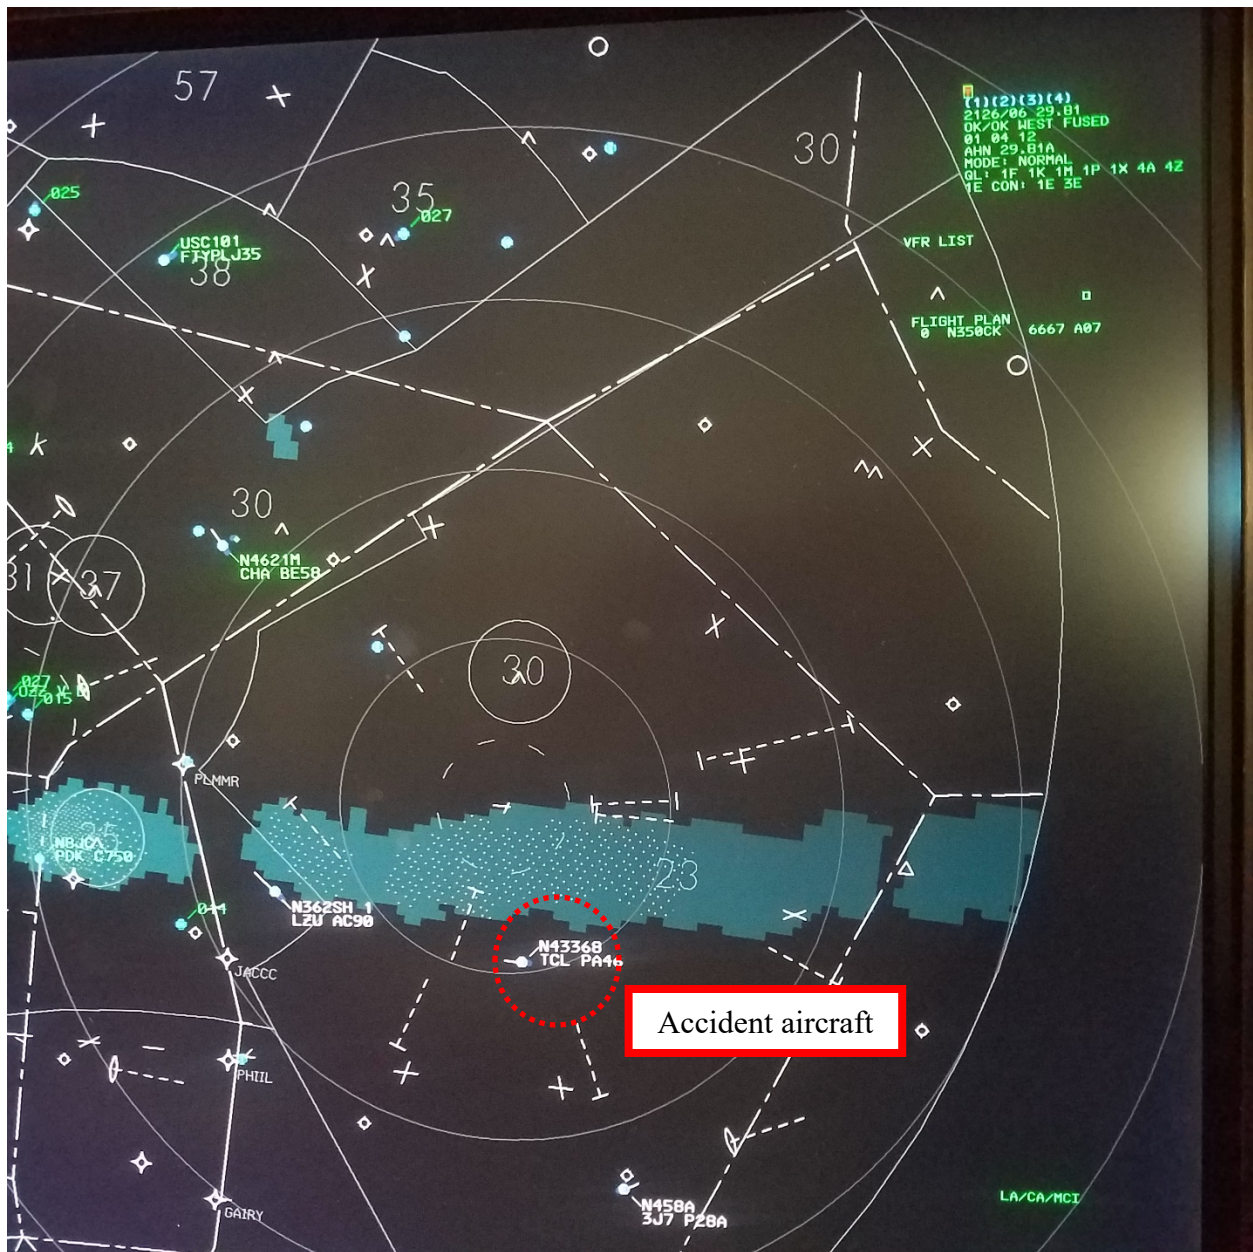
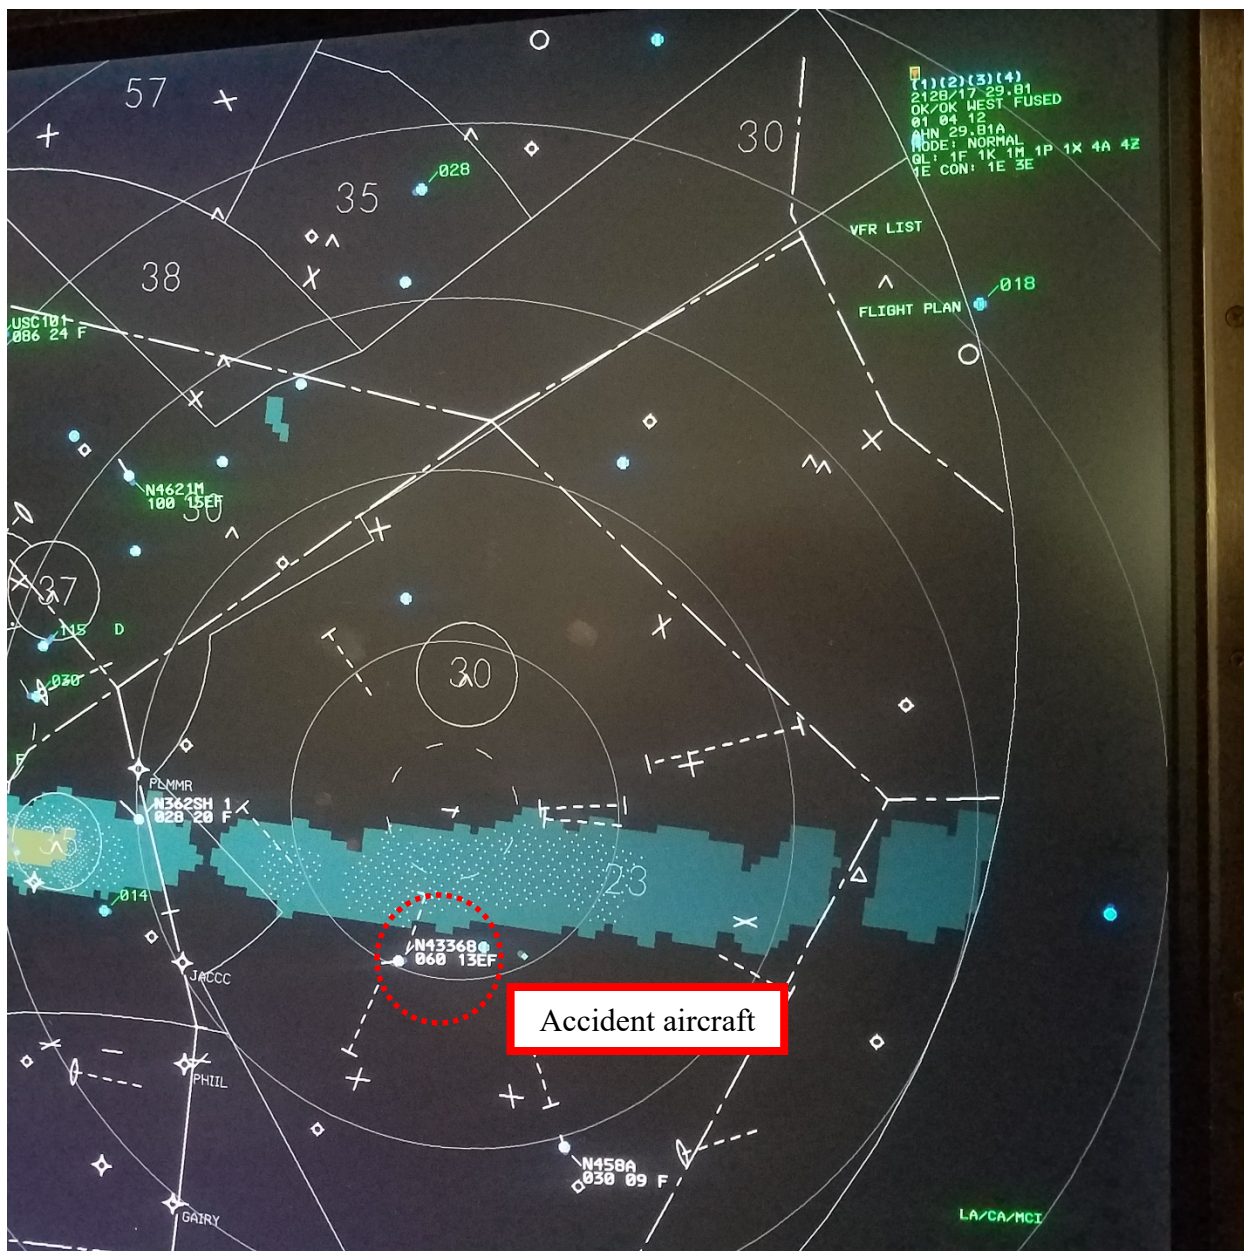
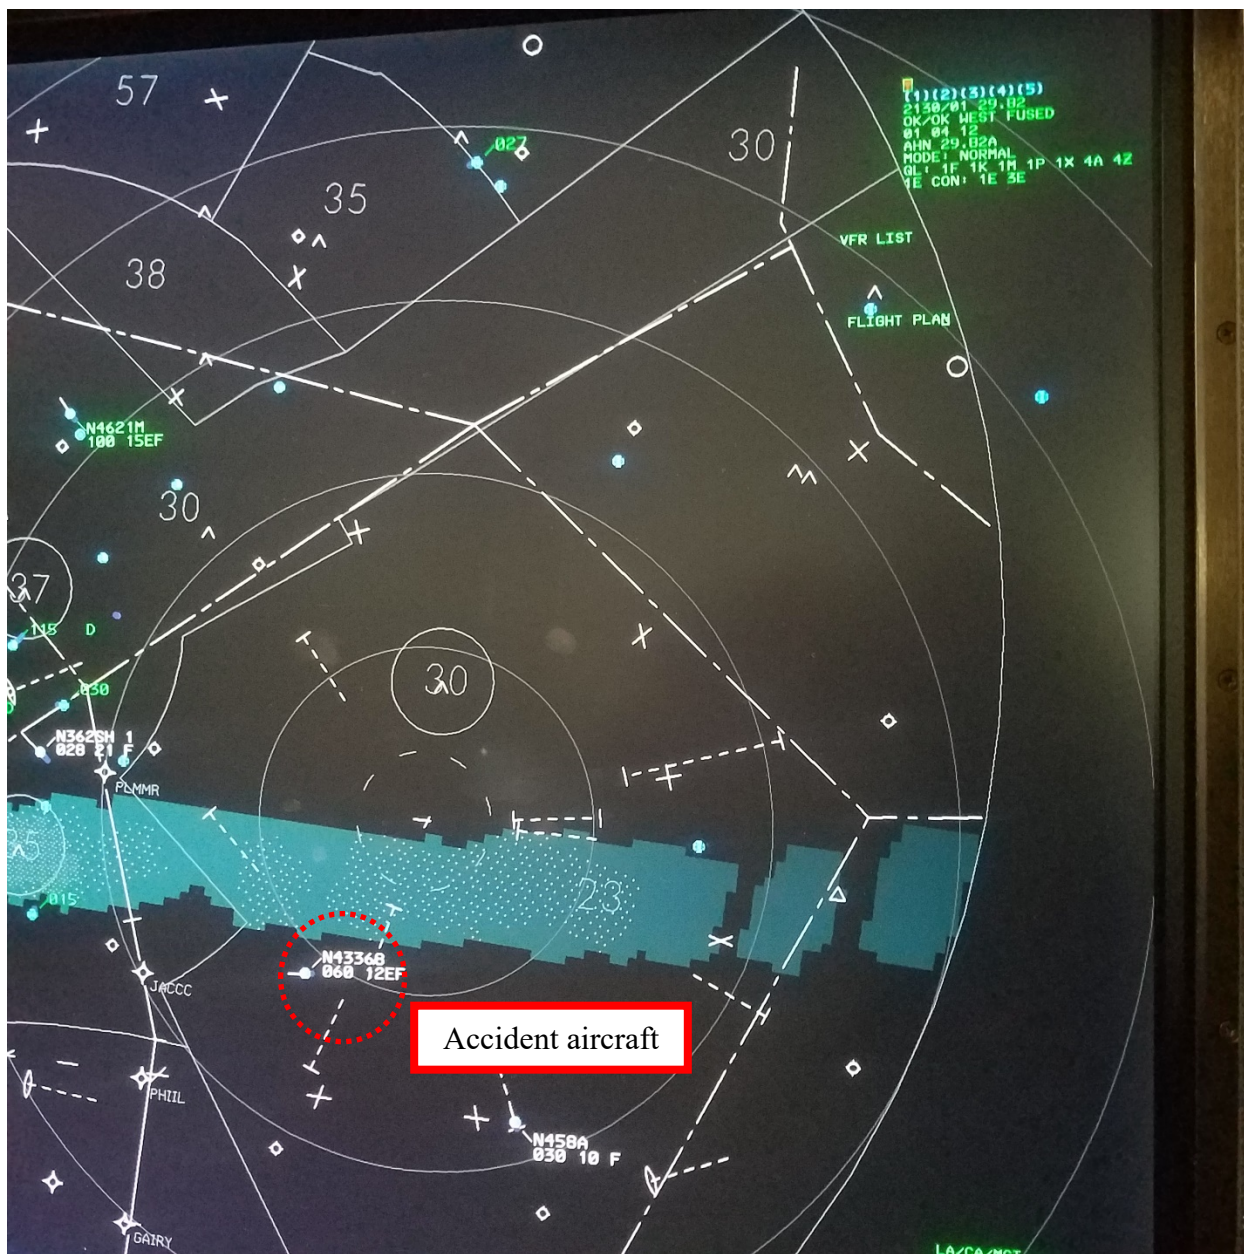
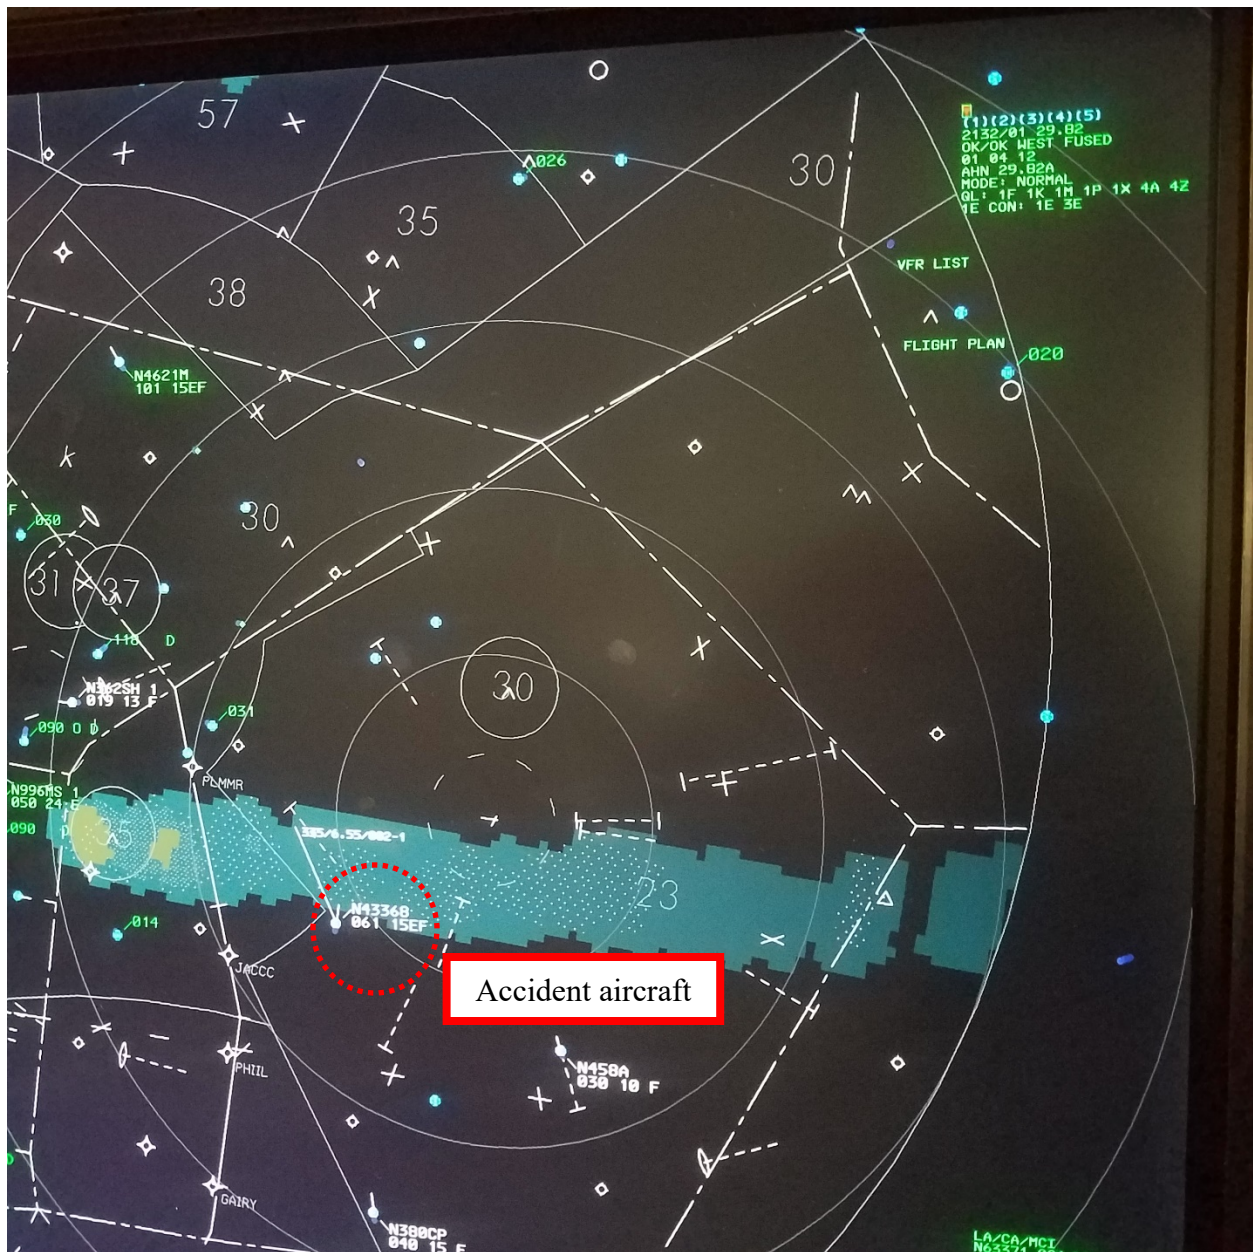
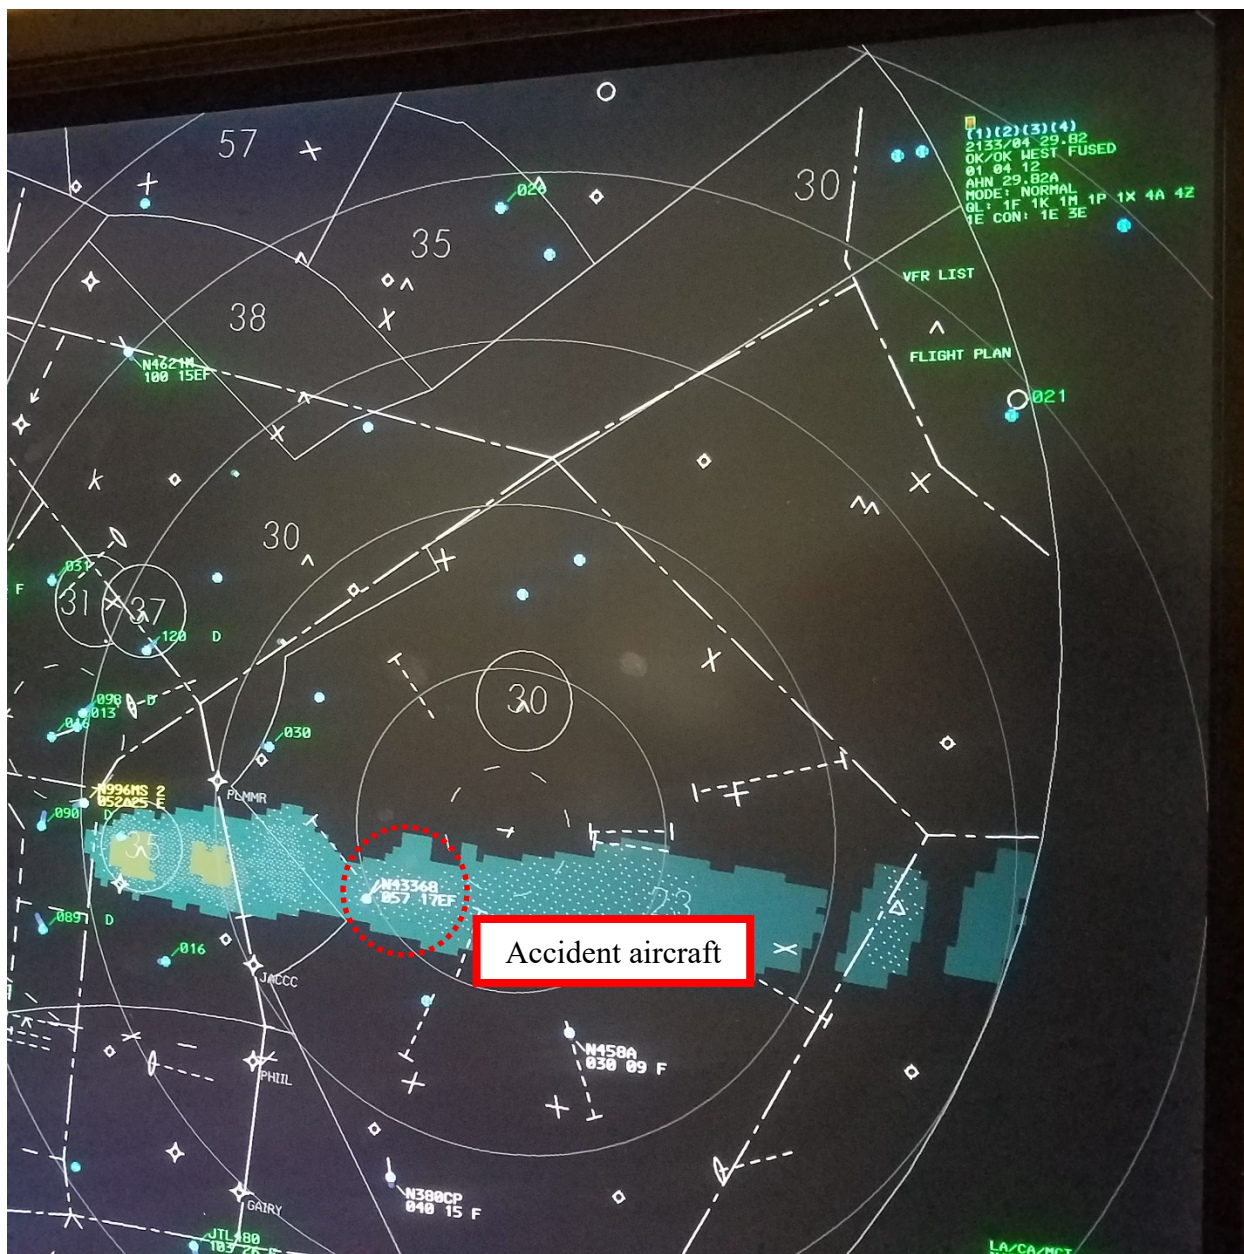
The accident aircraft remained south of the depicted precipitation until between 1632 and 1633 EST. The accident aircraft remained in level 1 to 3 depicted precipitation between 1633 and 1634 EST.

**Figure 40 – STARS weather and precipitation level display used and seen by accident controller from 1624 EST**

**Figure 41 – STARS weather and precipitation level display used and seen by accident controller from 1626 EST**

**Figure 42 – STARS weather and precipitation level display used and seen by accident controller from 1628 EST**

**Figure 43 – STARS weather and precipitation level display used and seen by accident controller from 1630 EST**

**Figure 45 – STARS weather and precipitation level display used and seen by accident controller from 1633 EST**

**Figure 46 – STARS weather and precipitation level display used and seen by accident controller from 1634 EST**

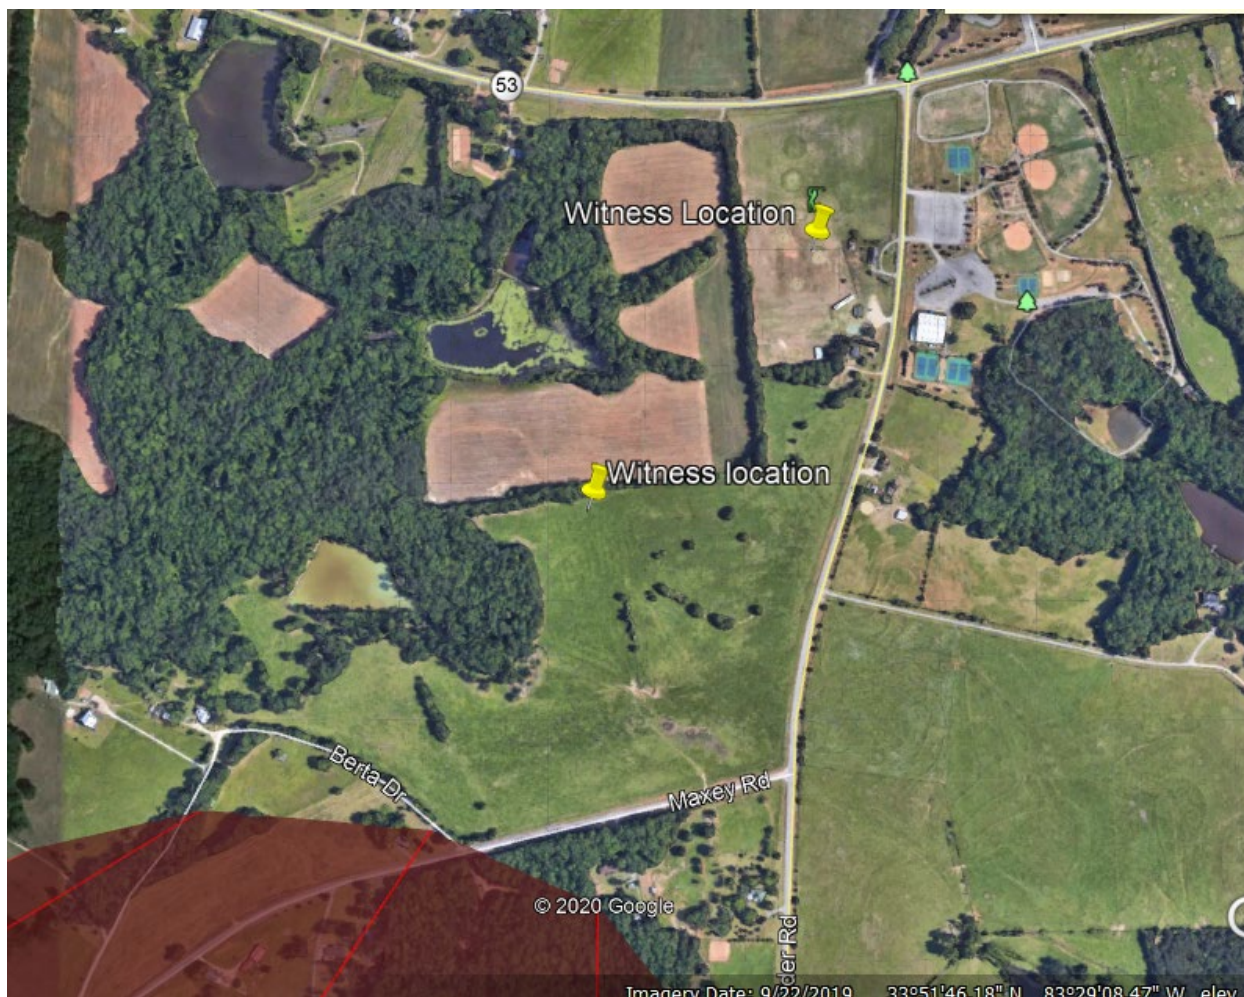
Witness information was retrieved from around the accident timeframe and their locations are located in figure 47 approximately 0.4 miles north of the accident site and approximately 0.7 miles north-northeast of the accident site, respectively. The witness located 0.4 miles north of the accident site stated that after the accident sequence that he had “never seen it rain harder than it was right after the accident.” The witness located 0.7 miles north-northeast of the accident site stated around the accident timeframe there were scattered rain showers in the area with cloud bases about 2,500 to 3,000 ft agl and no lightning or thunder with visibility of about 20 miles. For more information please see attachments 17 and 18.

**Figure 47 – Witness locations compared to accident flight track (red line)**
