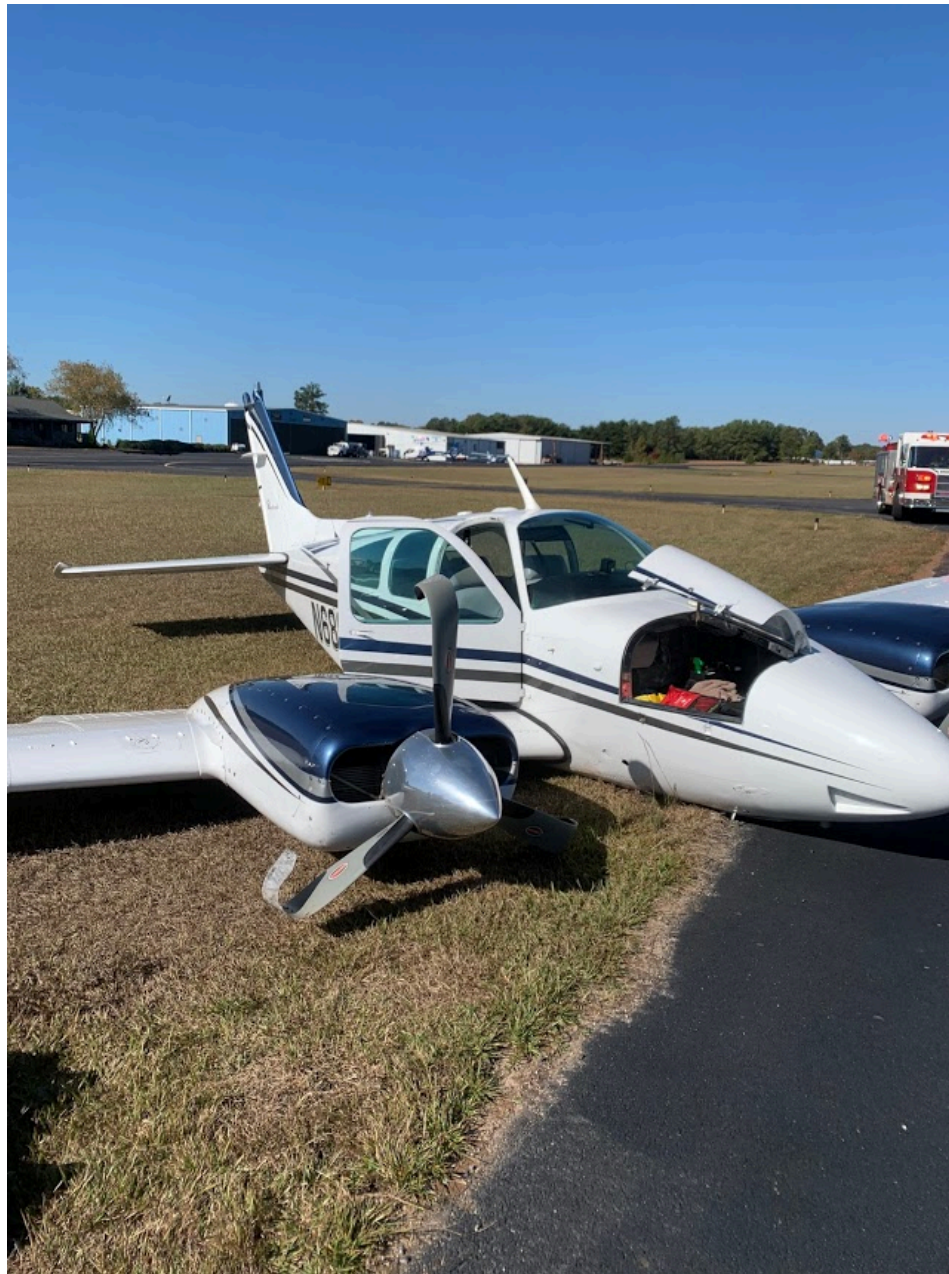
**Photo 1 – View of right front quarter of airplane at rest on the side of the runway. Note gear up configuration and propeller damage. (Courtesy of FAA)**

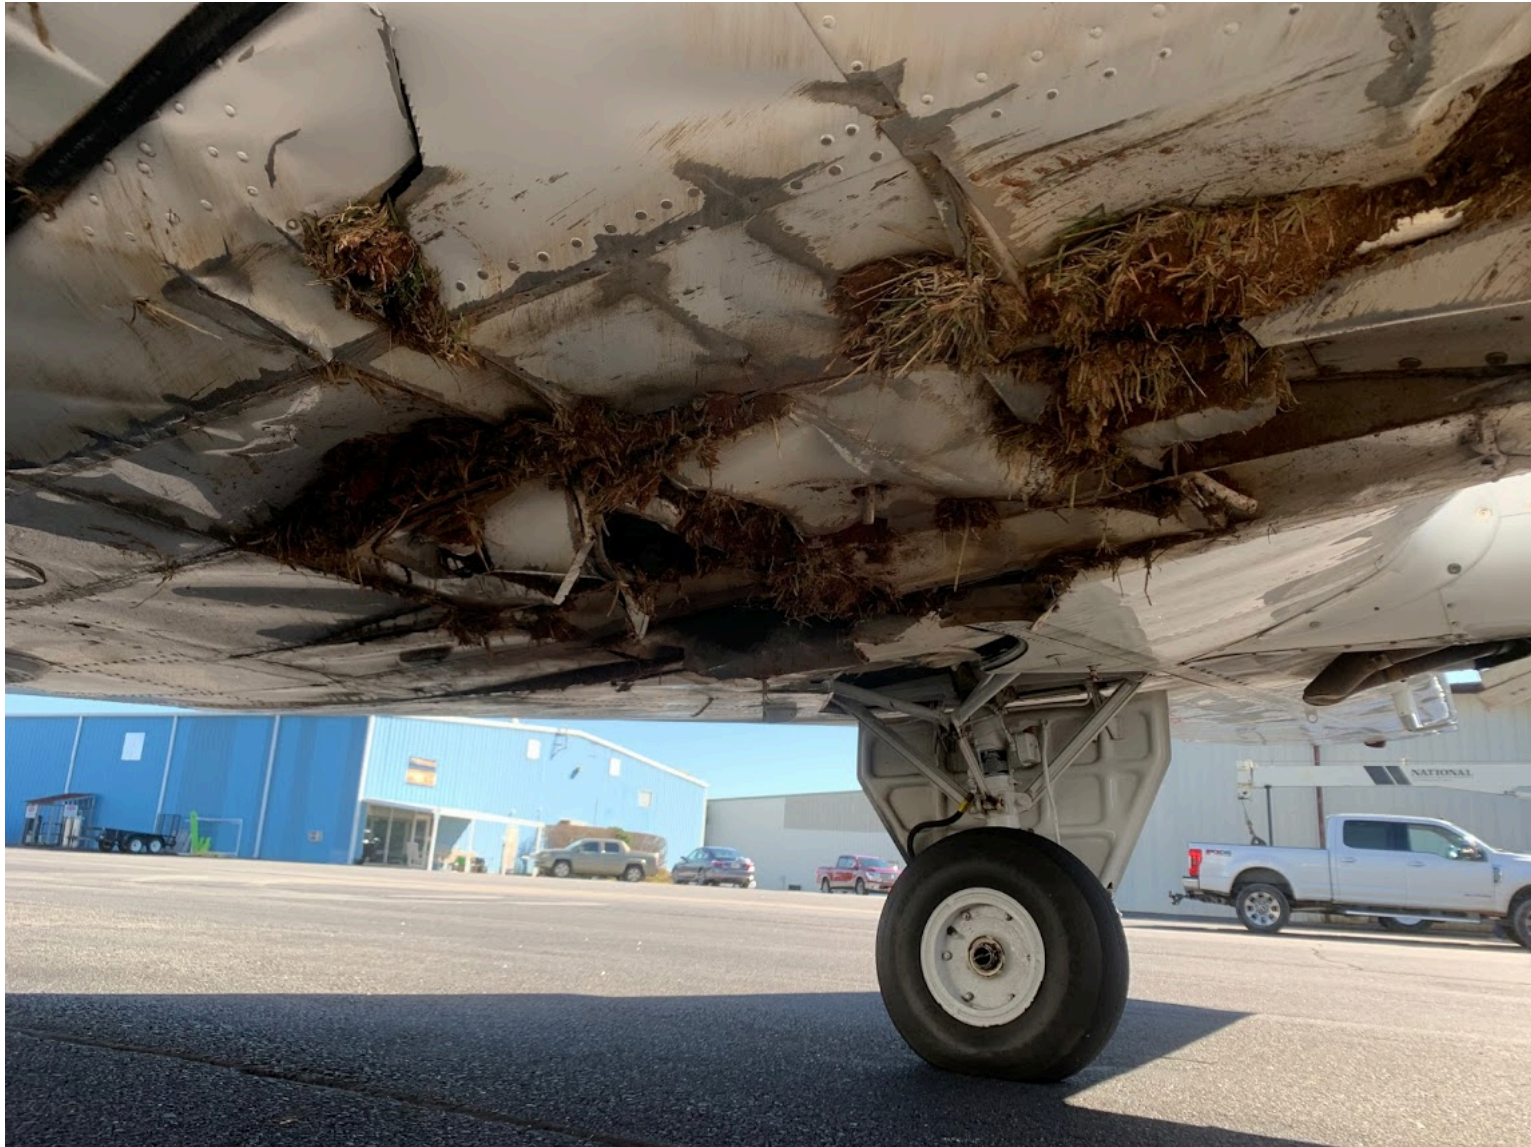
**Photo 2 – View of damage to underside of fuselage. (Courtesy of FAA)**

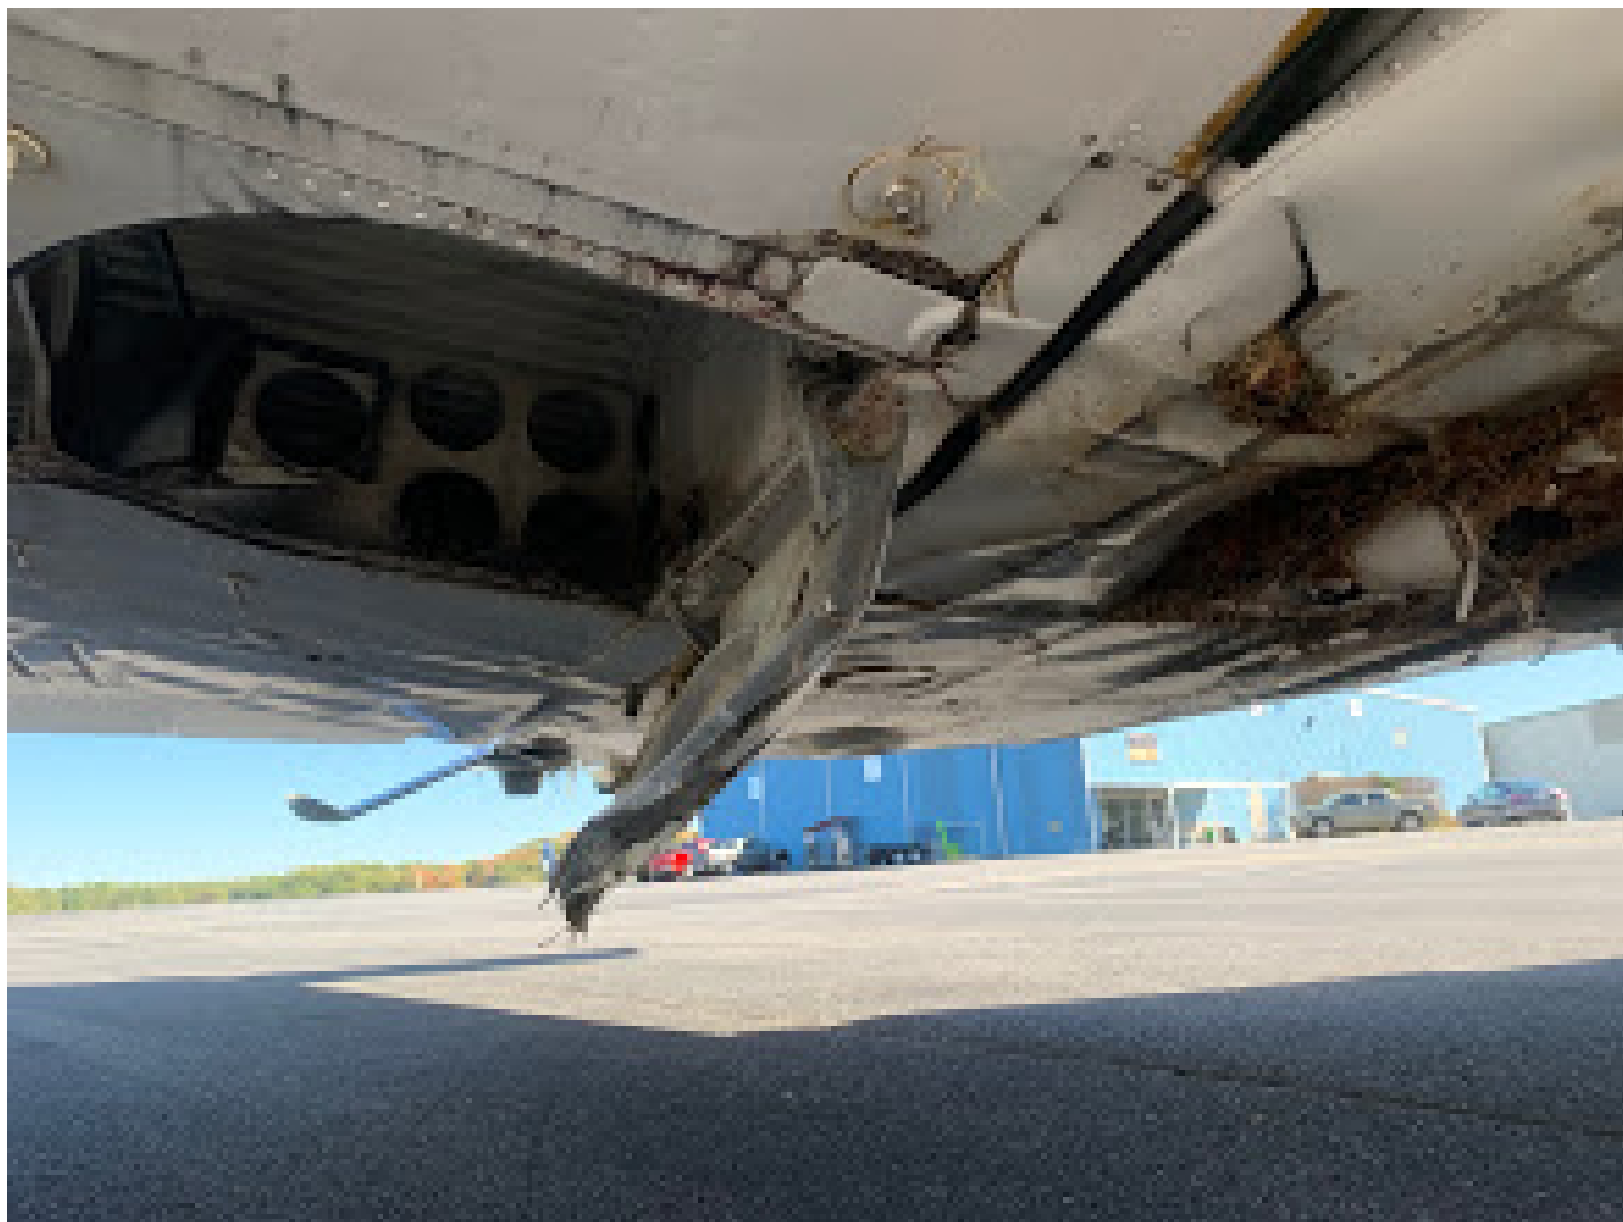
**Photo 3 – View of damage to fuselage and right landing gear door. (Courtesy of FAA)**

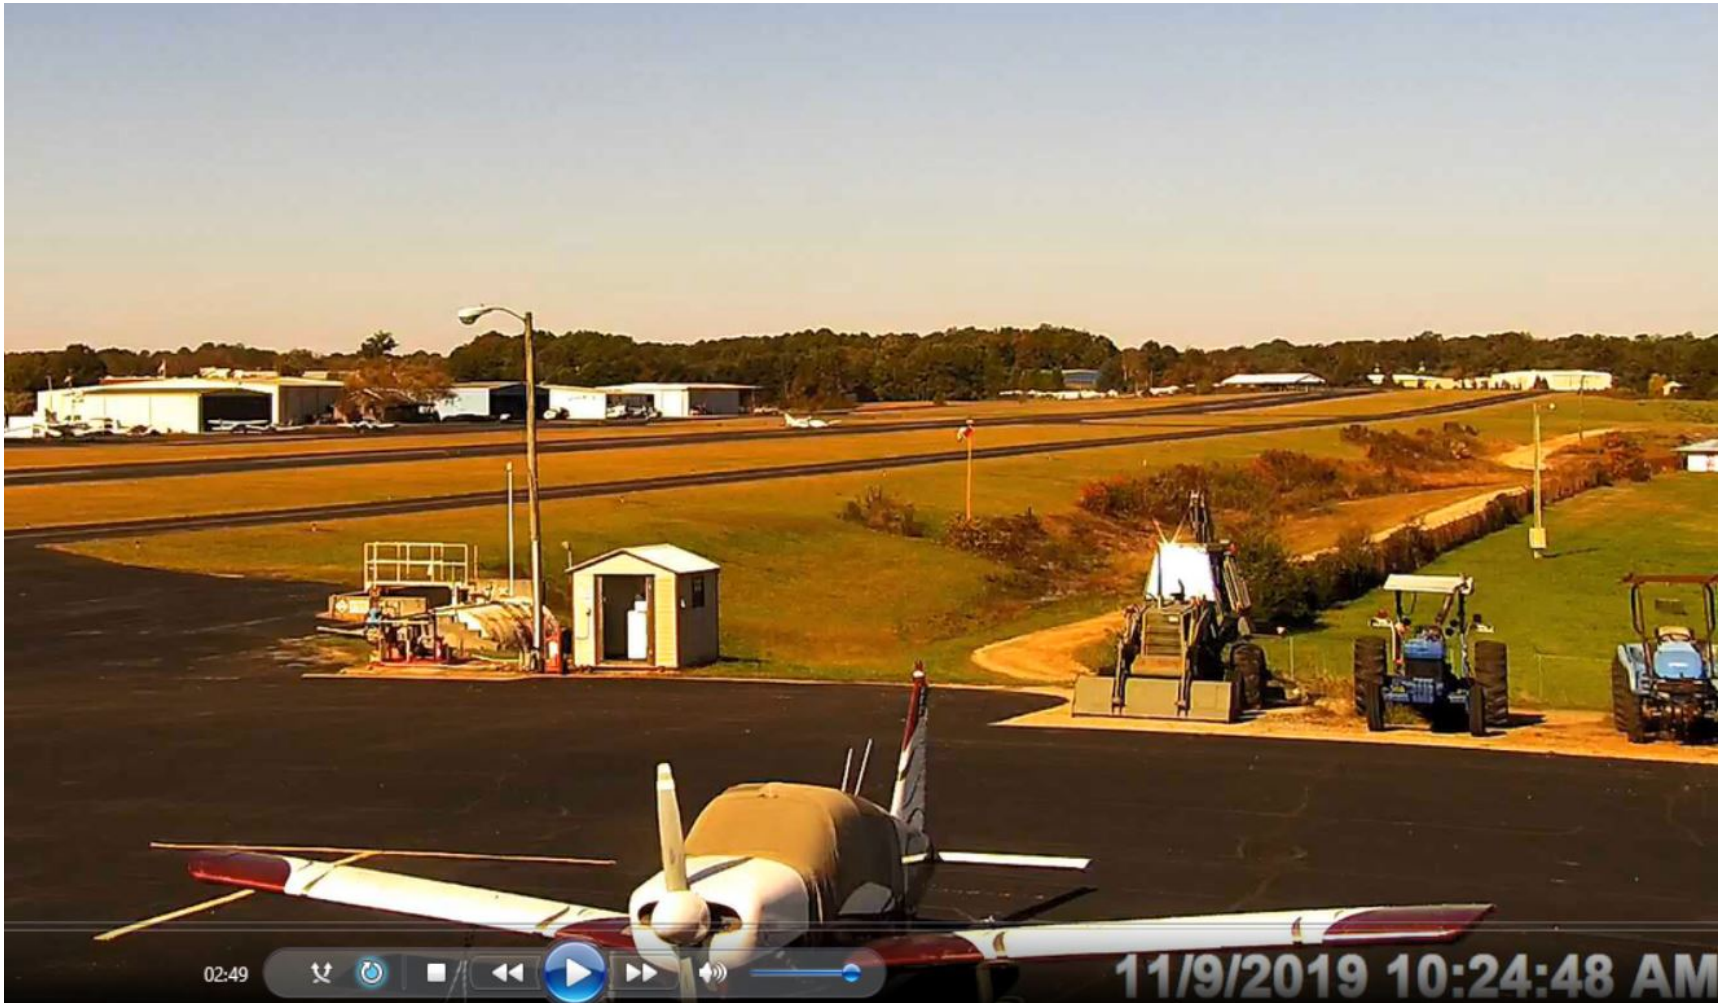
**Photo 4 – Airport surveillance video screen capture of airplane shortly after it came to rest. (Courtesy of Airport Authority)**
