## MEMORANDUM FOR RECORD

**Subject:** ERA20LA051  
**Who:** Michael Budinski – Chief of NTSB Materials Laboratory

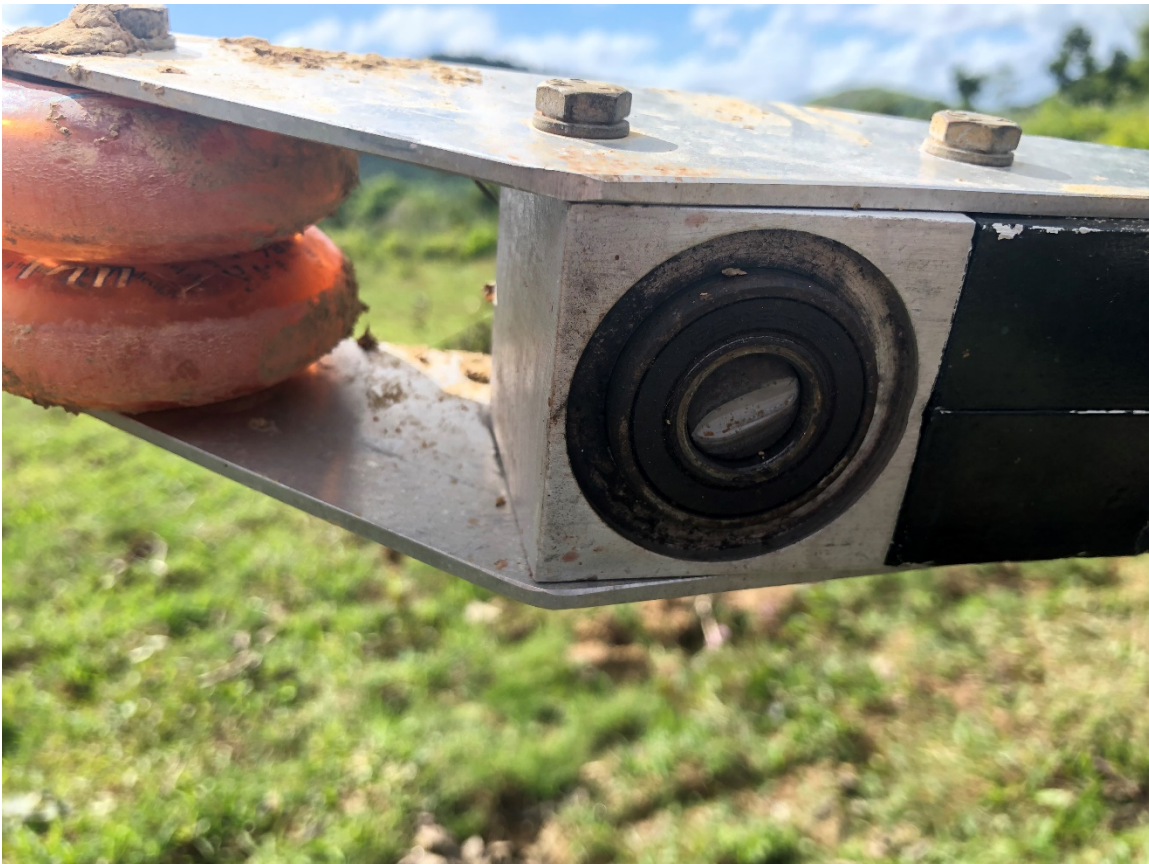
- The bolt fractured by reverse bending fatigue.

*Figure 1. View of Fractured Bolt at Accident Site*

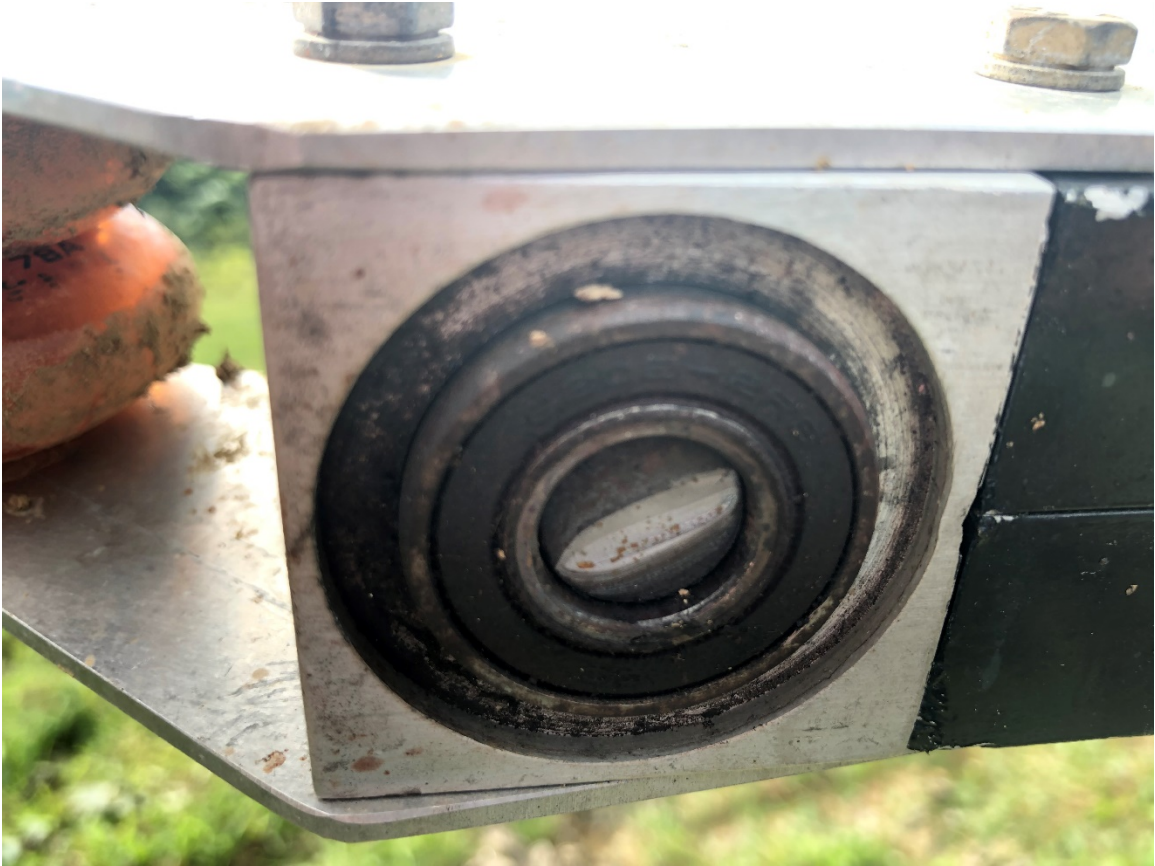
*Figure 2. Closer view of fractured bolt.*
