## NTSB MEMORANDUM FOR RECORD

**Date: April 13, 2020**  
**Person Contacted: Phillip Grice (Continental Motors)**  
**NTSB Accident Number: ERA20LA064**

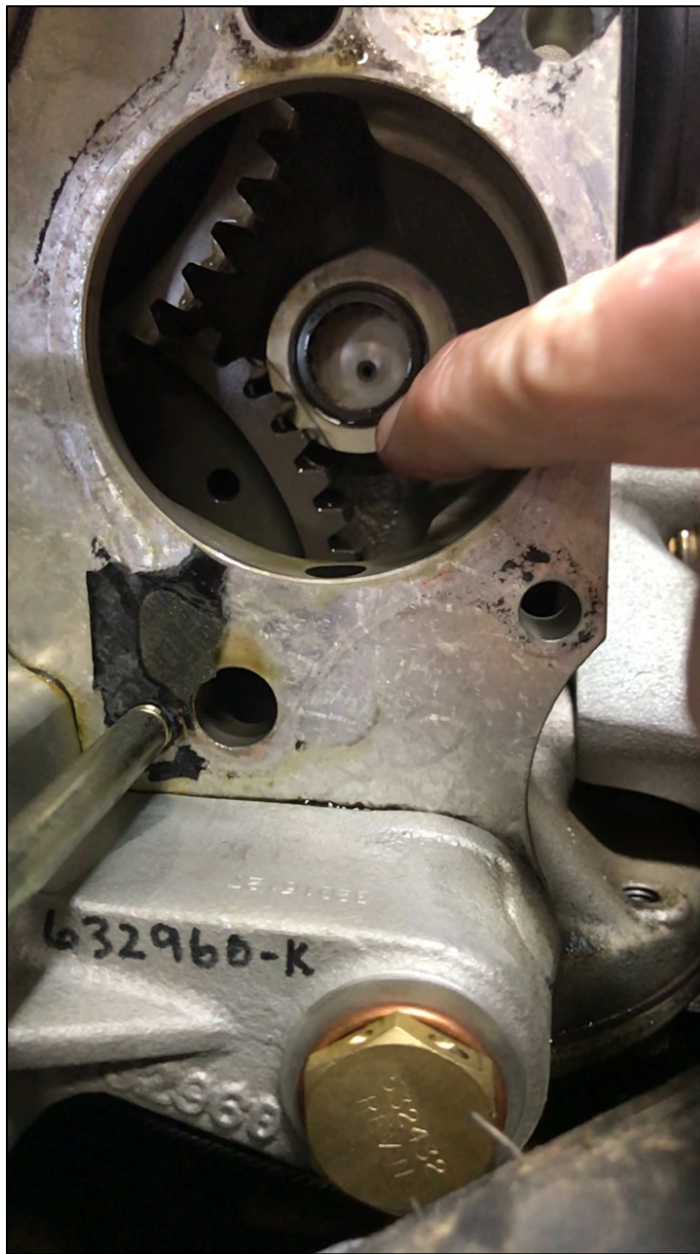
Photo 1: View of the camshaft gear (item #4)

- The engine was rotated manually by hand and in doing so, the camshaft gear (item #4) rotated through a complete 360° rotation. The camshaft gear was not missing any gear teeth and there were no abnormalities observed with its condition.
- When the engine was again rotated by hand, the camshafts governor drives (item #7 and #8) would not rotate as expected.

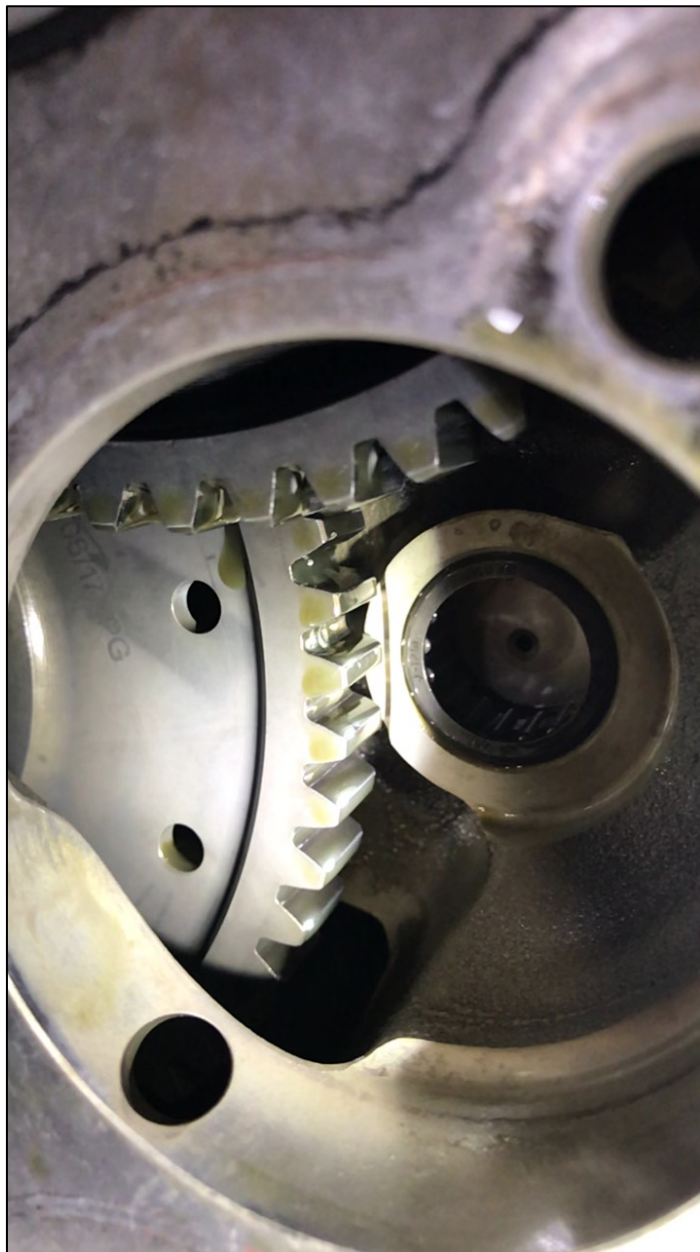
Photo 2: Closer view of the camshaft gear (item #4). The condition of the gear was unremarkable.
