## Inspector Statement

N377SB accident on 02/15/2020. The pilot reported that the aircraft had pulled hard to the left after touchdown on runway 08. The aircraft left the runway and proceeded through the grass until it contacted a drainage ditch.

On 02/19/2020 Inspector Aaron deVogel traveled to Downtown Island Airport (DKX) in Knoxville, TN to inspect N377SB. This aircraft is a Rockwell International, model 112B, serial number 526 with 3049 total airframe hours. The last annual inspection was performed in April 2019.

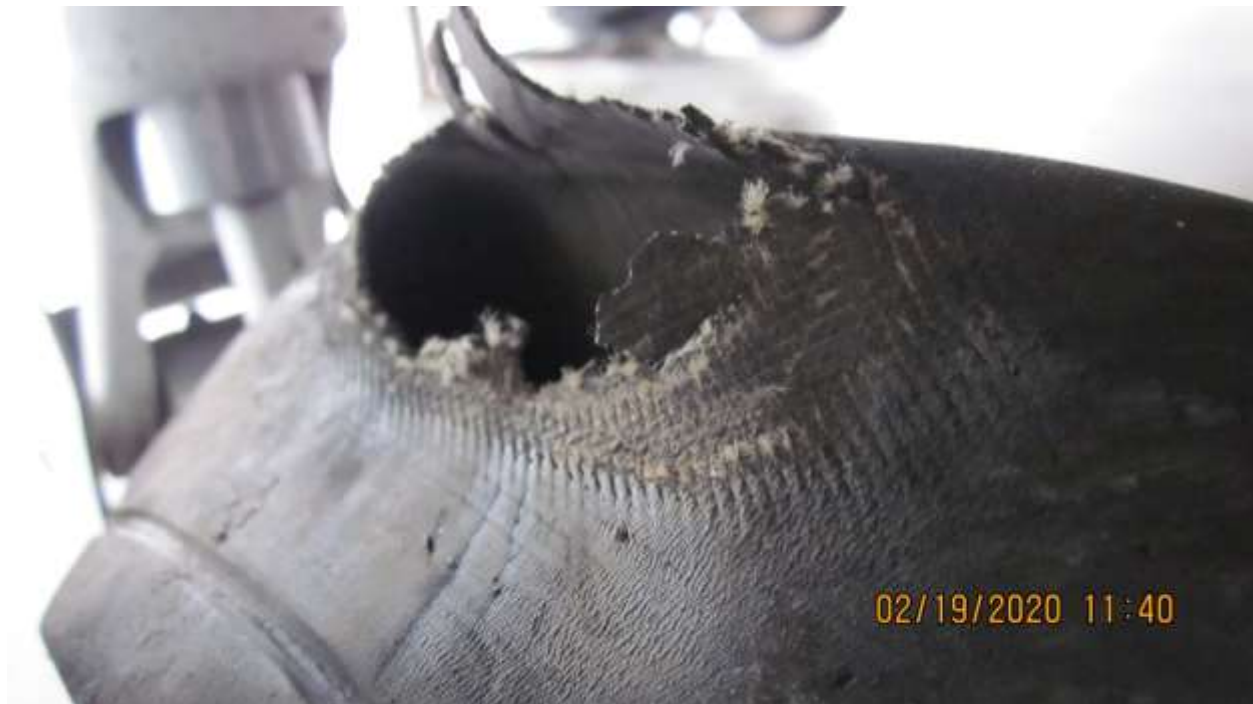
The left main landing gear tire had worn down to the point of failure.

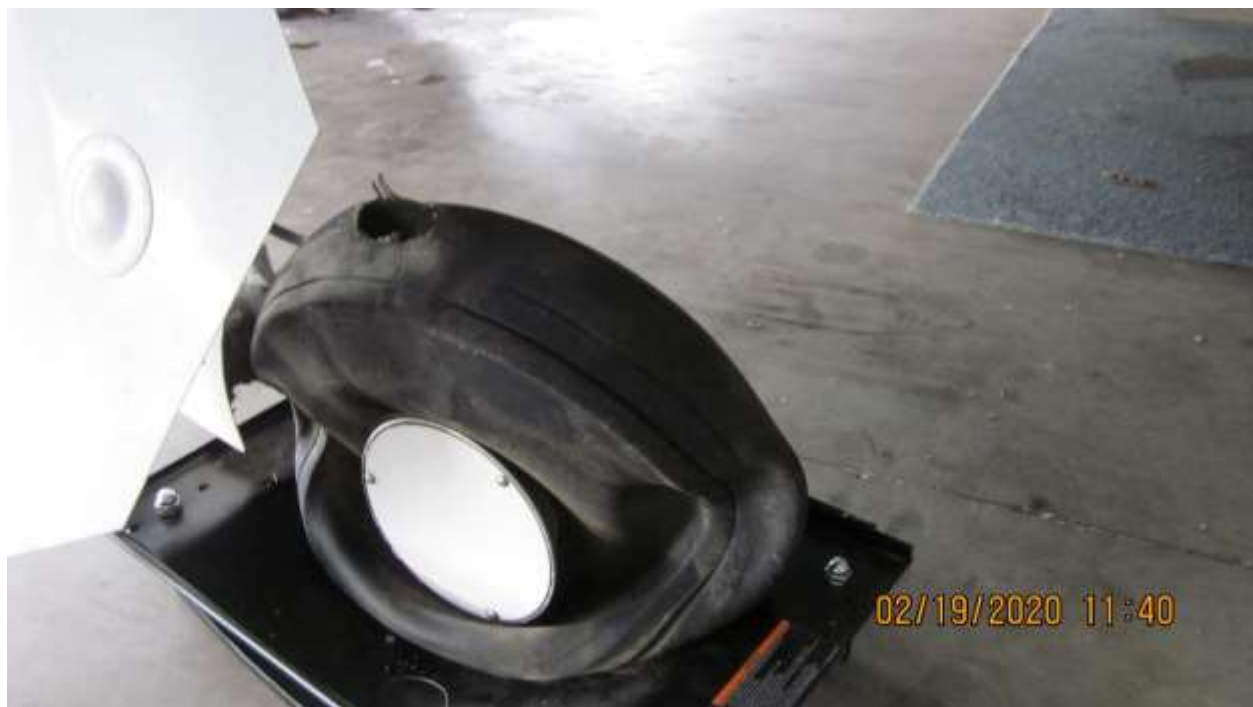
The tread on the rest of the tire was in good condition.

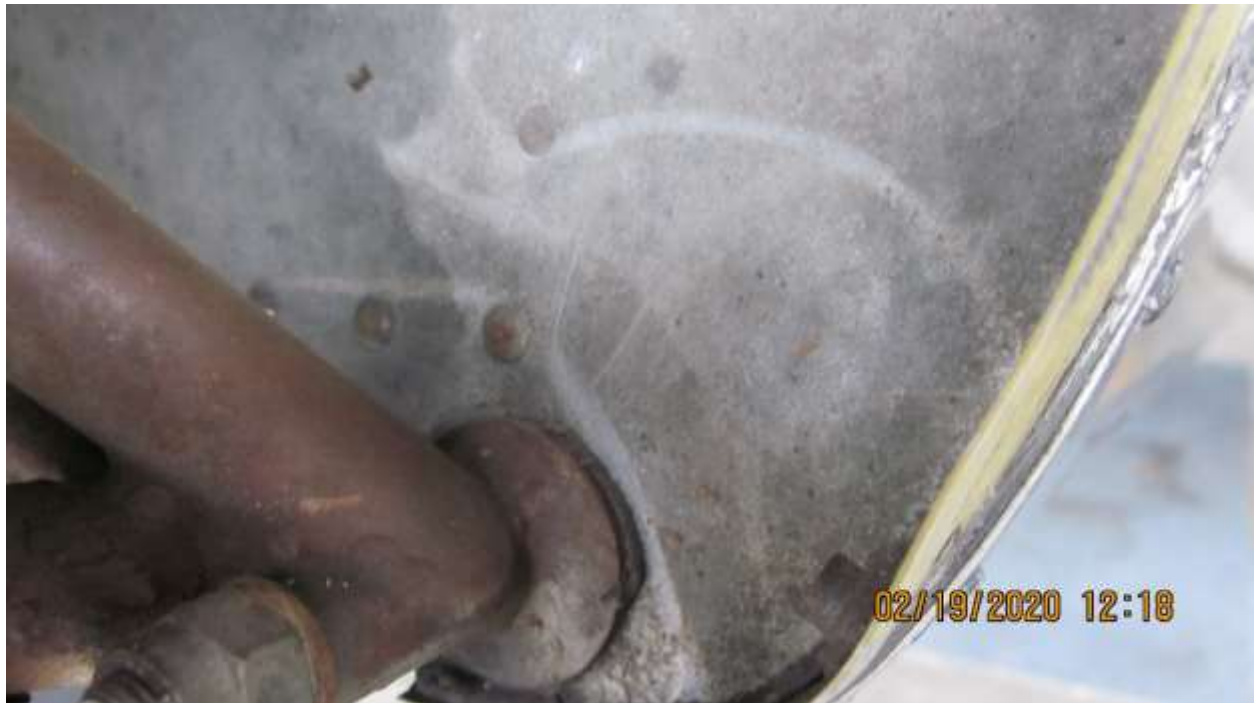
The engine firewall is buckled on the lower left engine mount.

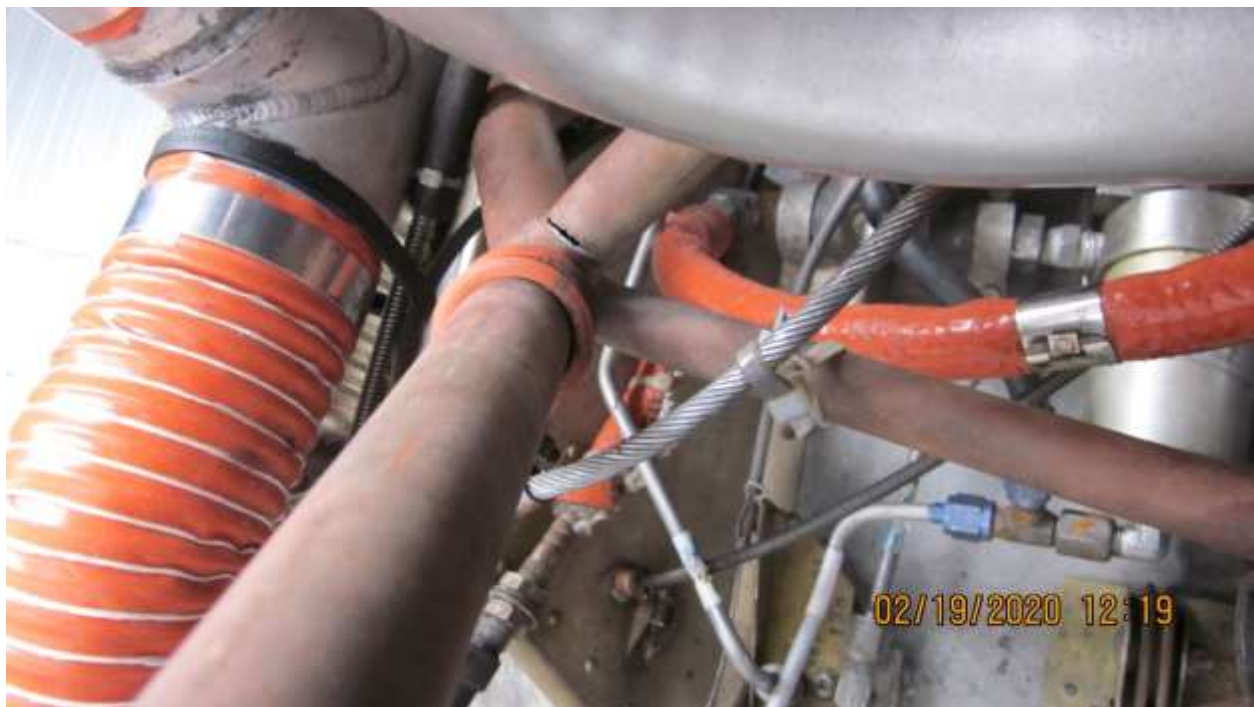
The engine mount suffered multiple fractures.

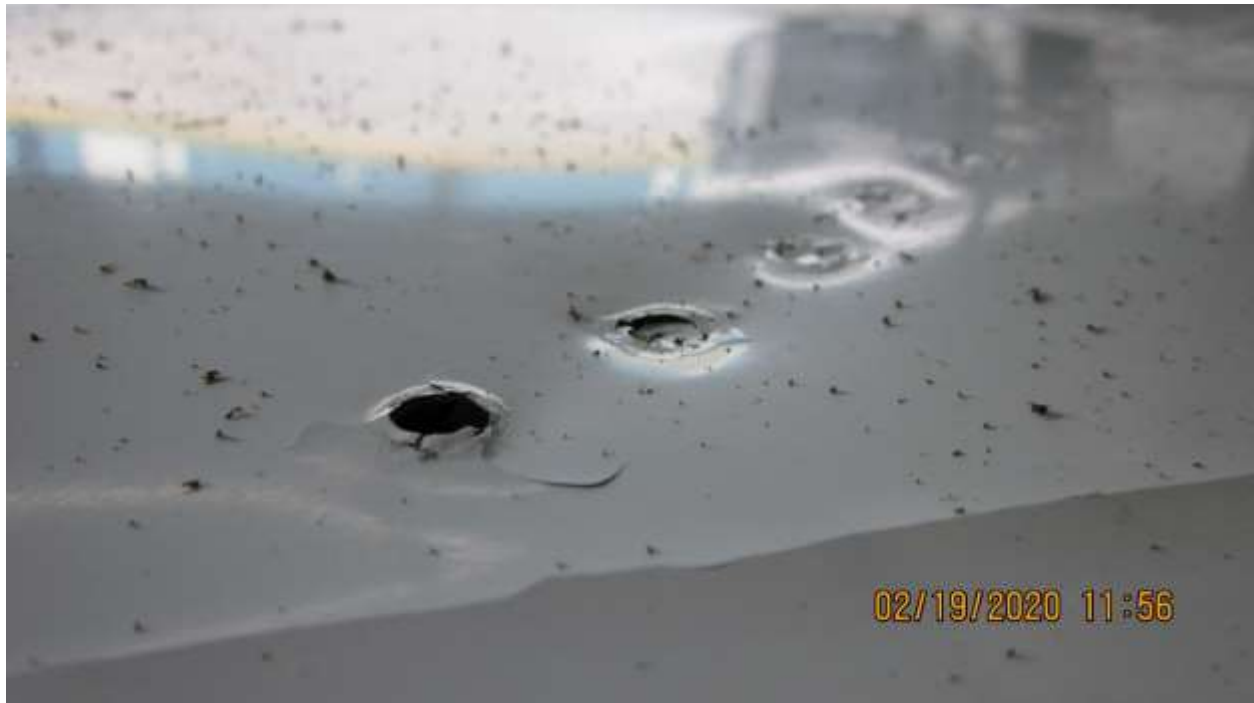
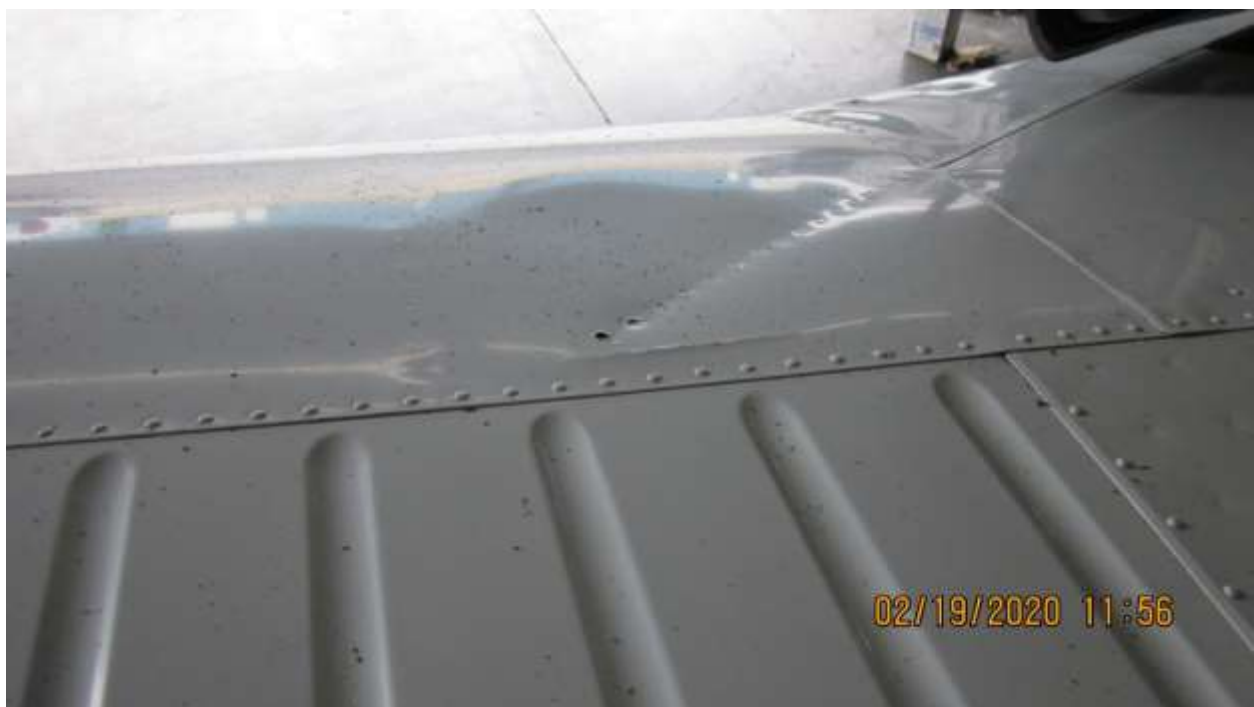
Multiple rivets were torn through the skin on the left wing.

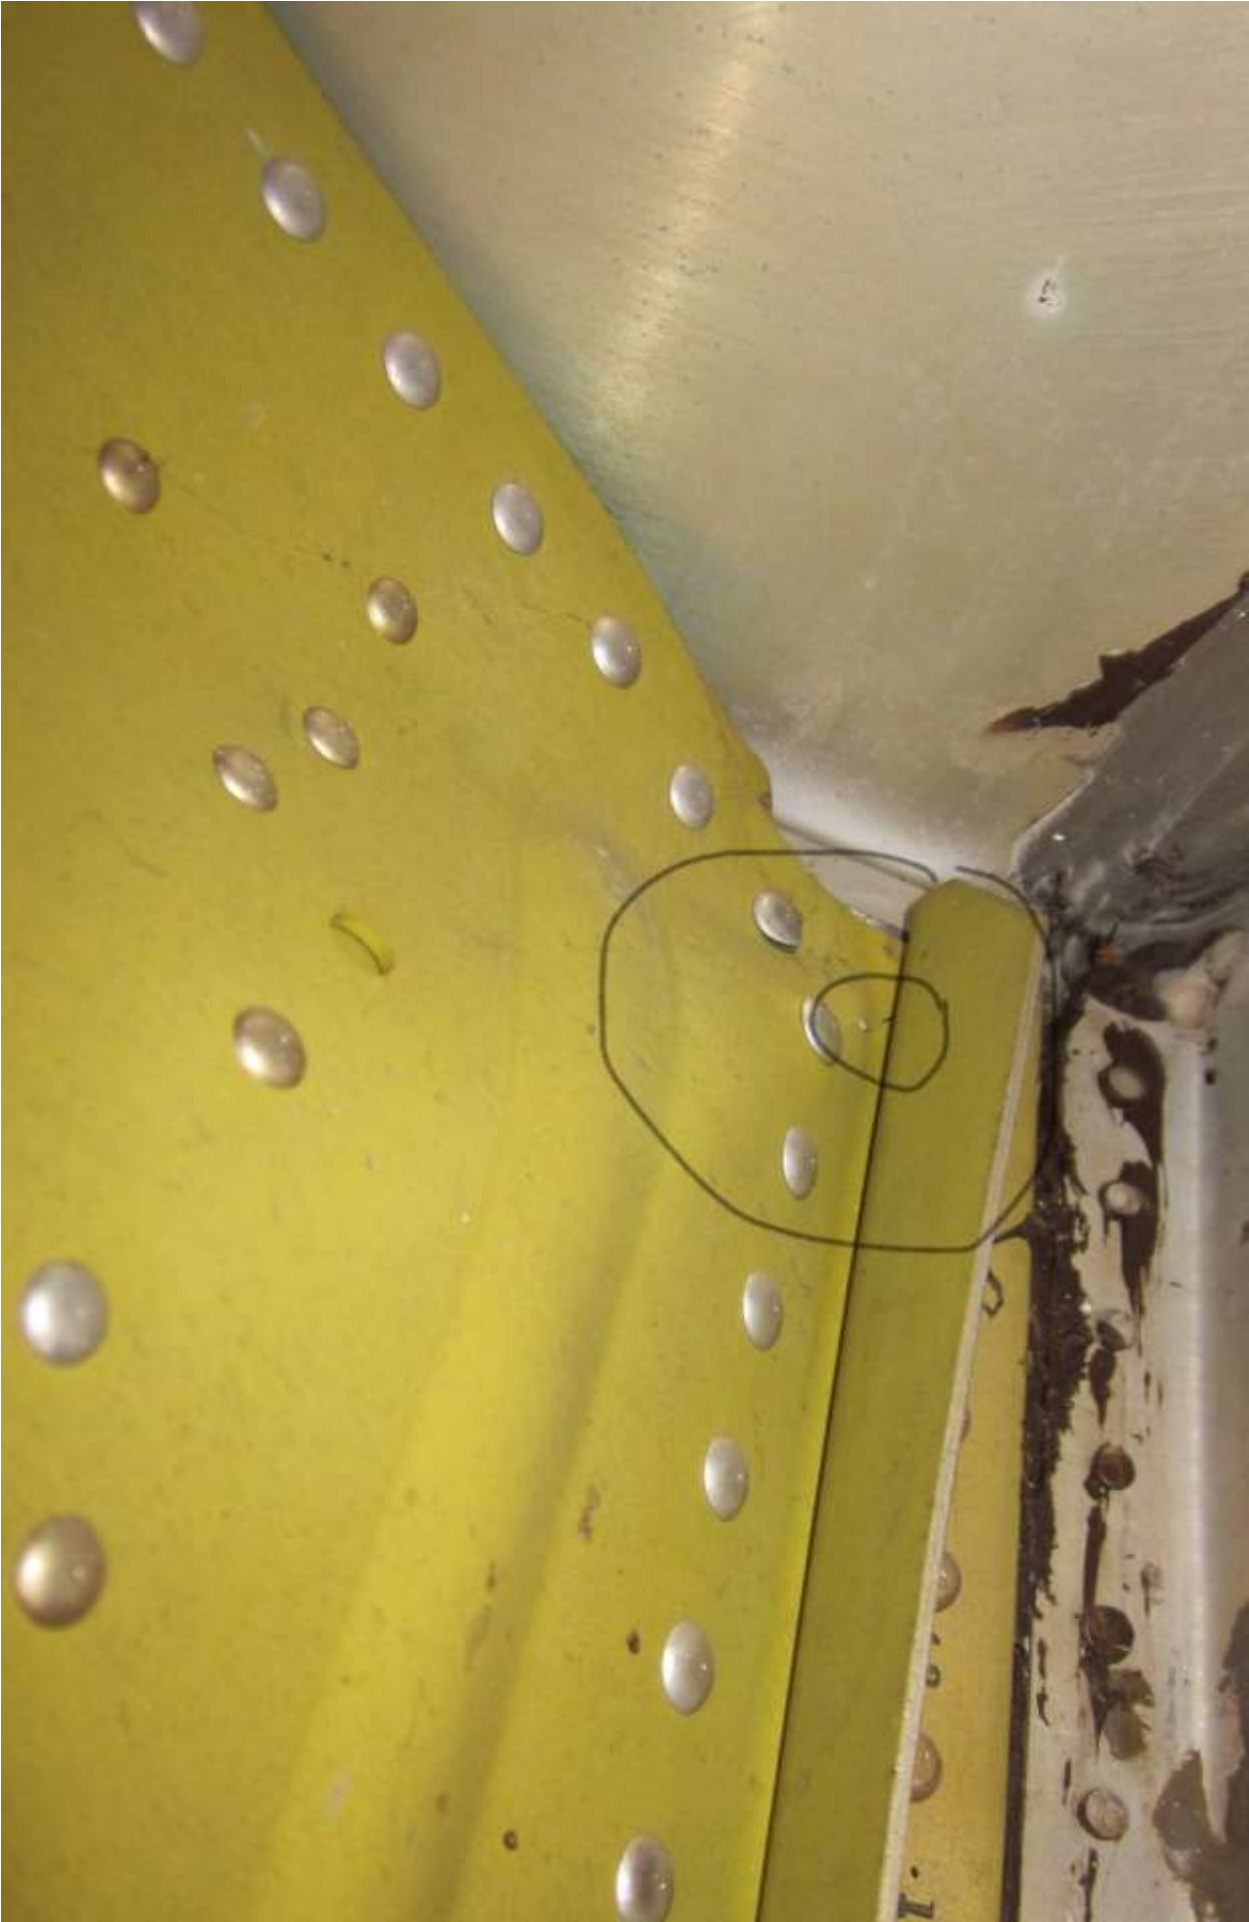
There were multiple cracks found on or near the left wing spar. This was viewed through an inspection hole under the left wing.

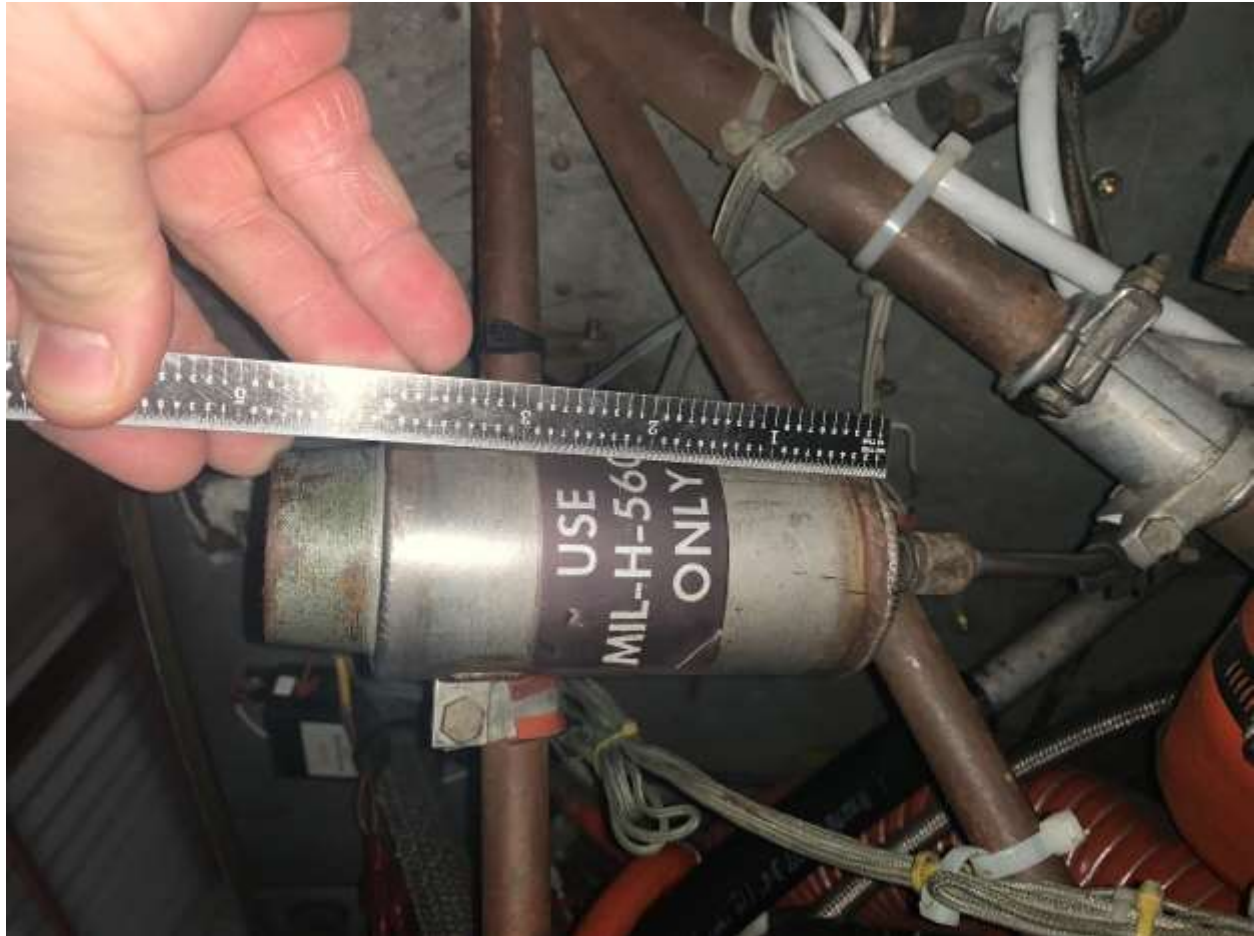
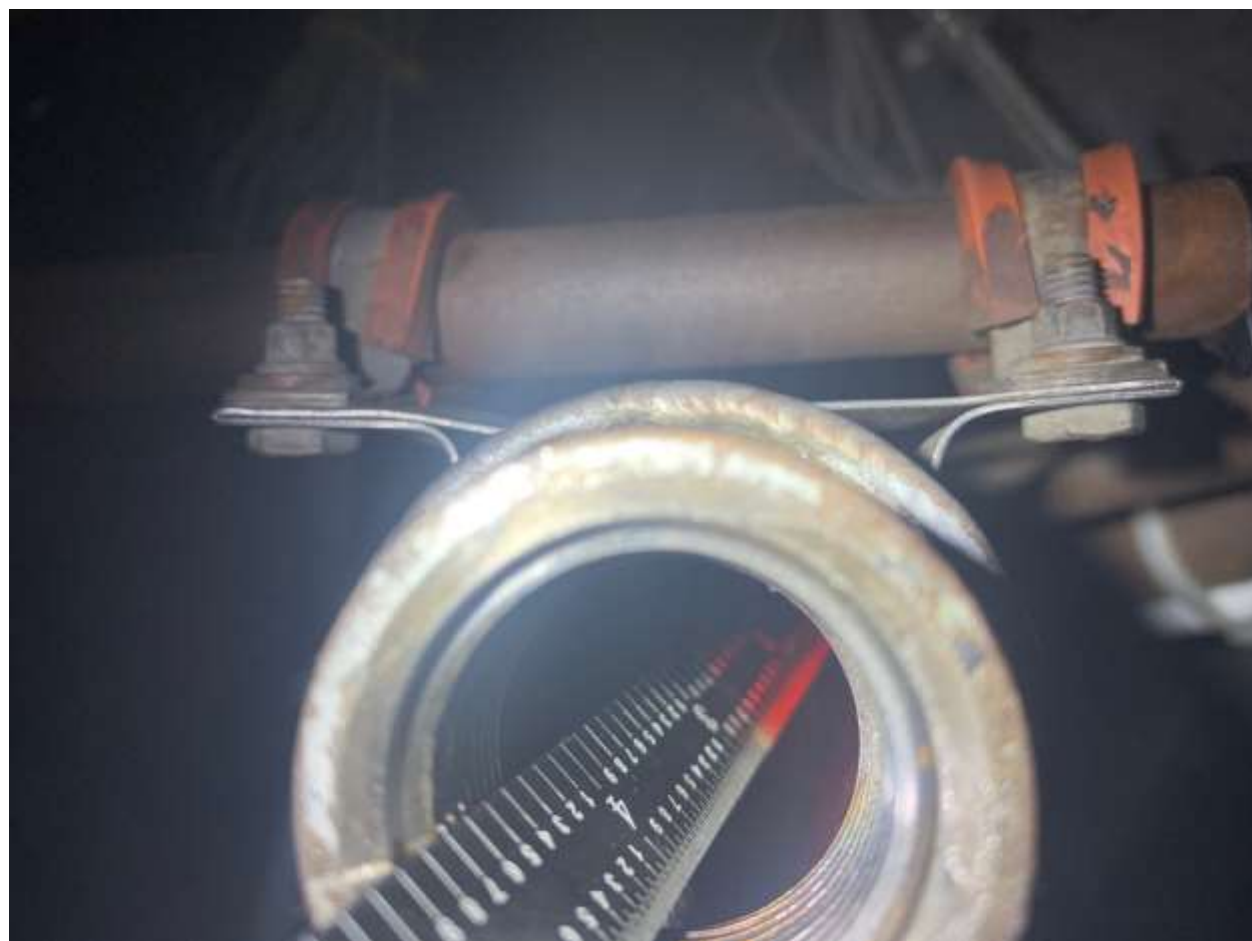
A brake function check was performed satisfactory and the system was inspected for leaks. The brake calipers locked the brakes appropriately and released them when the brake pedals were released. A post inspection picture was taken of the brake reservoir and fluid levels.

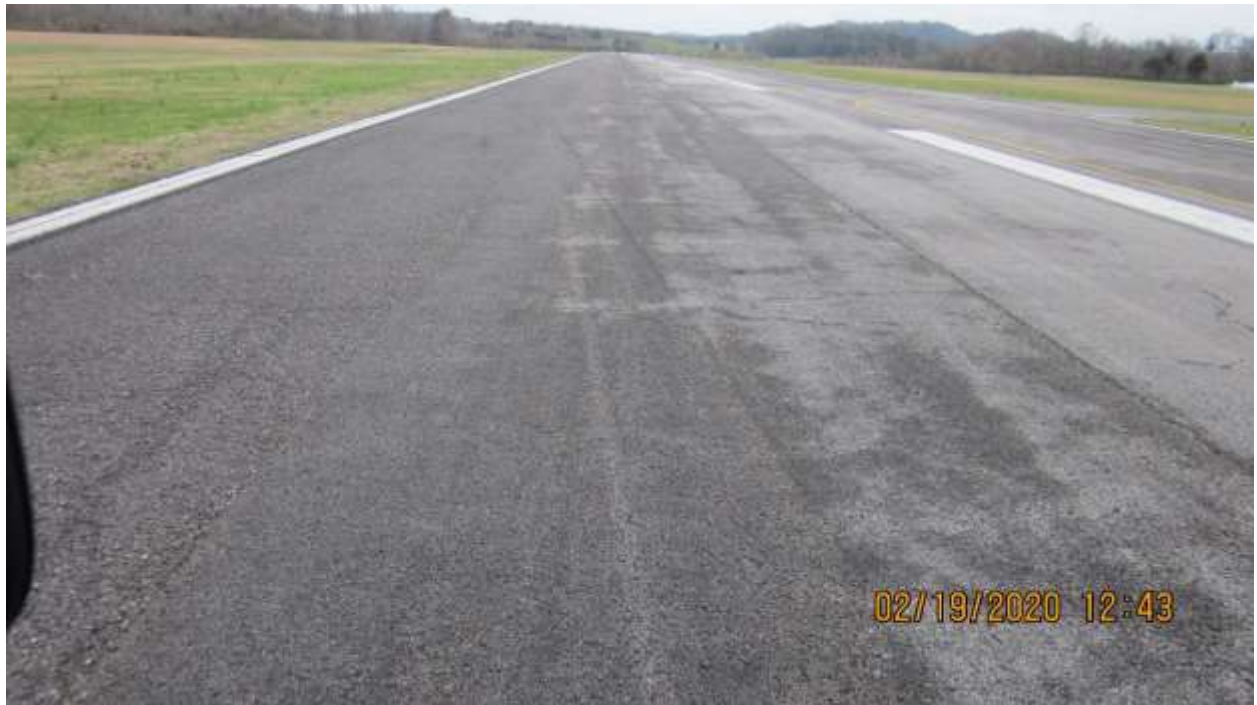
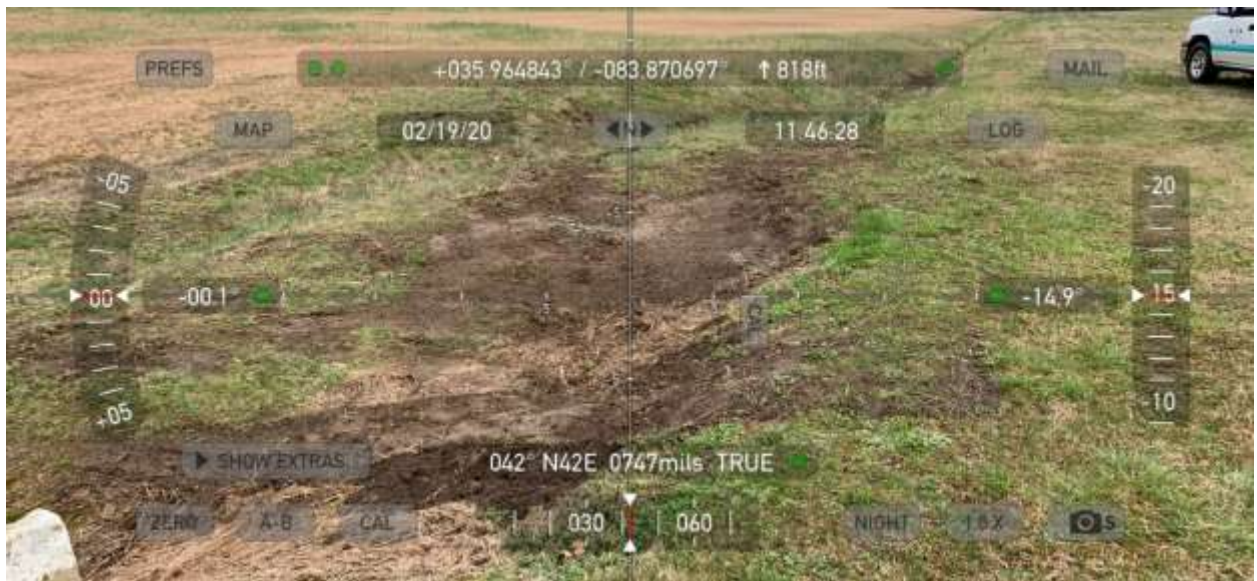
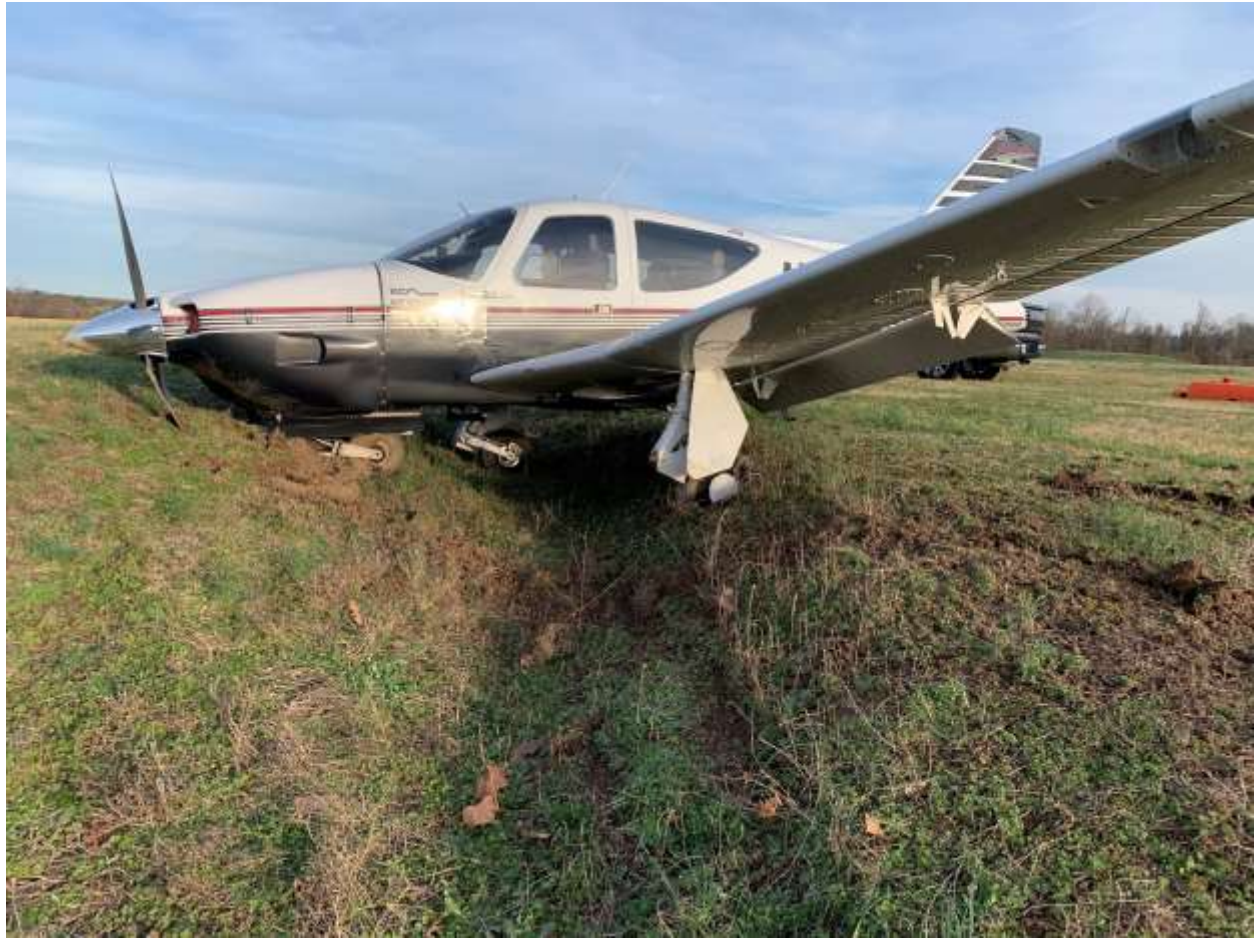
The following pictures show the rubber skid mark of the left main tire on the runway, the point the aircraft exited the runway and the final resting place of the aircraft.
