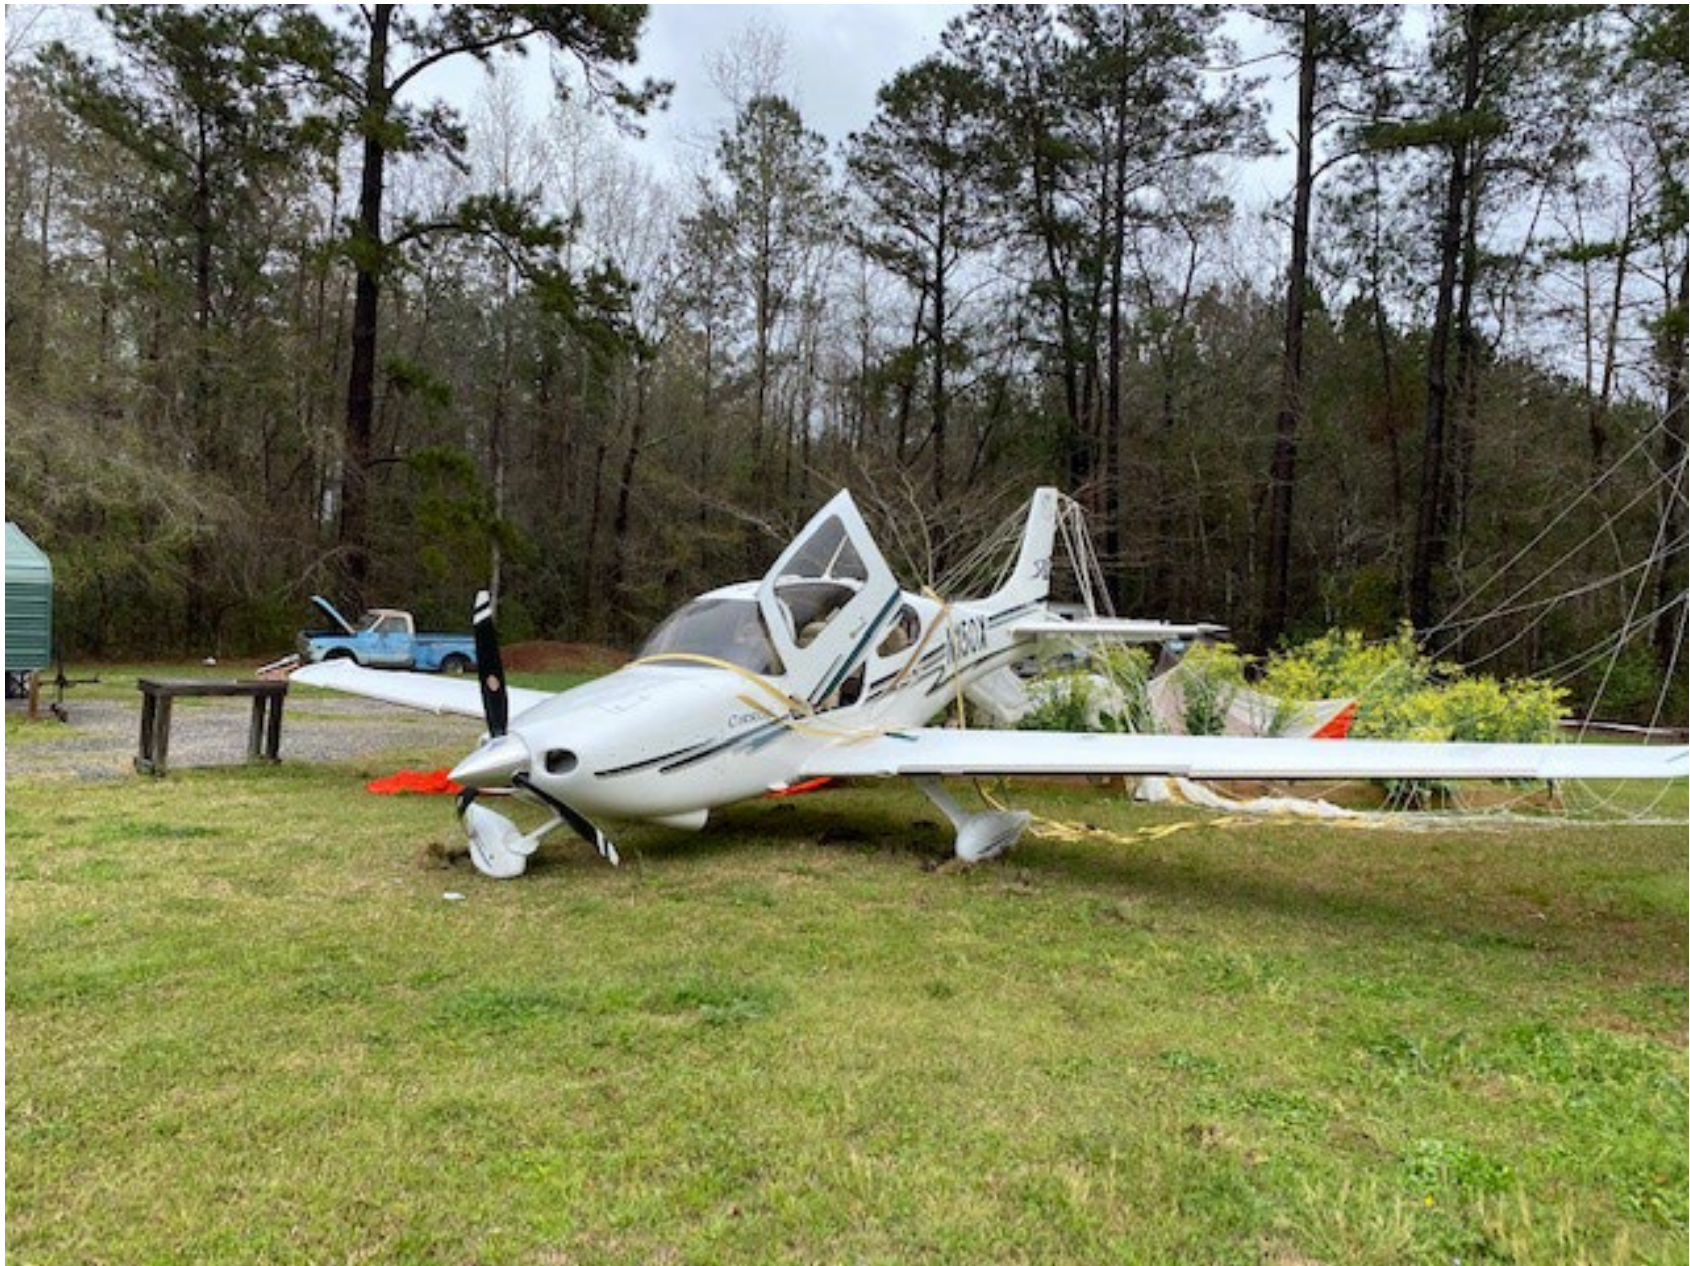
**Photo 1 – Digital Photograph From ARFF Deputy Chief MYR Airport. Left Forward View of the Airplane Where it Came to Rest.**

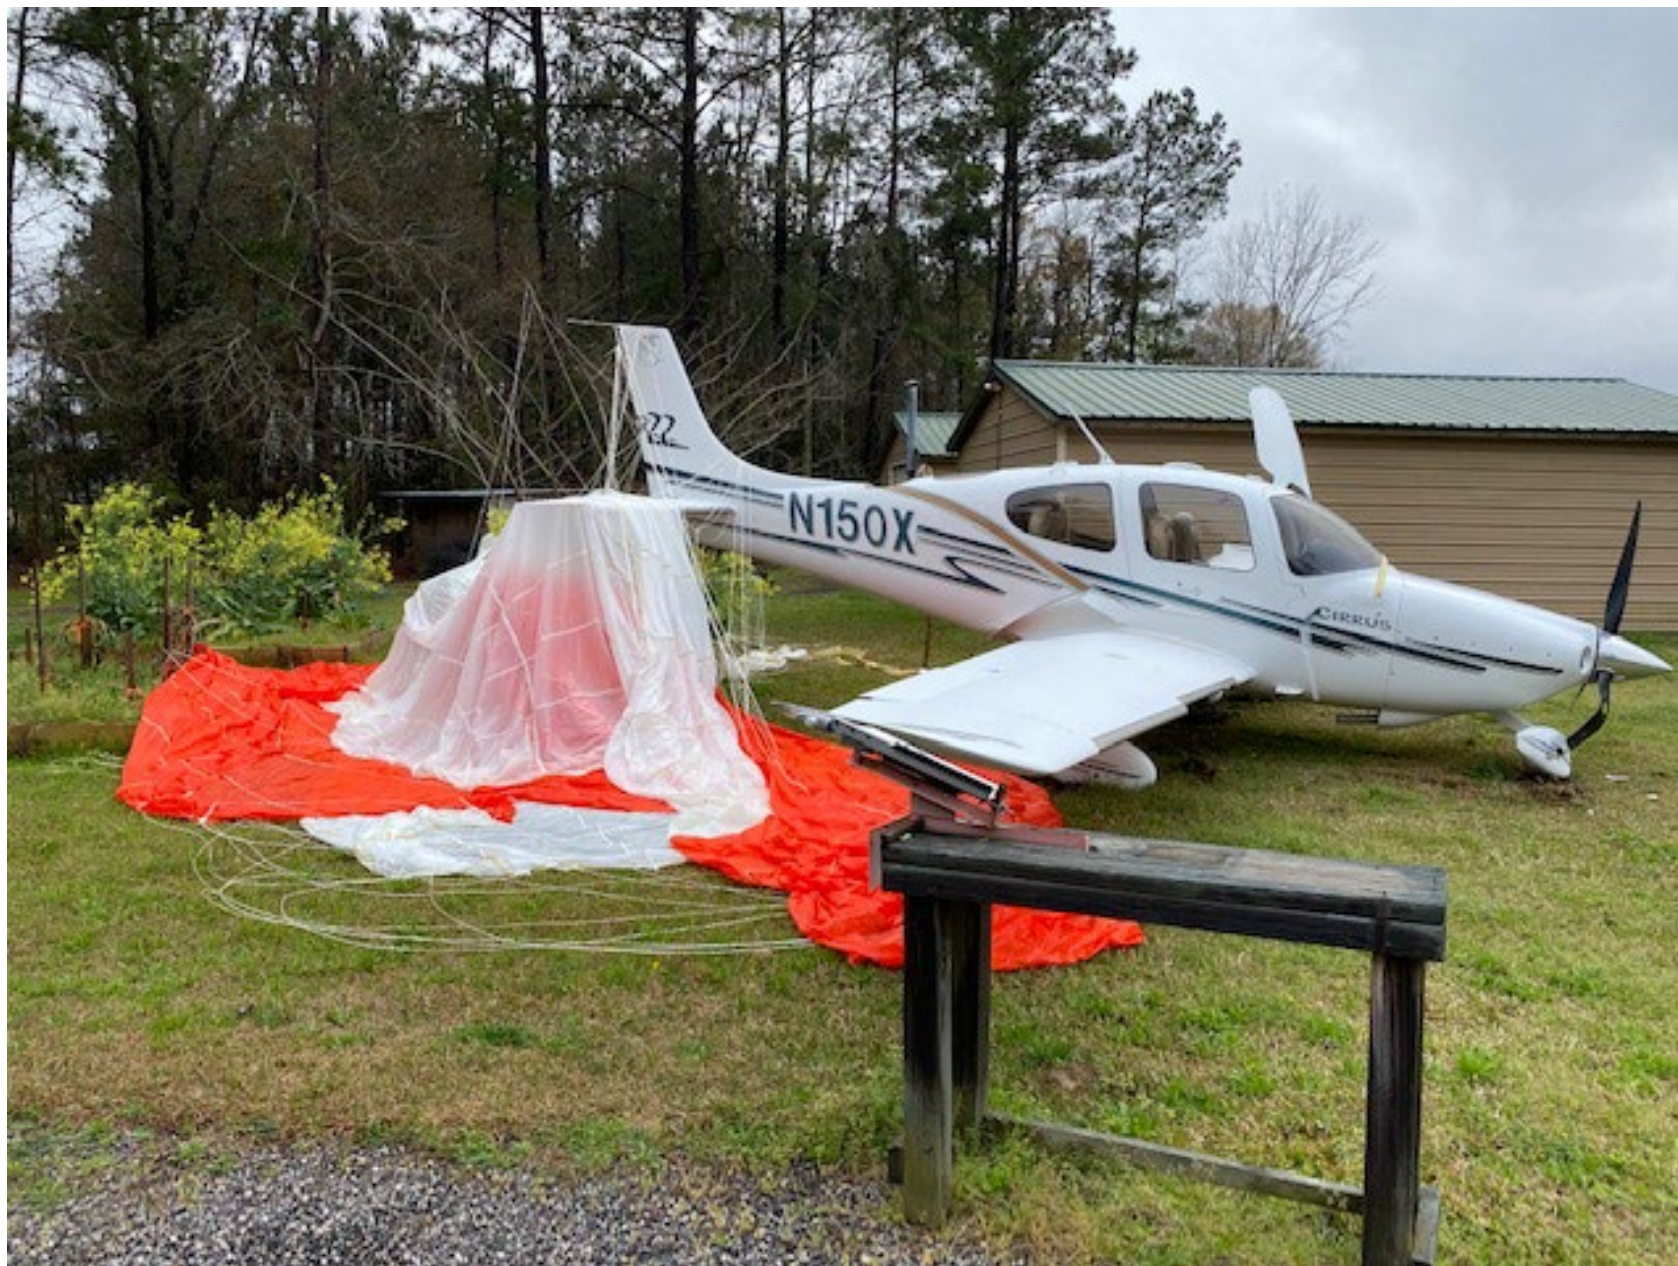
**Photo 2 - Digital Photograph From ARFF Deputy Chief MYR Airport. Right Side View of the Airplane Where it Came to Rest.**

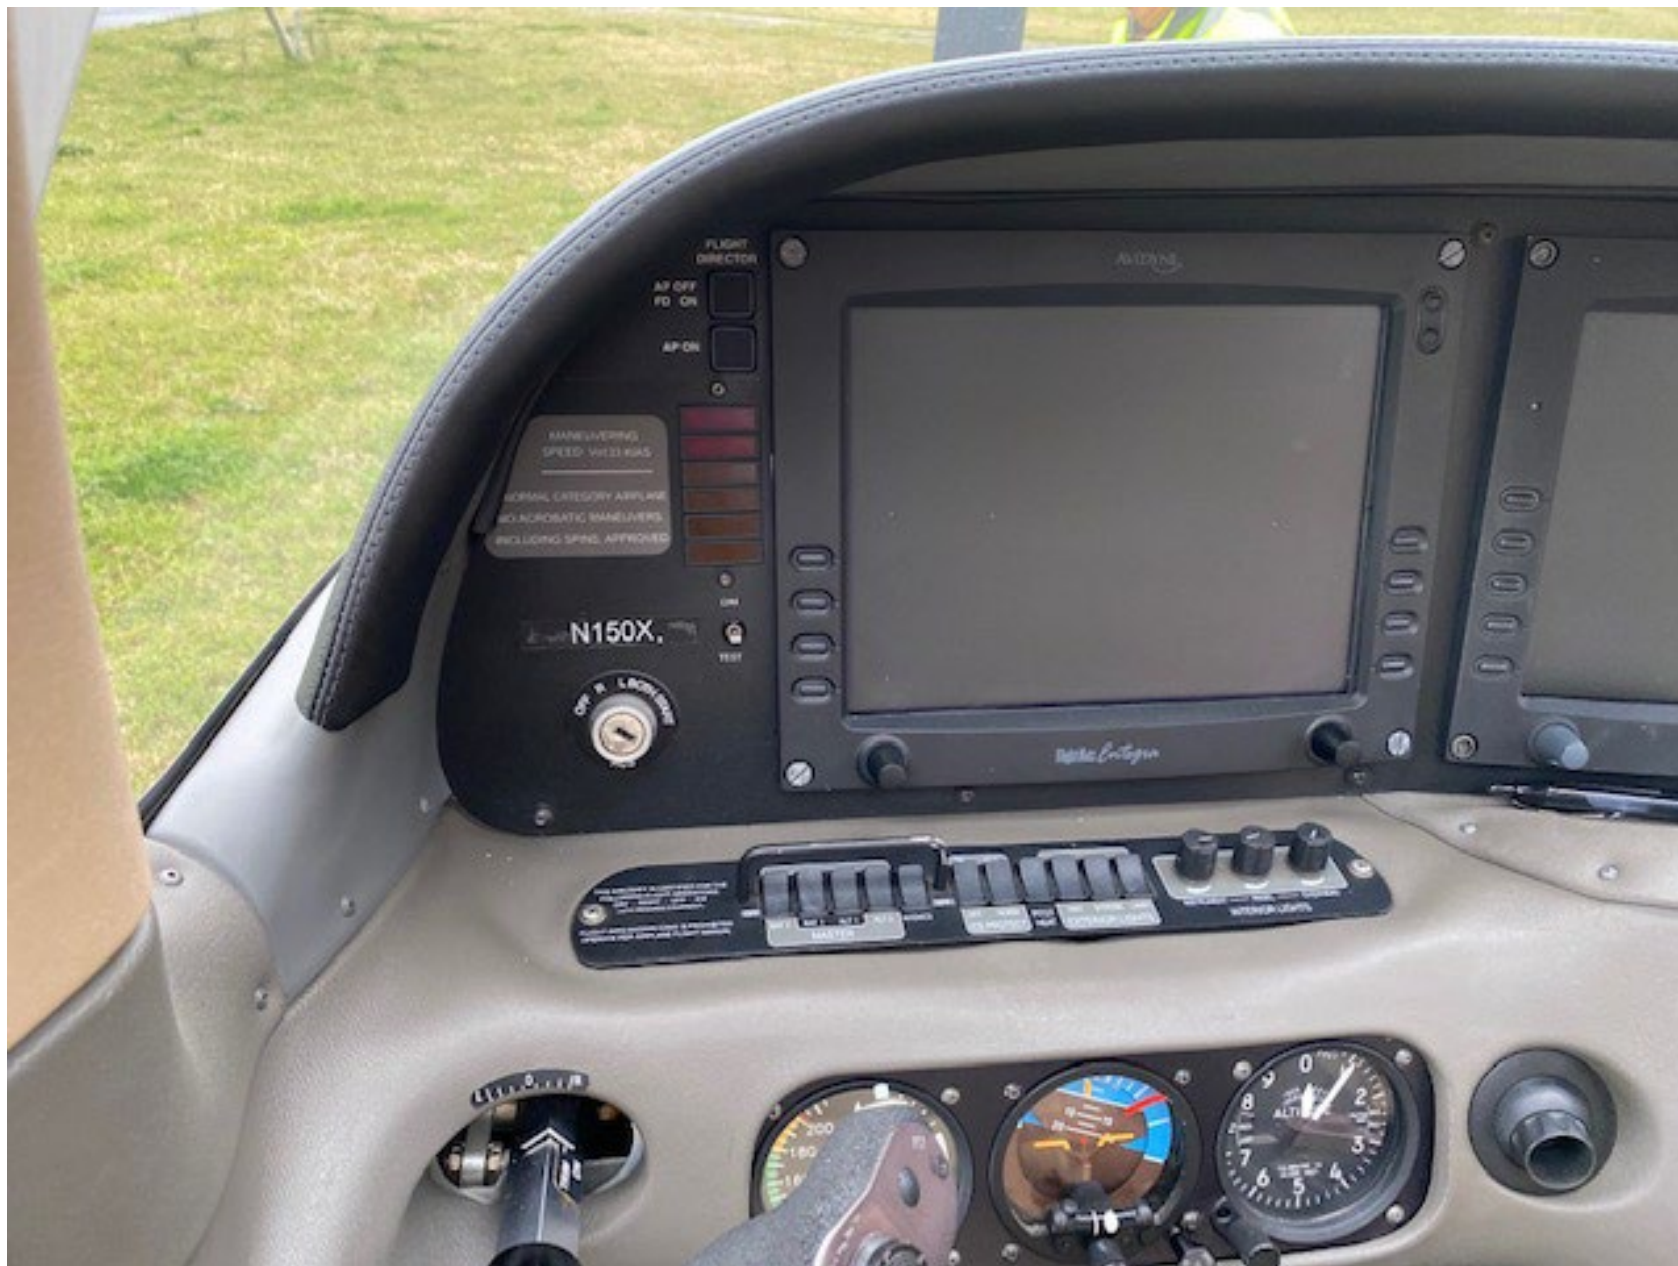
**Photo 3 - Digital Photograph From ARFF Deputy Chief MYR Airport. View of the Left Side of the Instrument Panel. Note the Roll Indicator.**

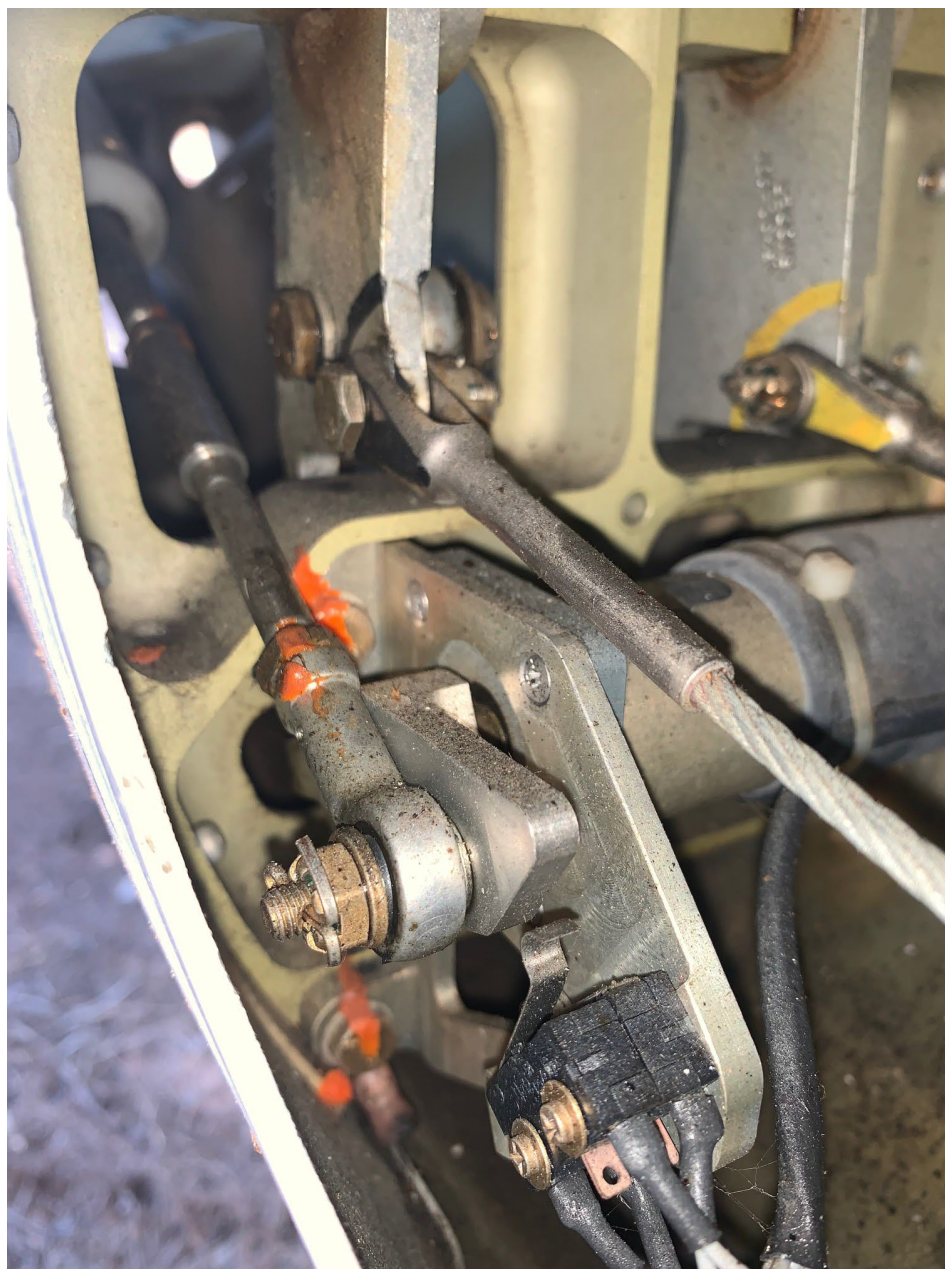
**Photo 4 - Digital Photograph From Atlanta Air Salvage. View of the Position of the Pitch Trim Actuator which was near Full Airplane Nose Down.**
