**NATIONAL TRANSPORTATION SAFETY BOARD**  
Vehicle Recorder Division  
Washington, D.C. 20594

## **Electronic Flight Instrument System (EFIS)**

**Specialist's Factual Report**  
**By Sean Payne**

Location: Charleston, SC  
Date: March 21, 2020  
Aircraft: Cessna 310  
Registration: N8080M  
Operator: Private  
NTSB Number: ERA20LA132

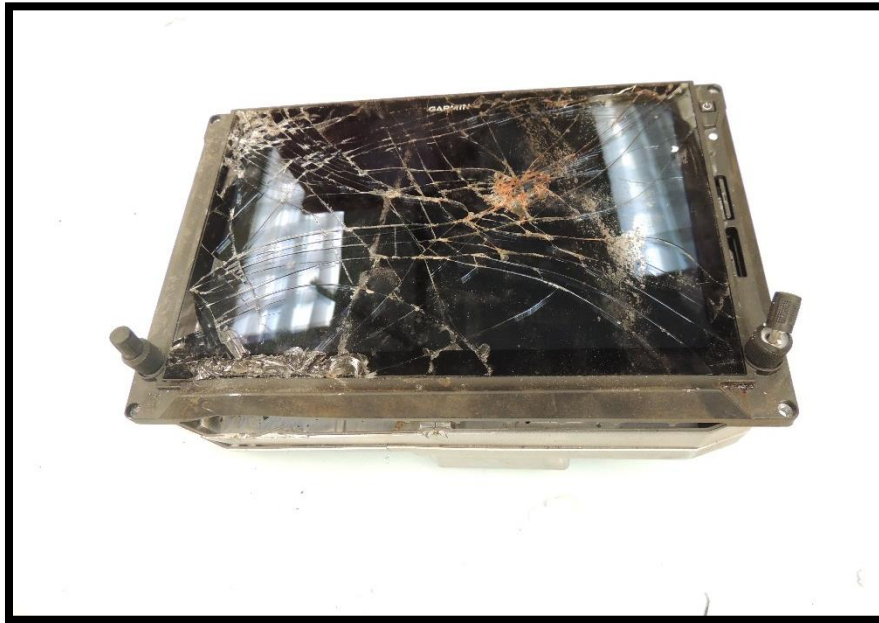
**Figure 1. Damaged exterior of damaged EFIS.**

The recorder was damaged in the event. The extent of the damage is shown in figure 1. Data was extracted from one of the unit's SD card which was installed in the PFD during the accident flight. The SD card contained the flight data. Additionally, the device was sent to the manufacturer for a retrieval of the unit's internal data contents. The manufacturer was unable to retrieve the internal data.

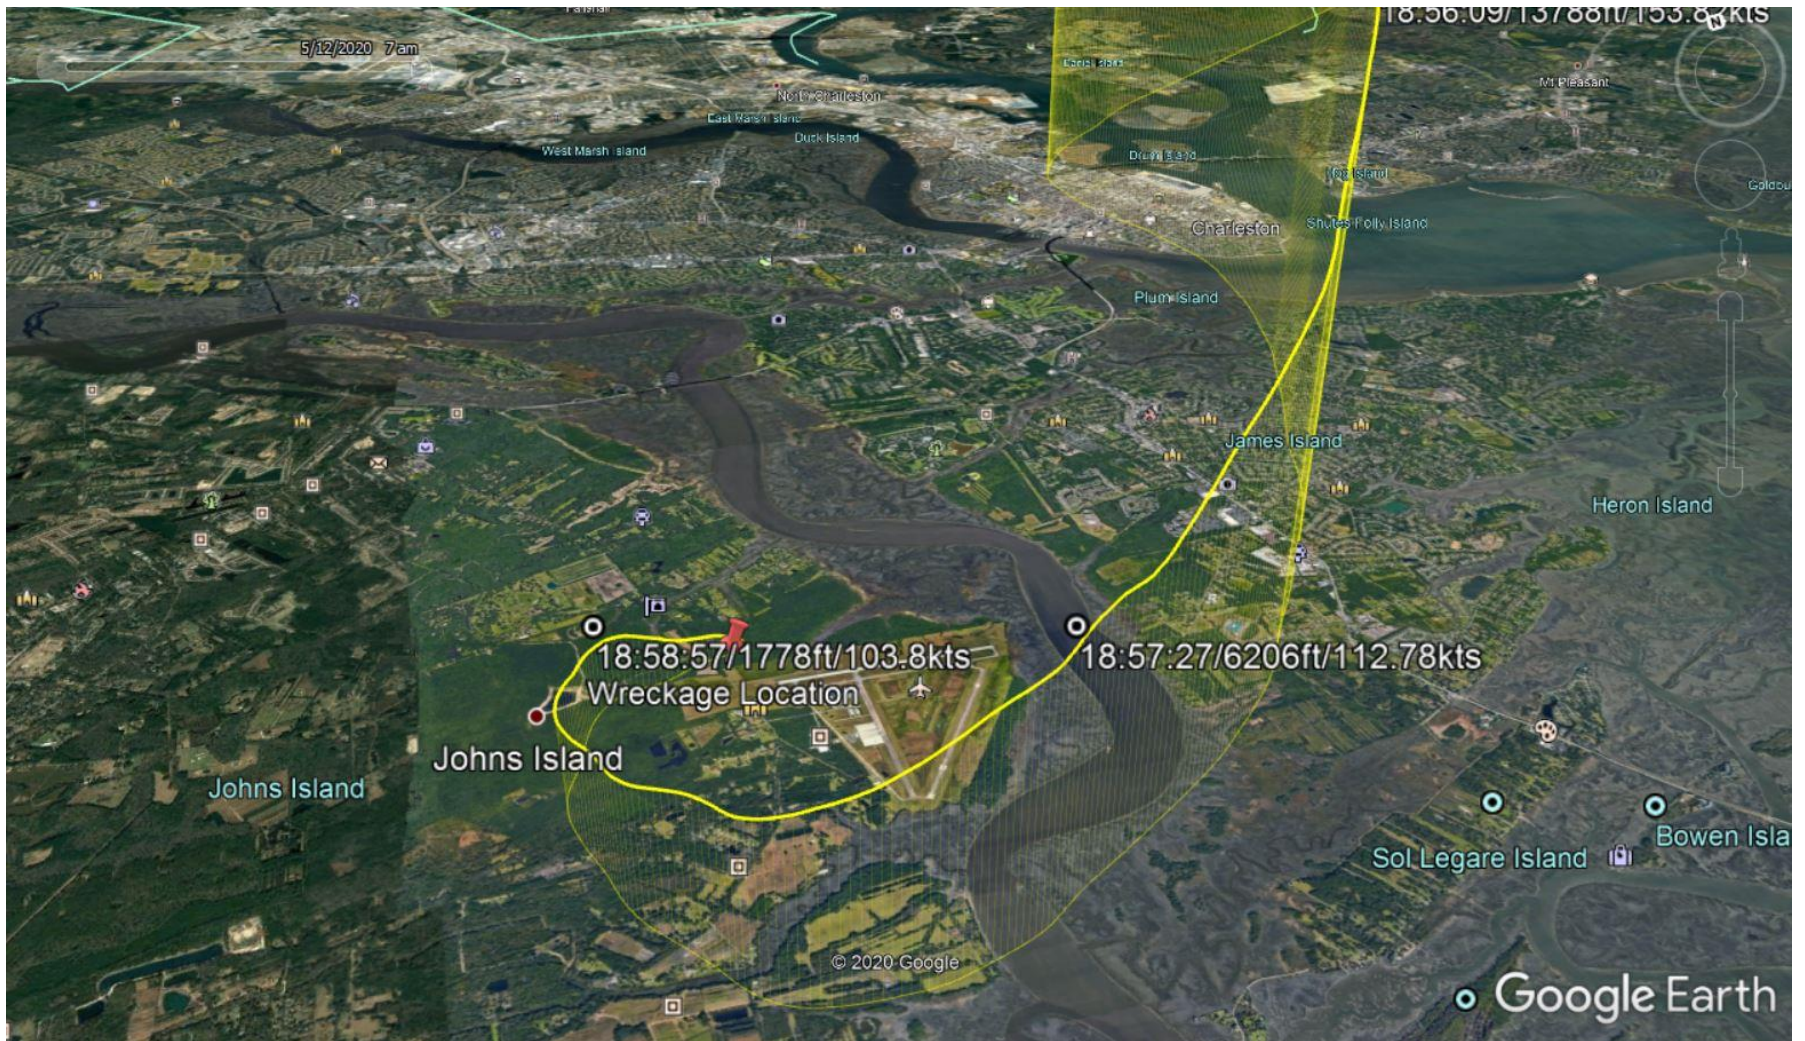
Figure 4. A detailed Google Earth depiction of the aircraft's descent to the accident location, zoomed in to the accident site.

Figure 4 is a detailed Google Earth depiction of the aircraft's descent to the accident location, zoomed in to the accident site.

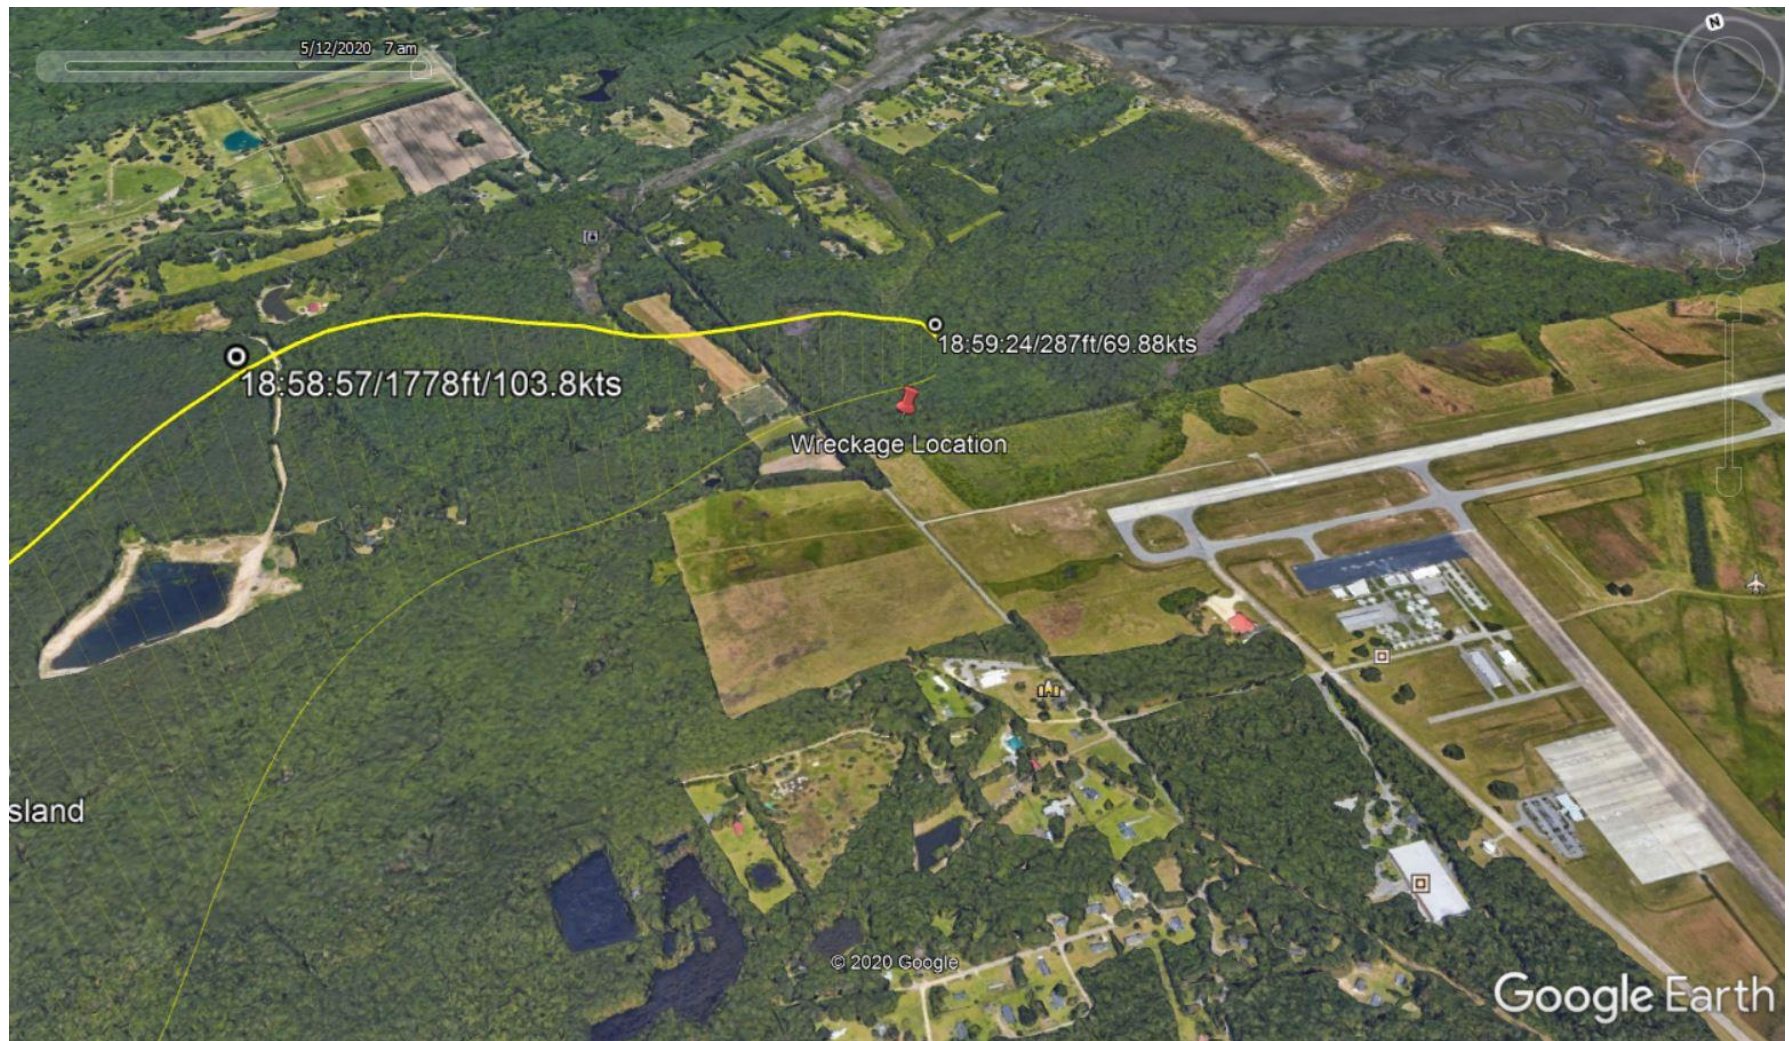
Figure 5. A detailed view of the aircraft's ground and altitude track in the immediate vicinity of the accident site. Note the wreckage location is subject to GPS errors of the collection device.

Figure 5 is a detailed view of the aircraft's ground and altitude track in the immediate vicinity of the accident site. Note the wreckage location is subject to GPS errors of the collection device.
