## **NATIONAL TRANSPORTATION SAFETY BOARD**

### **Weather Study**

# **METEOROLOGY**

ERA20LA134

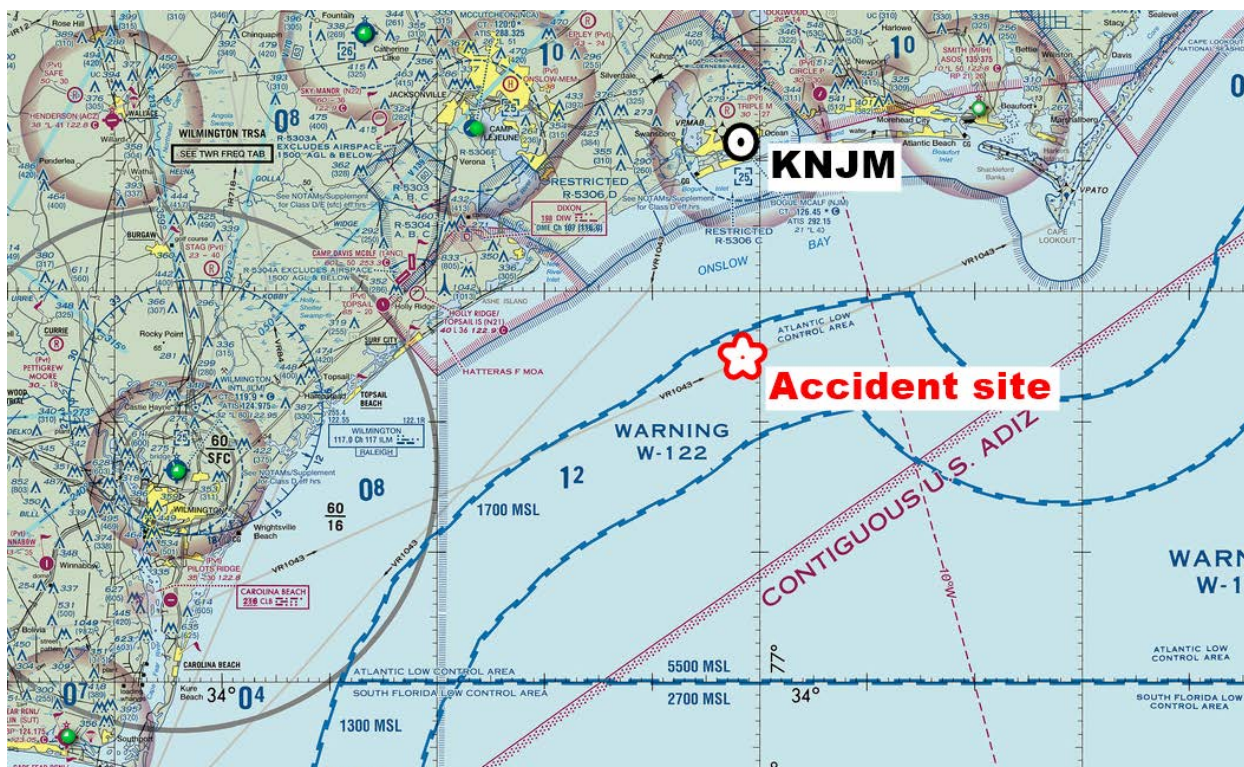
The area surrounding the accident site was documented using official Meteorological Aerodrome Reports (METARs) and Specials (SPECIs). The following observations were taken from standard code and are provided in plain language. Figure 5 is a local sectional chart with the accident site and the closest weather reporting location marked.

Bogue Field Marine Corps Auxiliary Field (KNJM) had the closest official weather station to the accident site. KNJM was located 16 miles north of the accident site, at an elevation of 21 feet (ft), and had a 10° westerly magnetic variation<sup>3</sup> (figure 5). The following observations were taken and disseminated during the times surrounding the accident:<sup>4</sup>
