# NATIONAL TRANSPORTATION SAFETY BOARD

## Onboard Image Recorder

### Specialist's Factual Report By Gerald Kawamoto

Location: Ozark, Alabama  
Date: May 30, 2020  
Vehicle: Hughes Schweizer 269  
Registration: N9421P  
Operator: Private  
NTSB Number: ERA20LA197

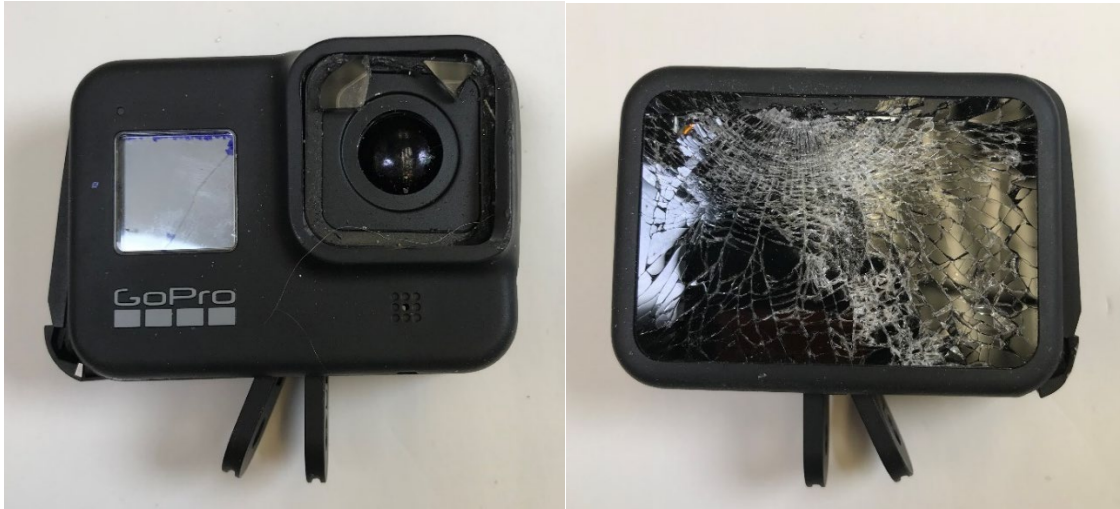
Upon arrival at the NTSB Vehicle Recorder Division, an external examination revealed the device had sustained impact damage, as shown in Figure 1, rendering it inoperable. An internally mounted 400 GB micro SD card was undamaged and data were extracted normally using laboratory tools.

**Figure 1. GoPro Hero 8 as received.**
