**NATIONAL TRANSPORTATION SAFETY BOARD**  
Vehicle Recorder Division  
Washington, D.C. 20594

### **Specialist's Factual Report By W. Deven Chen**

Location: San Juan, Puerto Rico  
Date: June 2, 2020  
Aircraft: Piper PA-23-250  
Registration: N14181  
Operator: Private  
NTSB Number: ERA20LA202

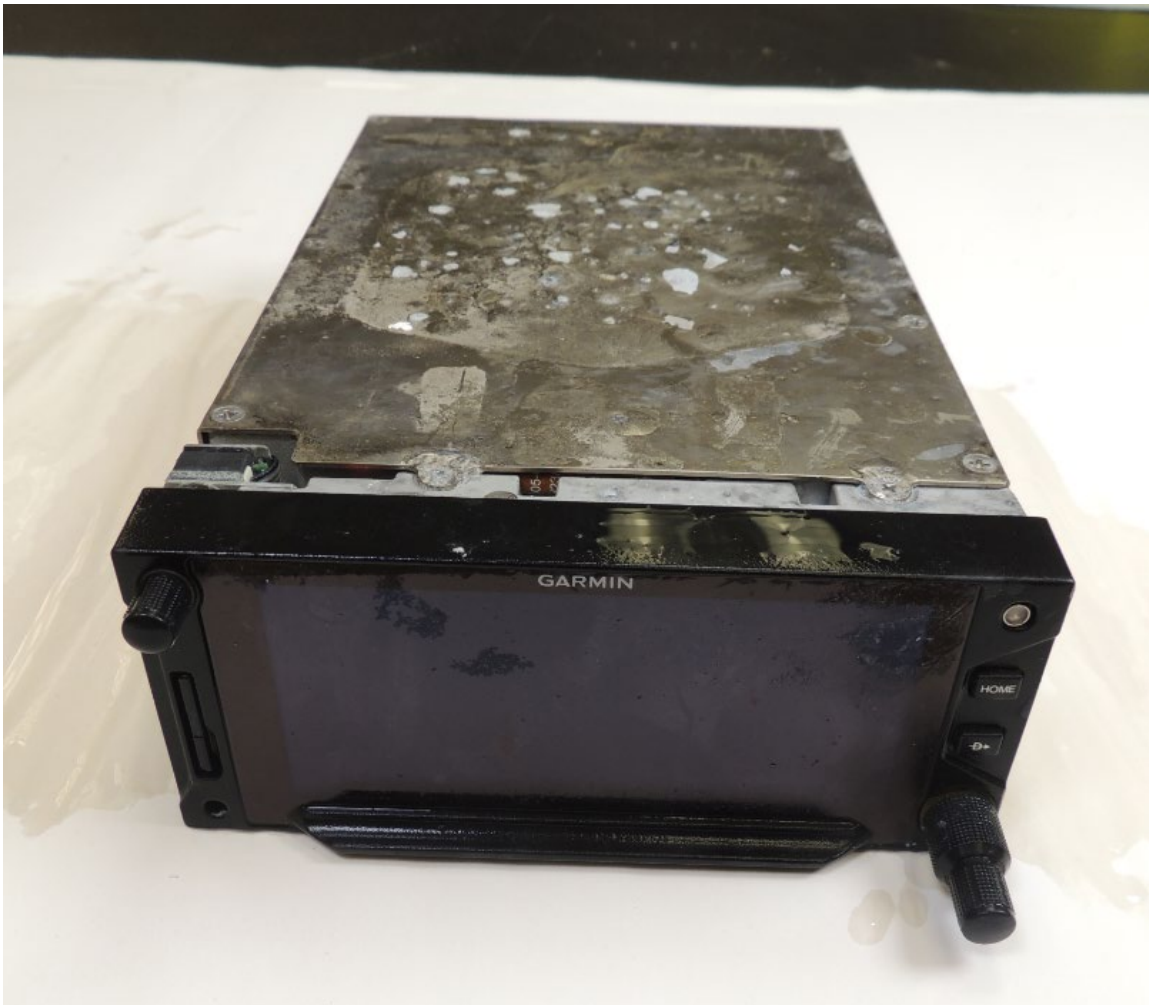
The device was submerged in water upon arrival at the Vehicle Recorder Division and an exterior examination revealed the device had no impact damage, as shown in Figure 1. The device was cleaned and dried; however, it did not power up normally. The device itself did not have a data storage system to store flight data, thus no data were recovered from this device.

**Figure 1: Garmin GTN 650 as received.**

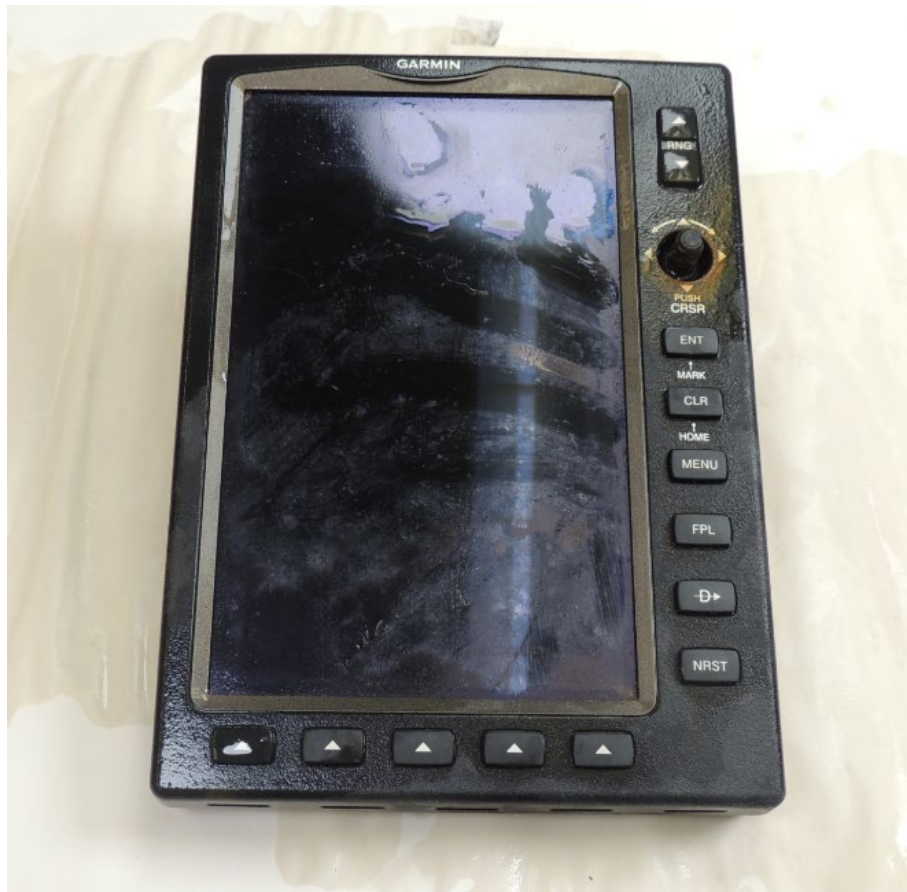
The device was submerged in water upon arrival at the Vehicle Recorder Division, and an exterior examination revealed the device did not have impact damage, as shown in Figure 2. The device was cleaned and dried; however, the device did not power up normally. The non-volatile memory<sup>1</sup> was removed, readout and converted to engineering units using laboratory tools. The data showed a total of 301 sessions from August 23, 1999 to April 4, 2019. The last flight on April 4, 2019 was a short flight from Jose Aponte de la Torre airport to Antonio Rivera Rodrigues airport. The accident flight was not captured; thus, no accident related data were recovered from this device.

**Figure 2: Garmin GPSMAP 696 as received.**

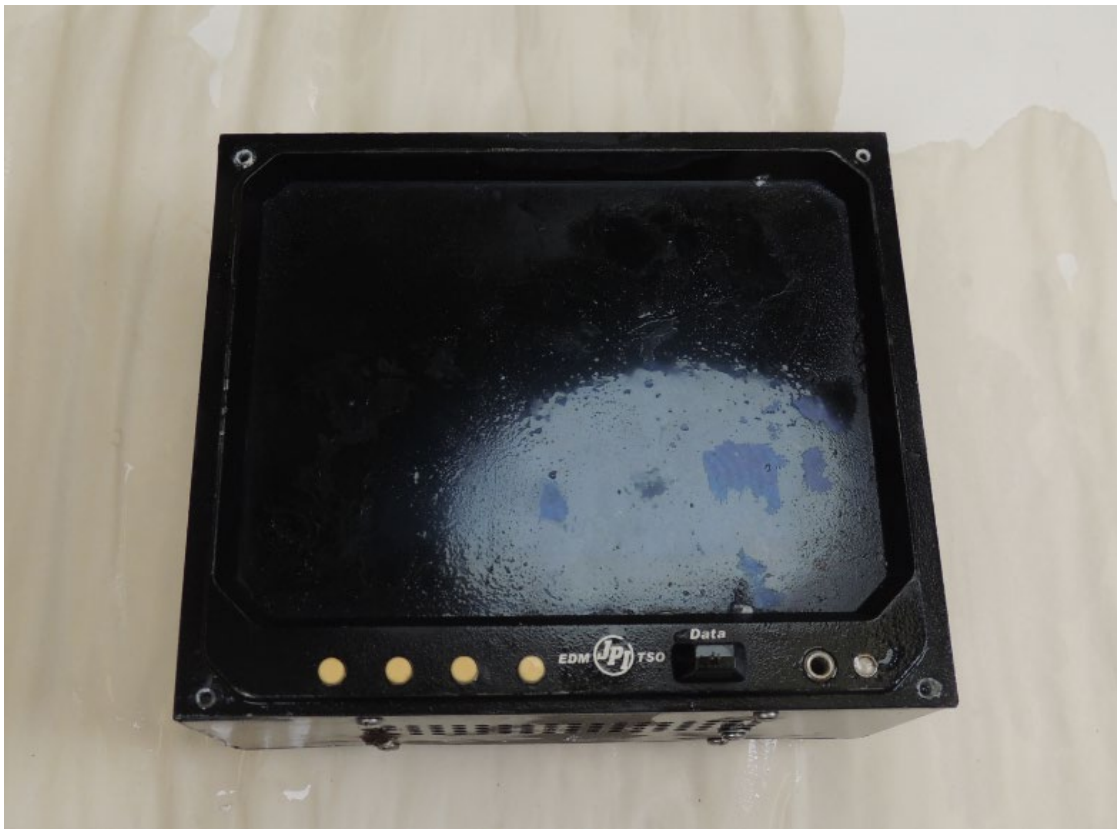
The device was submerged in water upon arrival at the Vehicle Recorder Division, and an exterior examination revealed the device did not have impact damage, as shown in Figure 3. The device was cleaned and dried; however, the device did not power up normally. The device was sent to the manufacturer for data recovery. The manufacturer sent back a raw data file, and this file was converted into engineering units using a software of the manufacturer at the Vehicle Recorder Division.

**Figure 3: JPI EDM 960 Display Unit as received.**
