# **NATIONAL TRANSPORTATION SAFETY BOARD**

## **Unmanned Aircraft System (UAS) Aerial Imagery Factual Report**

**ERA20LA206**

N135VE, Piper PA-31T

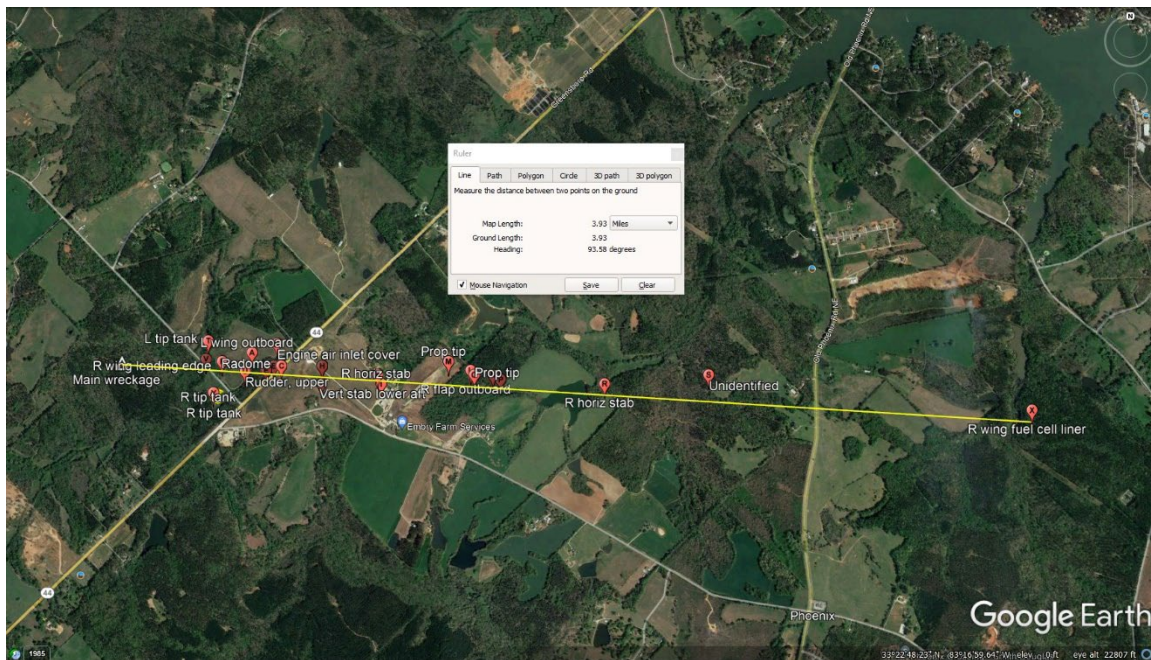
**Figure 3.** Google Earth image showing distribution of wreckage pieces. Furthest piece was about 3.9 miles east (about 094° true) from main wreckage.

Prelaunch information provided by the Putnam County Sheriff indicated that sheriff's department personnel had marked the locations of numerous pieces of wreckage that were found scattered throughout the area east of the main wreckage. Those pieces of wreckage had been recovered before the UAS RPIC arrived, but the tape markers remained. Aircraft recovery personnel provided photographs, GPS coordinates (derived from an iPhone), and preliminary identification of these recovered pieces. Other pieces of wreckage were subsequently located by a properly owner who left them in situ, and the UAS RPIC took coordinates for these pieces on April 9, 2021, using a Trimble differential GPS (dGPS).

The table below shows the coordinates (from an iPhone GPS) for the main wreckage and pieces A through S provided by aircraft recovery personnel for the pieces they retrieved before the RPIC's arrival. Air recovery personnel also provided photographs of these pieces. The coordinates for pieces T through W were obtained by the UAS RPIC using the dGPS. The coordinates for pieces X and Y were provided by the citizens who found the pieces.<sup>1</sup> Identification information for each piece was provided by the IIC following wreckage examination with the airframe party to the investigation.

Coordinates for all the pieces were entered into GoogleEarth as placemarks.

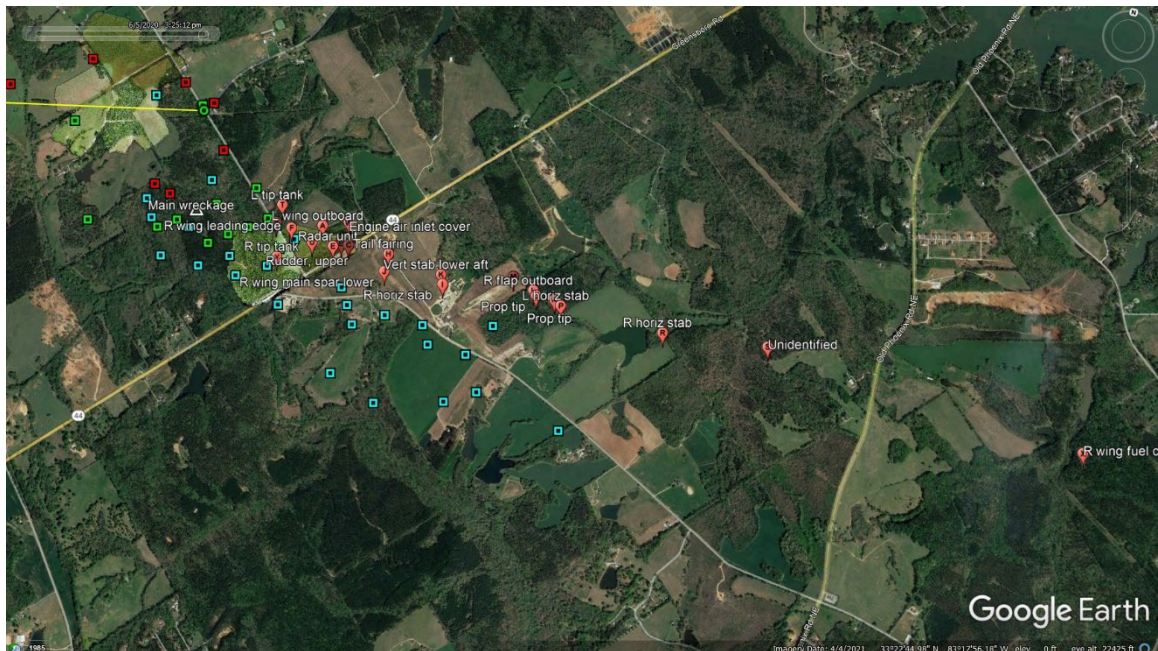
**Figure 4.** Orthomosaic in Google Earth showing the distribution of the wreckage pieces with regard to locations of radar returns.

The RPIC provided the IIC the Google Earth wreckage plot in .kml format.
