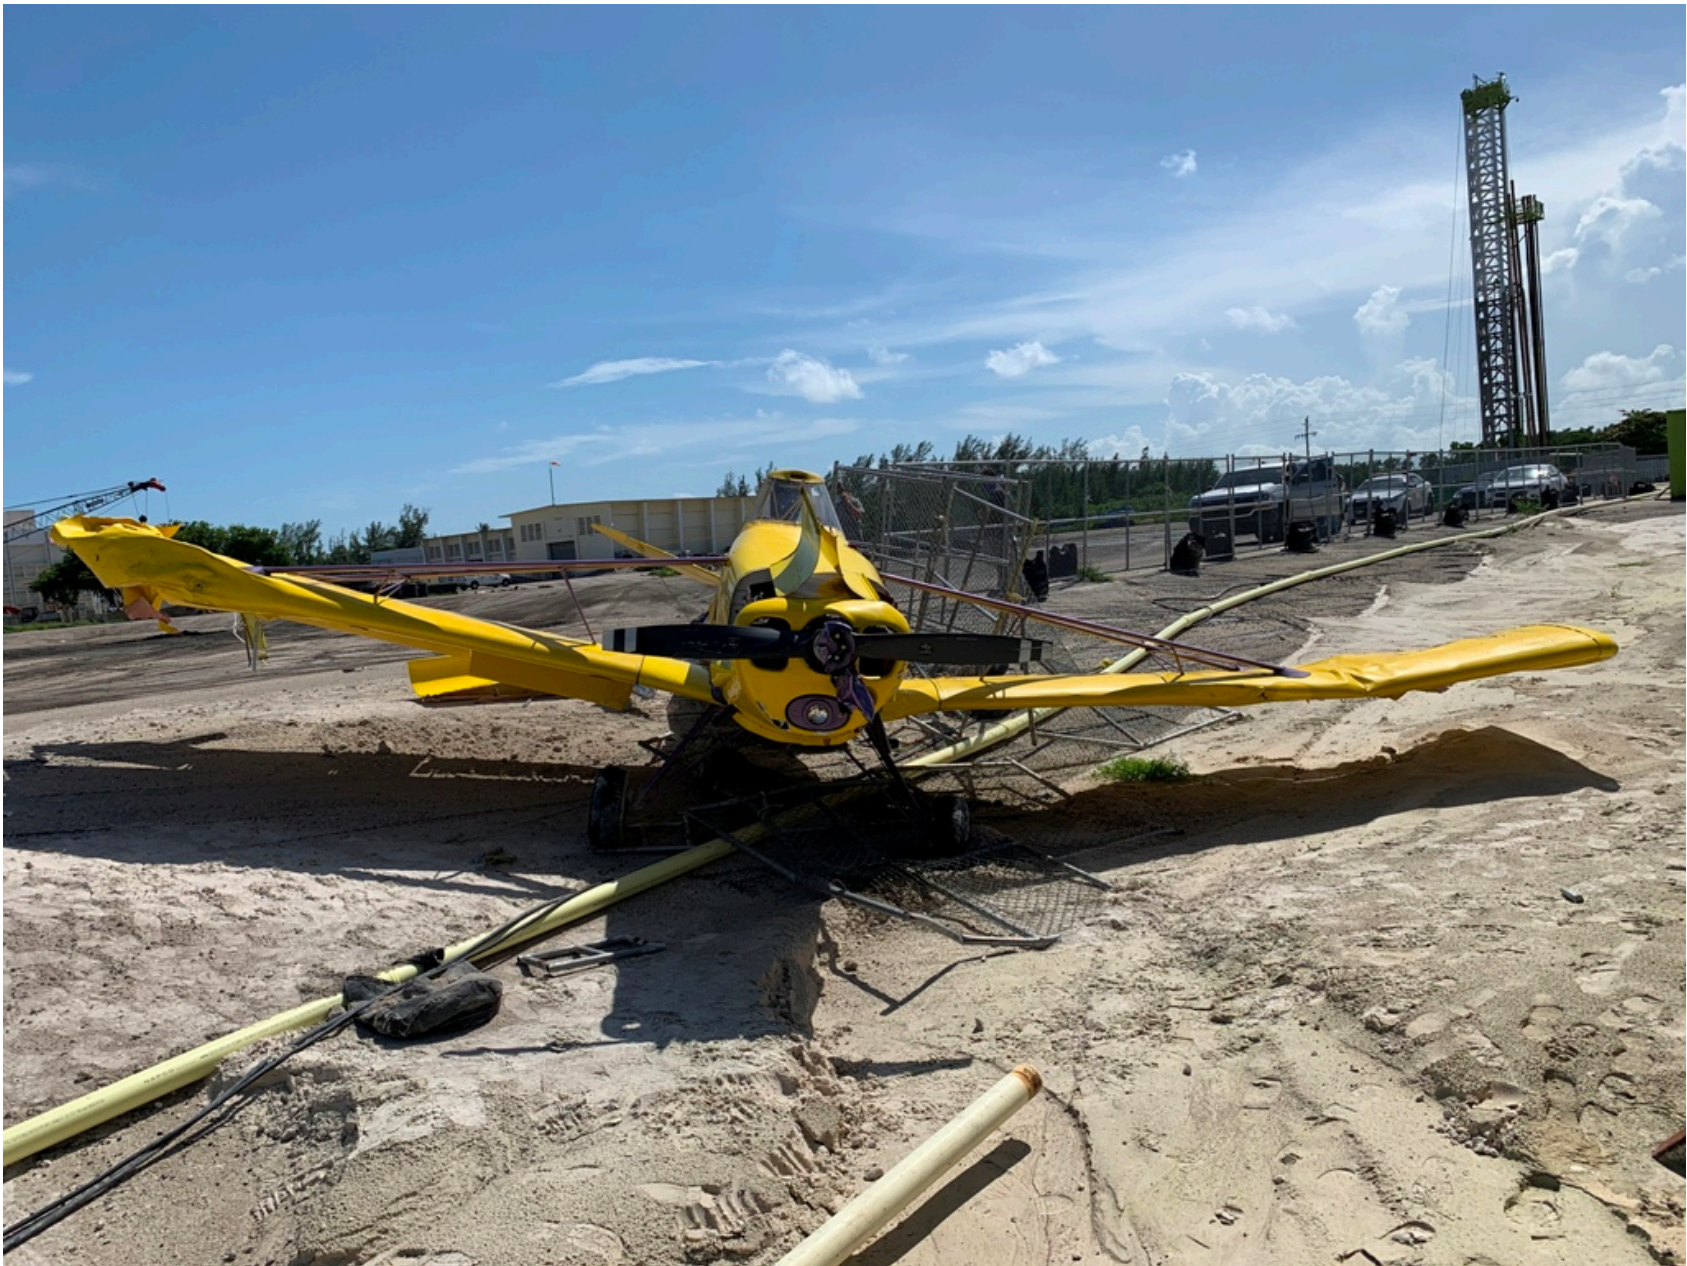
**Photo 1 – Digital Photograph from FAA. Front View of the Airplane At the Accident Site. Note the substantial Damage to Both Wings.**

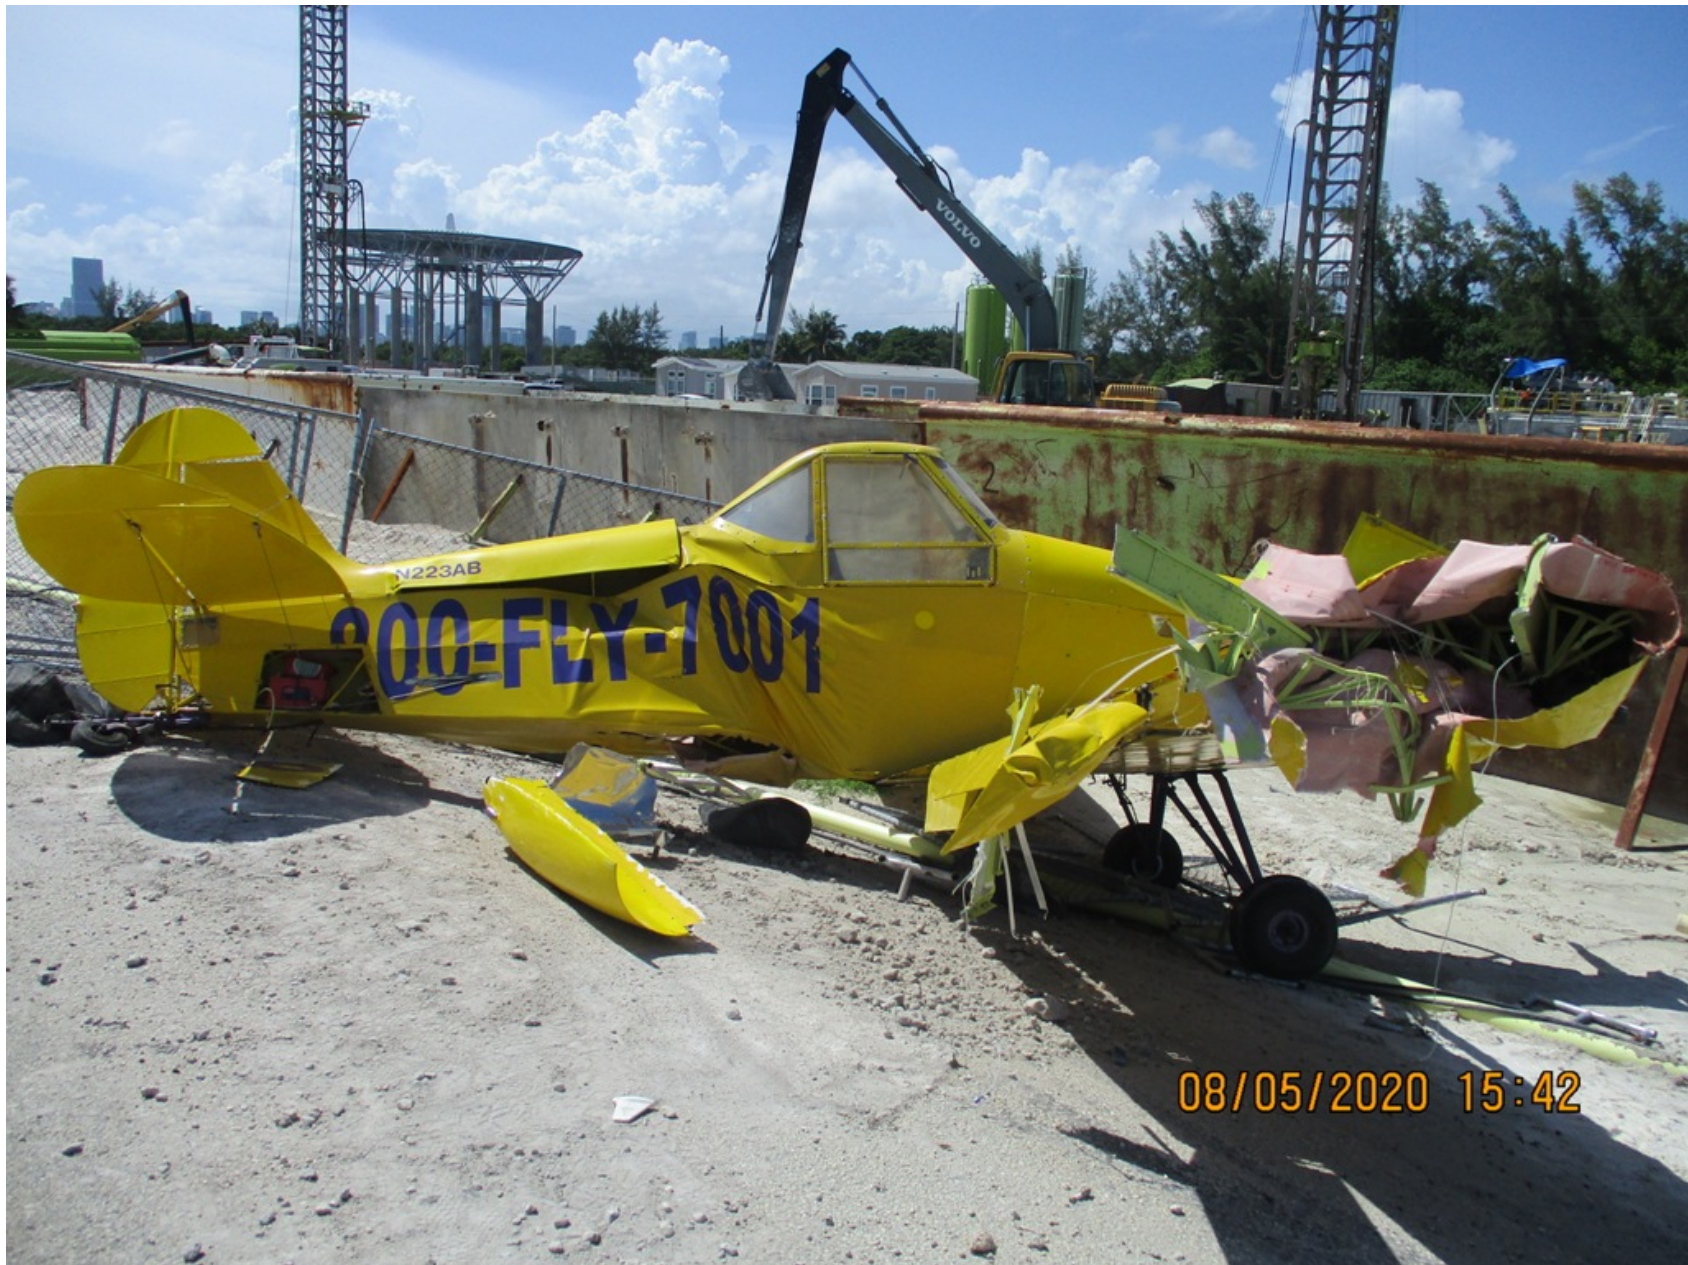
**Photo 2 - Digital Photograph from FAA. Right Side View of the Airplane At the Accident Site. Note the substantial Damage to The Right Wing and Empennage.**

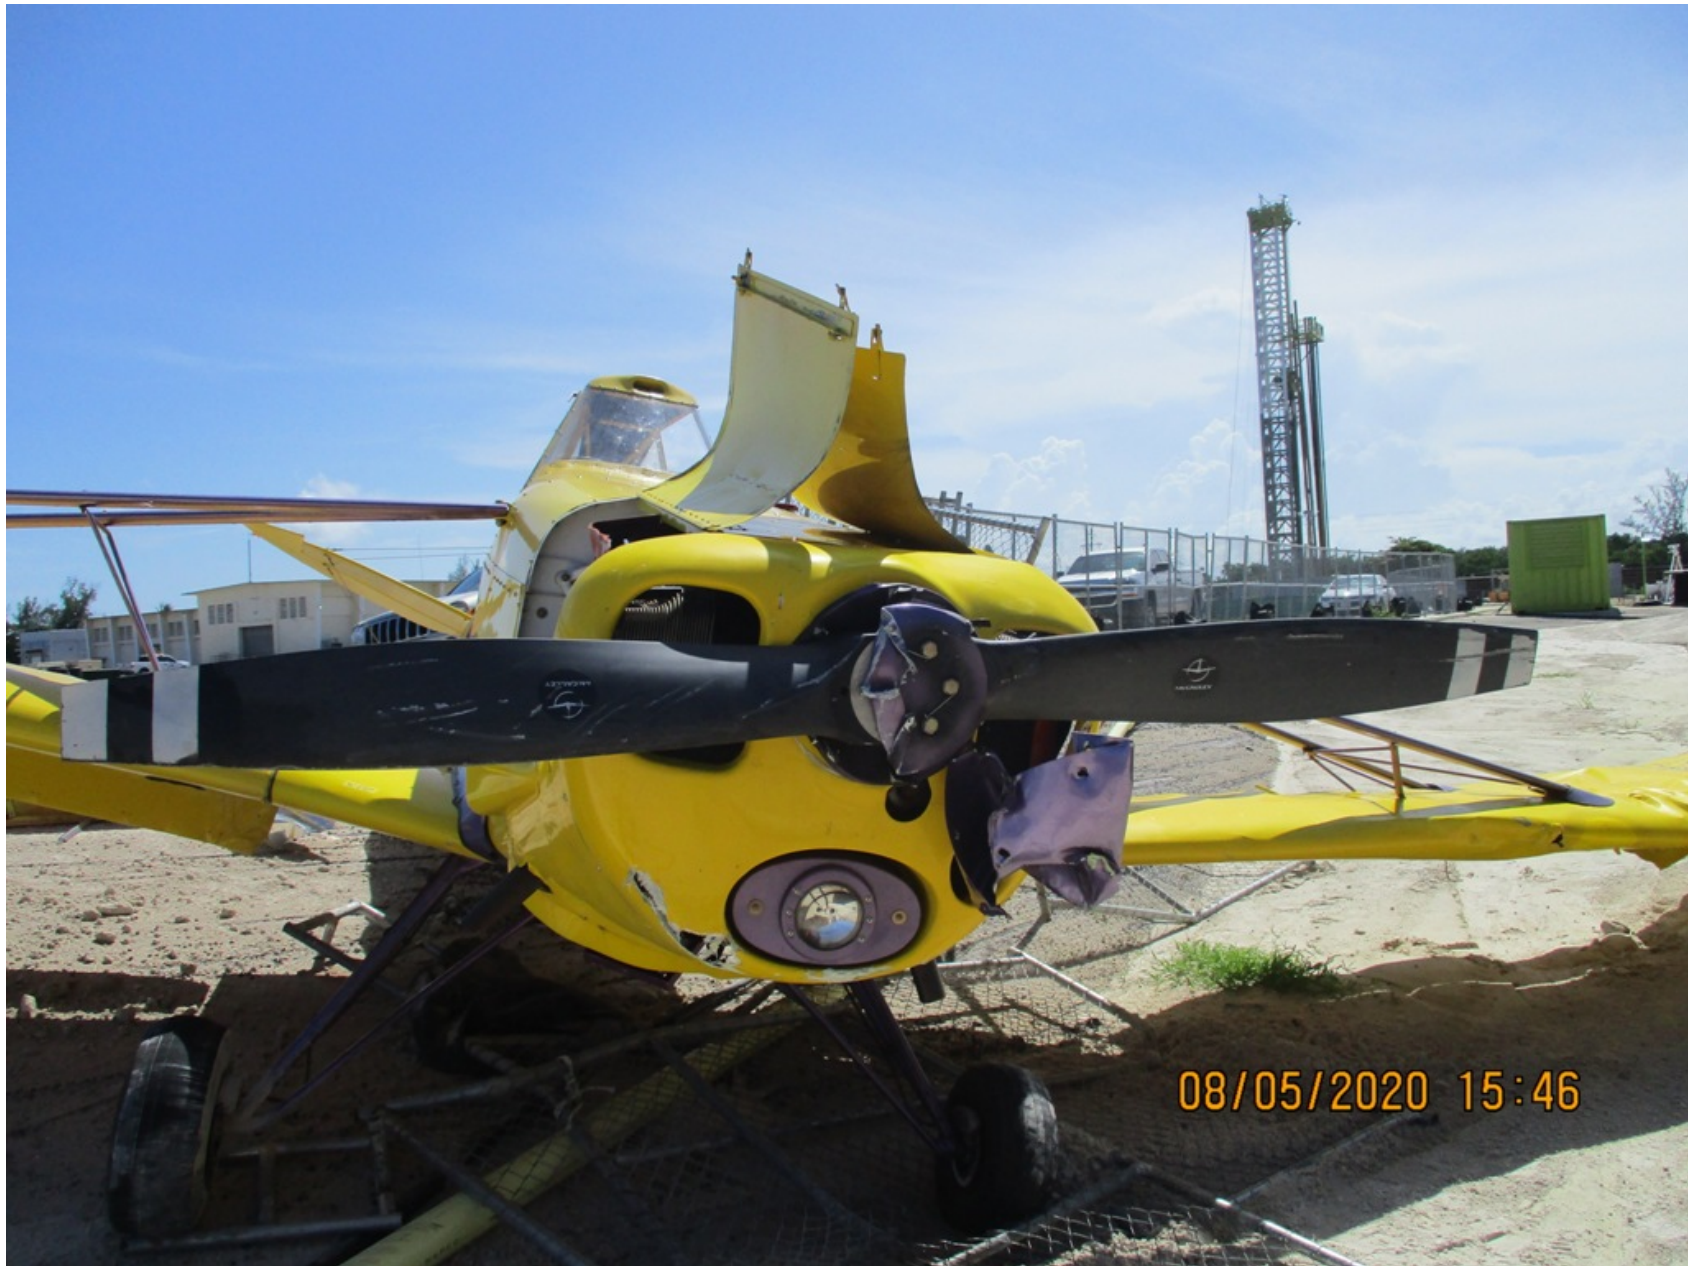
**Photo 3 - Digital Photograph from FAA. Close-Up Frontal View of the Propeller and Portions of the Fuselage and Both Wings At the Accident Site. Note the Damage to The Propeller Spinner and Scratches to the Propeller.**

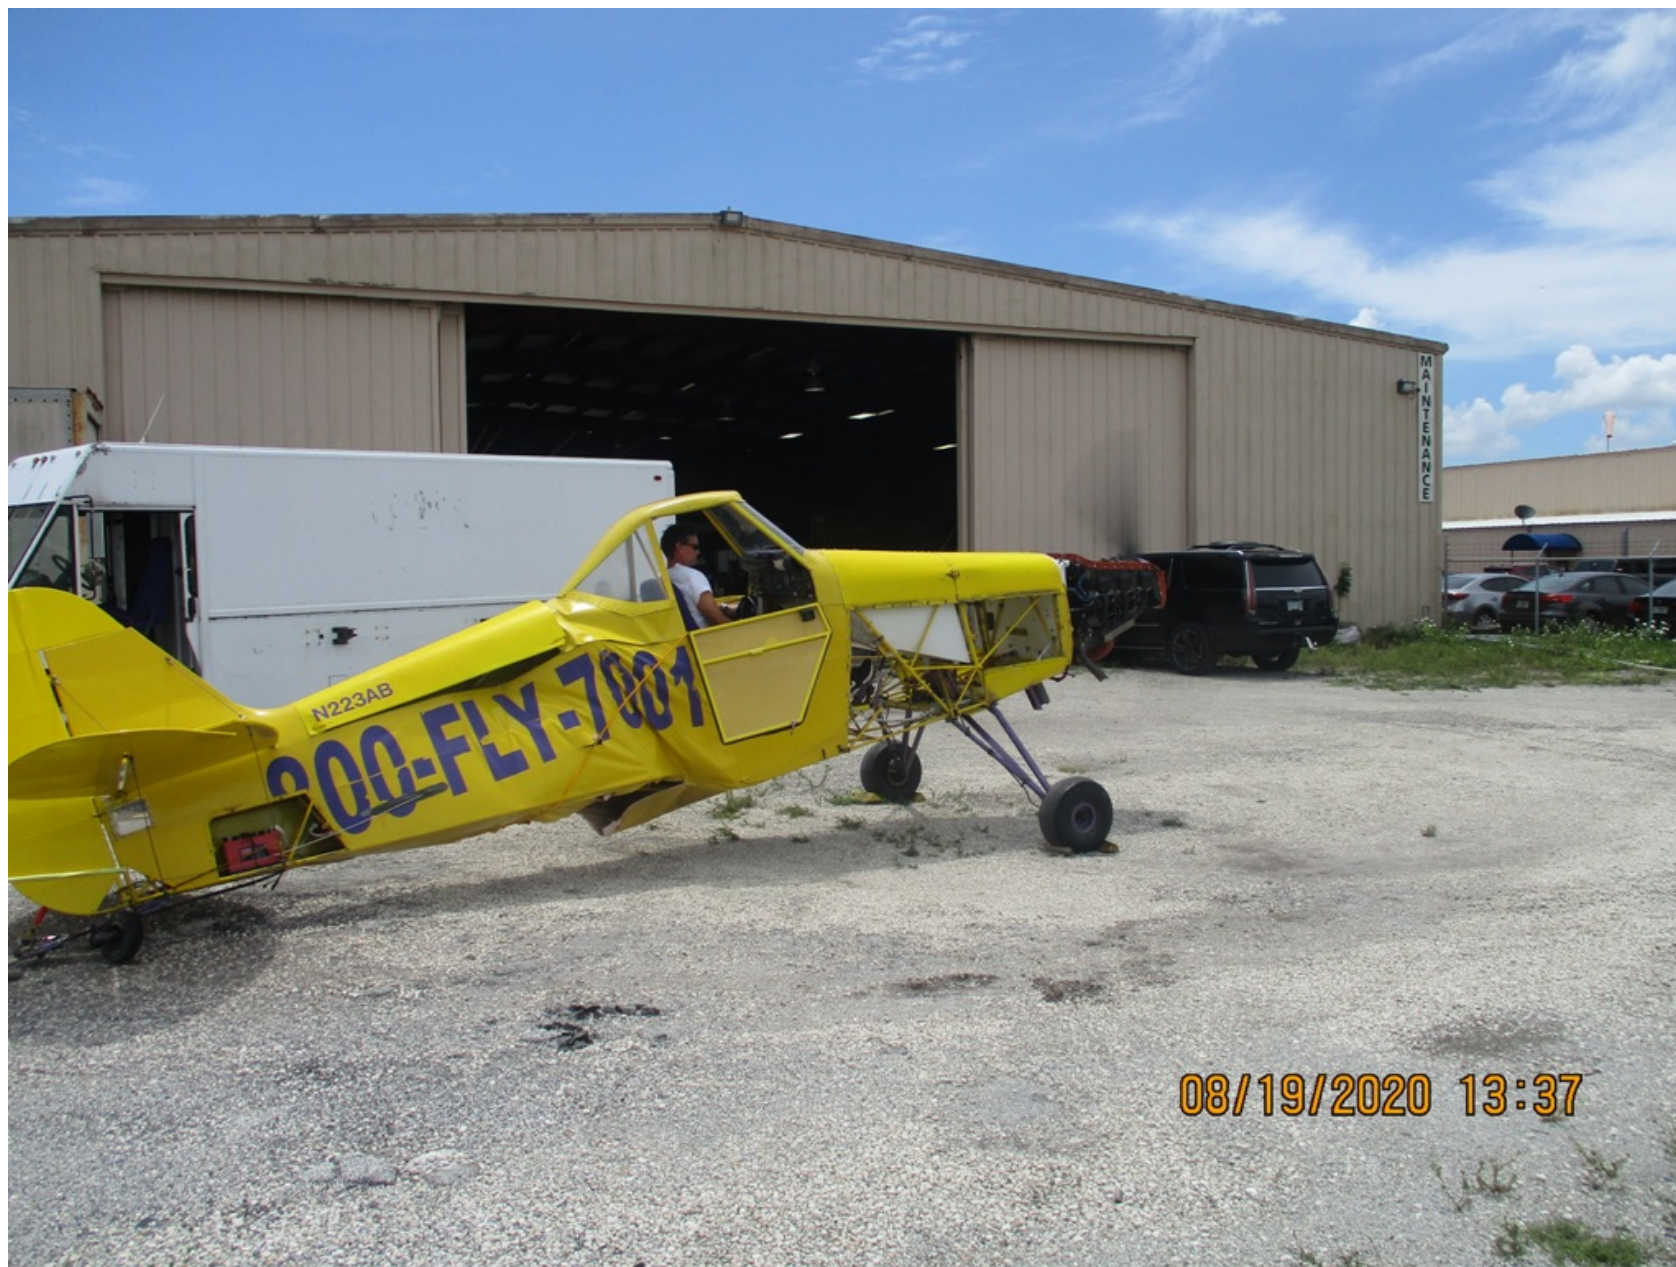
**Photo 4 - Digital Photograph from FAA. Right Side View of the Airplane During the Operational Test of The Engine.**
