## Memorandum For Record

**Date: January 28, 2022**  
**NTSB Accident Number: ERA20LA297**

### Email Report

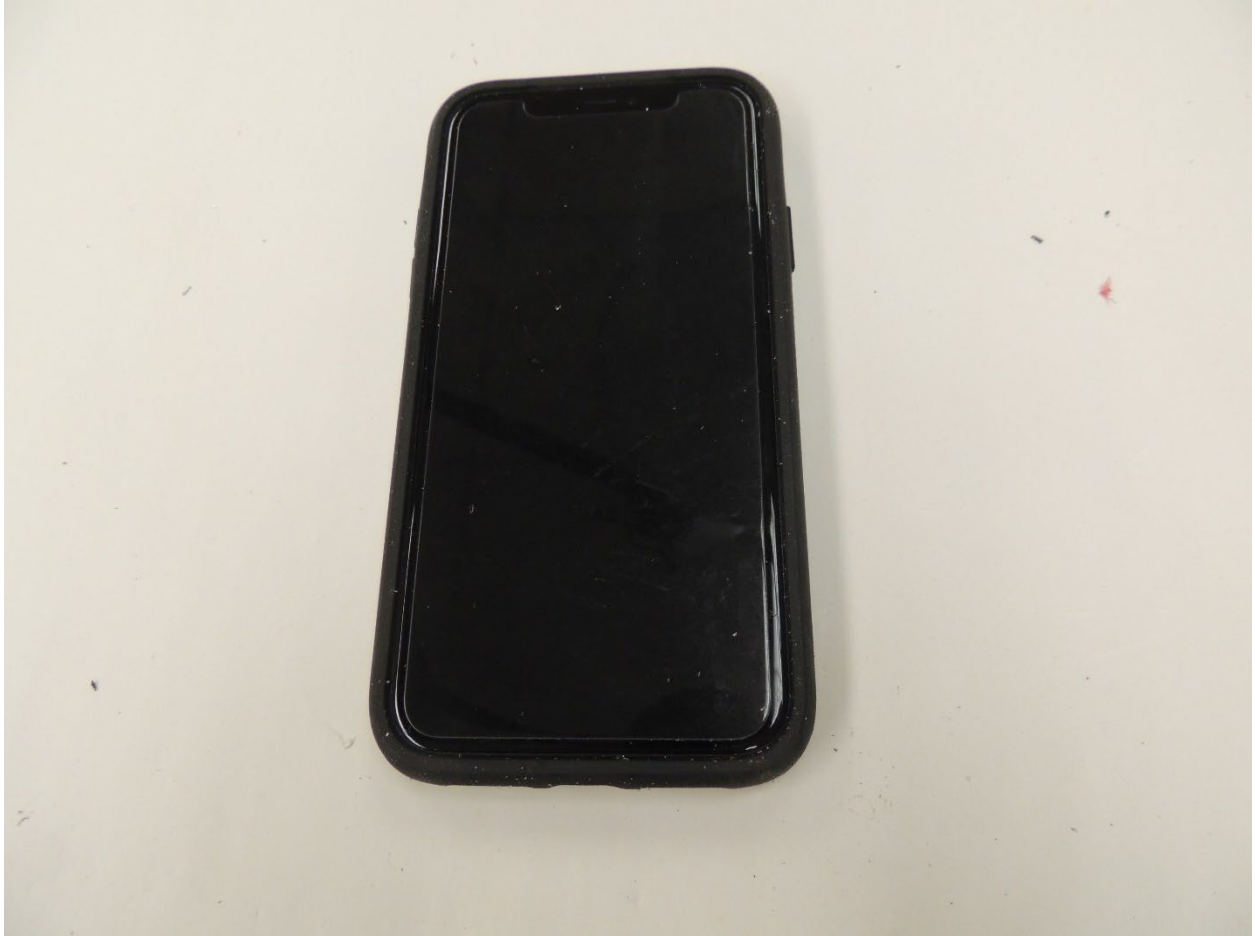
The iPhone was received in working condition. A photo of the device is attached as DSCN9654.jpg (Figure 1). The iPhone was determined to be associated with the 56-year-old left seat pilot. The iPhone was unlocked with a passcode provided by the pilot rated passenger's family member.

Figure 1: Photograph of the Left Seat Pilot's Cellular Phone in NTSB Vehicle Recorder Division.

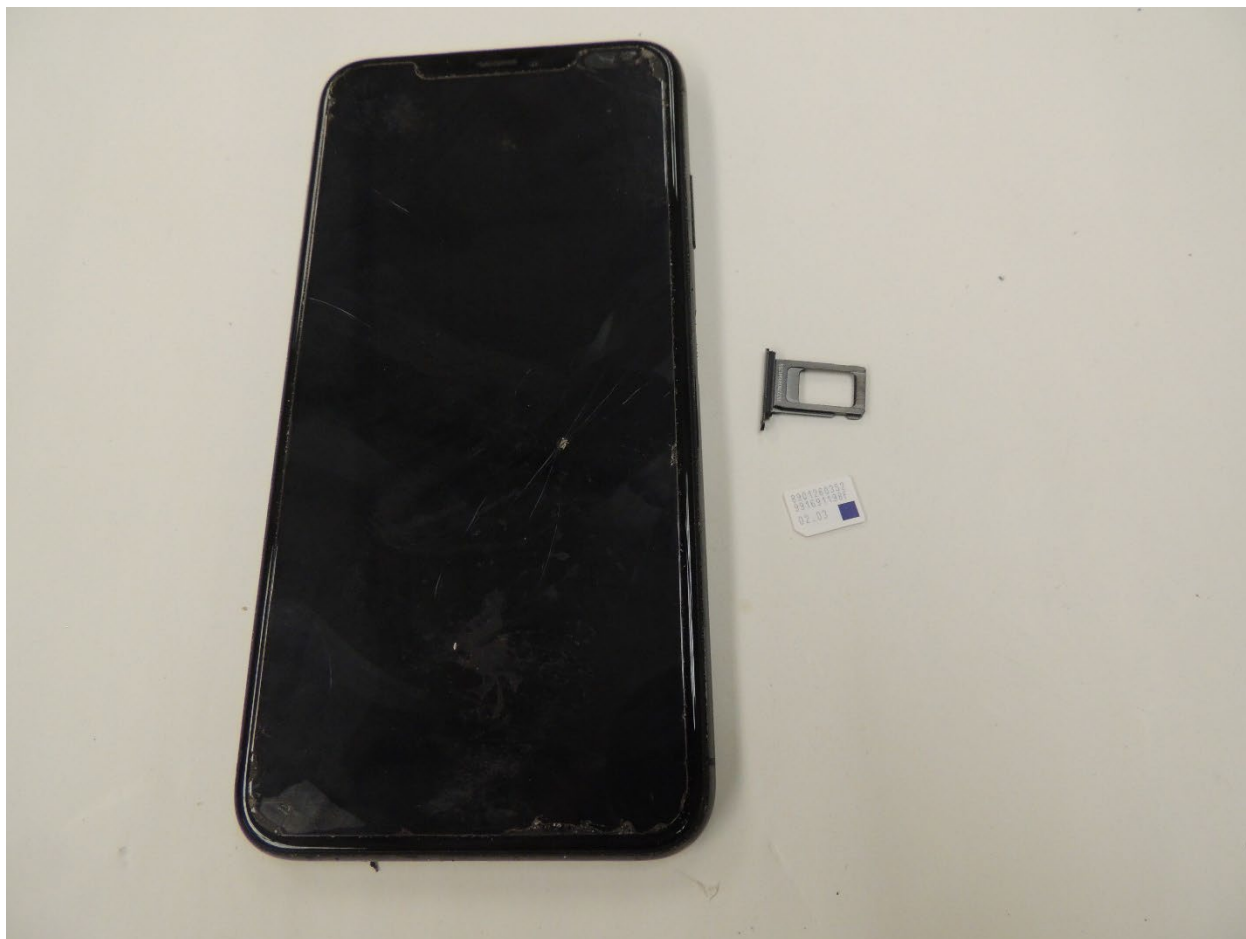
The iPhone was received in working condition. A photo of the device is attached as DSCN9653.jpg (Figure 3). The iPhone was determined to be associated with the 53-year-old right seat pilot. The iPhone was locked with a six digit numerical passcode. The pilot's relatives were contacted by the NTSB and were unable to provide a passcode for the device. As of the for time of writing of this report, there were no passcode bypass options available for this iPhone model and the particular version of iOS software the device was running at the time of the accident.

Figure 3: Photograph of the Right Seat Pilot's Cellular Phone in NTSB Vehicle Recorder Division.

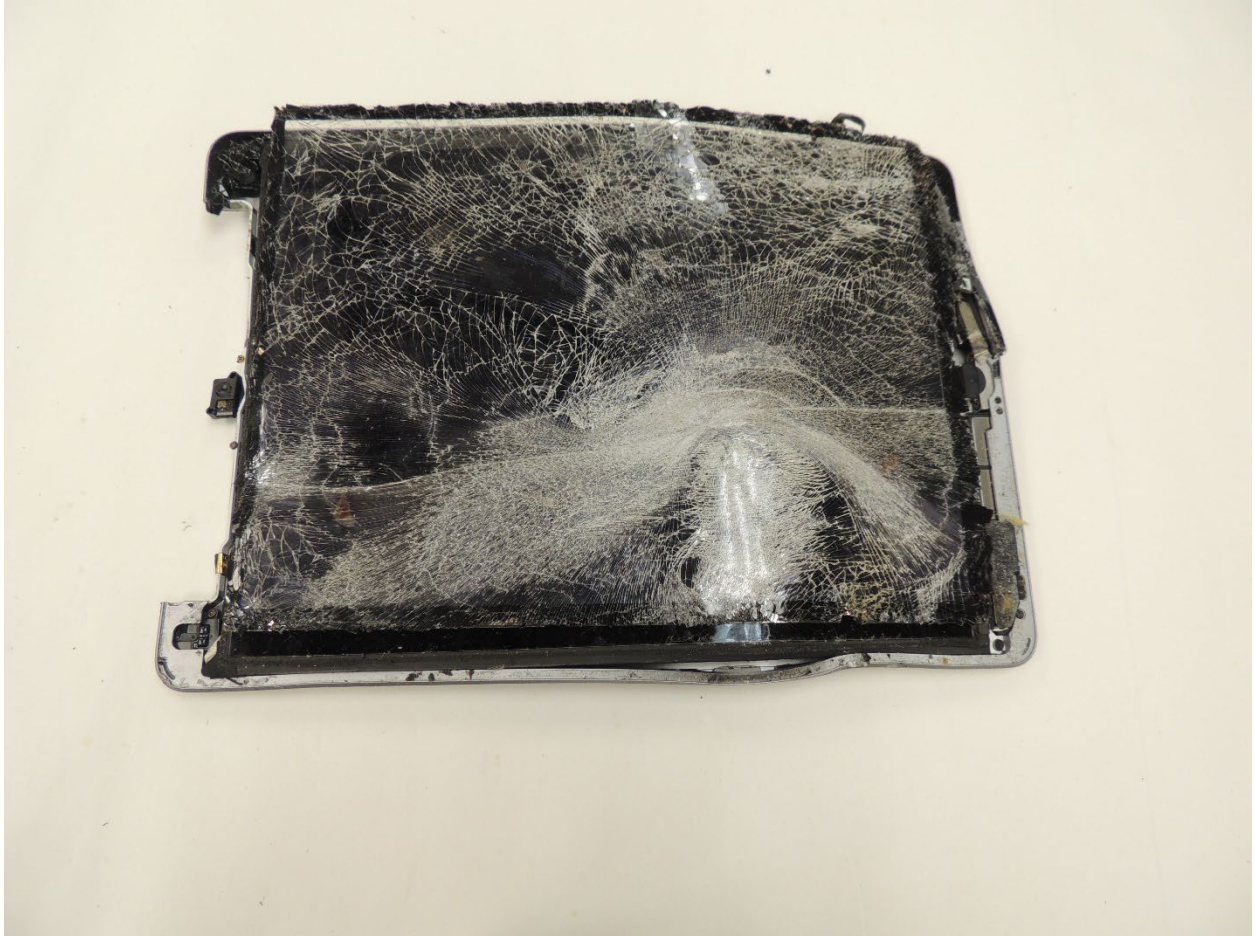
The iPad was received in damaged condition. The device's screen was shattered and the device's chassis and main board were bent. A photo of the device is attached as DSCN9647.jpg (Figure 4). The main board was removed and inspected. Although bent, there were no obvious defects. The main board was placed in a surrogate device and the iPad was unable to be powered. Further recovery efforts were not pursued.

Figure 4: Photograph of the Impact Damaged iPad in NTSB Vehicle Recorder Division.
