## Memorandum For Record

**Date: June 24, 2022**  
**NTSB Accident Number: ERA20LA297**

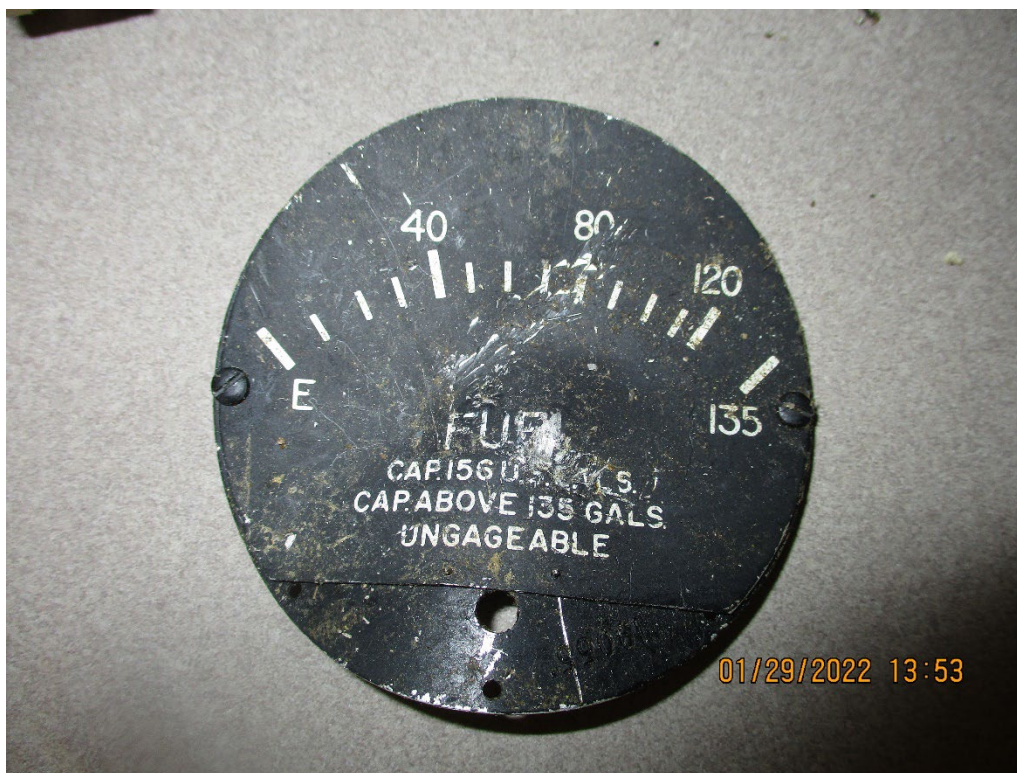
The faceplate of the fuel quantity indicator was located among the wreckage and examined which revealed the needle was separated (Figure 1). Visibly, there was no evidence of a needle impact impression. The faceplate was not retained.

Figure 1: FAA Digital Photograph. View of the Separated Fuel Quantity Gauge Faceplate. Note the Separated Needle. No needle slap mark was noted.
