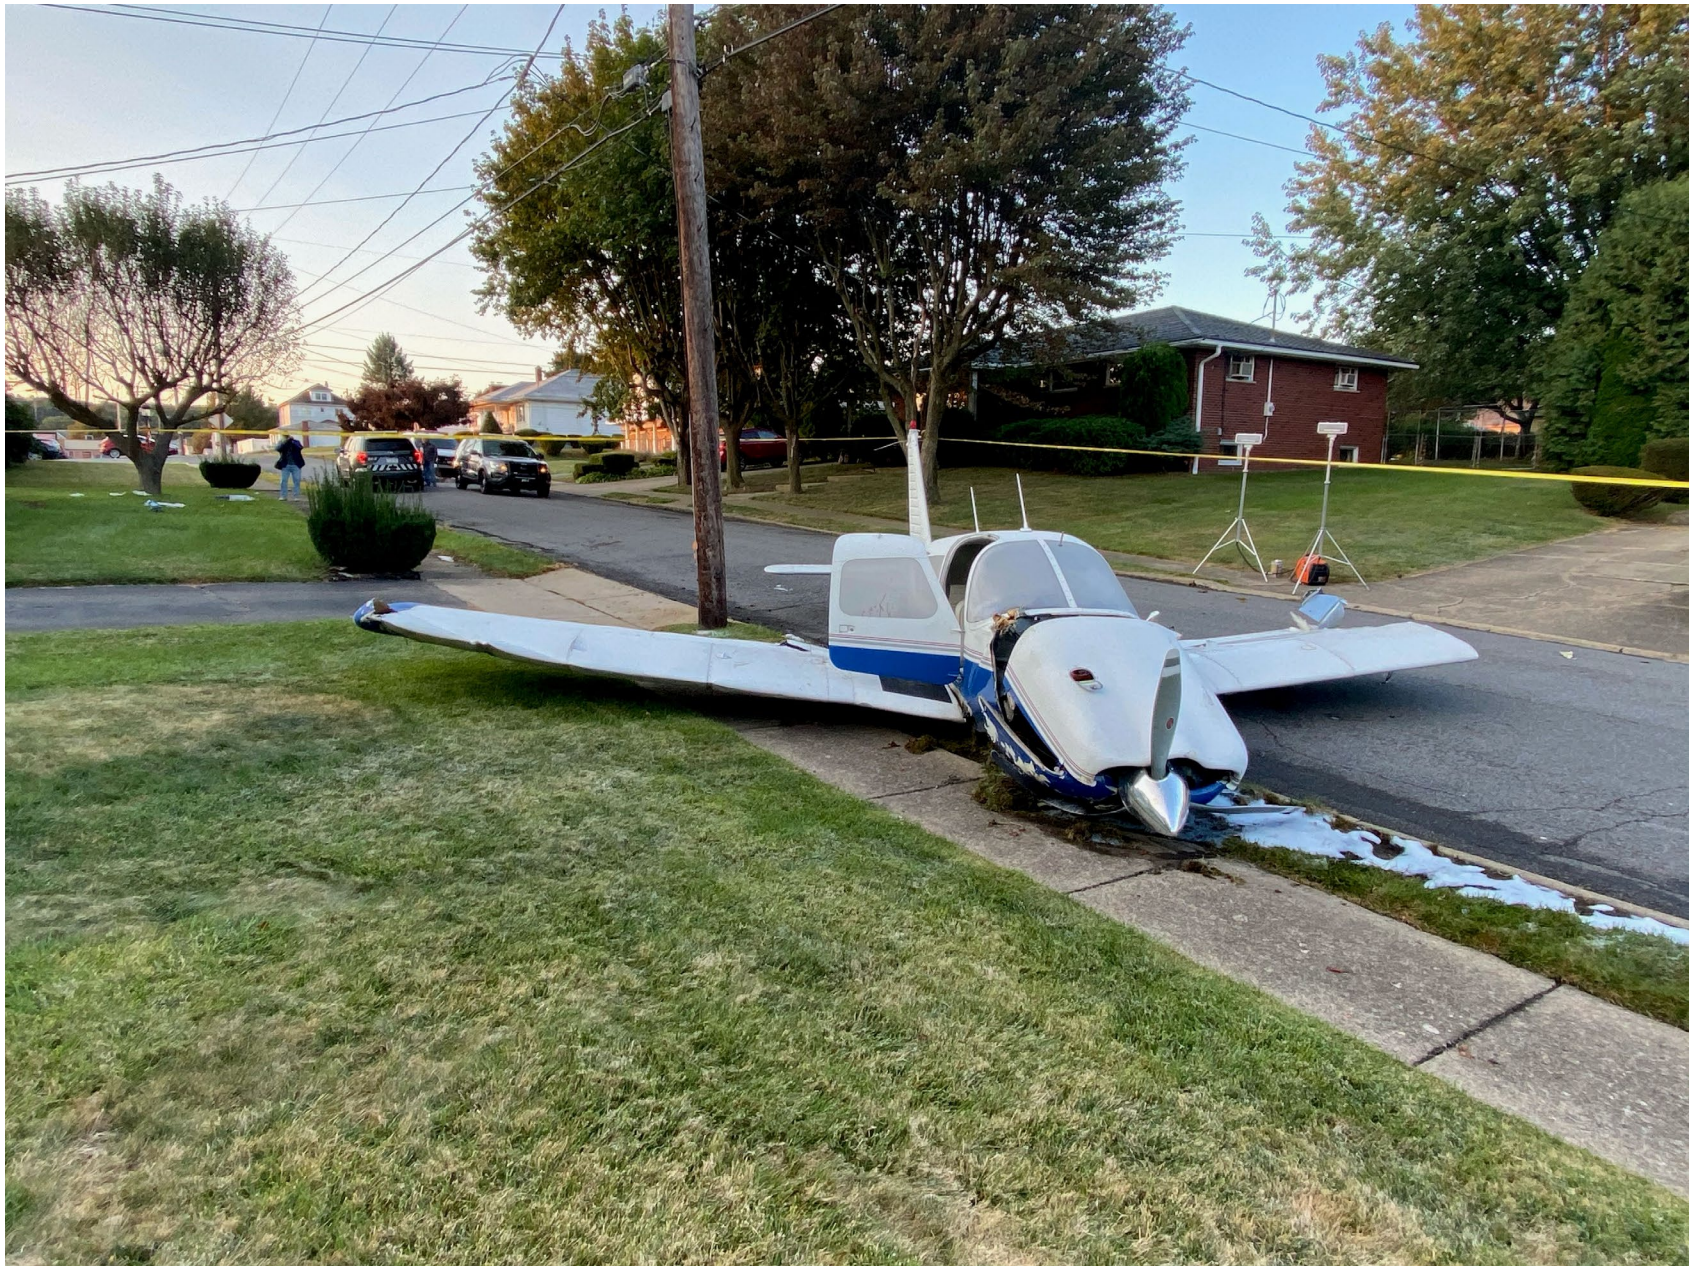
**Photo 1 – Digital Photograph Provided by FAA. Right Forward Quartering View of the Airplane at the Accident Site.  
Note the Separated Outer Section of the Left Wing.**

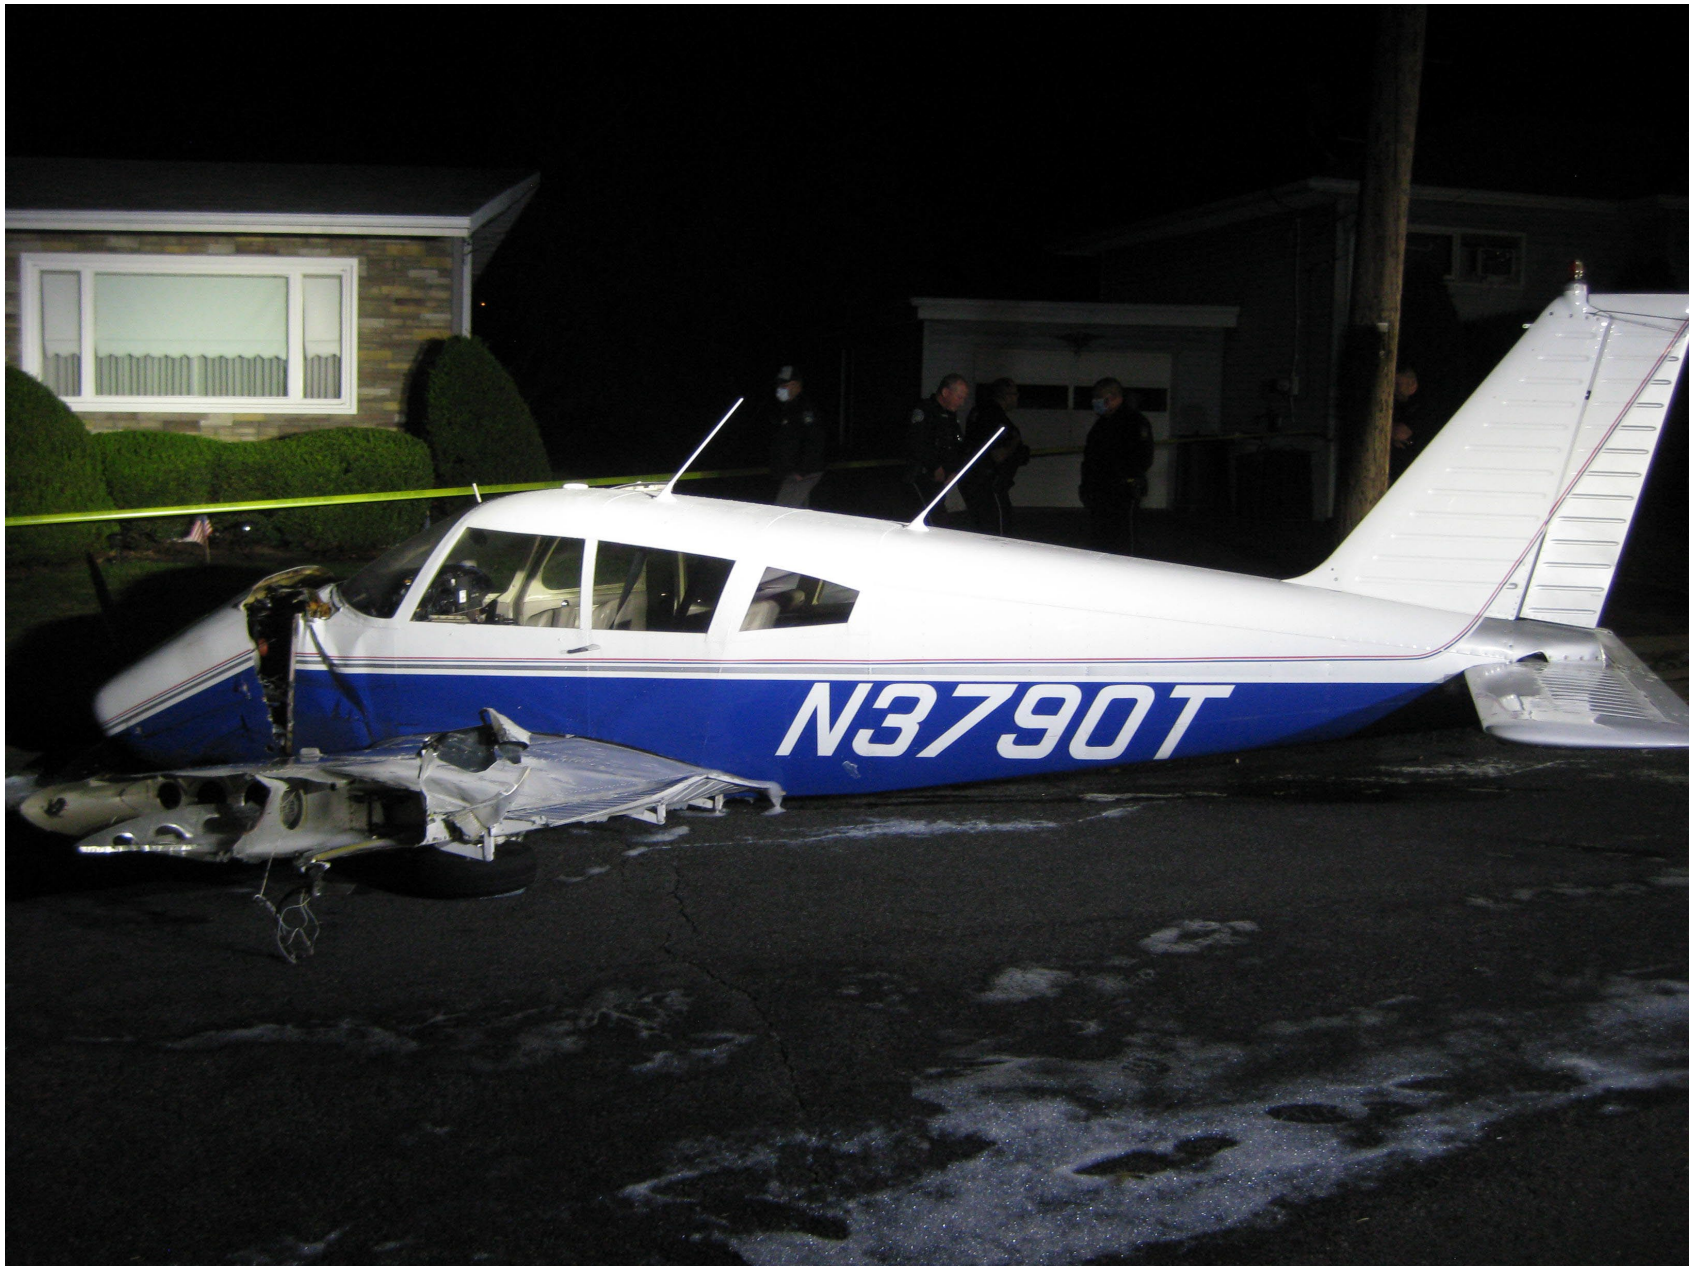
**Photo 2 - Digital Photograph Provided by FAA. Left Side View of the Airplane at the Accident Site. Note the Separated Outer Section of the Left Wing.**

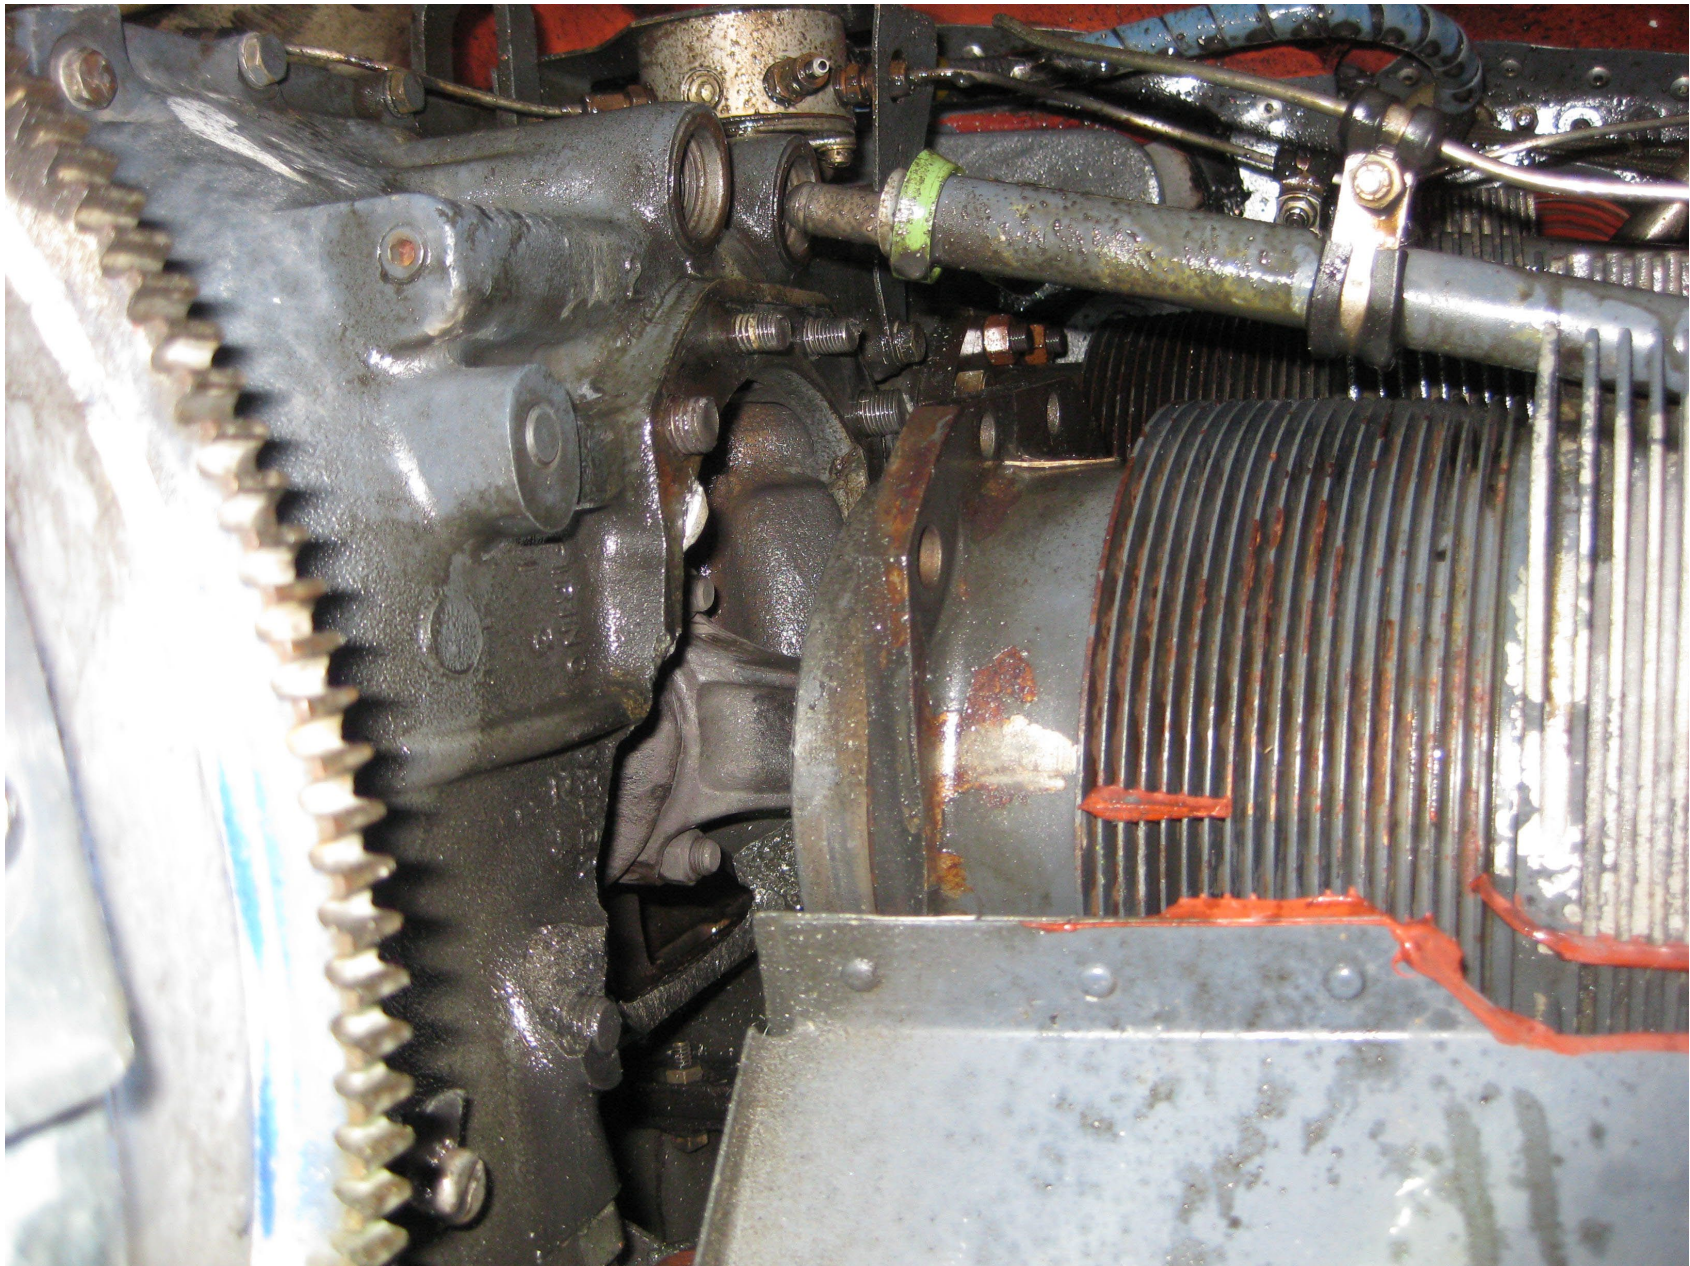
**Photo 3 - Digital Photograph Provided by FAA. View Showing Separated No. 2 Cylinder From the Crankcase.**

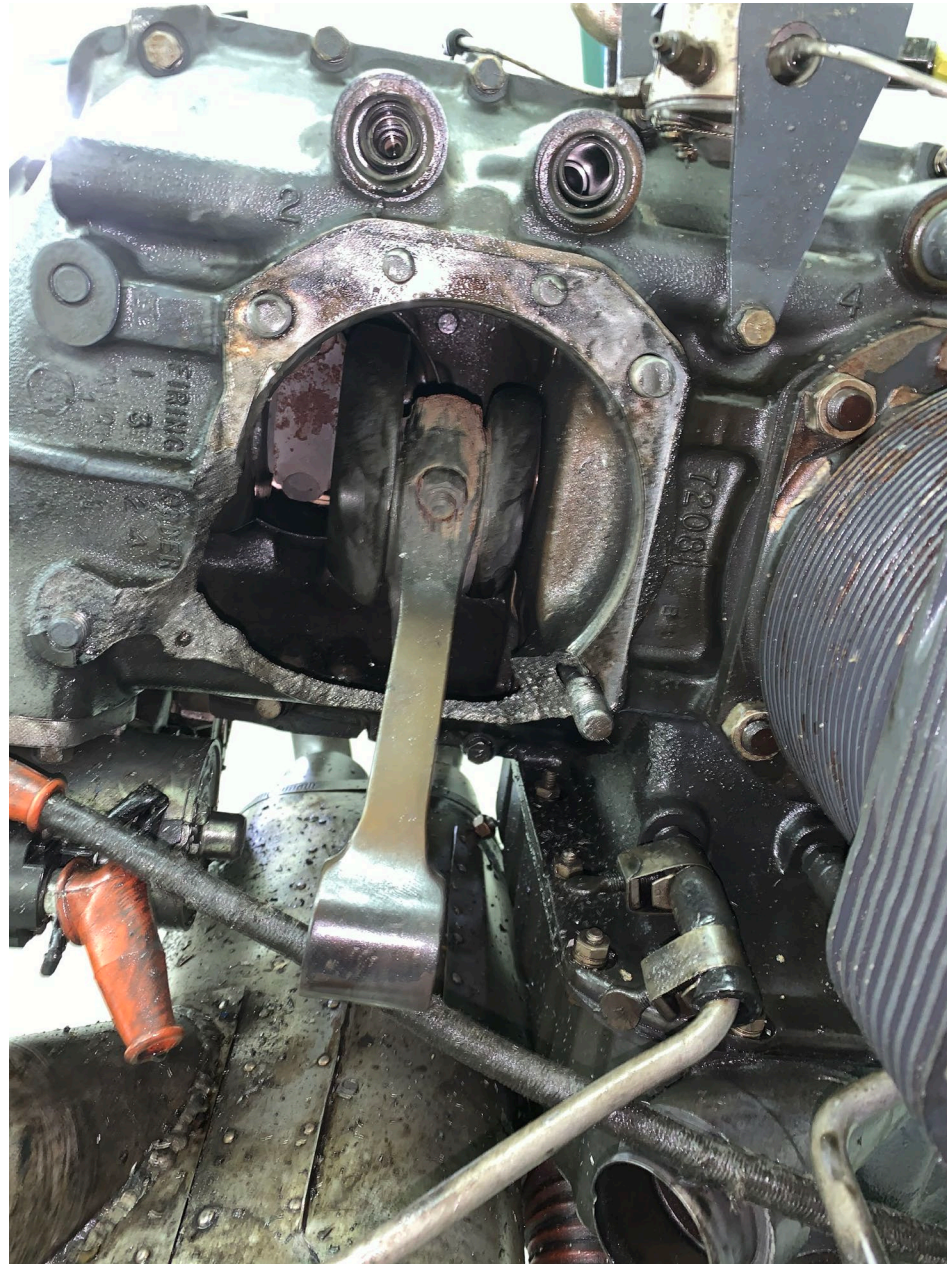
**Photo 4 - NTSB Digital Photograph. View Showing the No. 2 Cylinder Pad of the Crankcase. Note the heat Discoloration of the Connecting Rod Consistent with Lack of Lubrication.**
