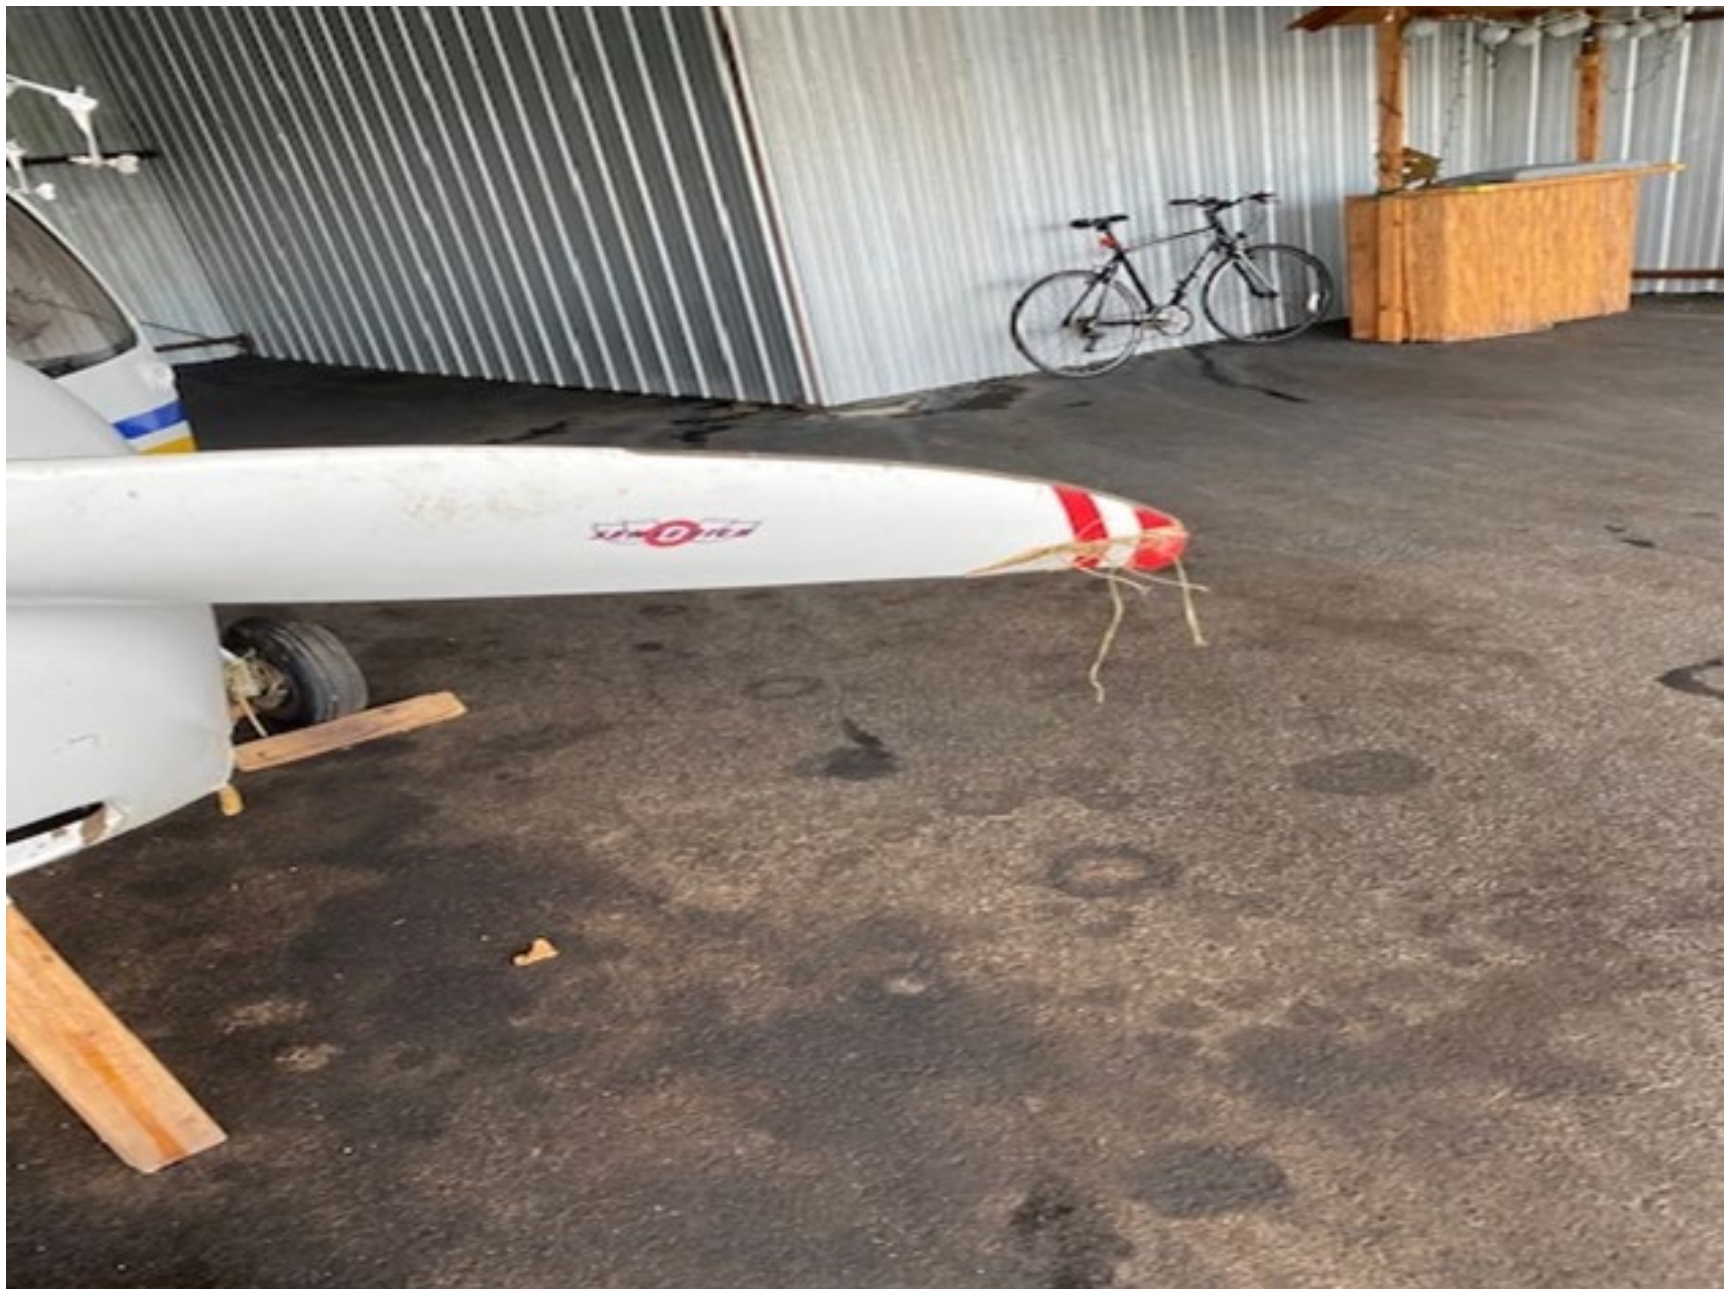
**Photo 1 – N562TU One Blade of the 2-Bladed Propeller – Courtesy of FAA**

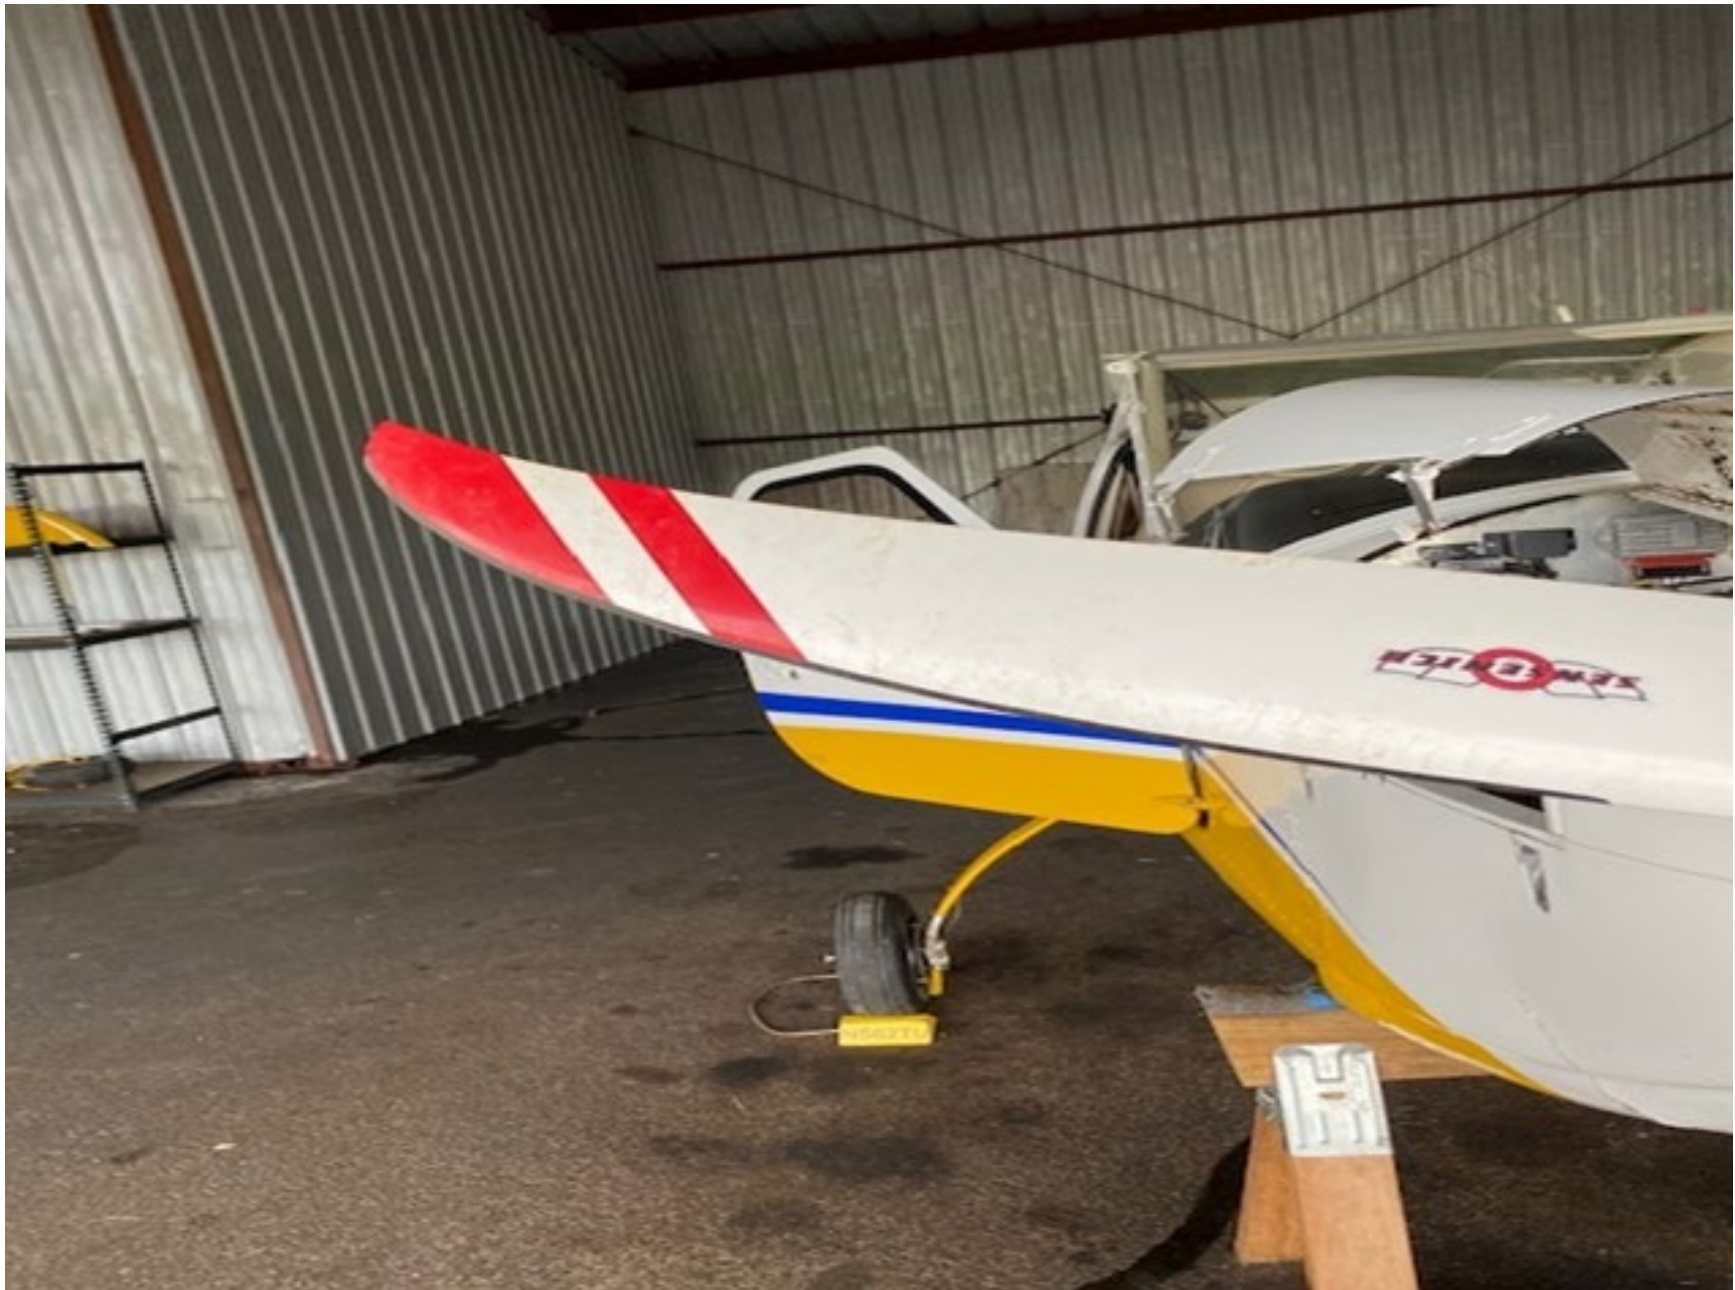
**Photo 2 – N562TU Second Blade of the 2-Bladed Propeller – Courtesy of FAA**

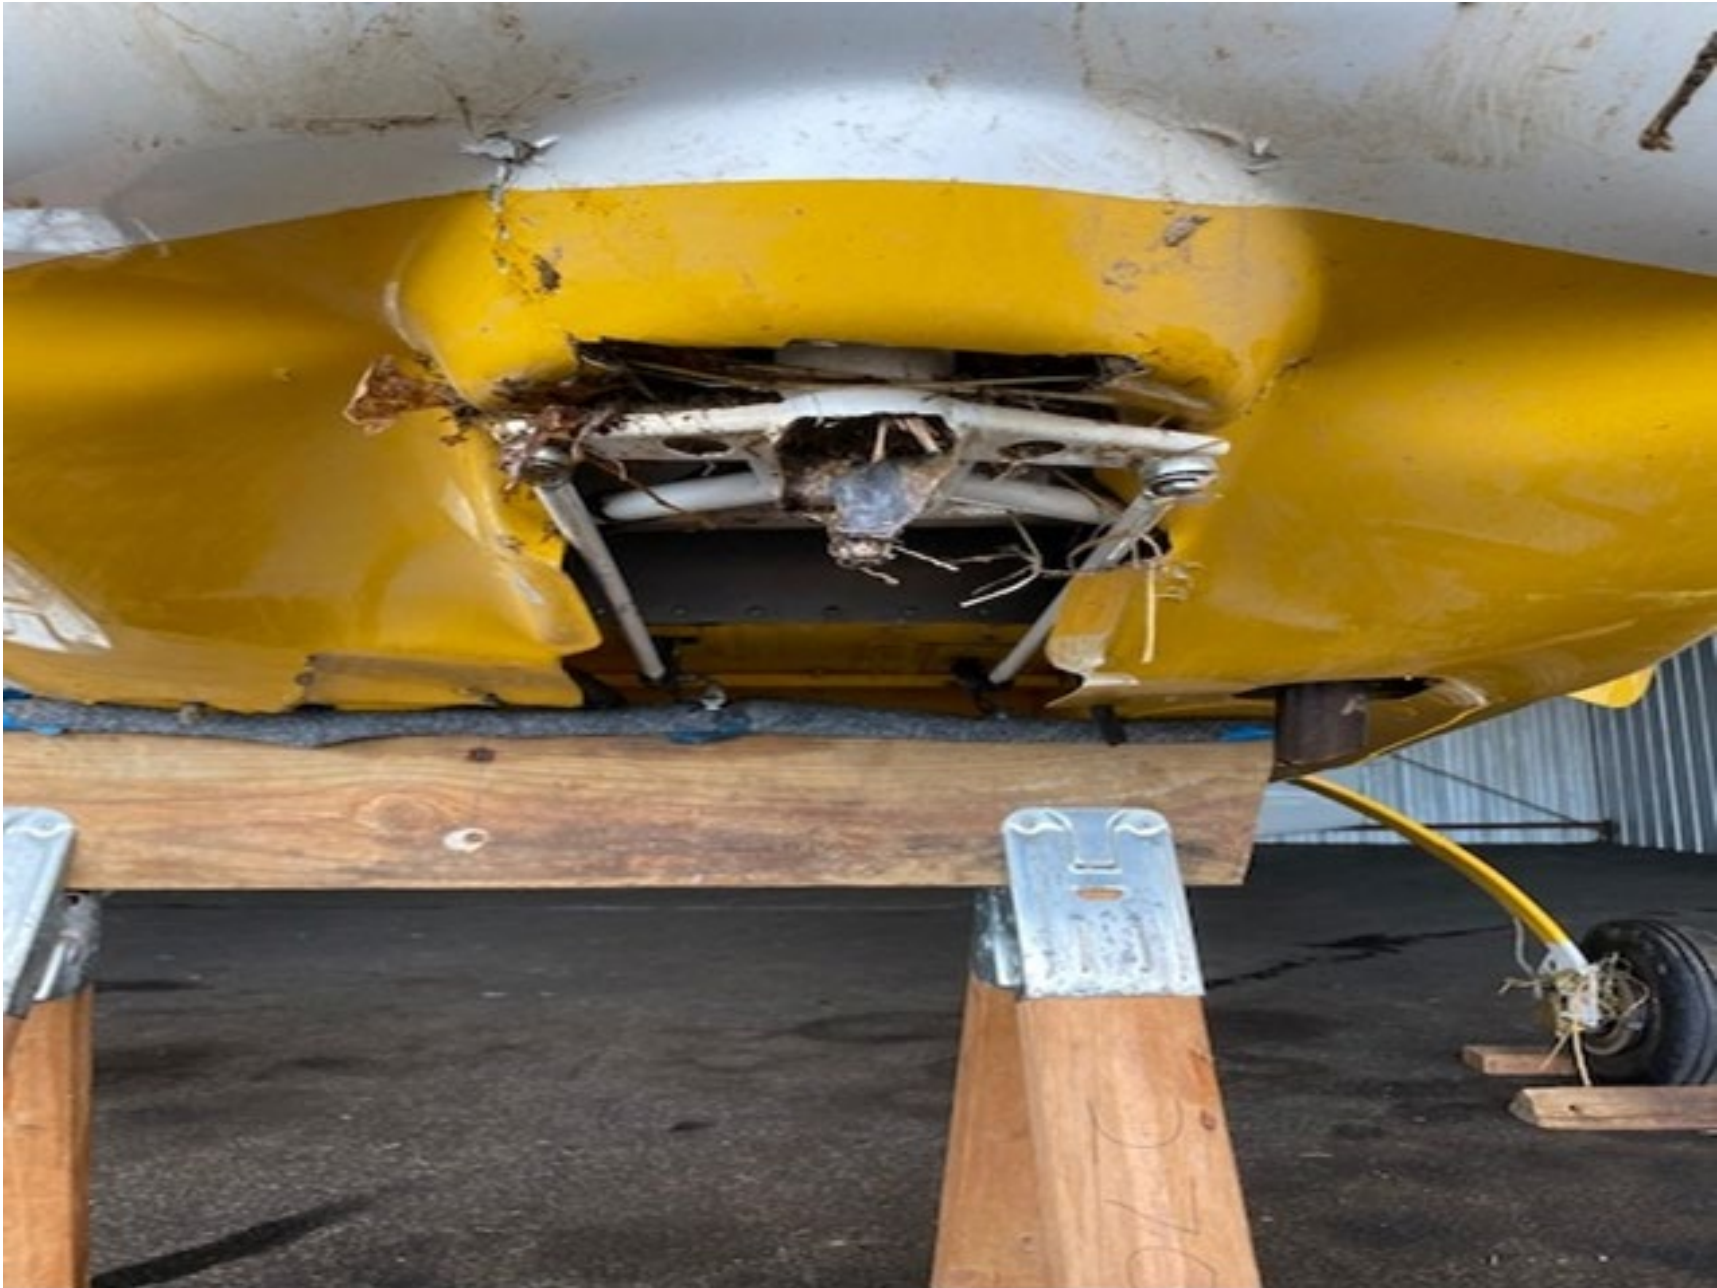
**Photo 3 – N562TU Lower Cowling and Nose Landing Gear Location– Courtesy of FAA**

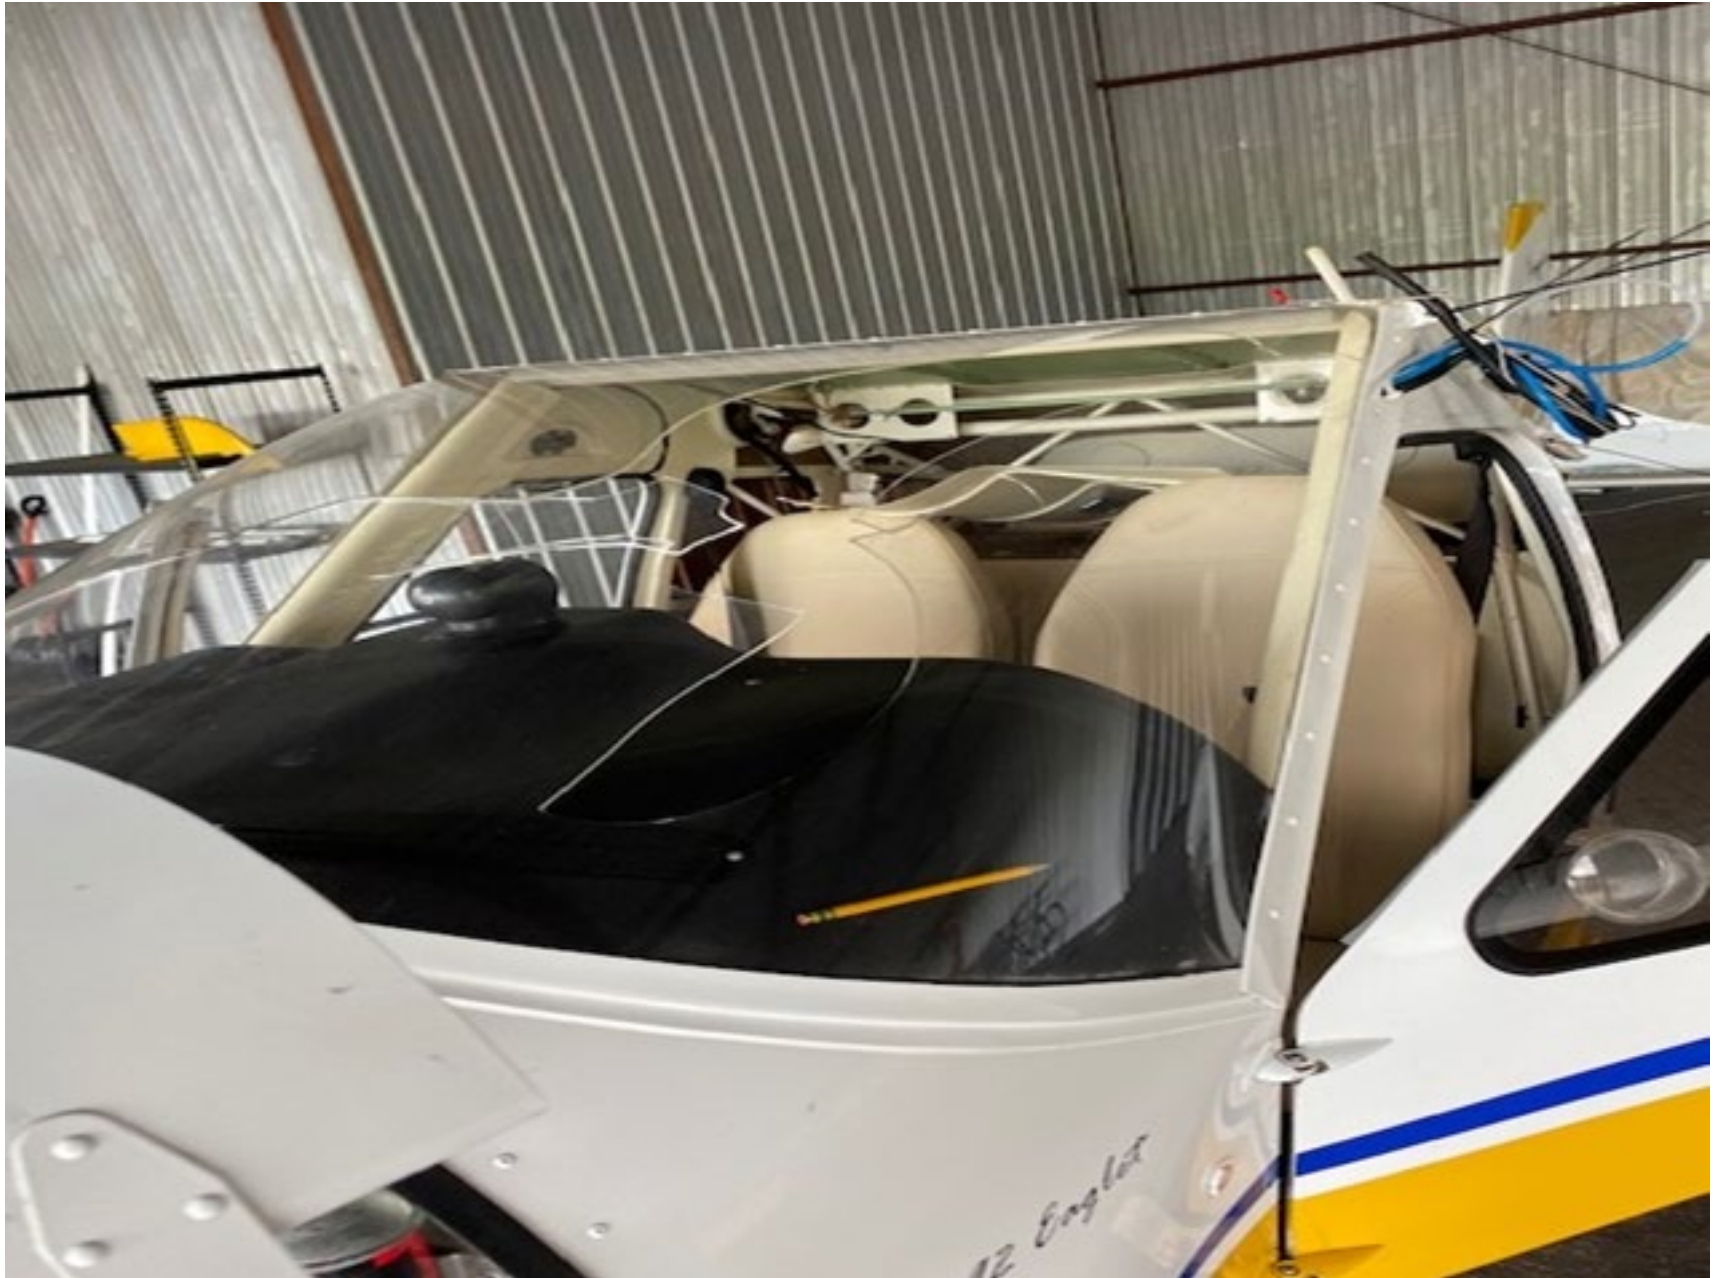
**Photo 4 – N562TU Windshield – Courtesy of FAA**

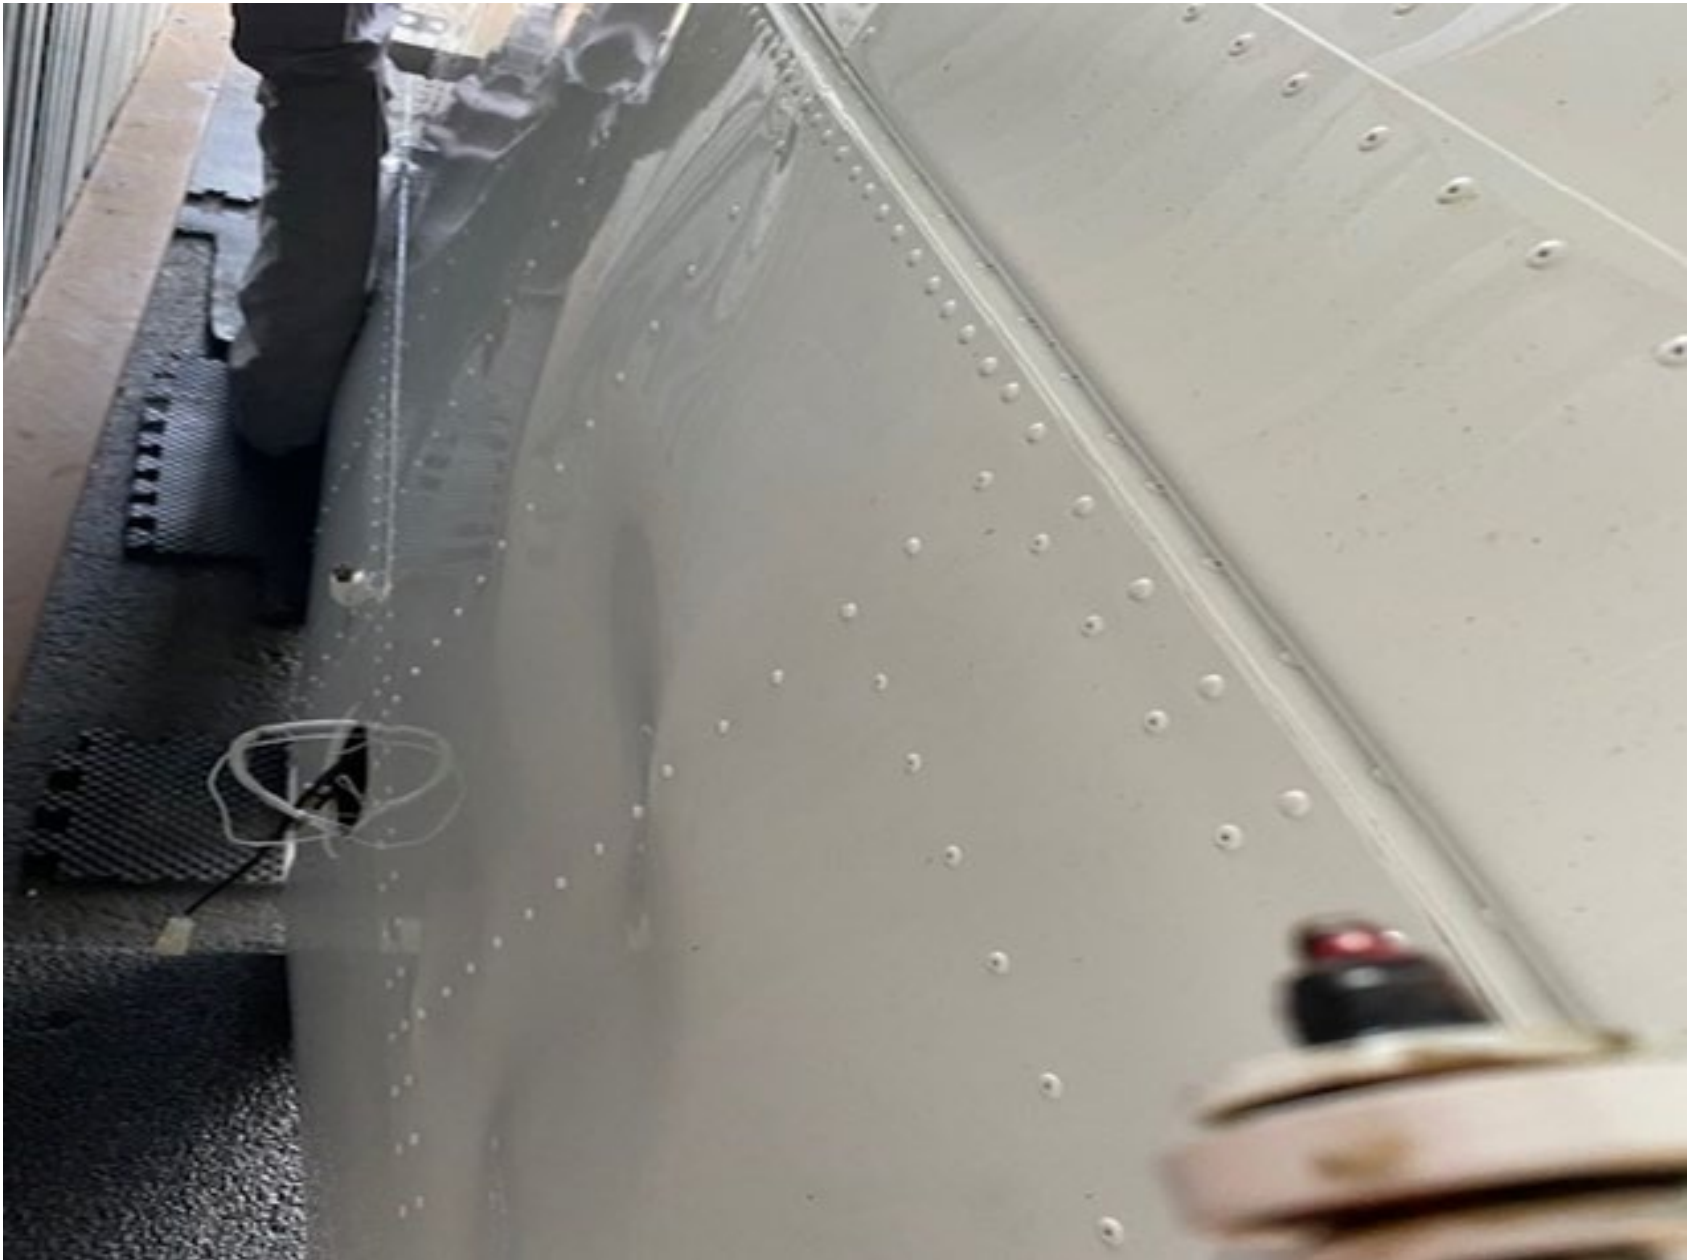
**Photo 5 – N562TU Right Wing– Courtesy of FAA**

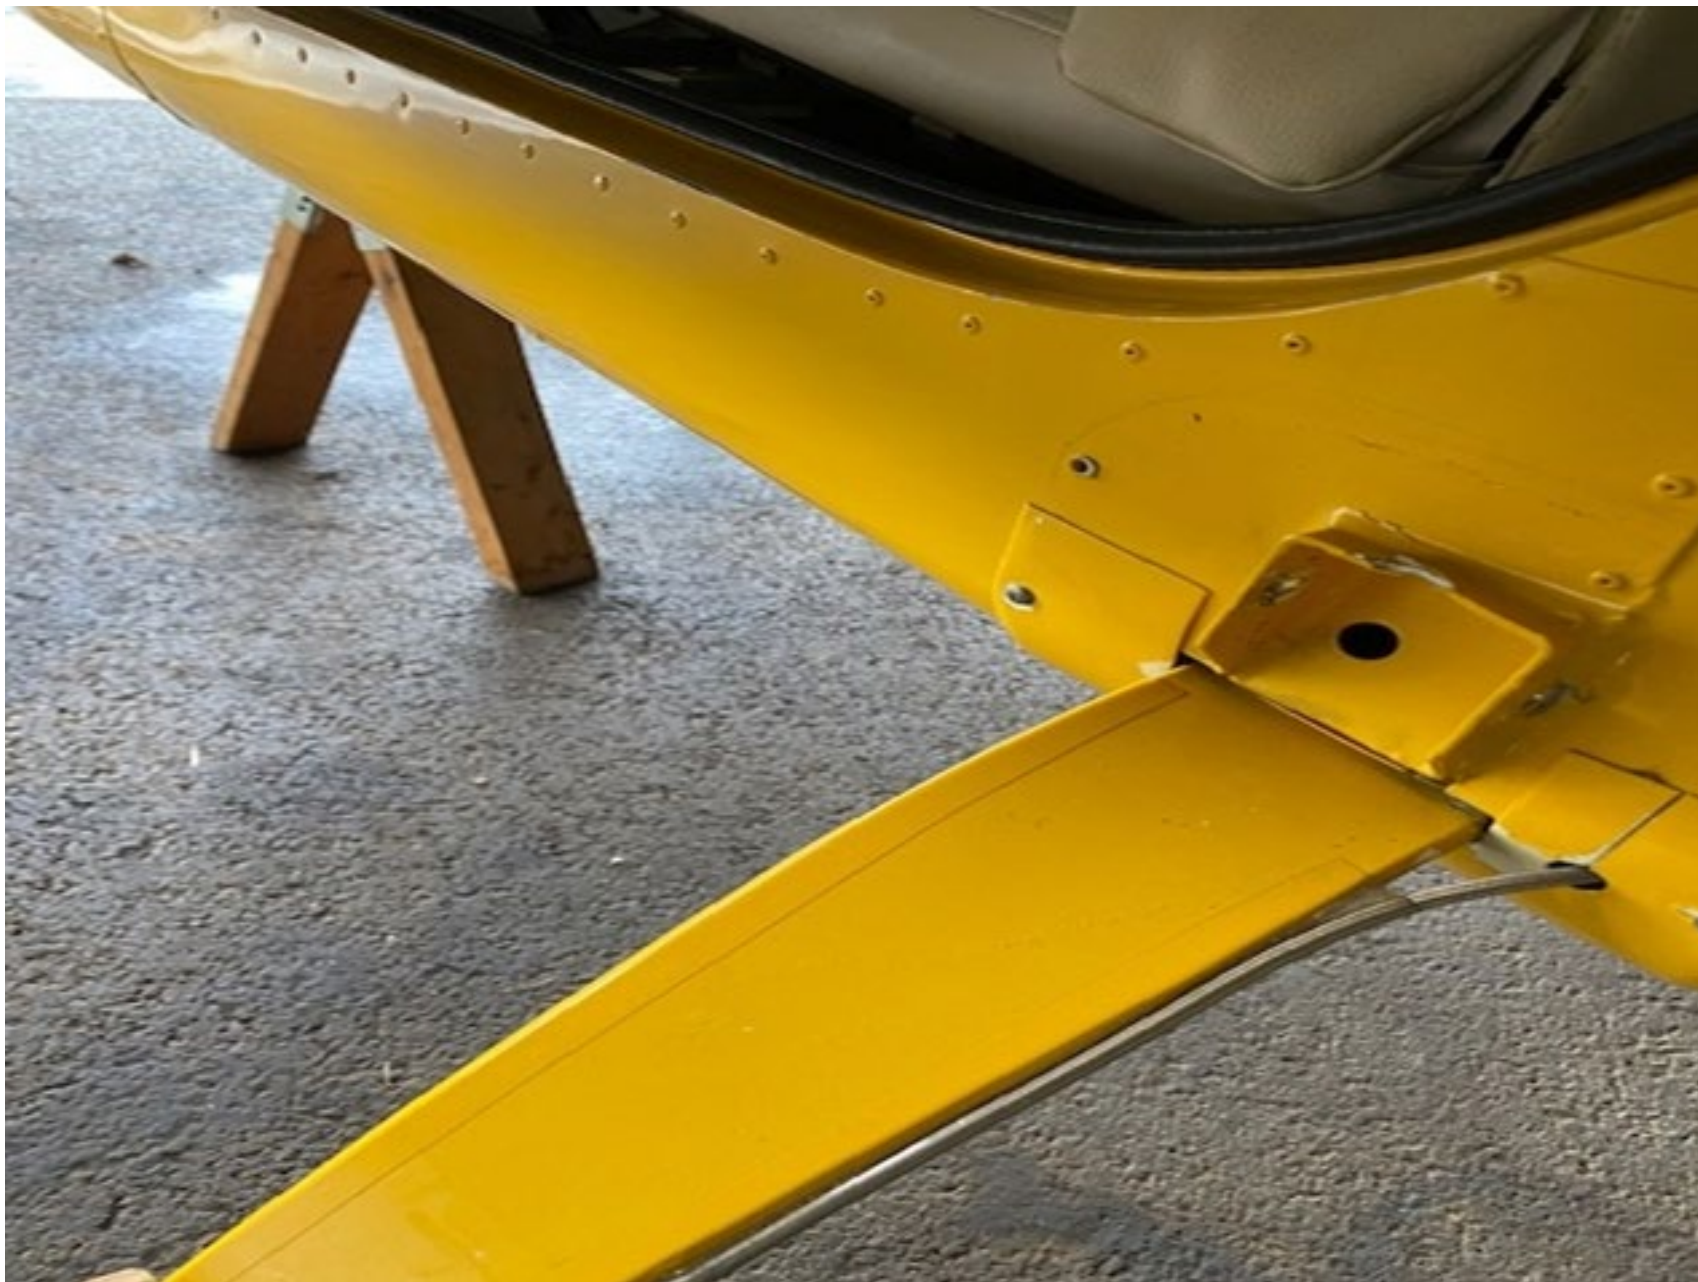
**Photo 6 – N562TU Left Main Landing Gear Mounting Location – Courtesy of FAA**

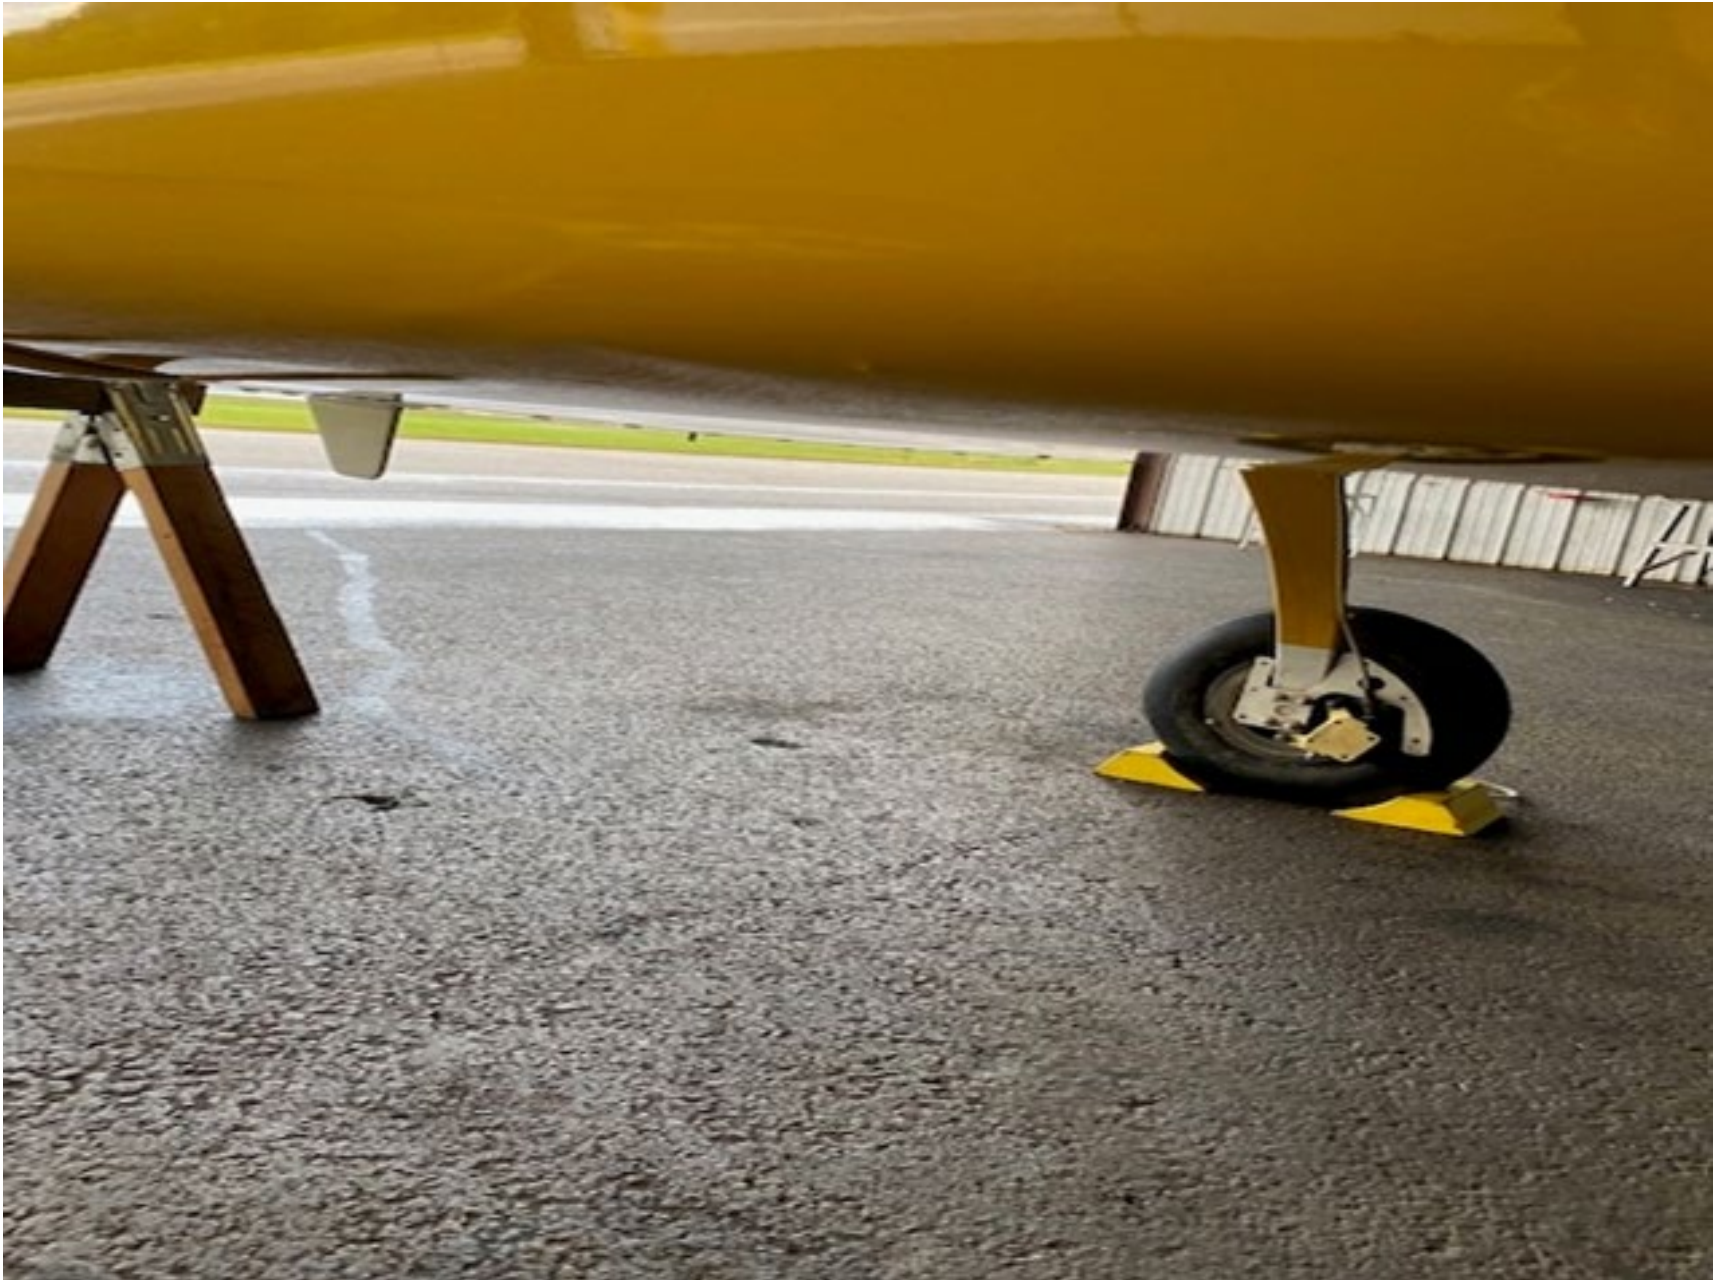
**Photo 7 – N562TU Lower Fuselage – Courtesy of FAA**

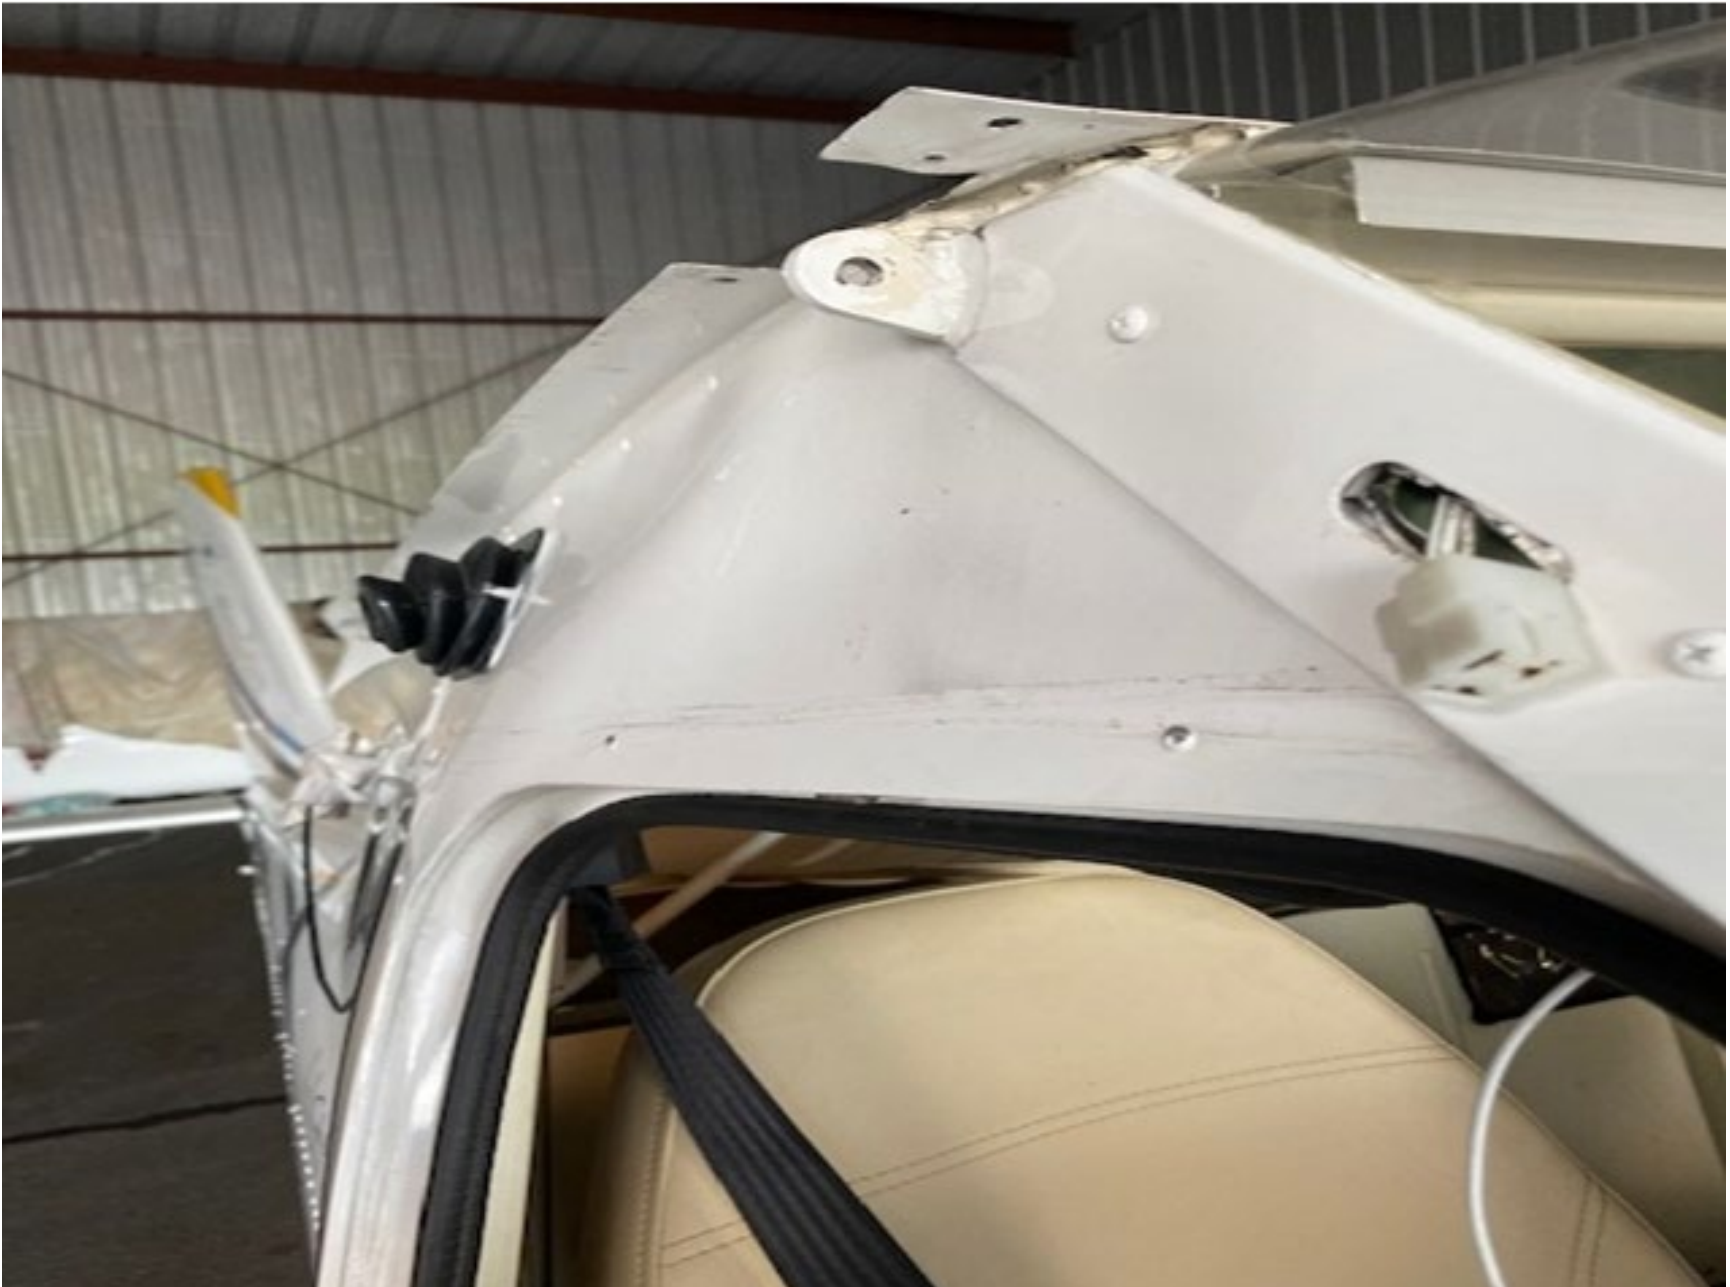
**Photo 8 – N562TU Right Upper Fuselage – Courtesy of FAA**

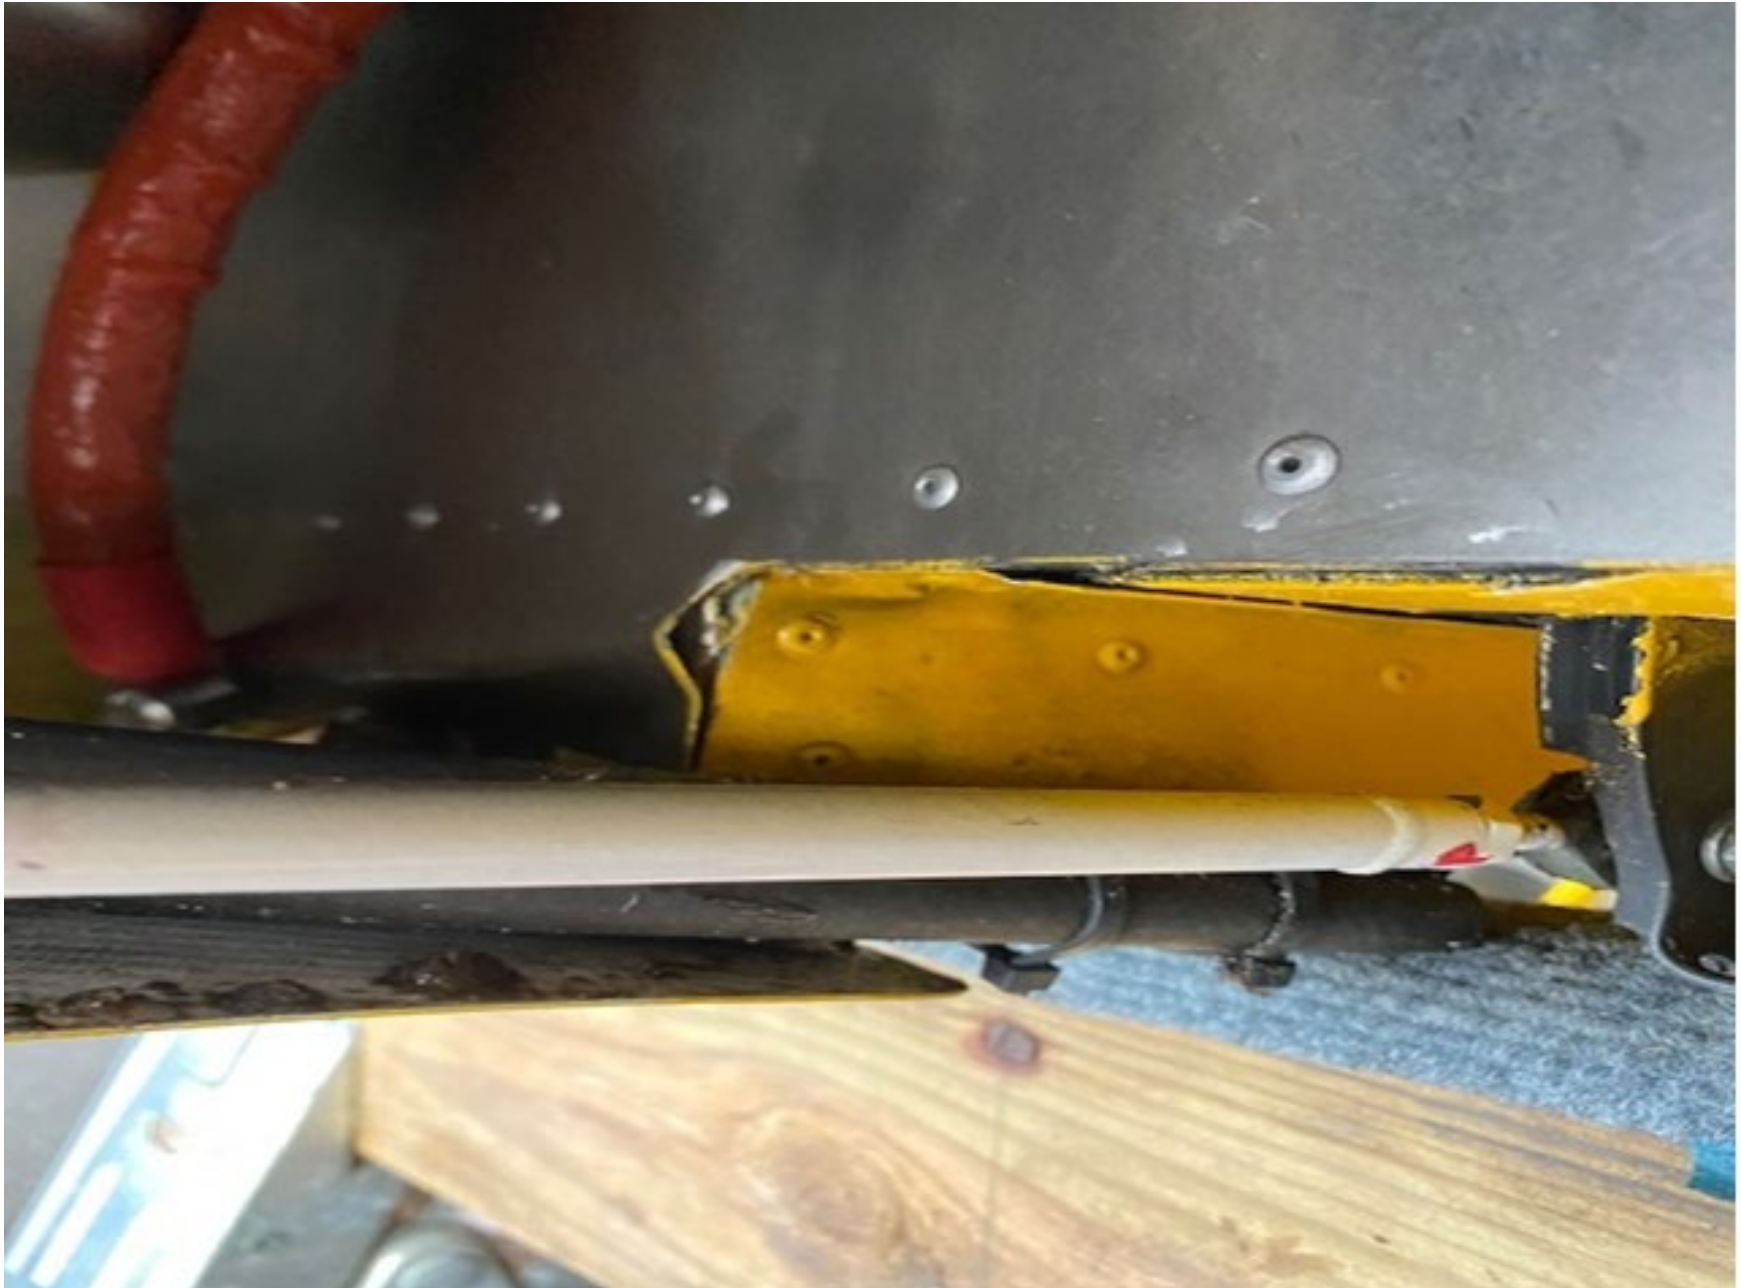
**Photo 9 – N562TU Lower Firewall**

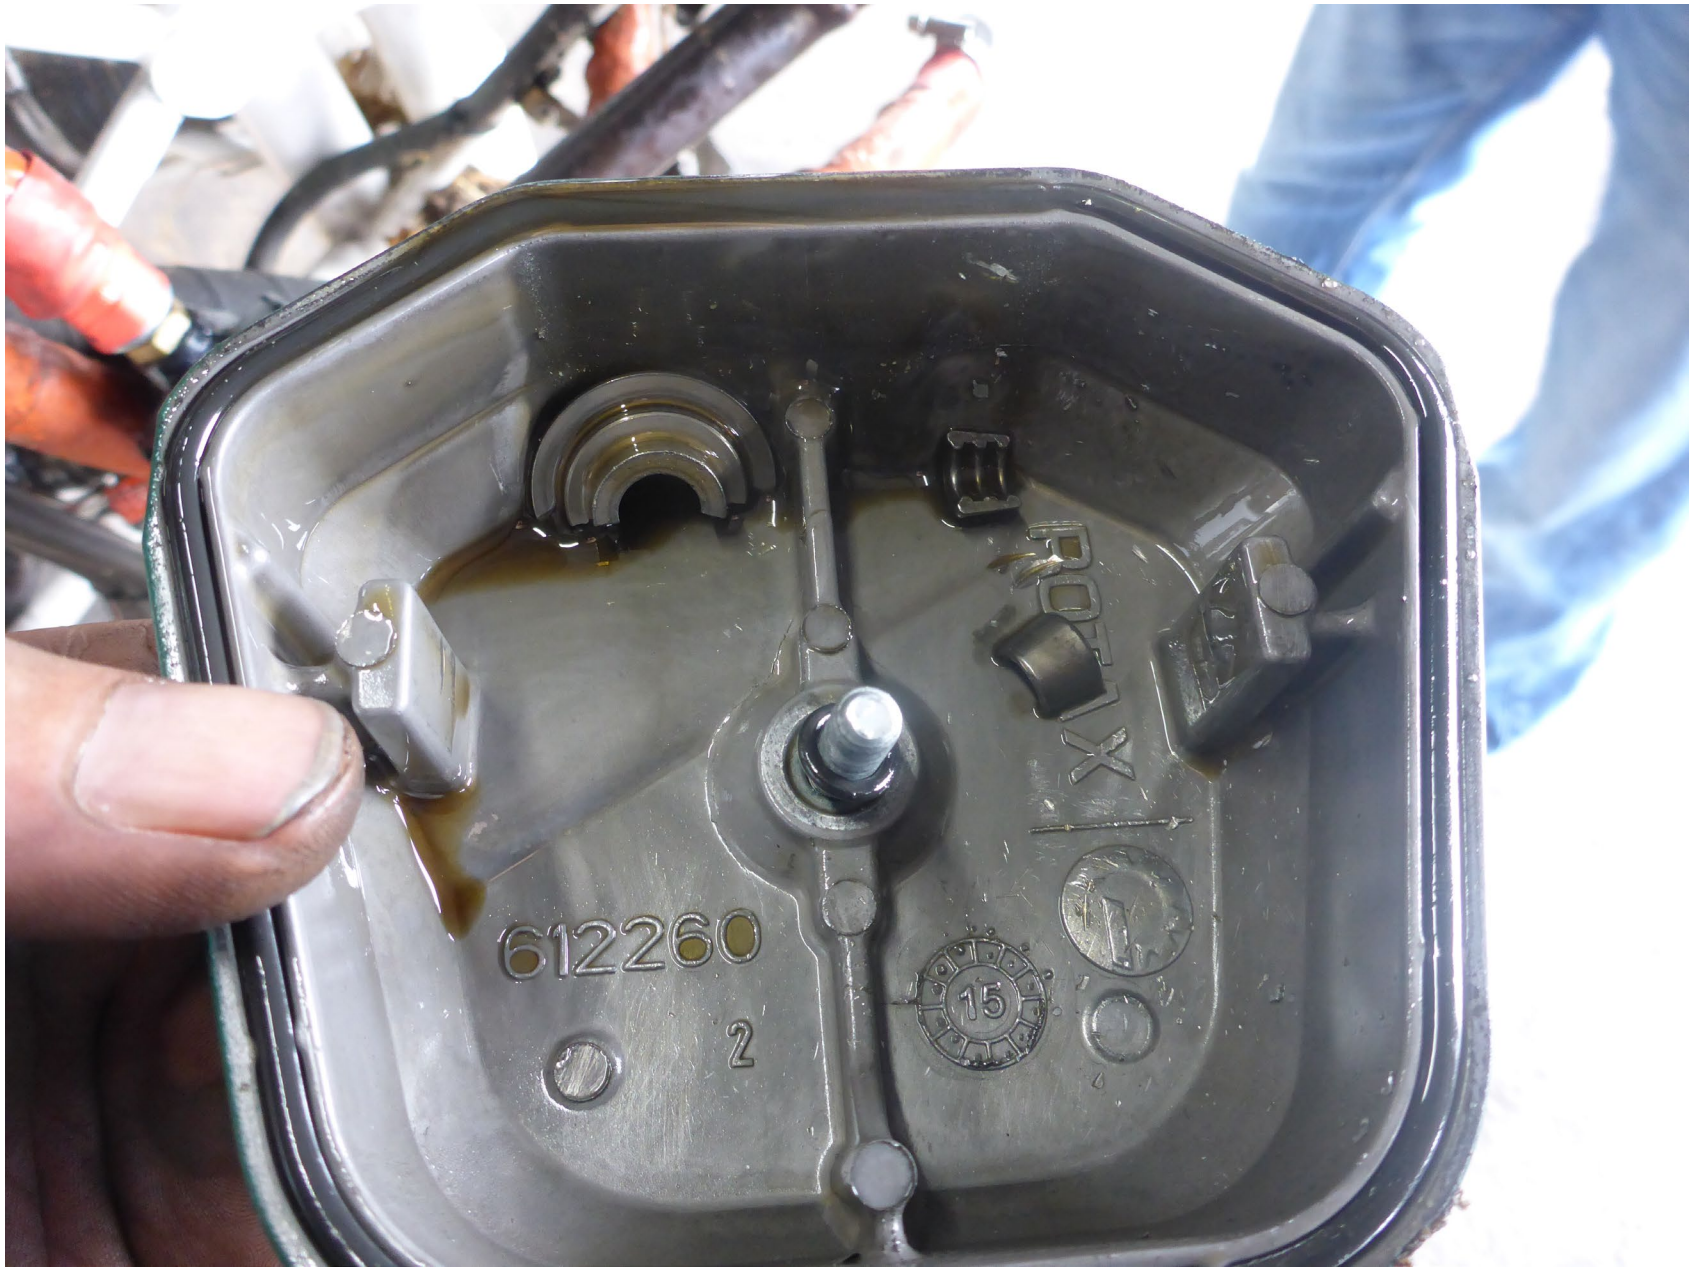
**Photo 11 – N562TU Cylinder No. 1 Broken Exhaust Valve Spring Retainer – Courtesy of Rotech Flight Safety**
