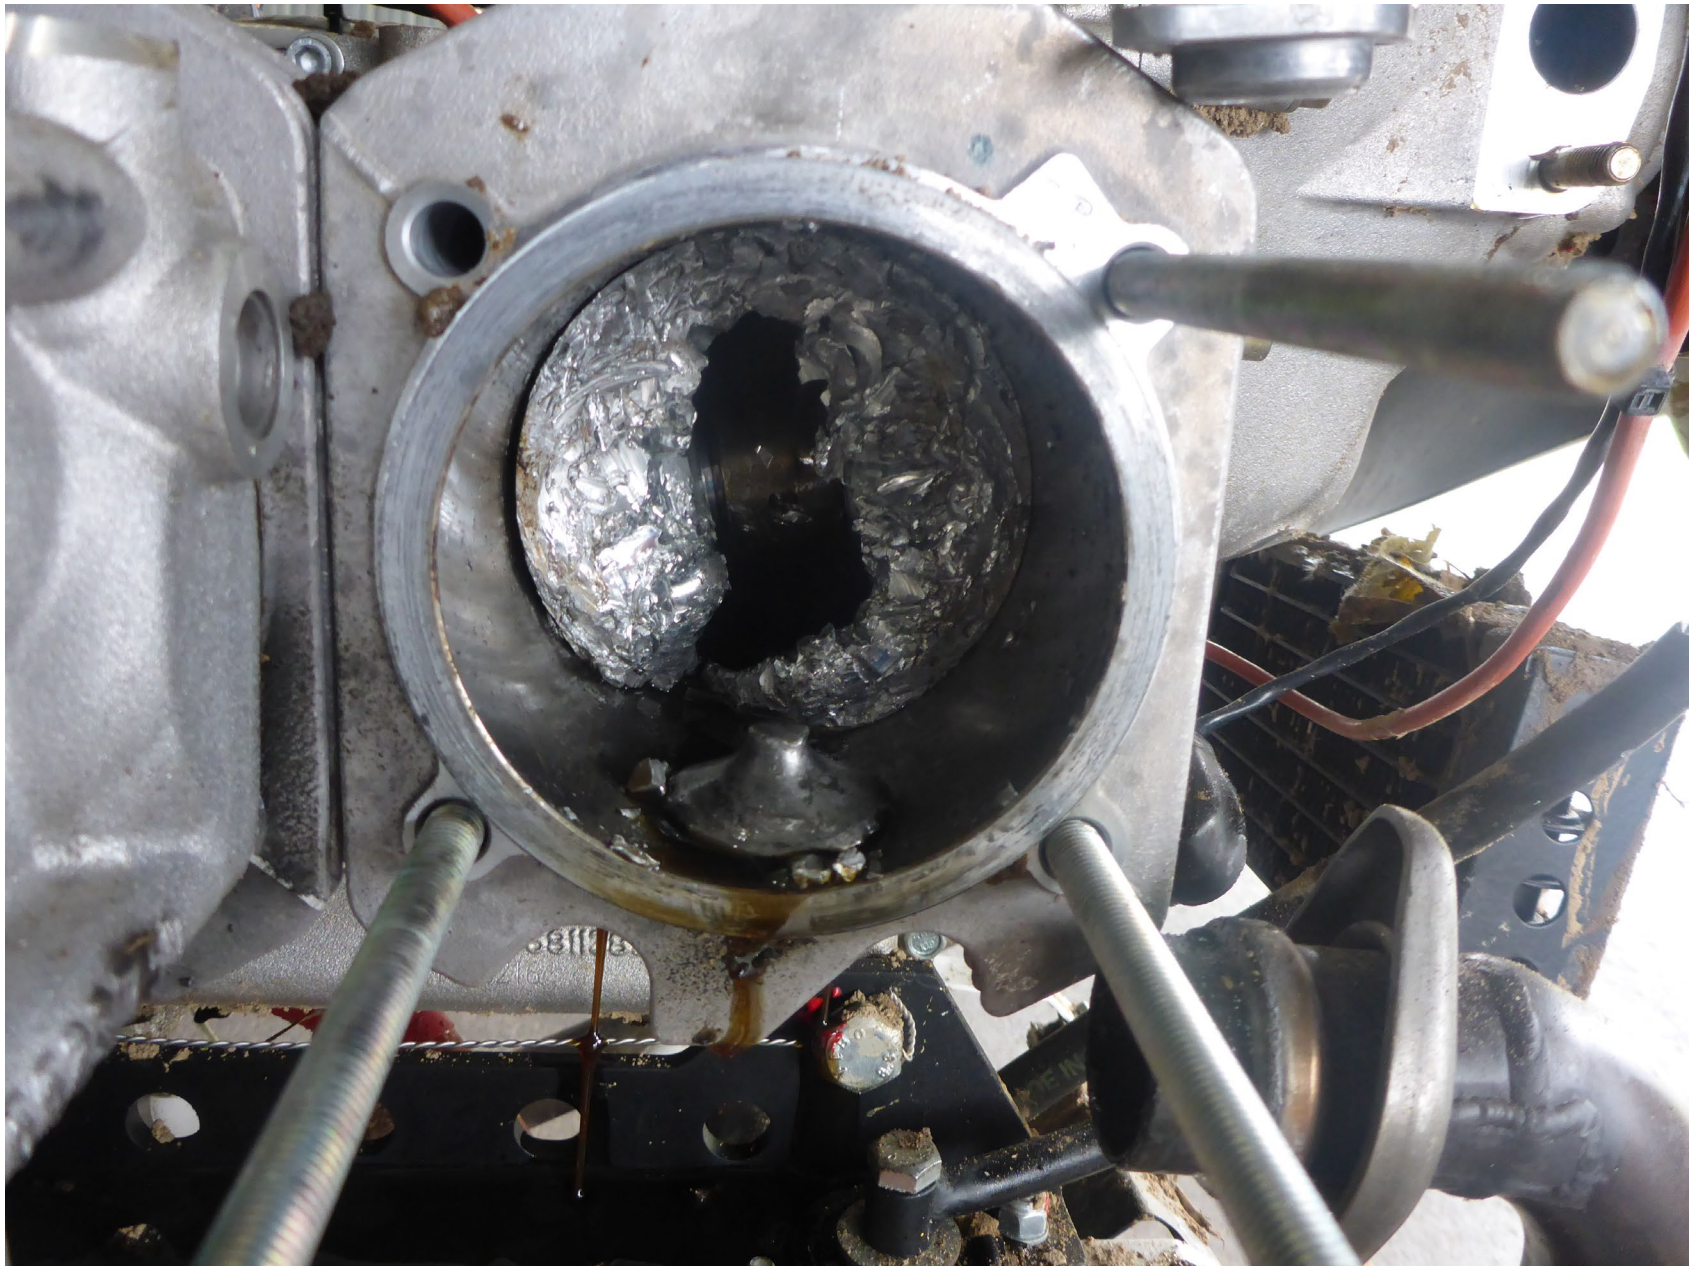
**Photo 12 – N562TU No.1 Piston and Exhaust Valve – Courtesy of Rotech Flight Safety**

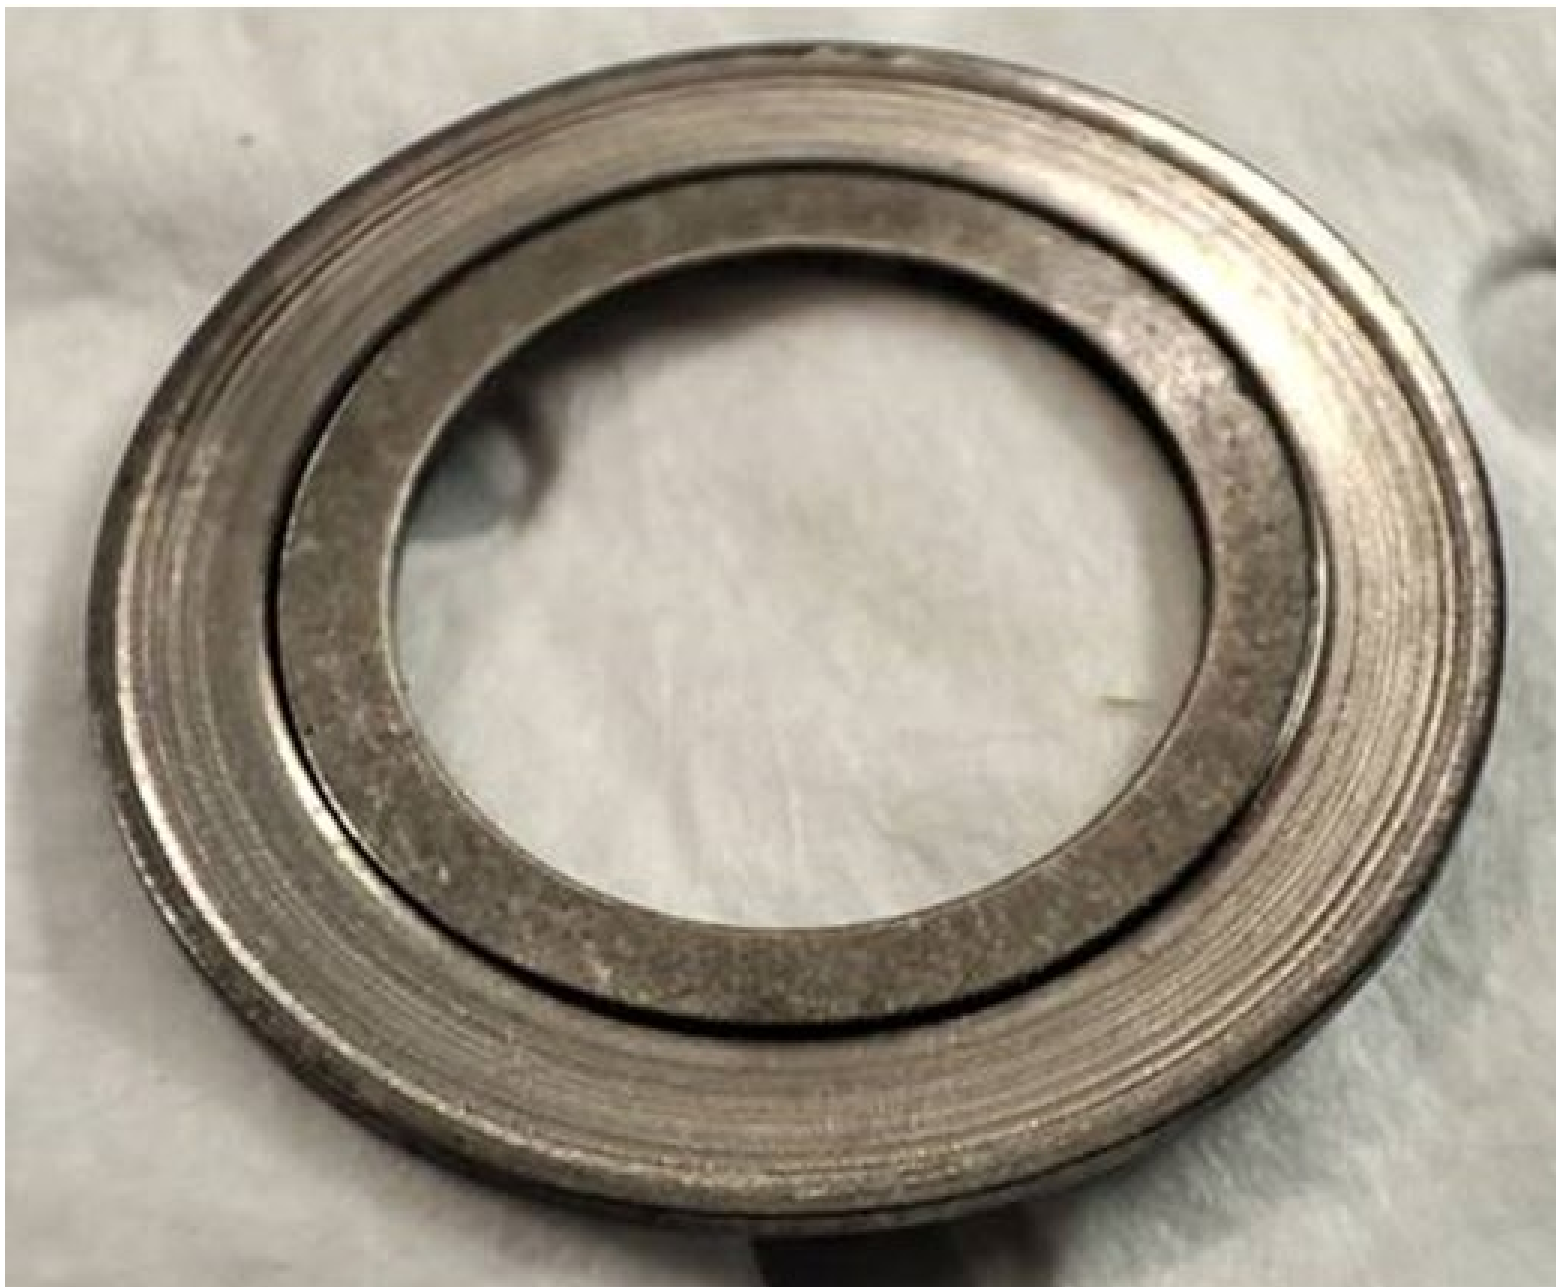
**Photo 13 - N562TU No.1 Cylinder Exhaust Valve Spring Shim Wear Marks – Courtesy of BMK**

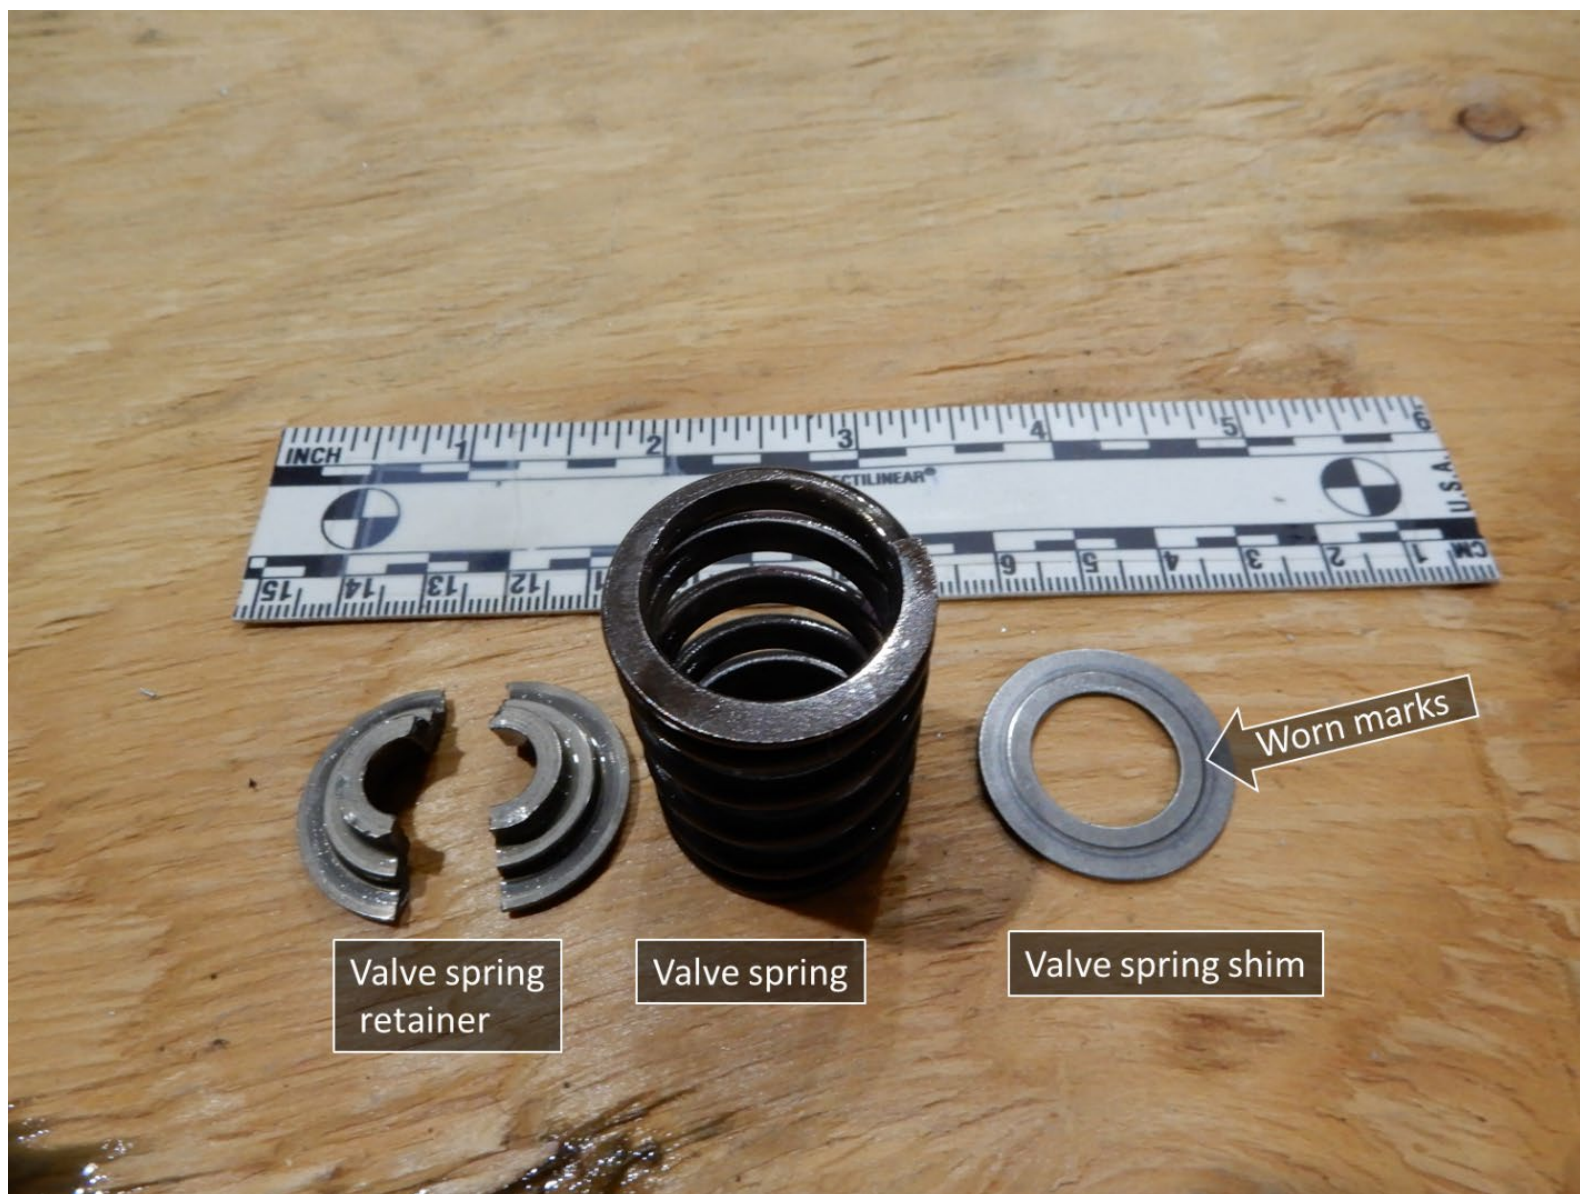
**Photo 14 – N204BF – No. 2 Cylinder Intake Valve Spring Retainer, Valve Spring, and Valve Spring Shim**

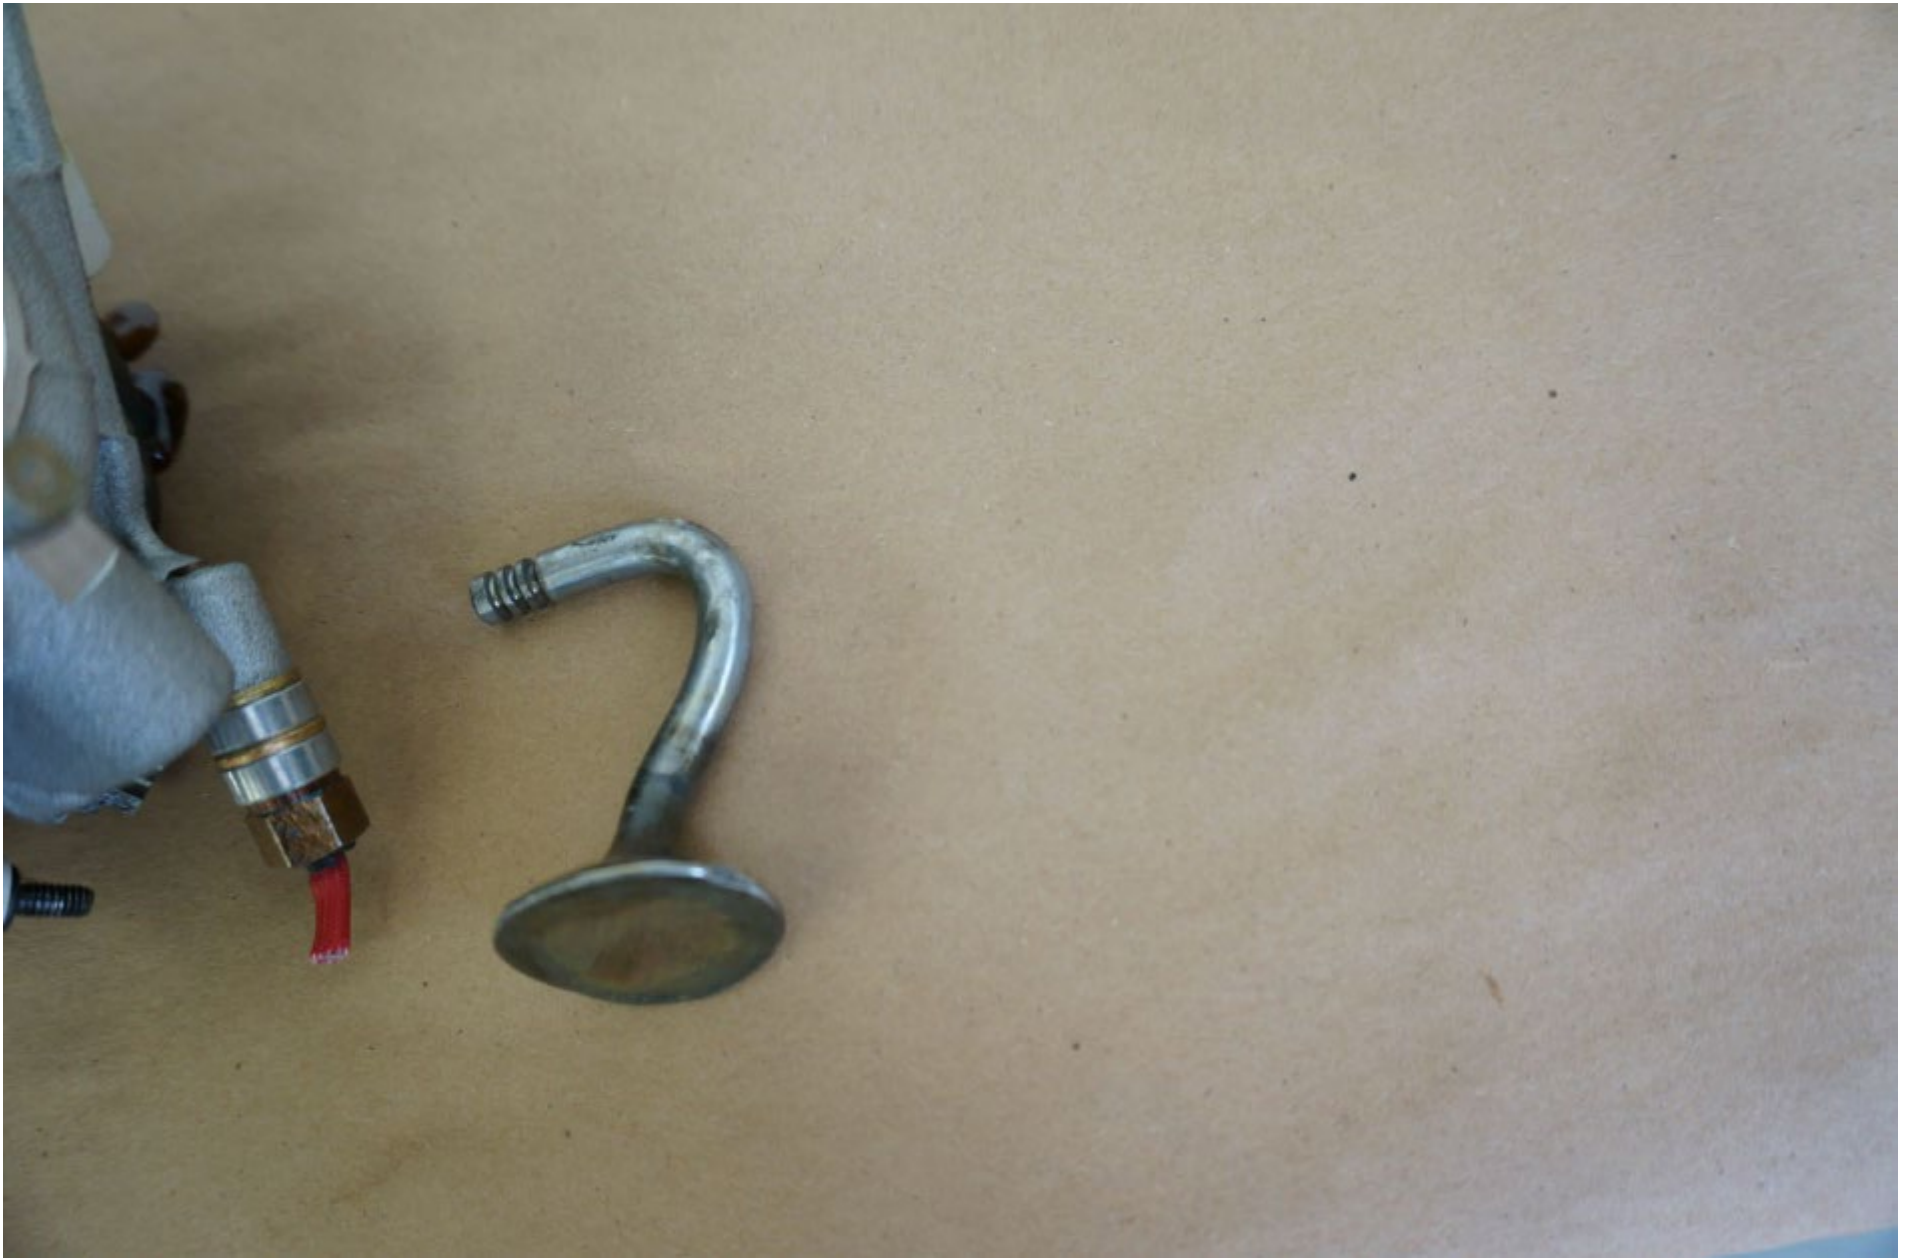
**Photo 16 – N561TU No. 1 Exhaust Valve**

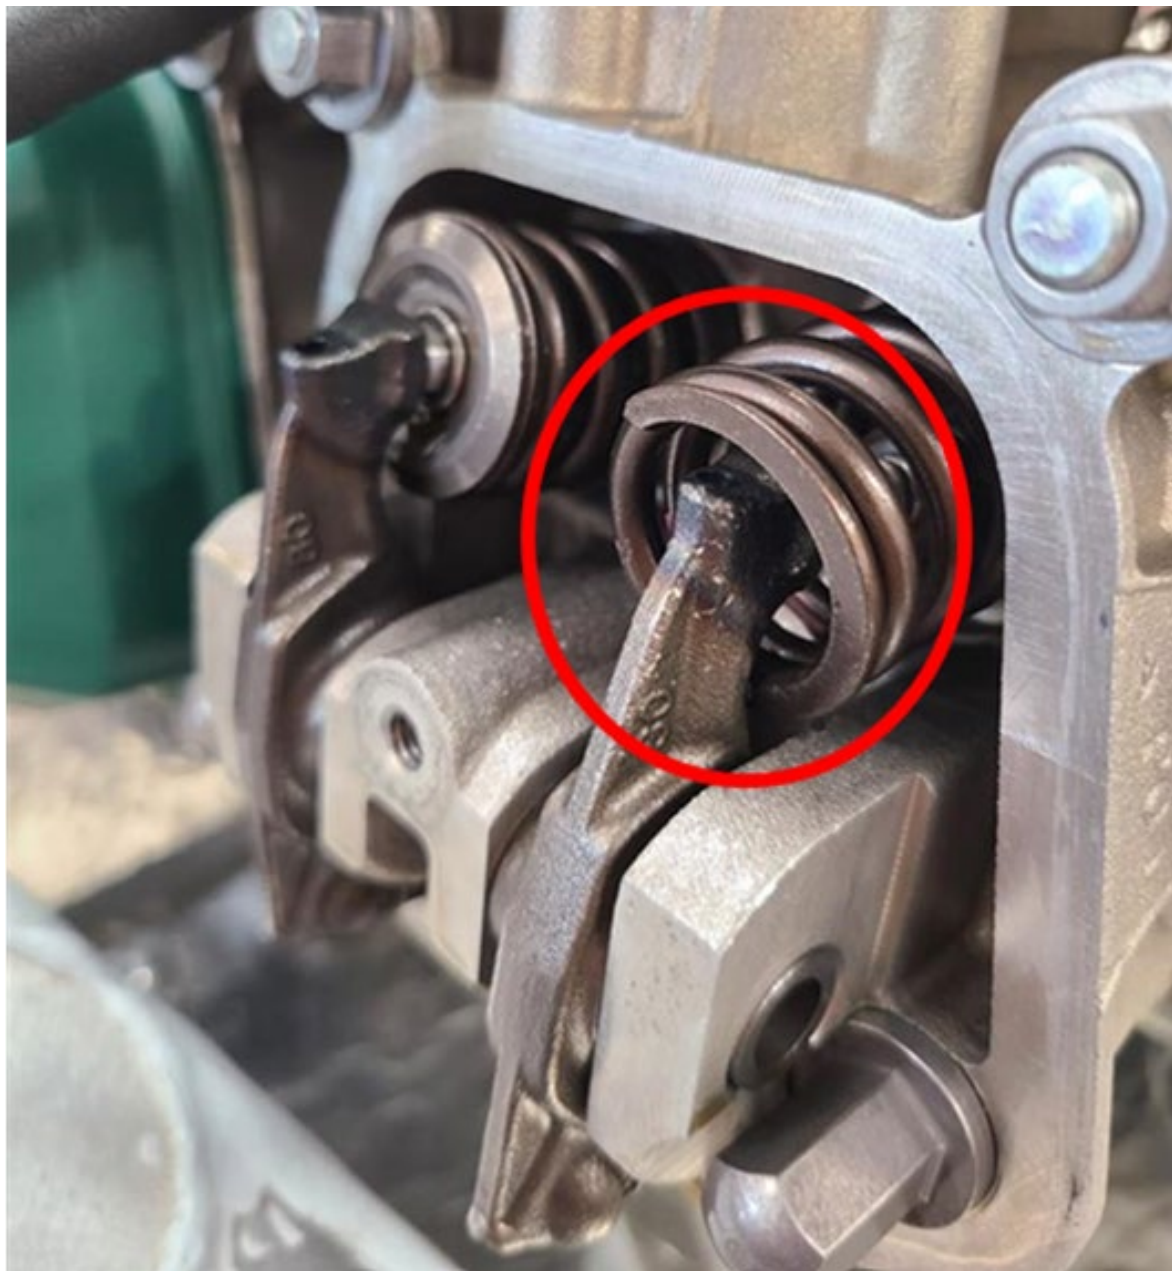
**Photo 18 – N639BA – No.1 Cylinder – Courtesy of Icon Aircraft**

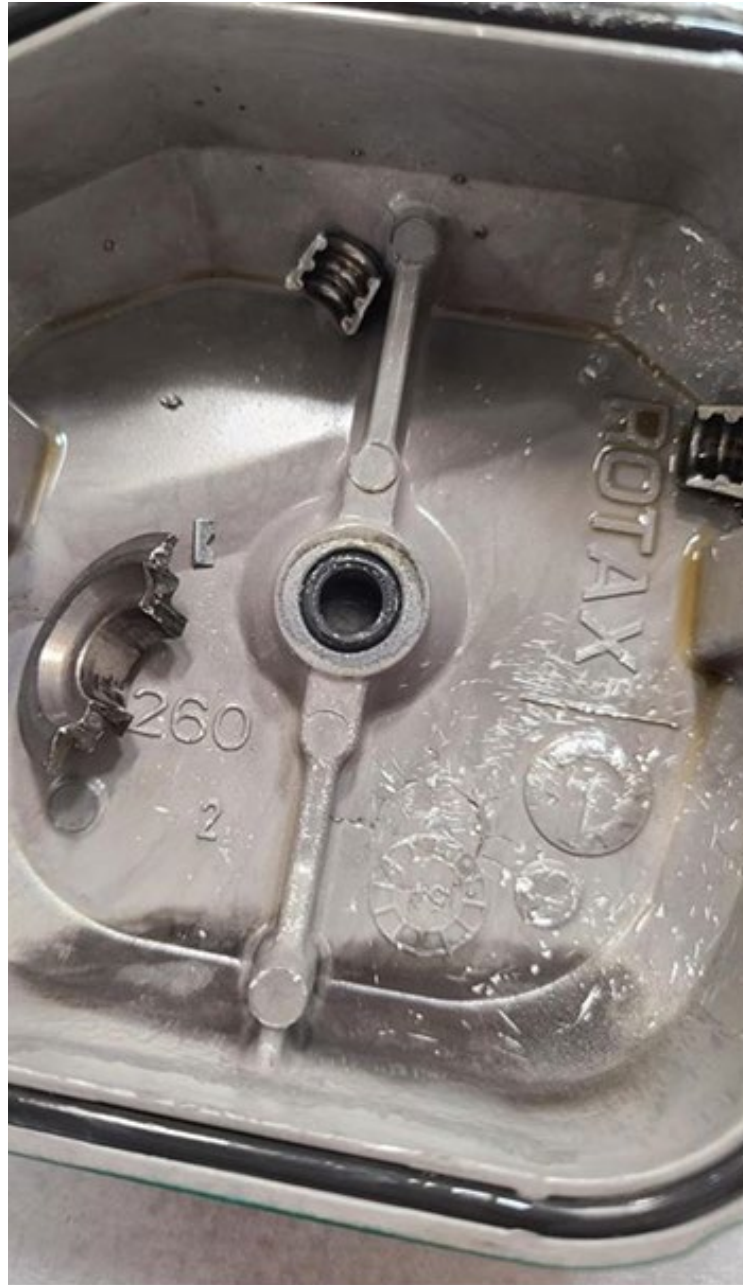
**Photo 19 - N639BA Cylinder No. 1 Broken Exhaust Valve Spring Retainer – Courtesy of Icon Aircraft**

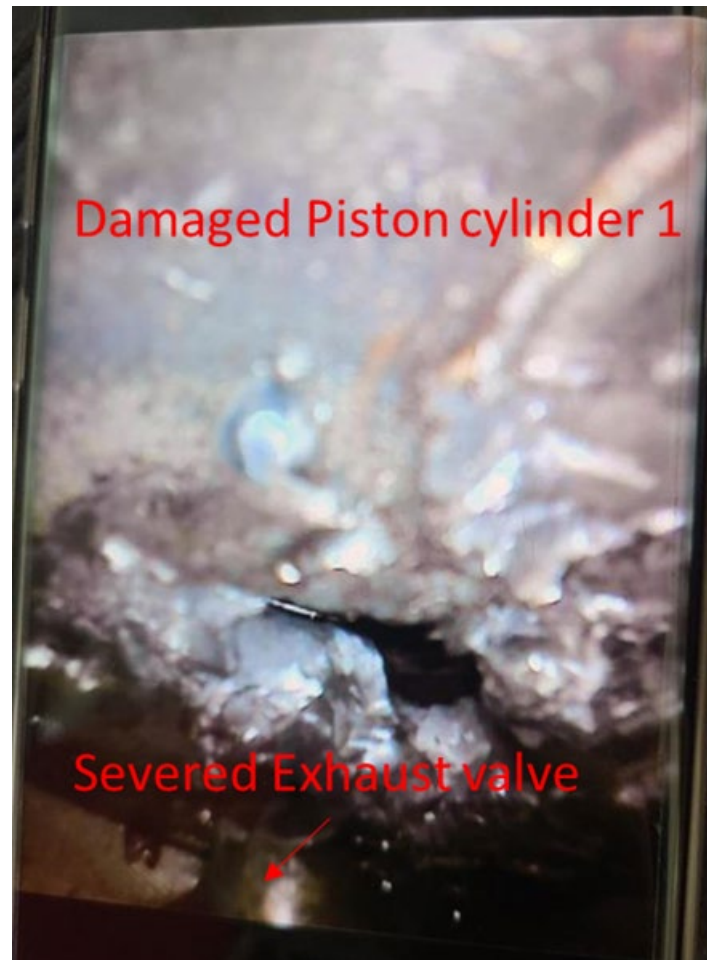
**Photo 20 - N639BA Cylinder No. 1 Piston and Exhaust Valve – Courtesy of Icon Aircraft**
