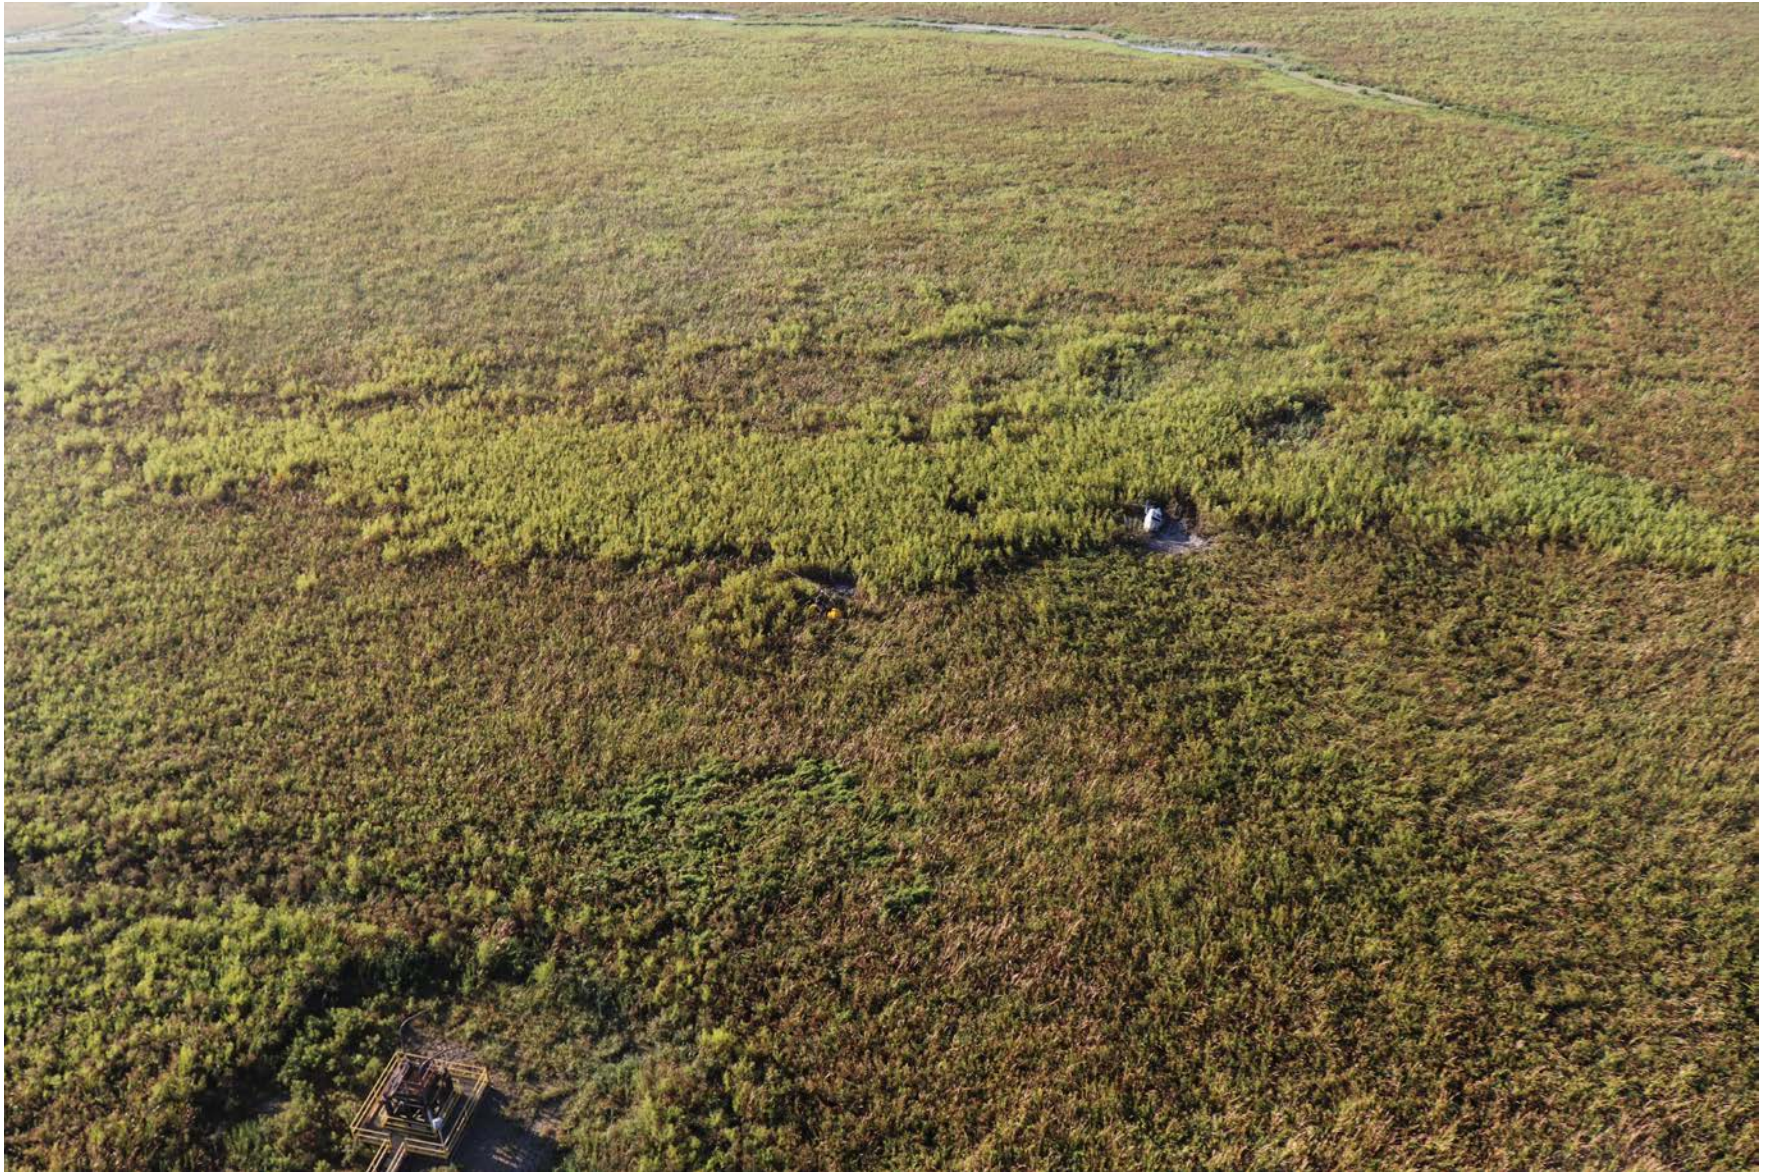
**Photo 1 – Overhead view of accident site from about 150 feet agl. Note police helicopter that attempted to rescue pilot about 100 feet to the right of gyroplane; See ERA20LA004. (Courtesy of FAA)**

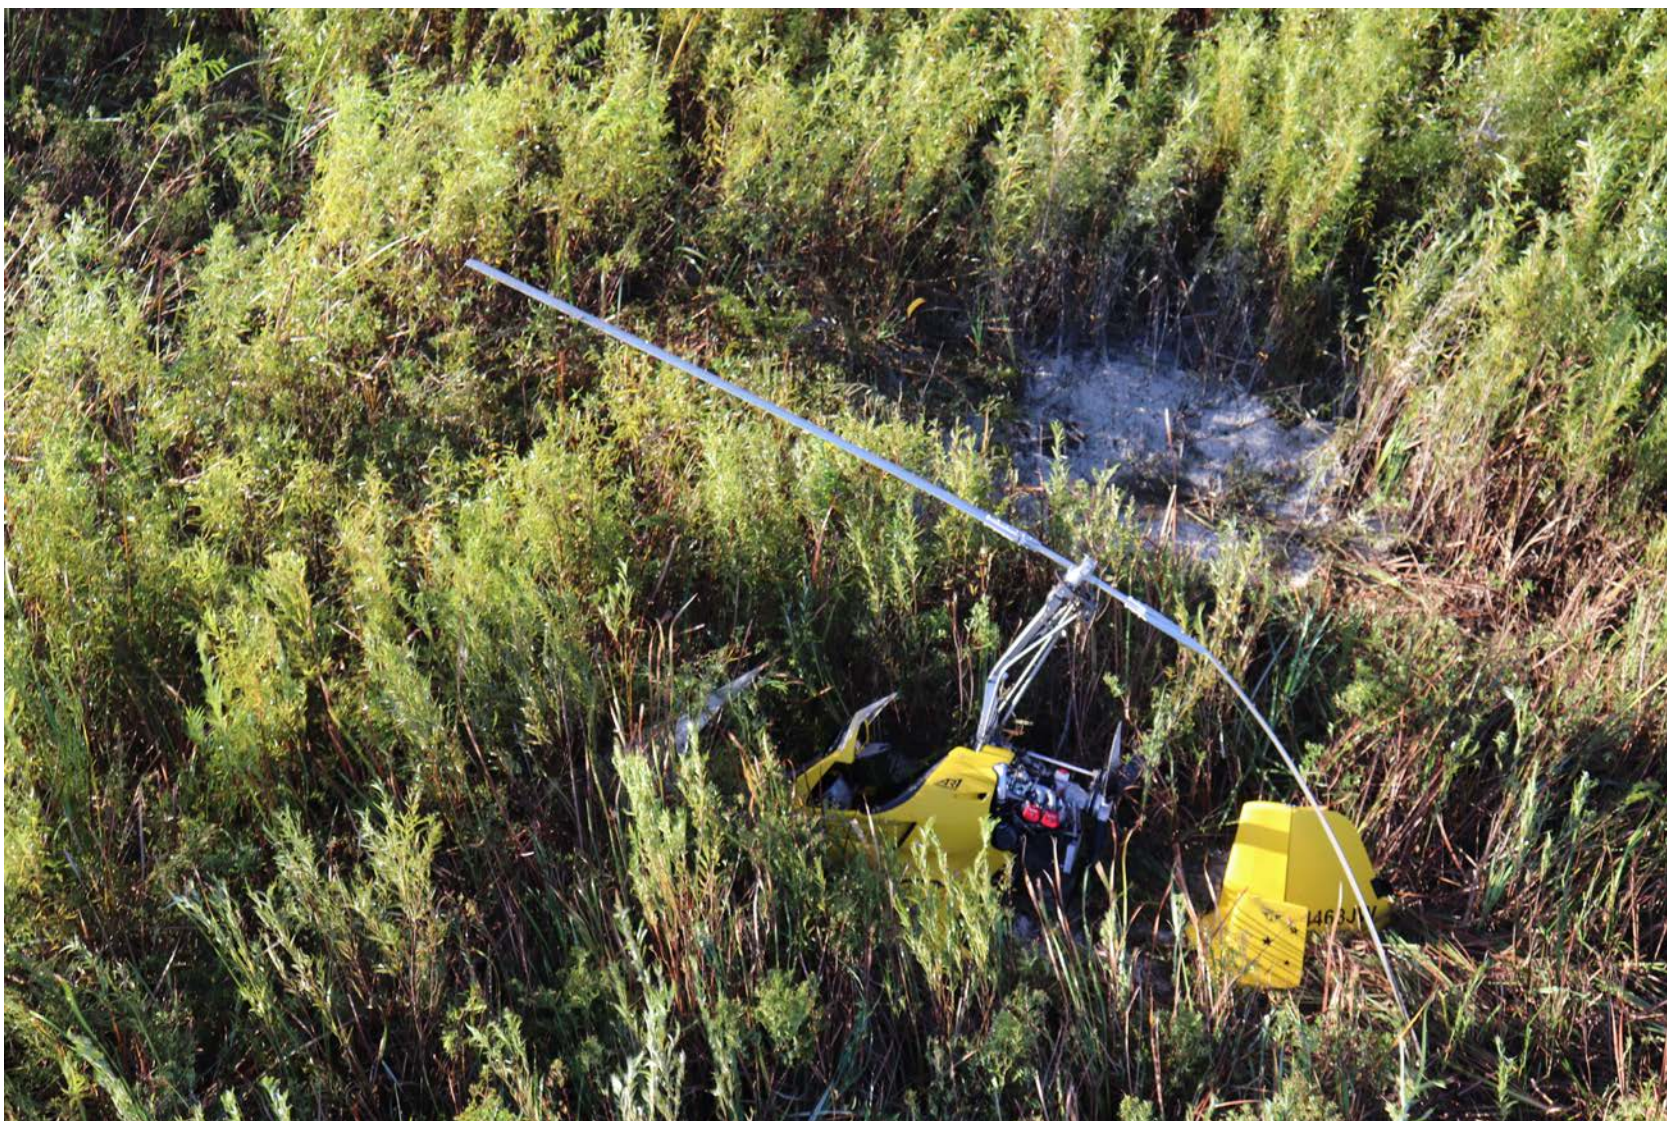
**Photo 2 – Overhead view of left side of gyroplane in the mud showing damage to the rotor blade. (Courtesy of FAA)**

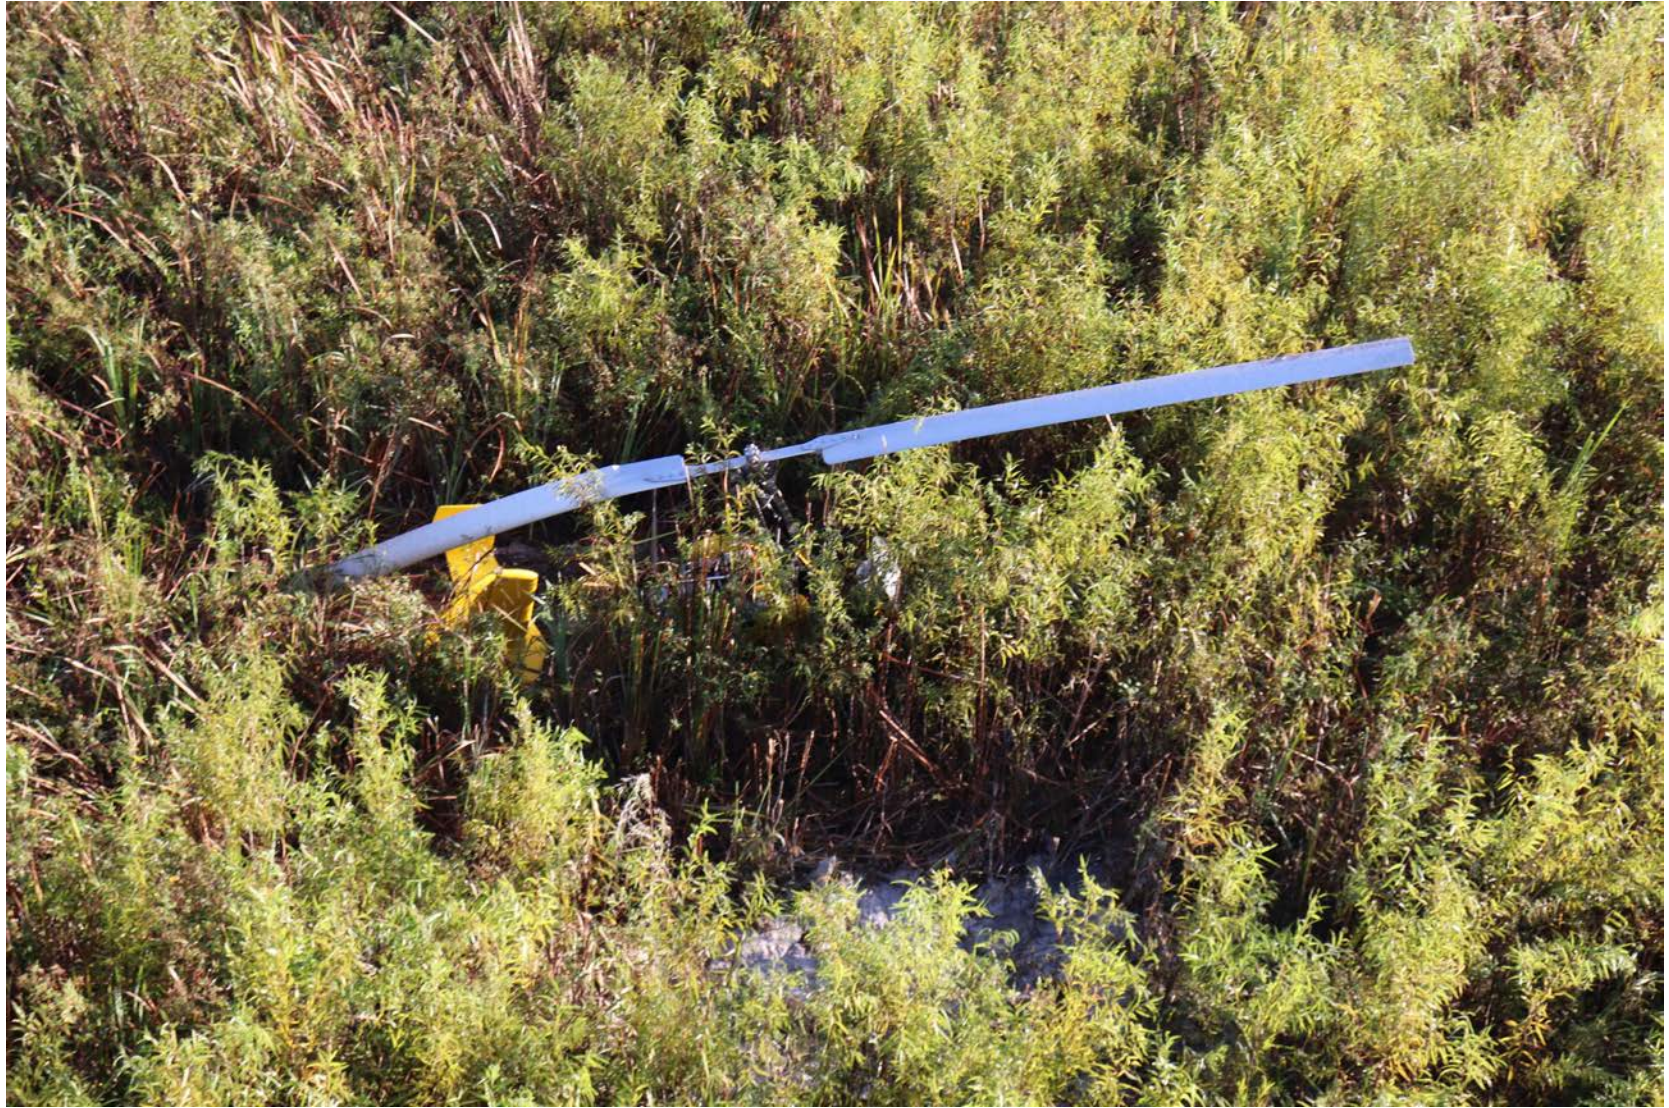
**Photo 3 – Overhead view of gyroplane in the grass and mud. Note the damaged rotor blade (Courtesy of FAA)**

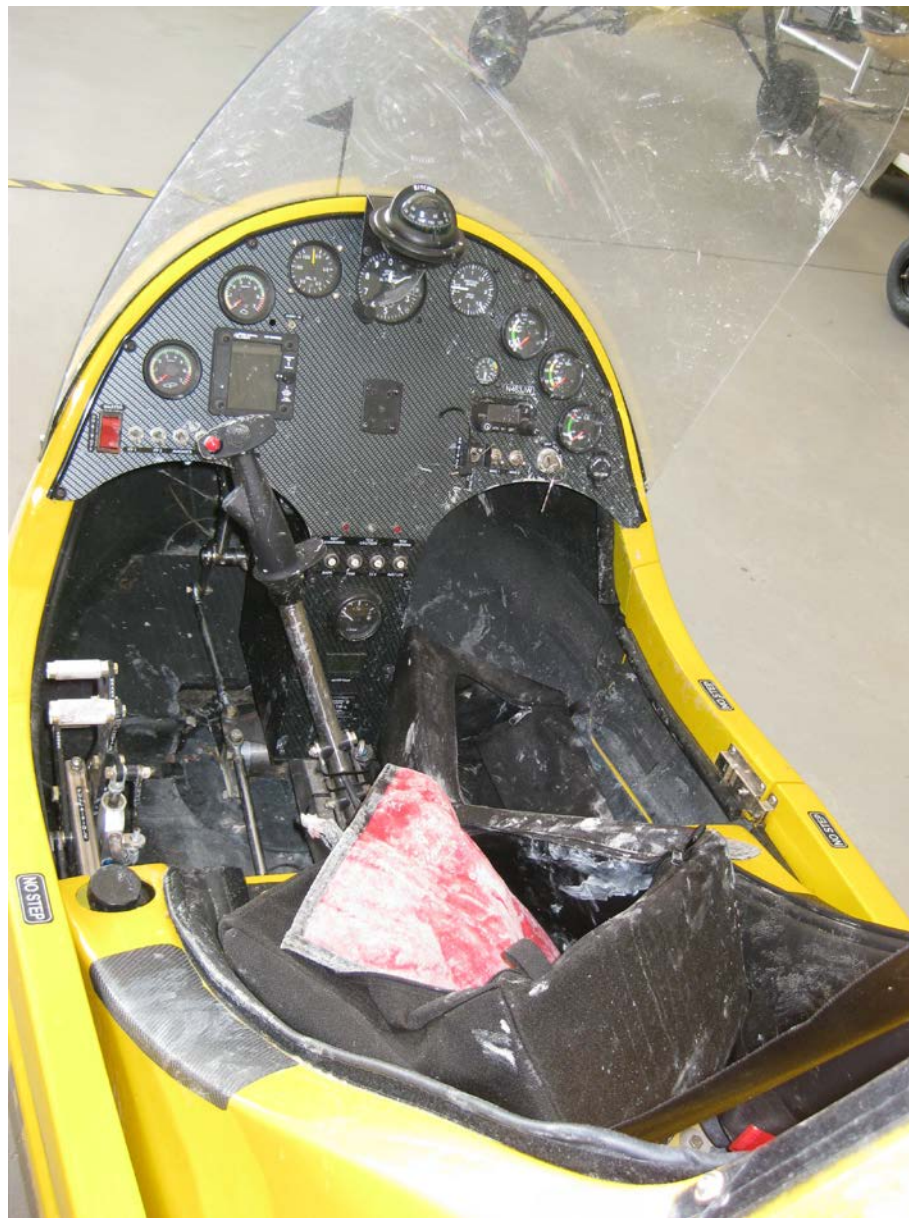
**Photo 4 – Photograph of interior of cockpit and fuselage buckling. (Courtesy of FAA)**

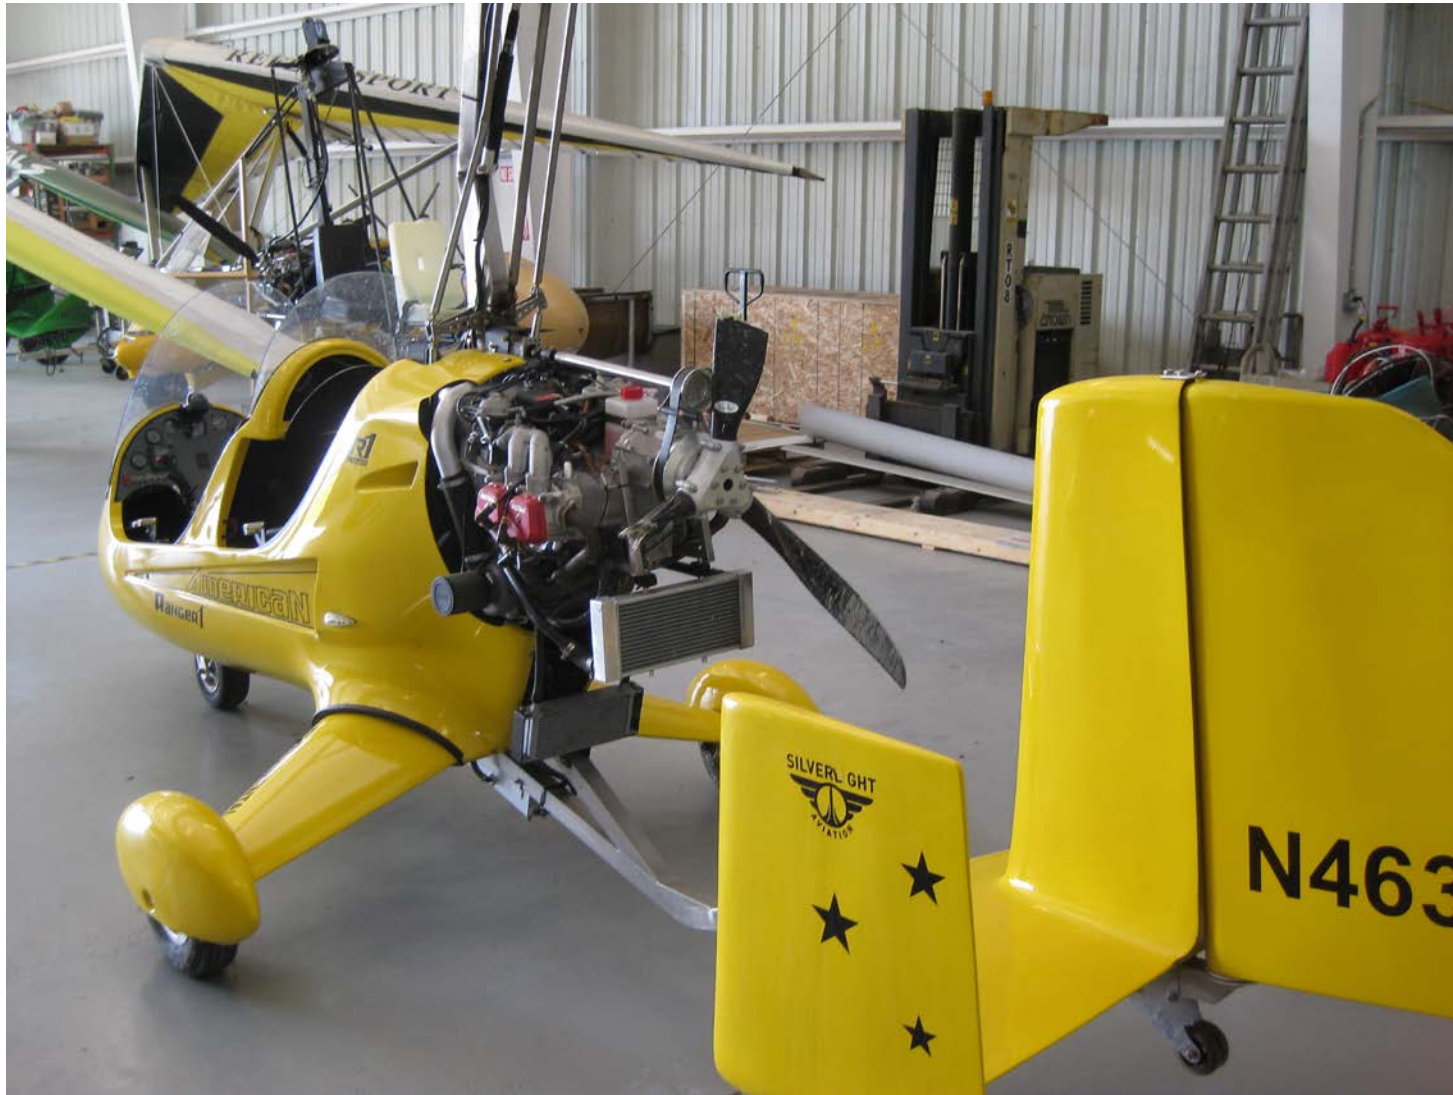
**Photo 5 – Damage to rotor mast and propellers. (Courtesy of FAA)**

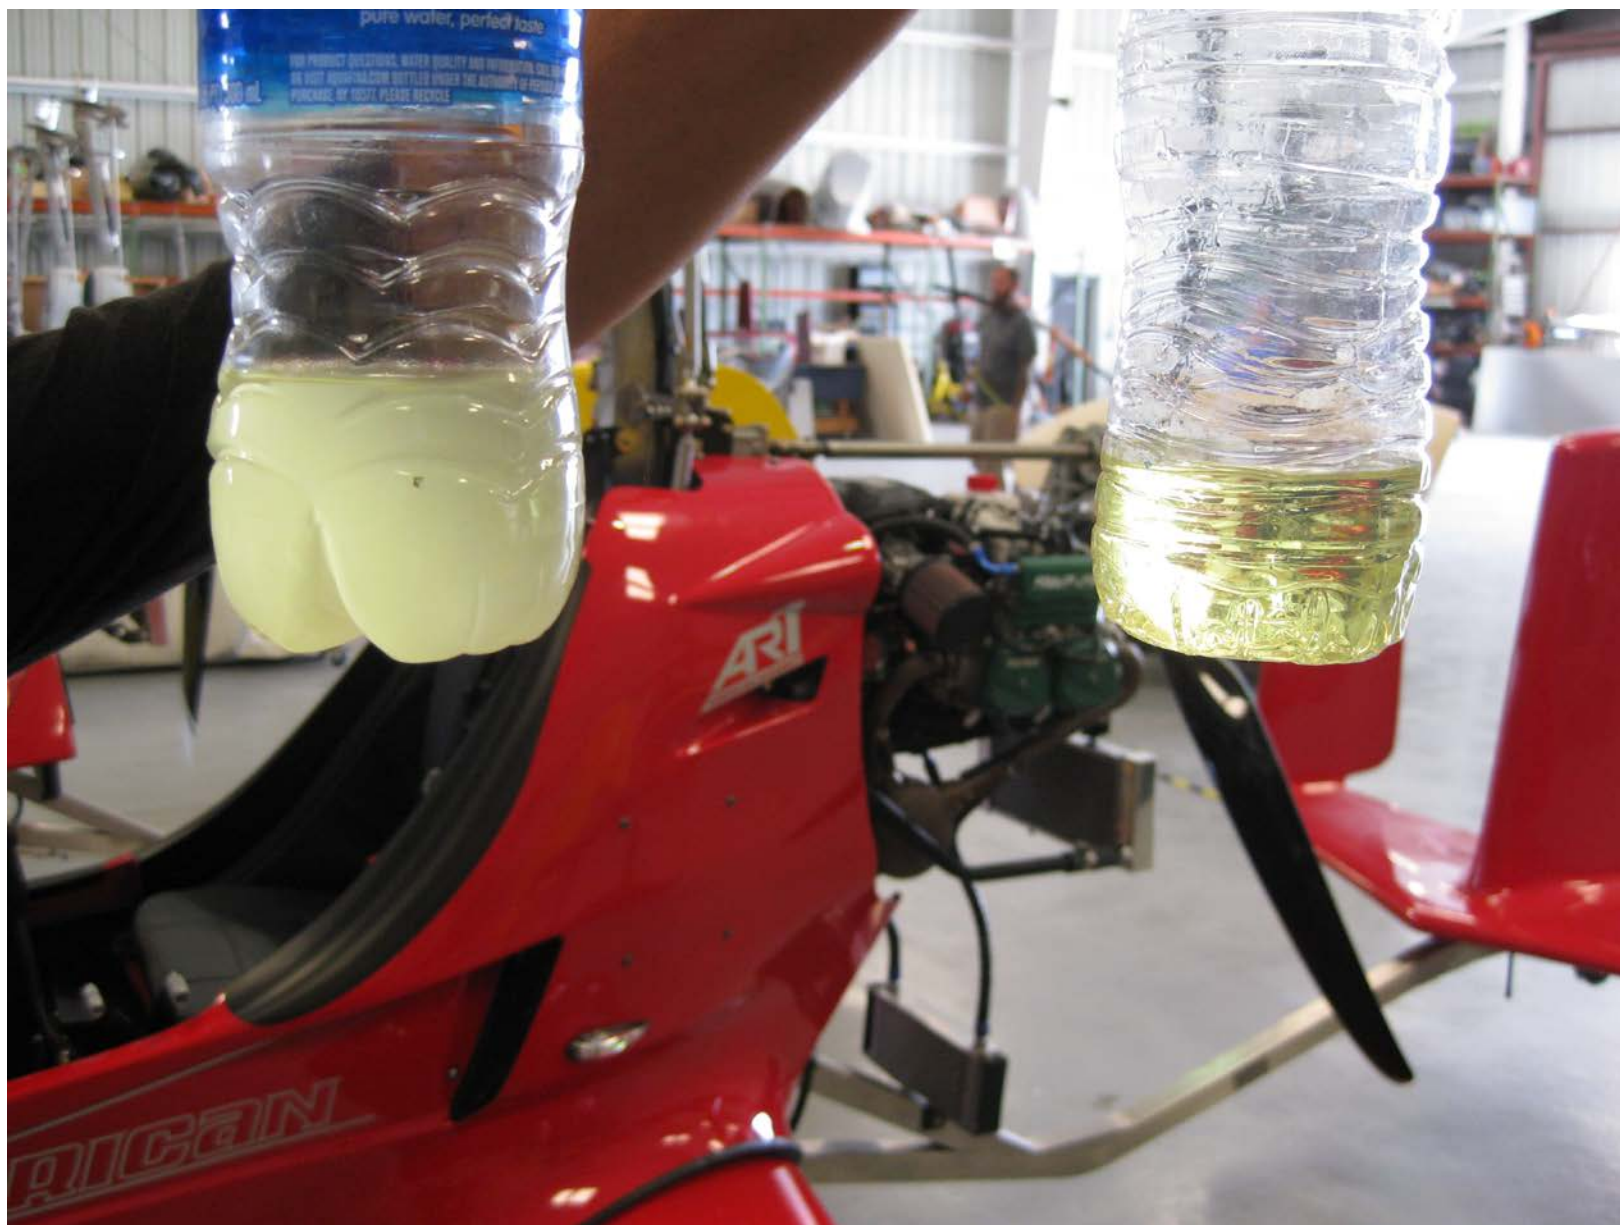
**Photo 6 – View of contaminated fuel drained from gyrocopter on left compared to clean fuel on right. (Courtesy of FAA)**
