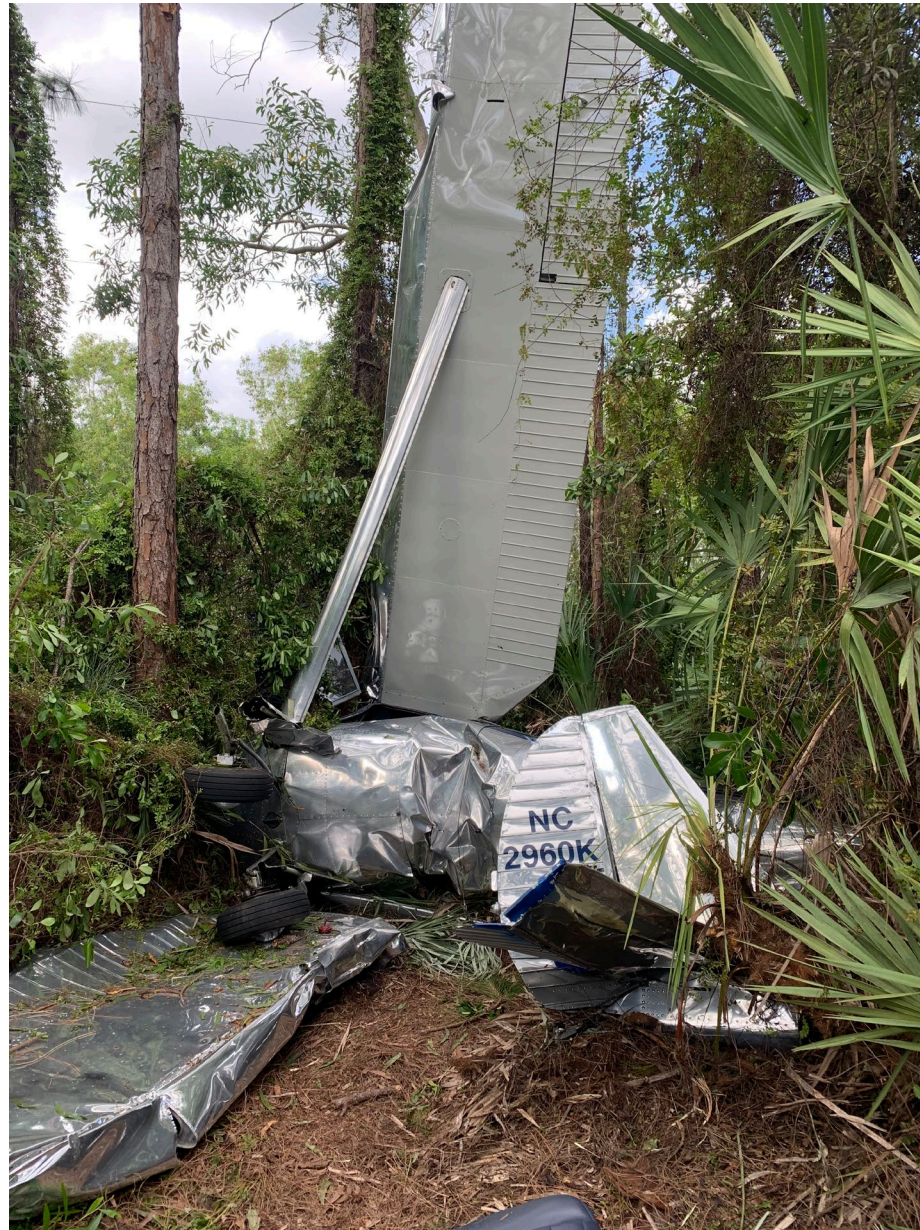
**Photo 1 –View of airplane wreckage as discovered. Left wing nearly vertical and right wing detached and resting beside wreckage on ground.**

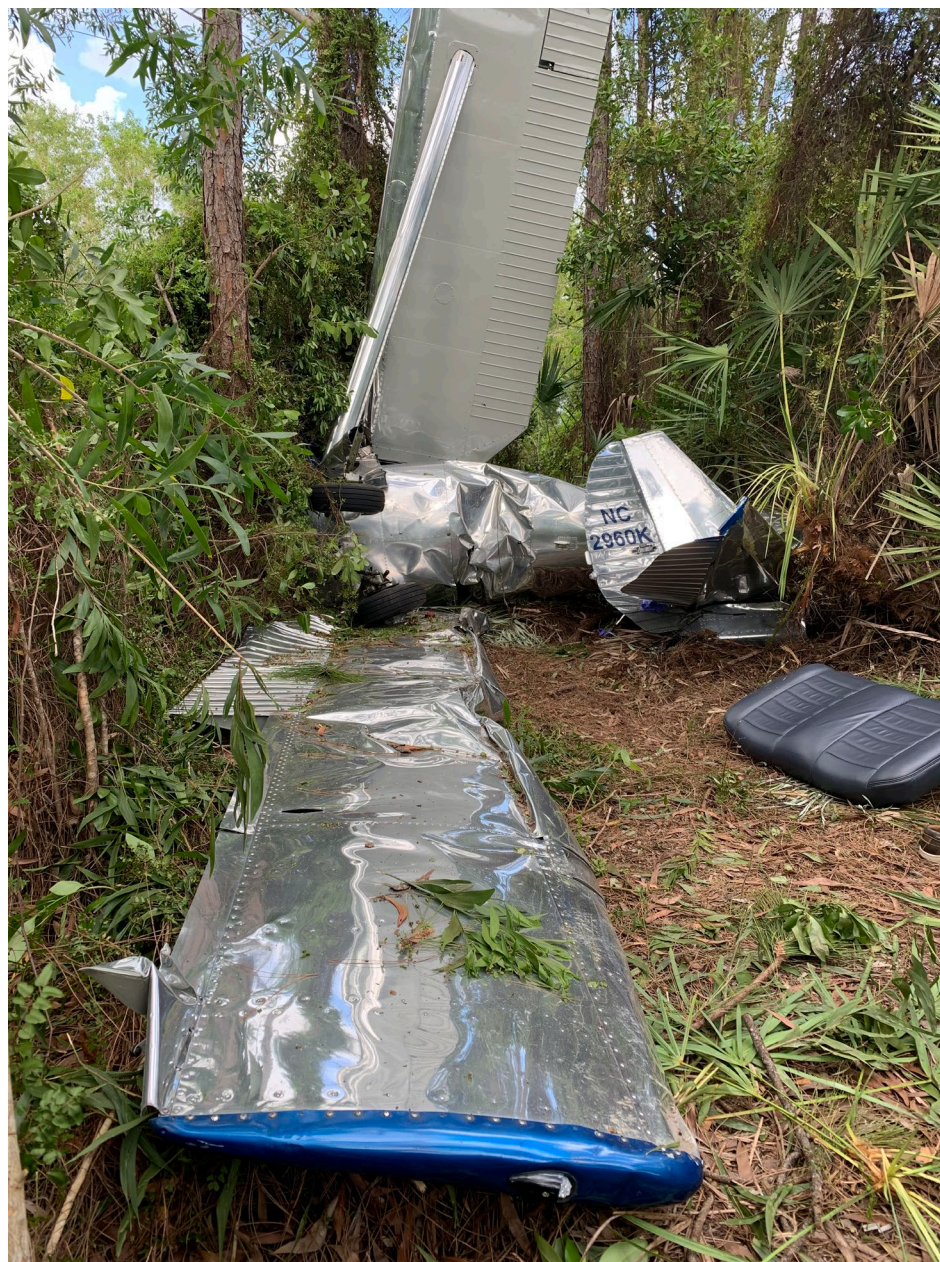
**Photo 2 – View of wreckage looking down right wing towards bottom side of fuselage.**

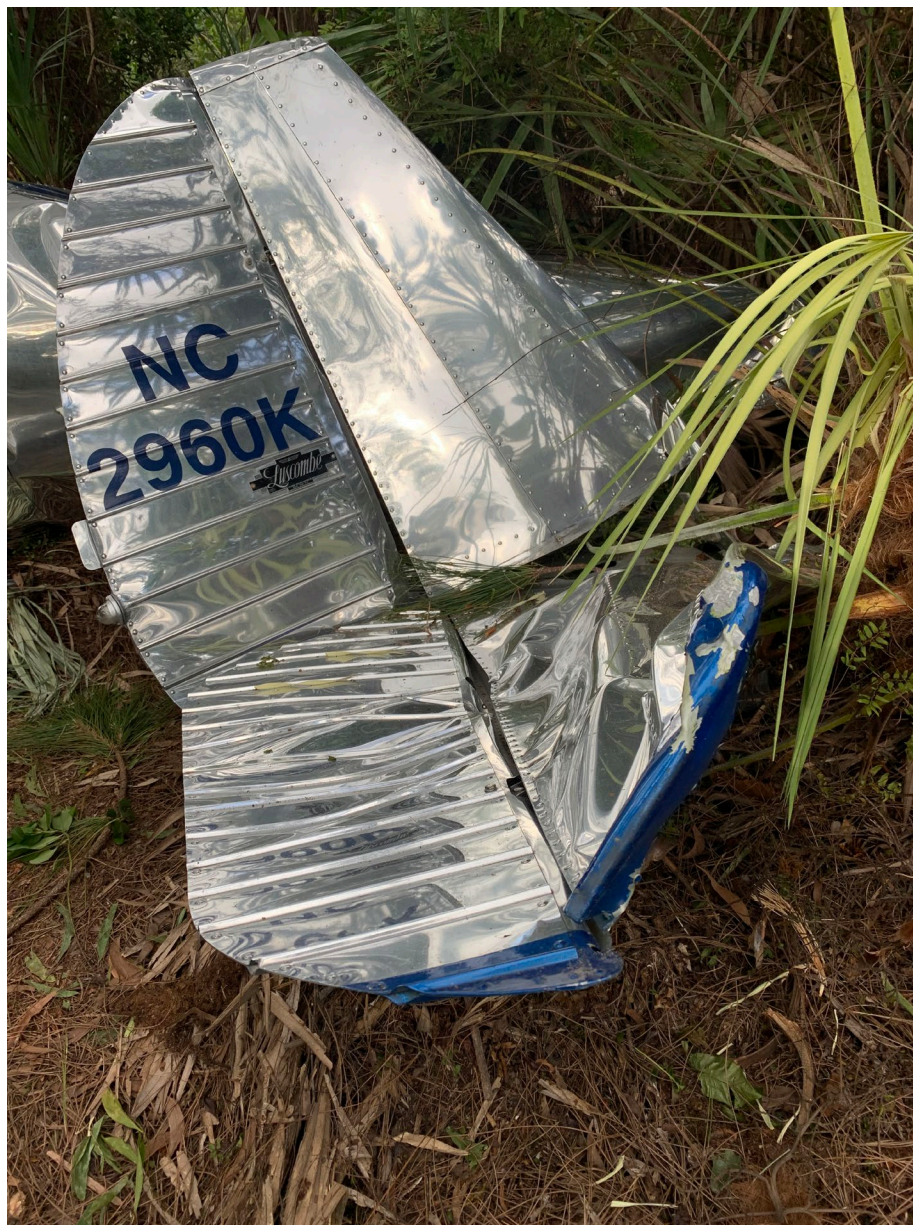
**Photo 3 – View of right side of rudder, elevator and stabilizer damage.**

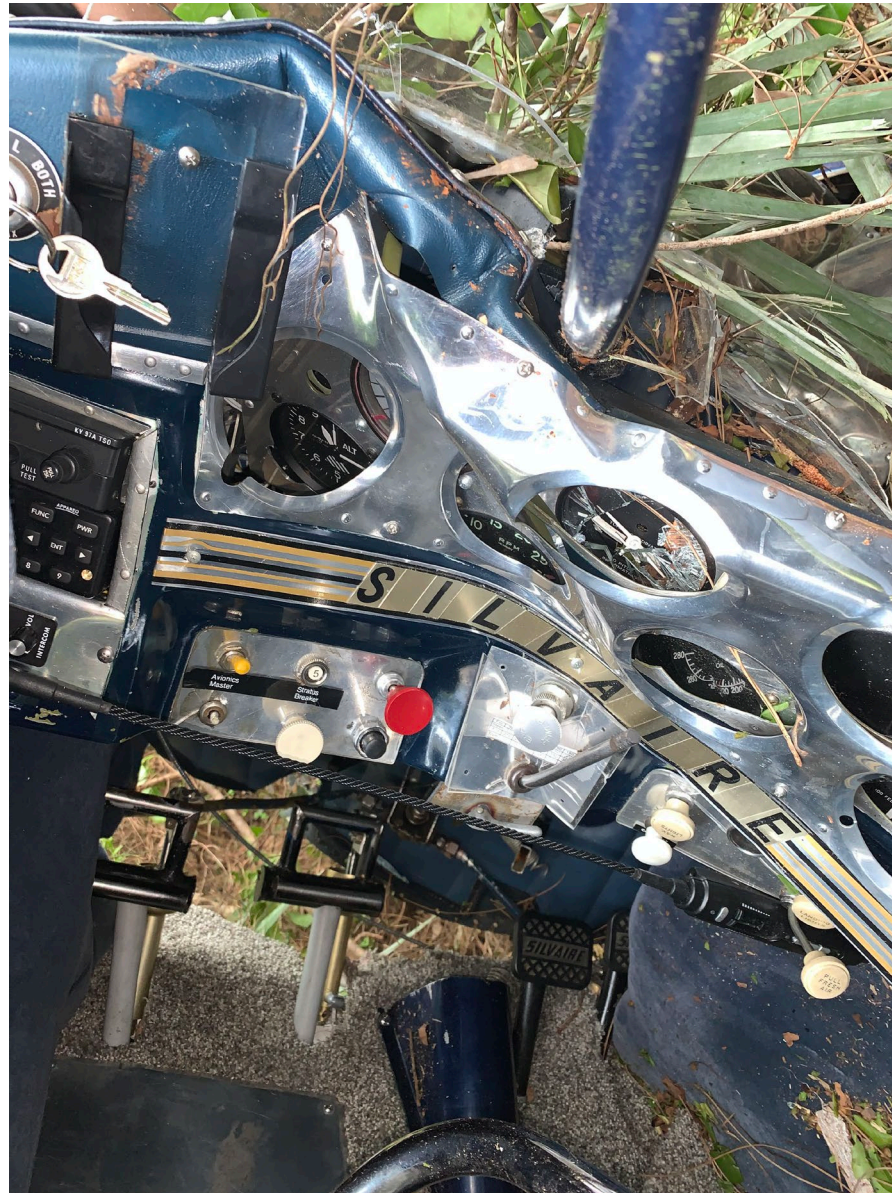
**Photo 4 – View from pilot seat, cockpit instrument panel and rudder pedals.**

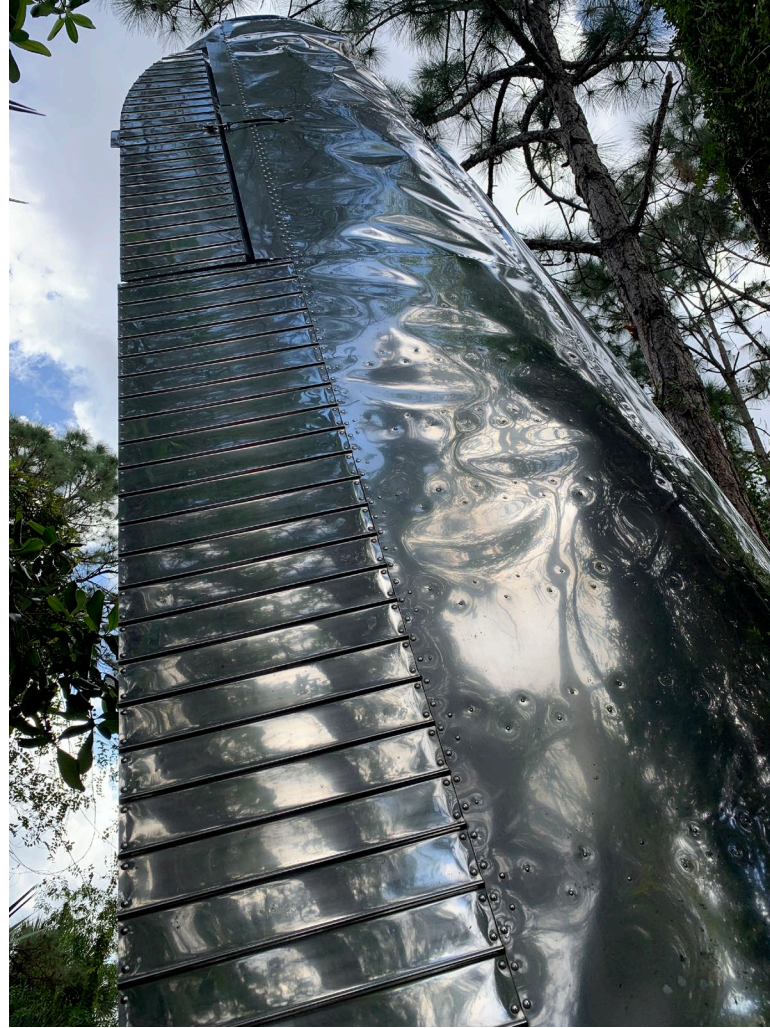
**Photo 5 – View of left wing damage. Note: Wing remained attached to fuselage and was oriented in a vertical position.**

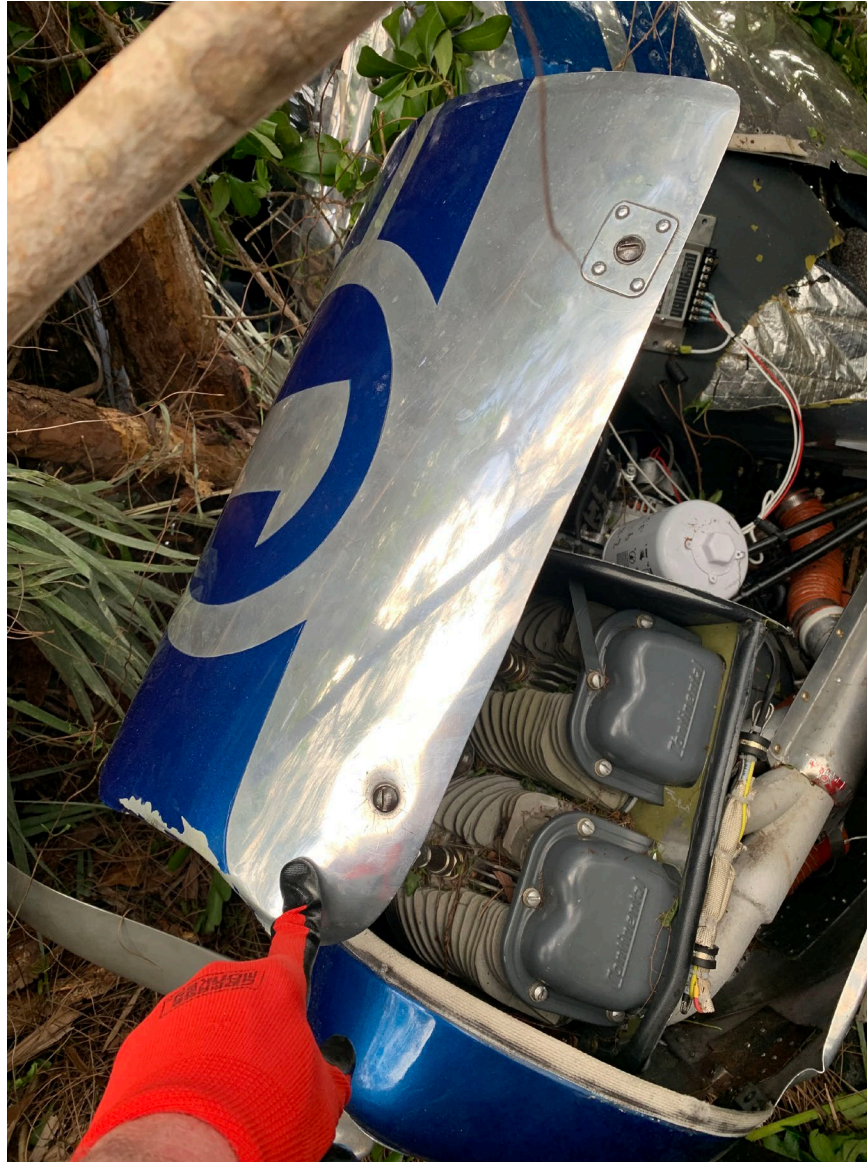
**Photo 6 – View of left cowl that opened during takeoff.**

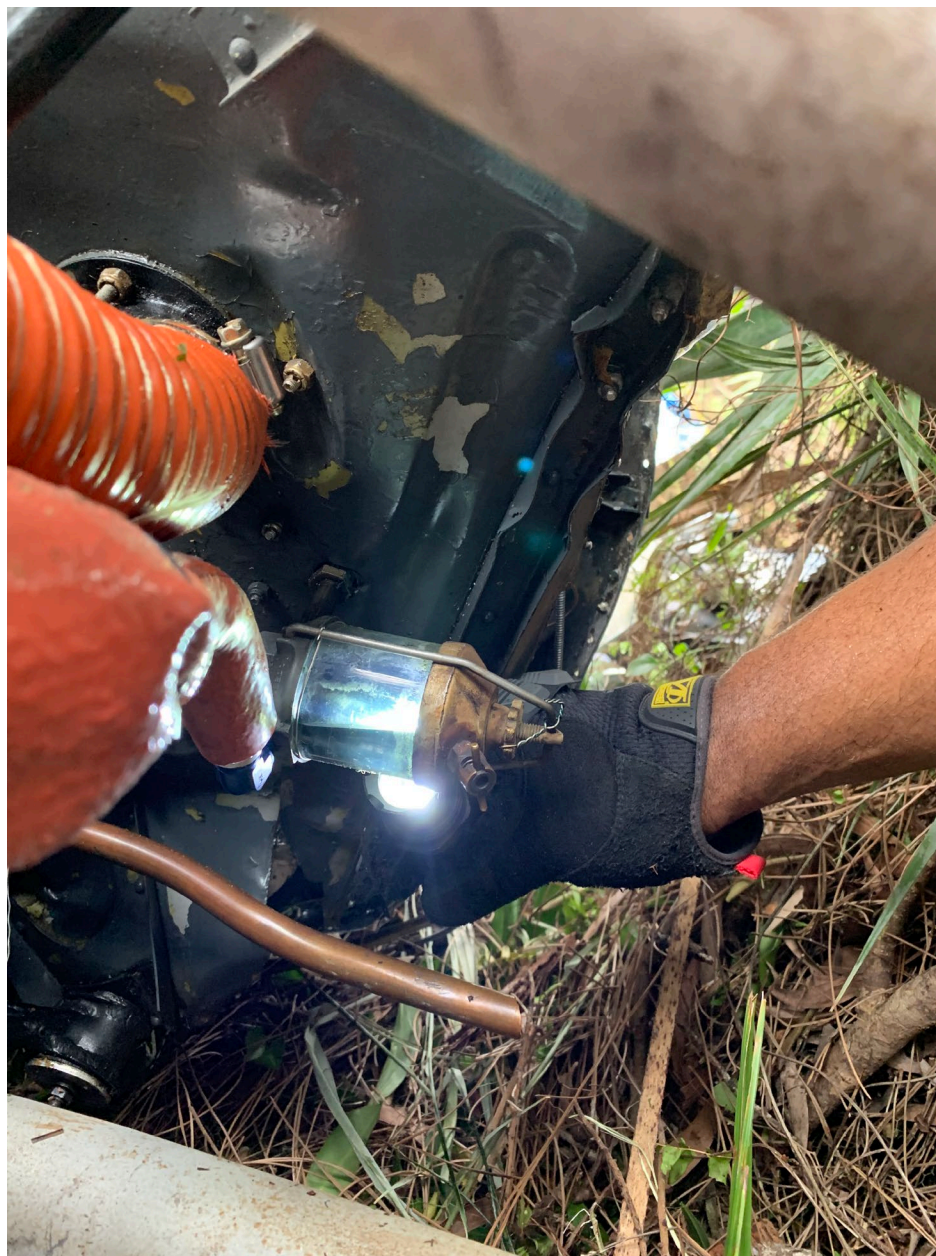
**Photo 7 – View of fuel gascolator in wreckage. Note: contained fuel.**

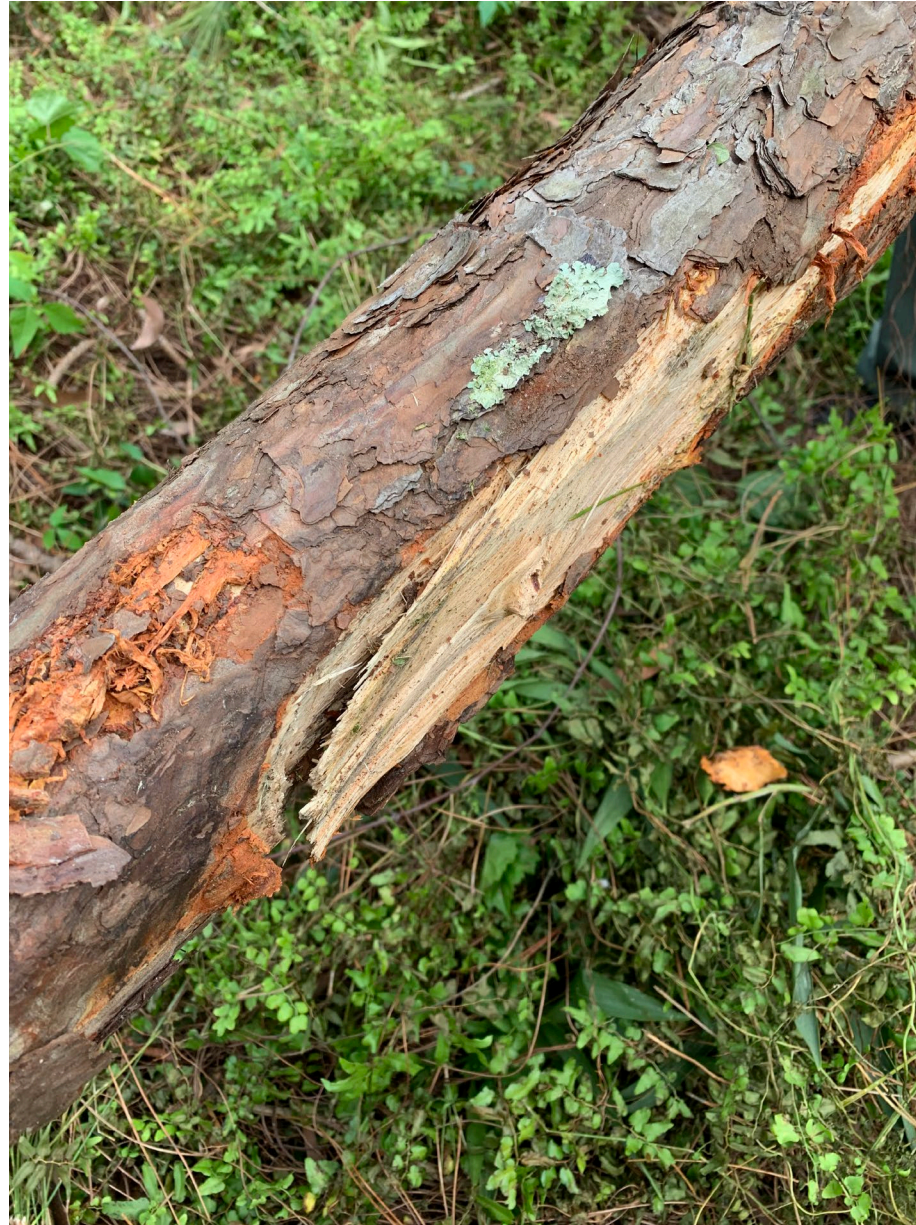
**Photo 8 – View of a 6-inch diameter branch that contained a distinct propeller slash indication.**

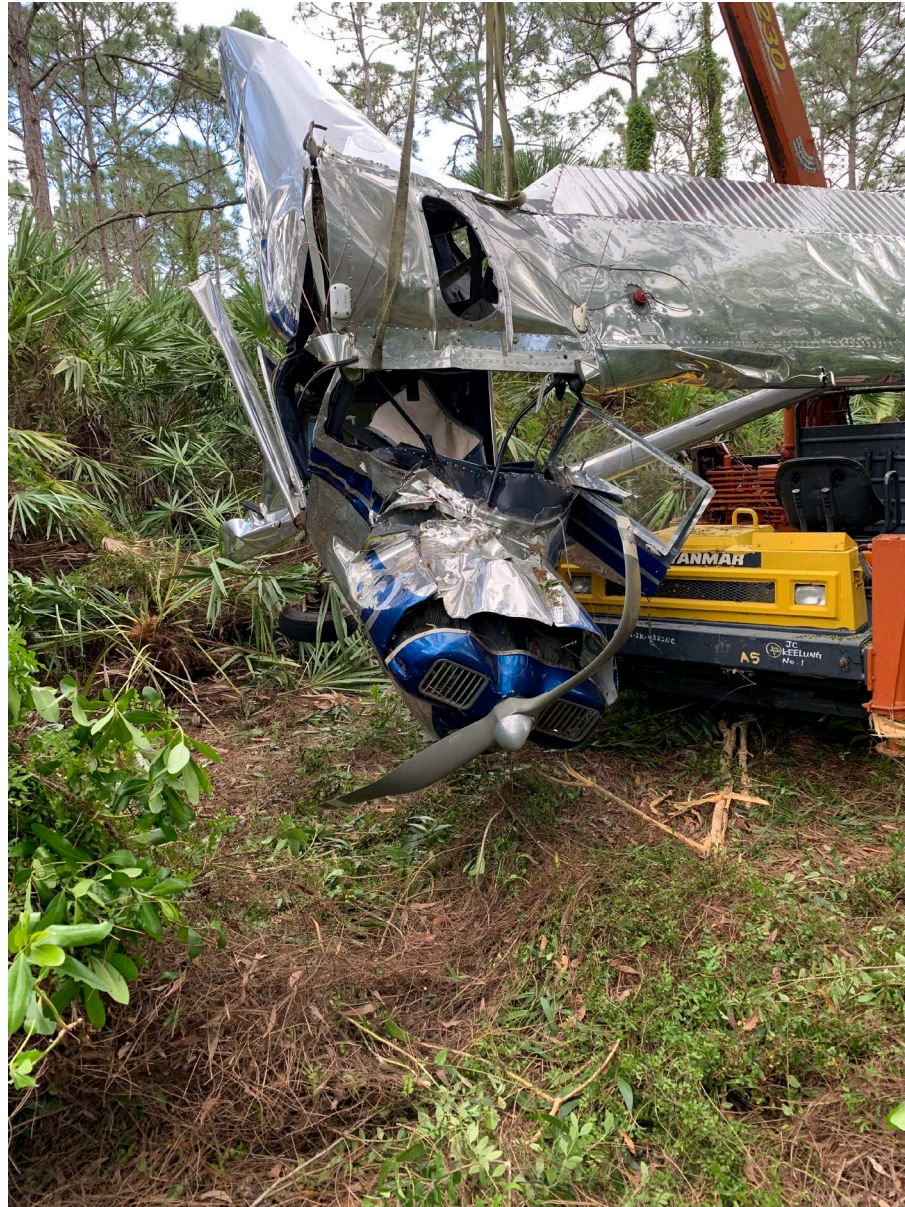
**Photo 9 – Overall forward view of wreckage during recovery. Note damage to cockpit, propeller and left wing.**

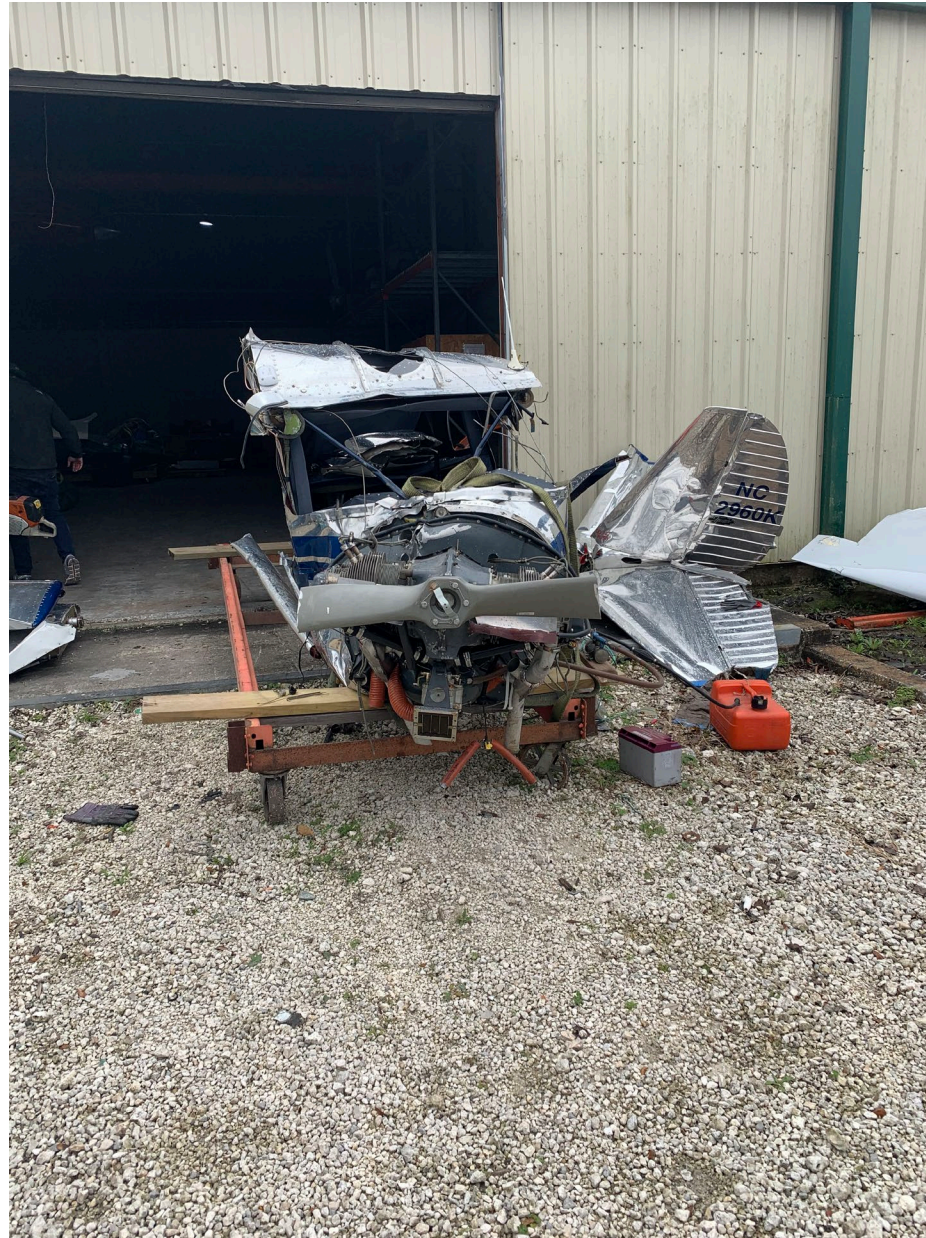
**Photo 10 – View of engine and fuselage on test stand after successful engine run.**
