# **NATIONAL TRANSPORTATION SAFETY BOARD**

## **Video Study**

**NTSB Case Number:  
ERA21FA142**

Location: Jupiter, Florida  
Date: February 28, 2021  
Time: 1230 EST  
Aircraft: Luscombe 8E

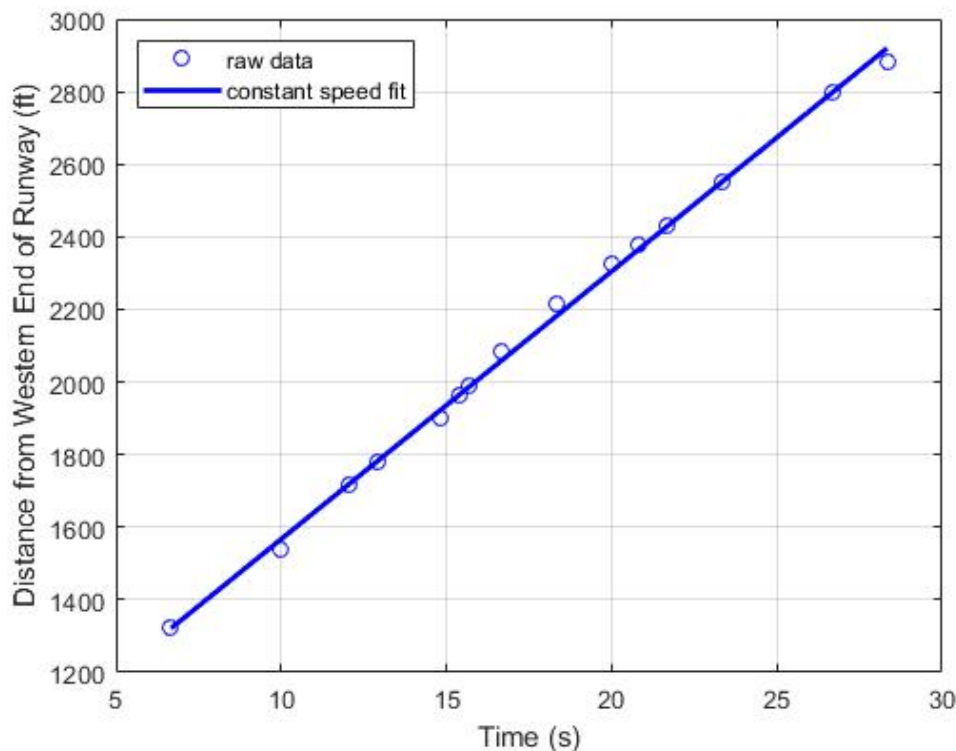
**Figure 3. Estimated Airplane Distance from the Western End of Runway**

Figure 3 shows the estimated locations of the airplane along the runway that is oriented in the west-to-east direction. The airplane was moving west-to-east. The camera was located about 1950 feet from the western end of the runway. Therefore, as seen in the figure, the airplane was in front of the camera at about video time 15 seconds.

The constant speed fit to the raw data in Figure 3 shows that the airplane was moving along the runway at the average speed of 43.7 knots.

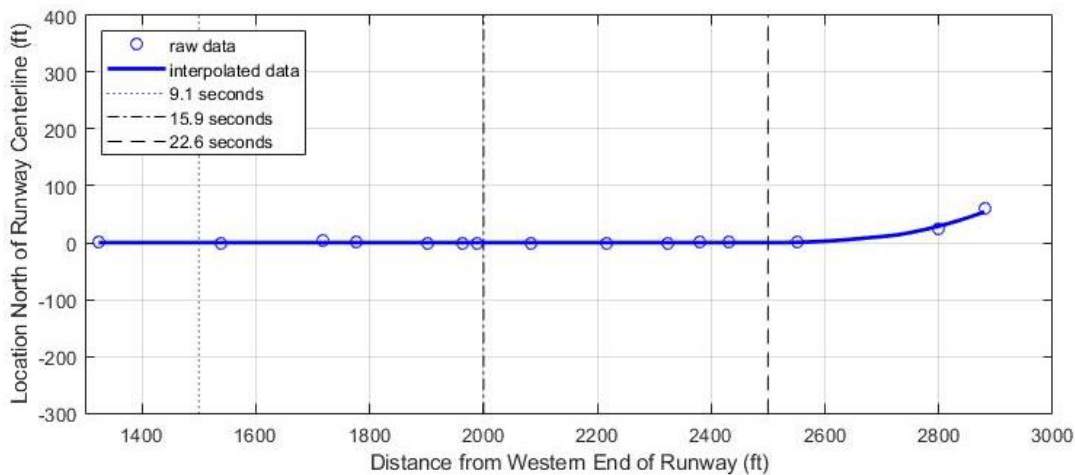
**Figure 4. Estimated Airplane Ground Track**

Figure 4 shows the estimated ground track of the airplane. The airplane was flying along the 3000-foot-long runway until about location 2600 feet. Past that location, it was turning left. Past the last data point in Figure 4, at runway distance 2880 feet, the airplane was obscured by a tree. The three vertical lines in the figure indicate the video times when the airplane was at locations 1500 feet, 2000 feet and 2500 feet along the runway.

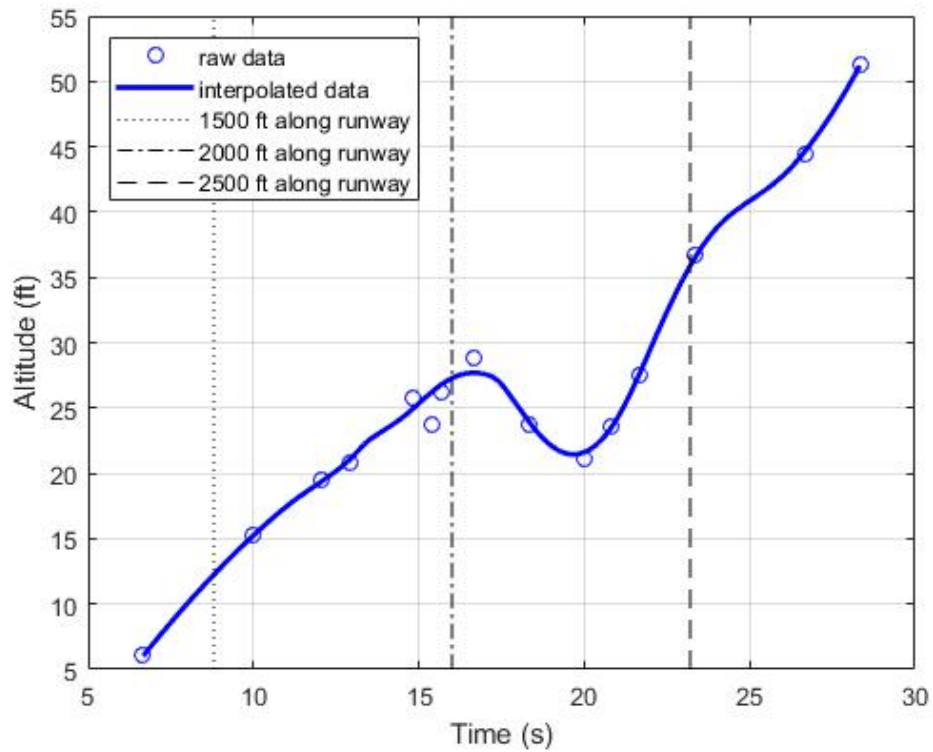
**Figure 5. Estimated Airplane Altitude above the Runway**

Figure 5 shows the estimated altitude of the airplane above the runway. The altitude was measured as the height of the airplane nose above the runway surface. The three vertical lines in the figure are at video times when the airplane was at locations 1500 feet, 2000 feet and 2500 feet along the runway. The interpolated data curve in the figure was generated by first interpolating between the raw data points and then smoothing the data to filter out altitude jumps caused by the  $\pm 2$  foot uncertainty of the estimated raw data points.

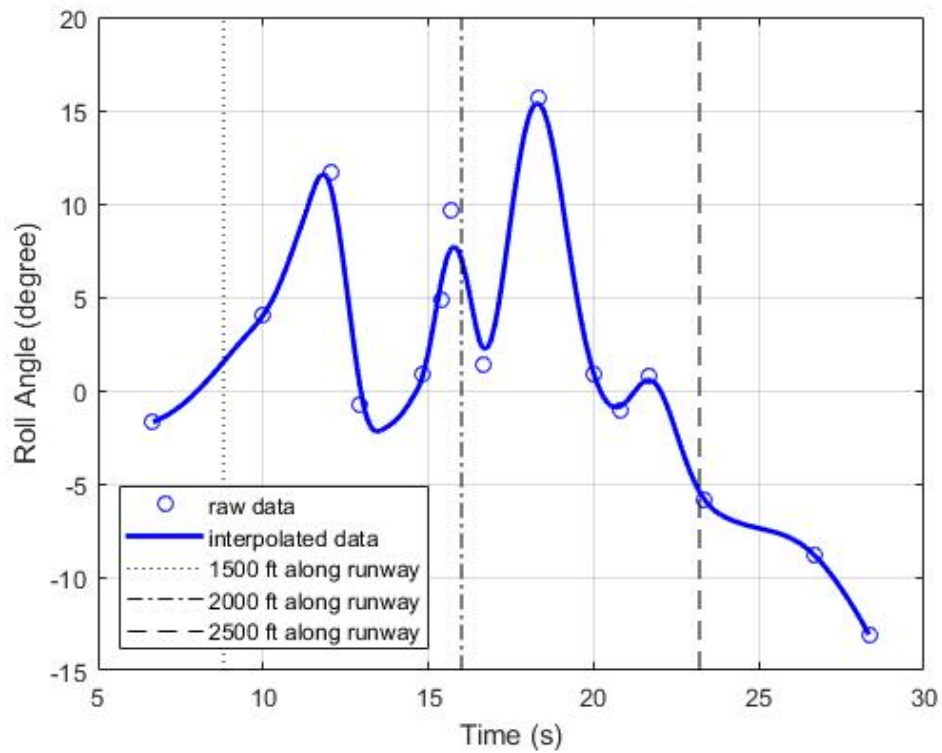
**Figure 6. Estimated Airplane Roll Angle**

Figure 6 shows the estimated roll angle of the airplane. The figure shows two large right-wing-down roll transients, one at about time 12 seconds peaking at about  $12^\circ$  and one at about time 18 seconds peaking at about  $15^\circ$ . The interpolated data curve in the figure was generated by first interpolating between the raw data points and then smoothing the data to filter out roll angle jumps caused by the  $\pm 2^\circ$  uncertainty of the estimated raw data points.

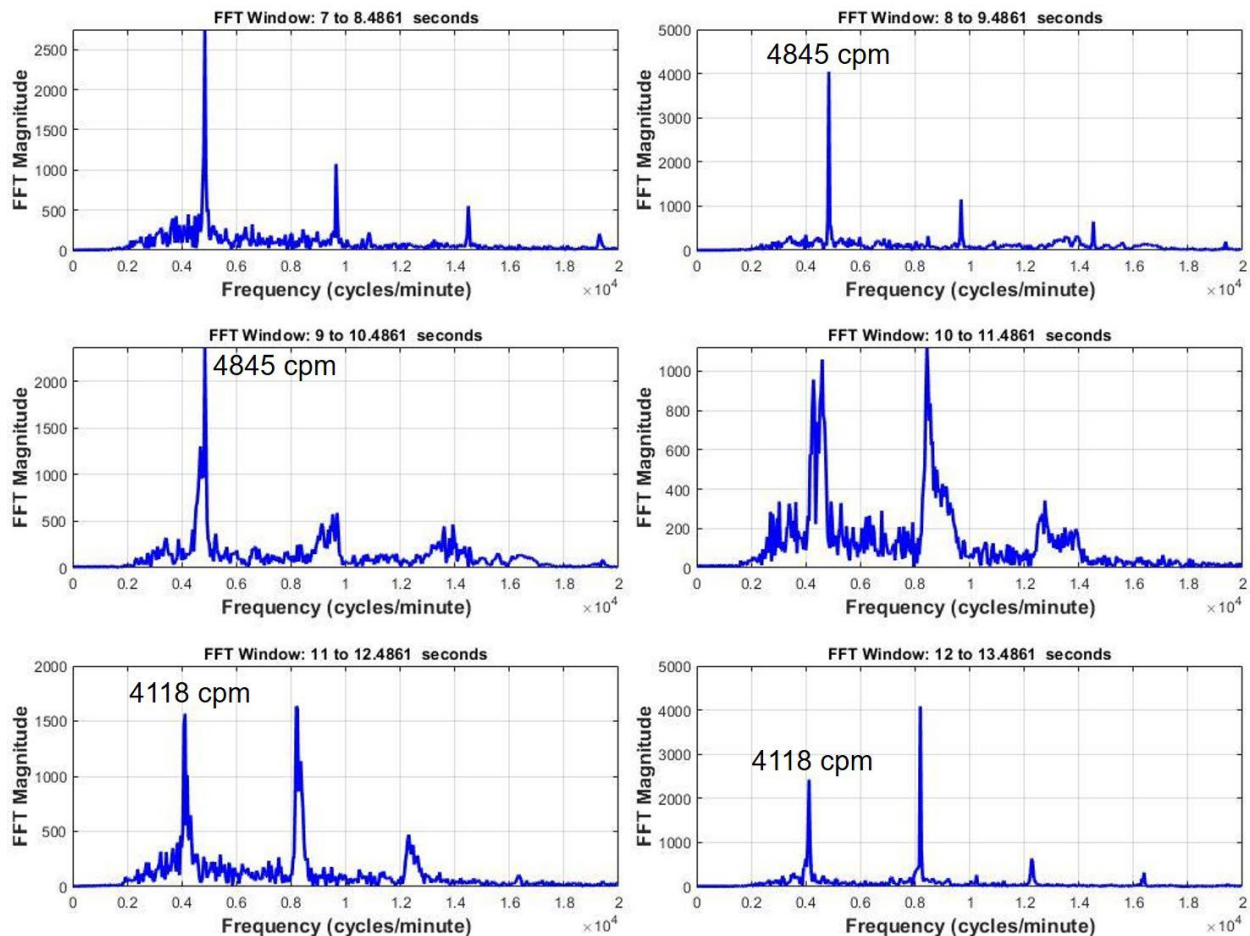
**Figure 7. Spectrum of the Recorded Sound**

Figure 7 shows six sound spectra computed in windows that were 1.5 seconds wide. The starting times of the six windows were all before the airplane reached the camera so that the Doppler factor was about 1.07 for all of them. The Fast Fourier Transform (FFT) algorithm used 65536 points and the frequency resolution was 40 cpm. The window starting at time 9 seconds shows BPF of 4845 cpm, that after Doppler shift correction corresponds to engine speed of  $4845/2/1.07=2264$  rpm. The window starting at time 11 seconds shows BPF of 4118 cpm, that after Doppler shift correction corresponds to engine speed of  $4118/2/1.07=1924$  rpm. This indicates an engine speed decrease of 340 rpm in about 3 seconds.

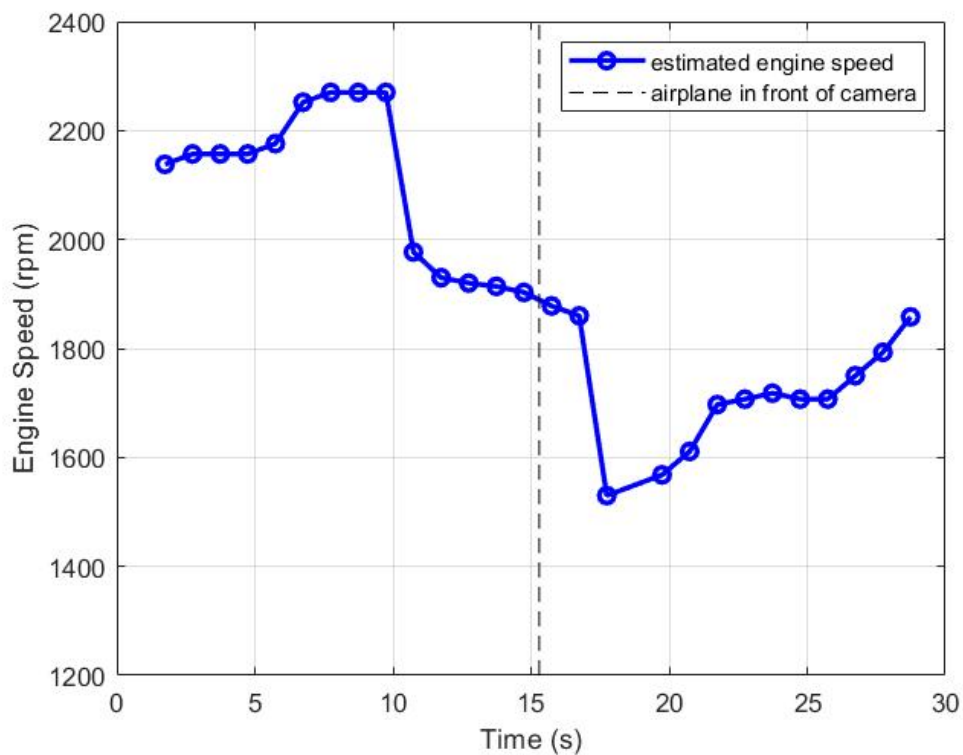
**Figure 8. Estimated Engine Speed**

Spectral analysis and Doppler shift correction were performed in 1.5-second-wide time windows over the duration of the video. Figure 8 shows the estimated engine speed vs. time. The Figure shows that starting at time 10 seconds, engine speed was decreasing for about 7.5 seconds. This period included two sudden speed decreases.

The decrease starting at about time 10 seconds was by about 290 rpm. The decrease at about time 17 seconds was by about 330 rpm. The speed was above 2250 rpm only between time 7 seconds and time 10 seconds. The speed reached a minimum of 1530 rpm at about time 18 seconds and then climbed to about 1860 rpm at the last data point at about time 29 seconds.
