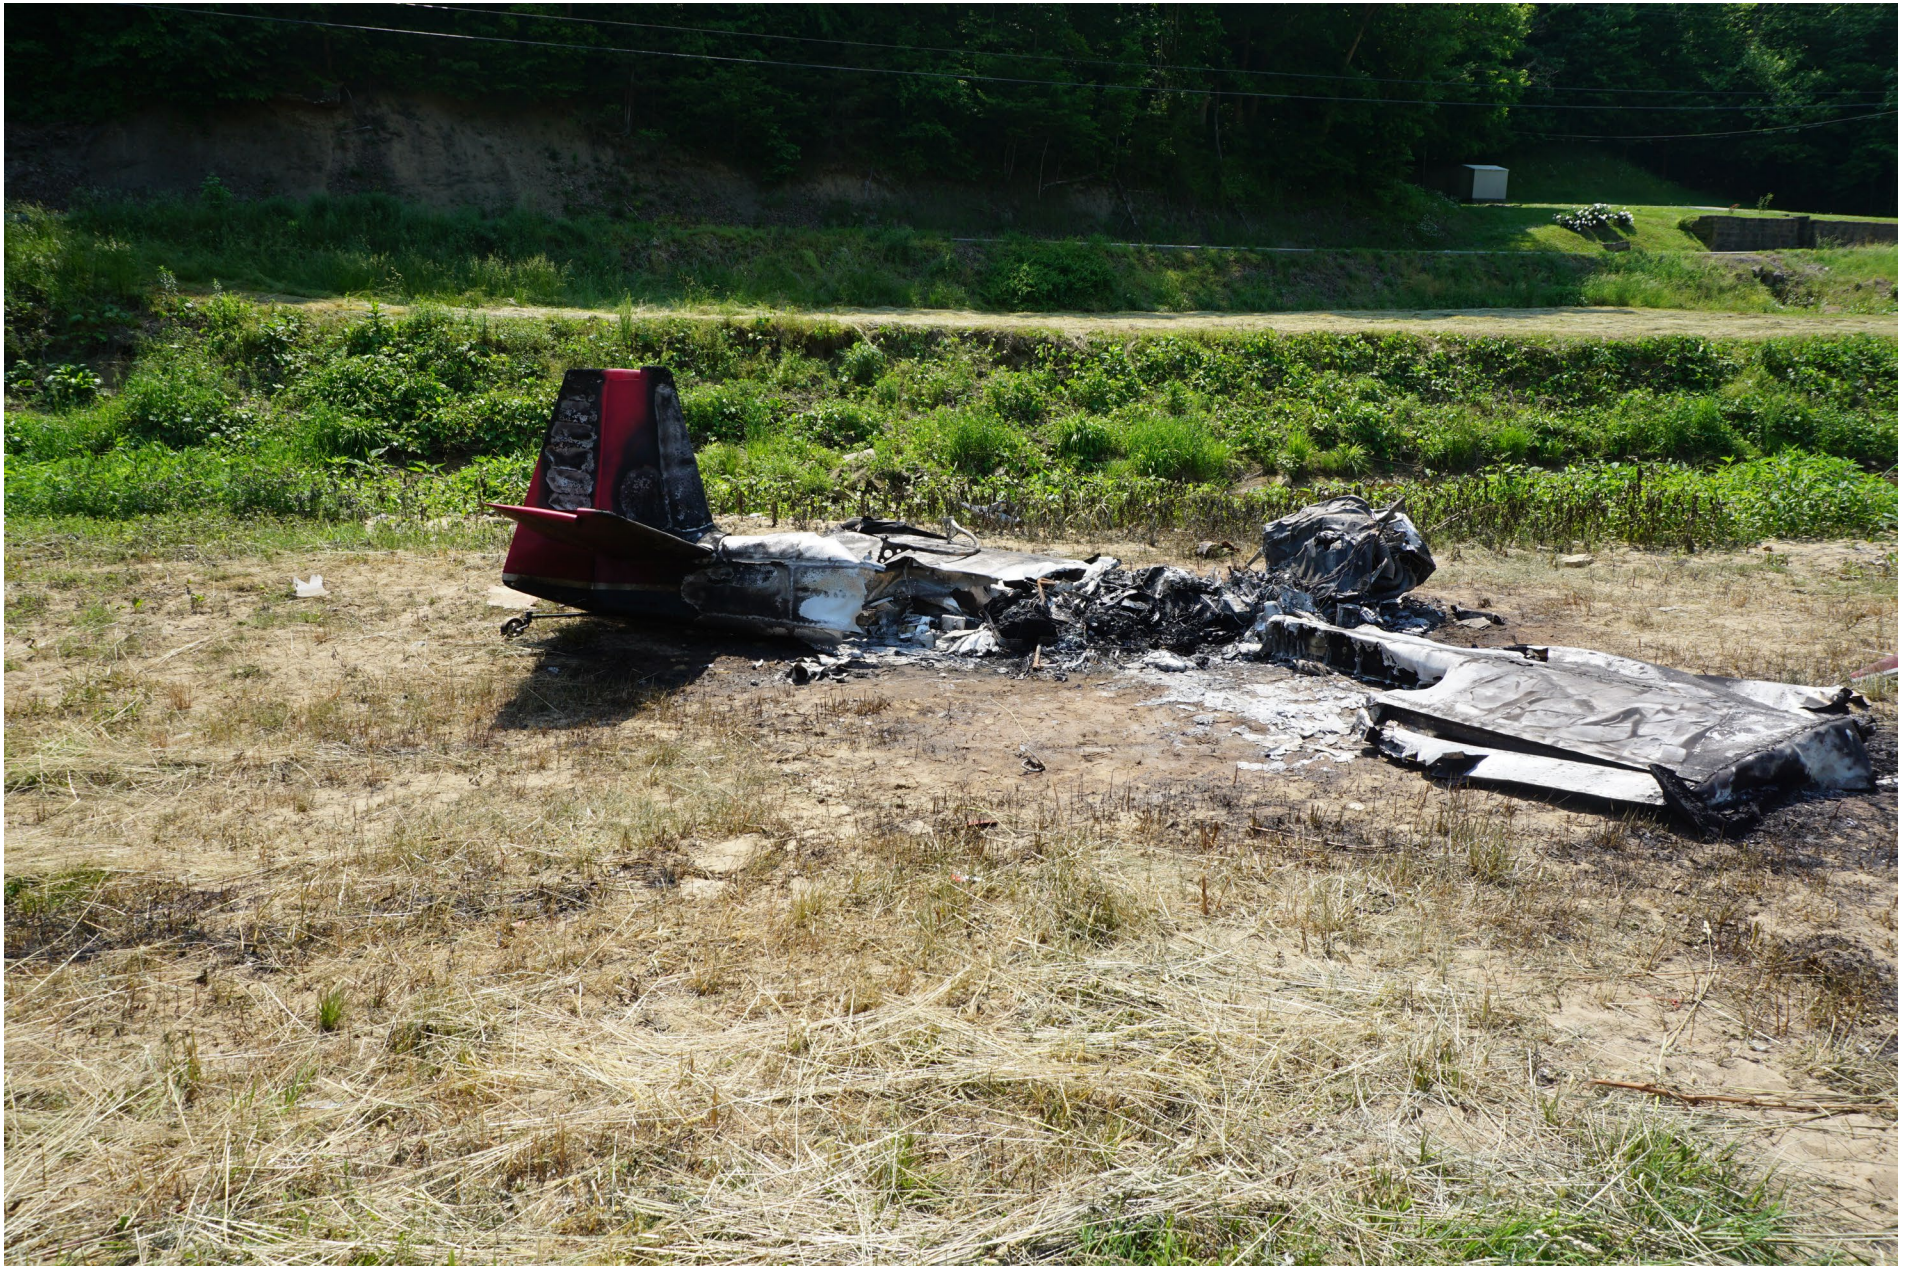
**Photo 1 – View of fire damaged airplane right side.**

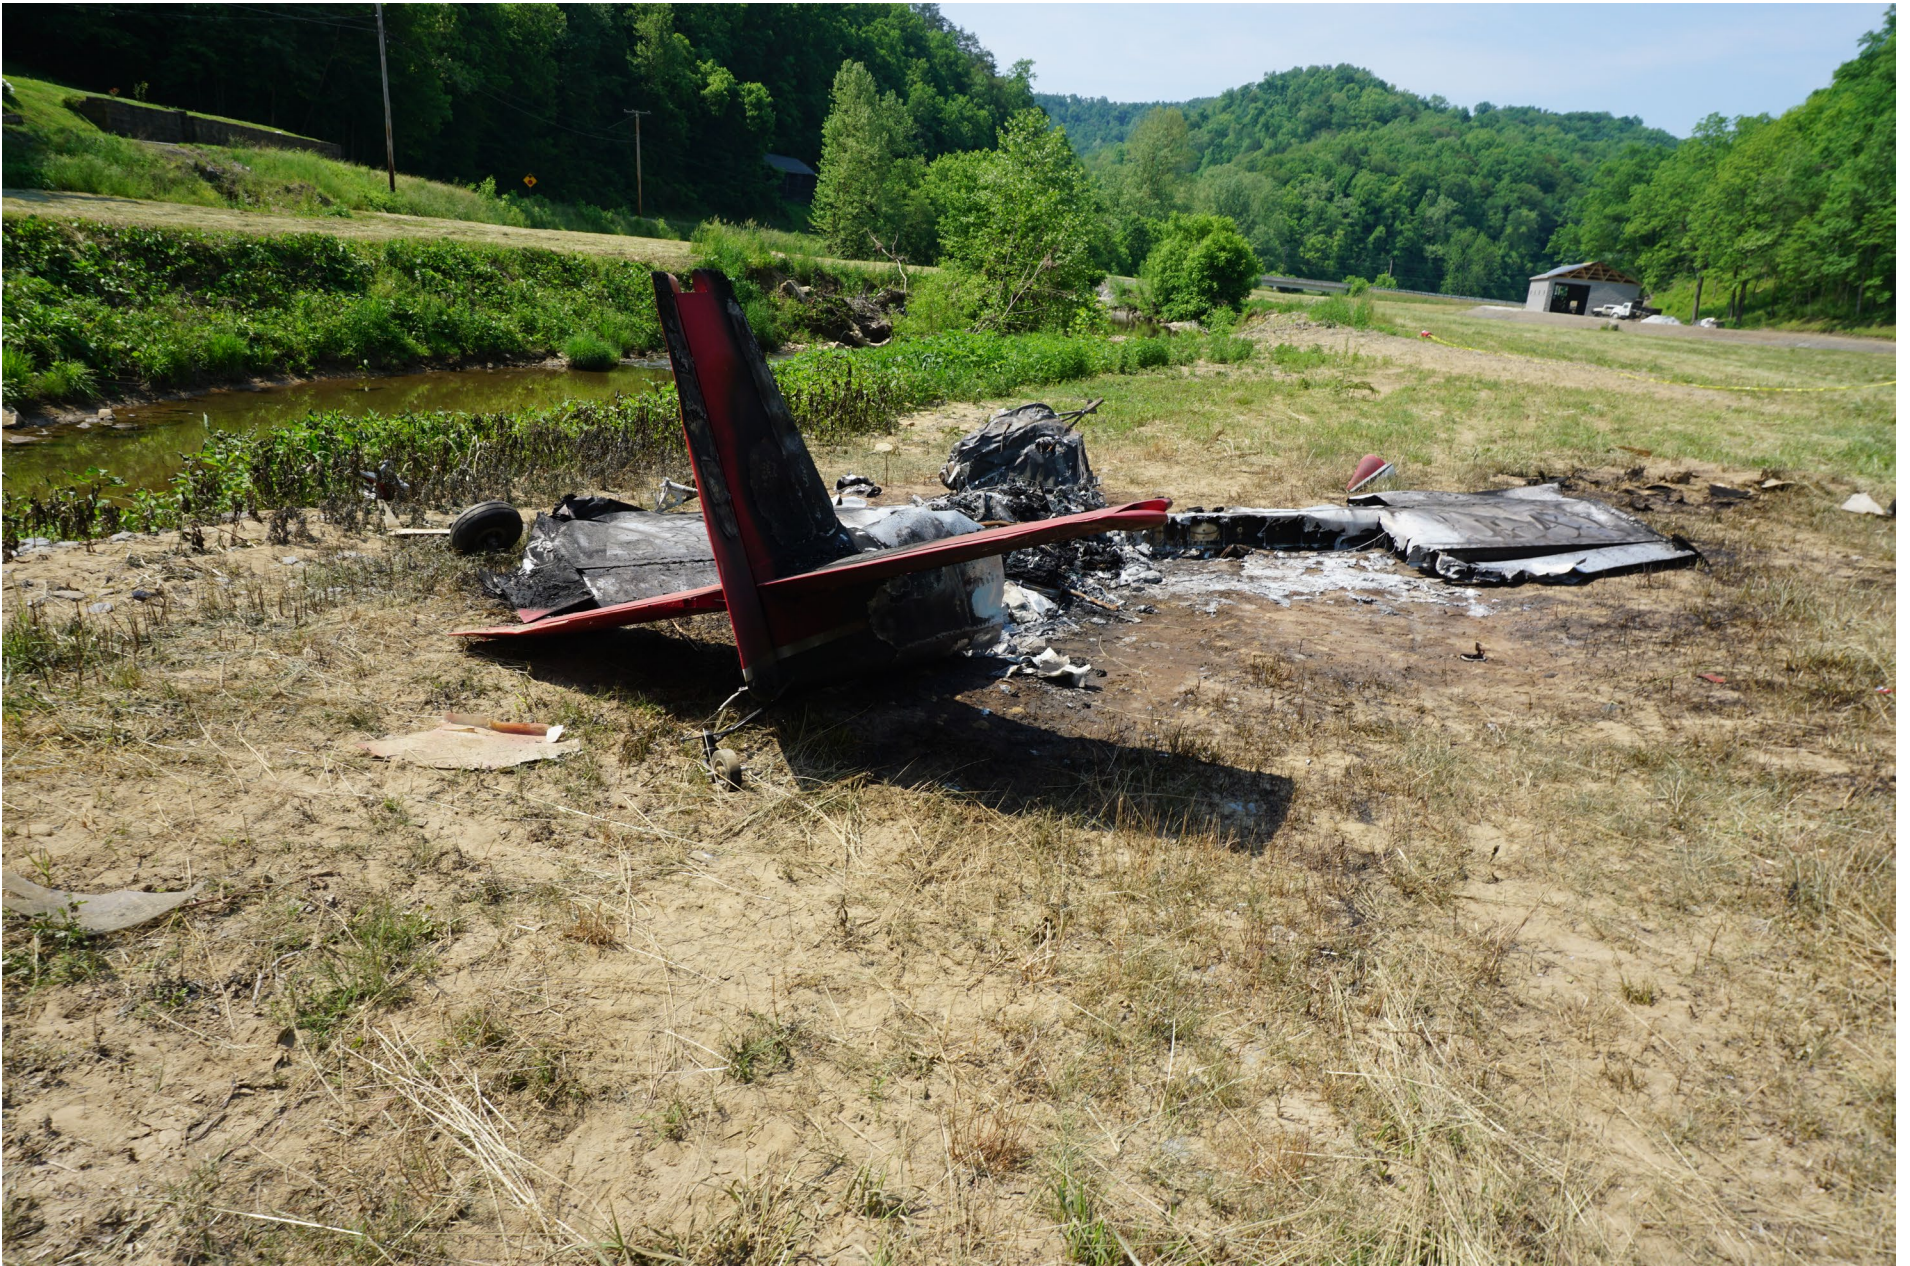
**Photo 2 – View of fire damaged airplane aft.**

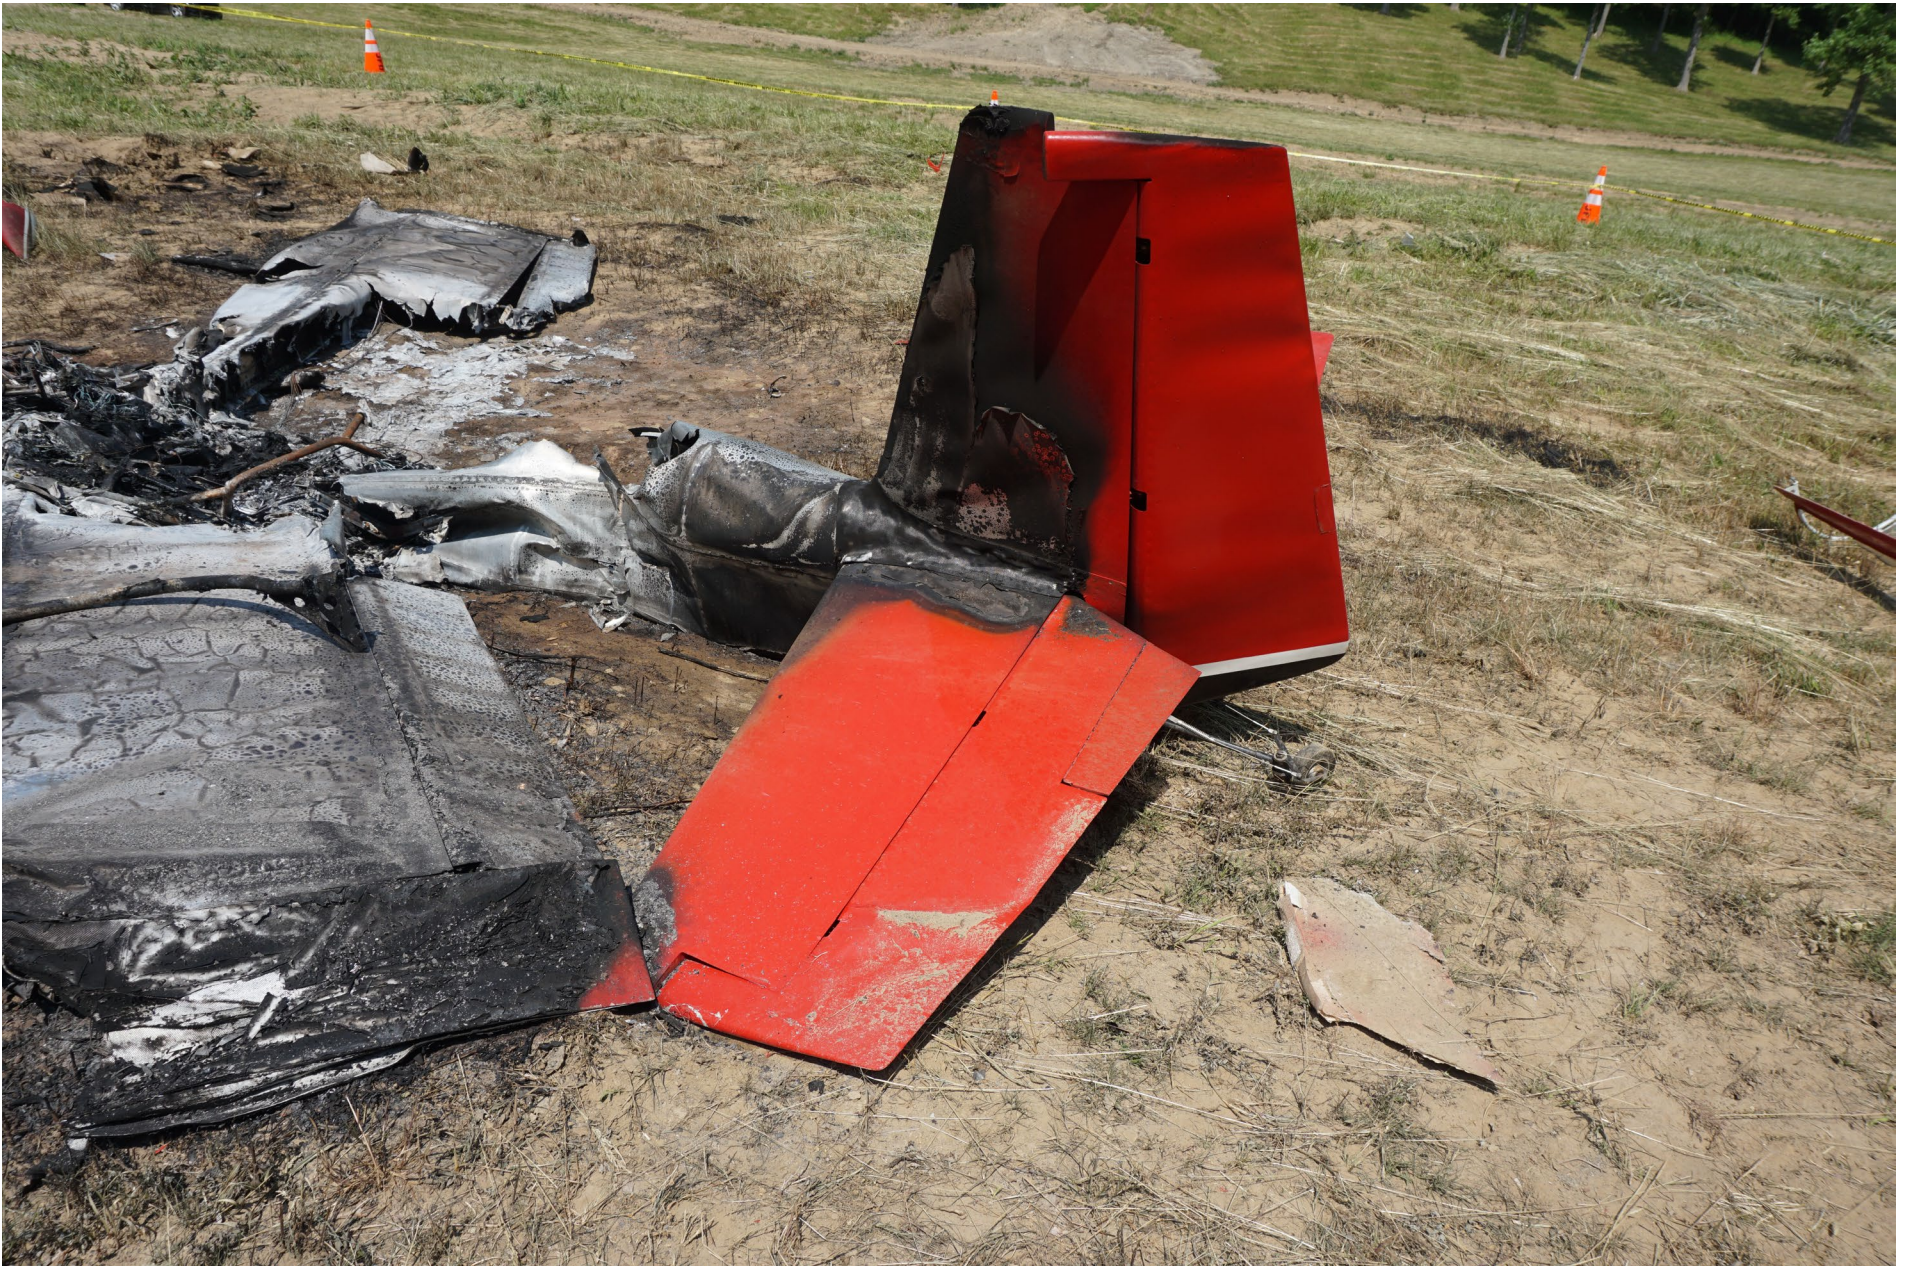
**Photo 3 – View of left side of airplane showing fire damaged fuselage and empennage.**

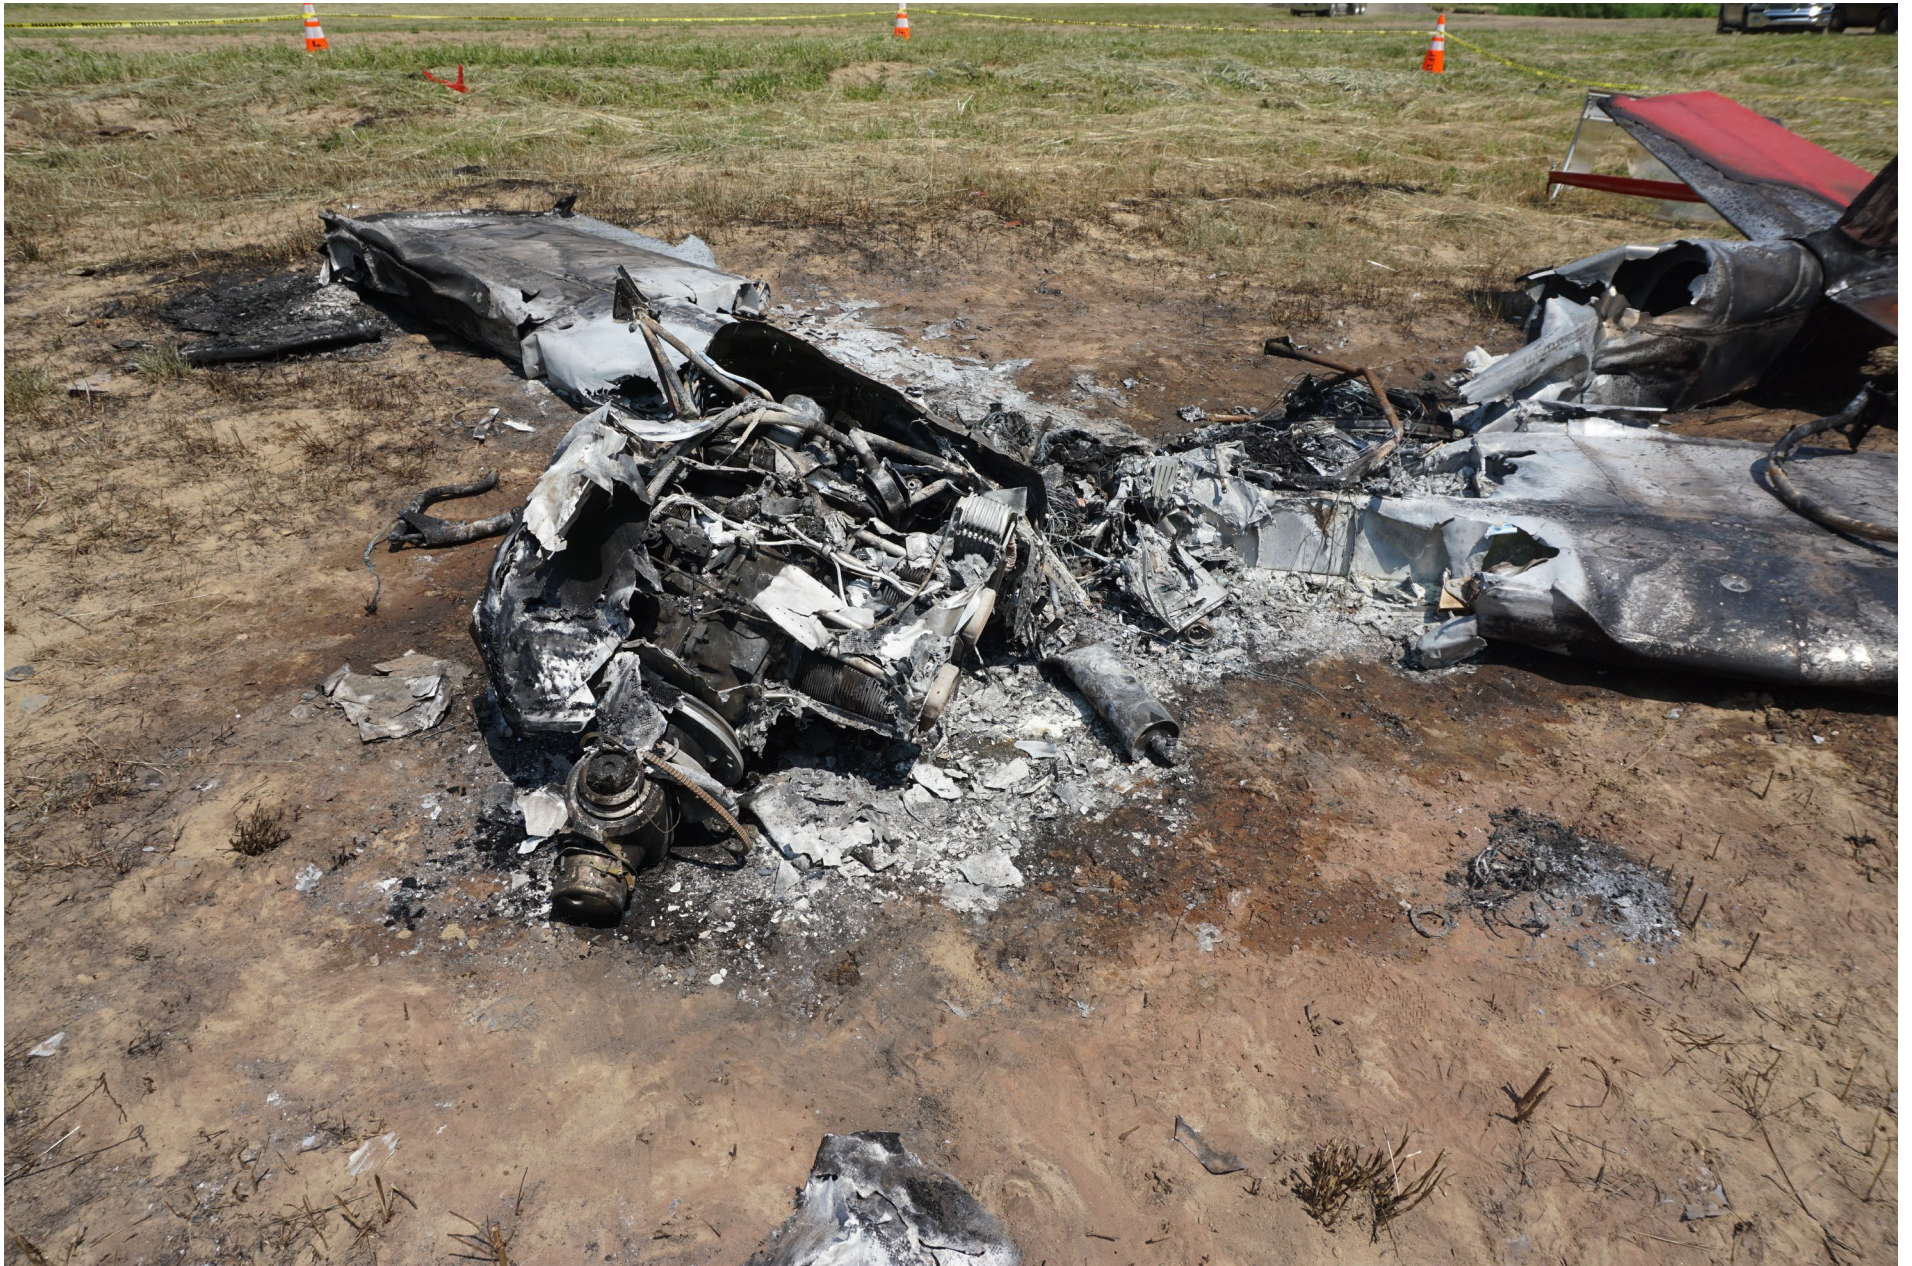
**Photo 4 – View of fire damaged airplane froward showing engine, and cockpit.**

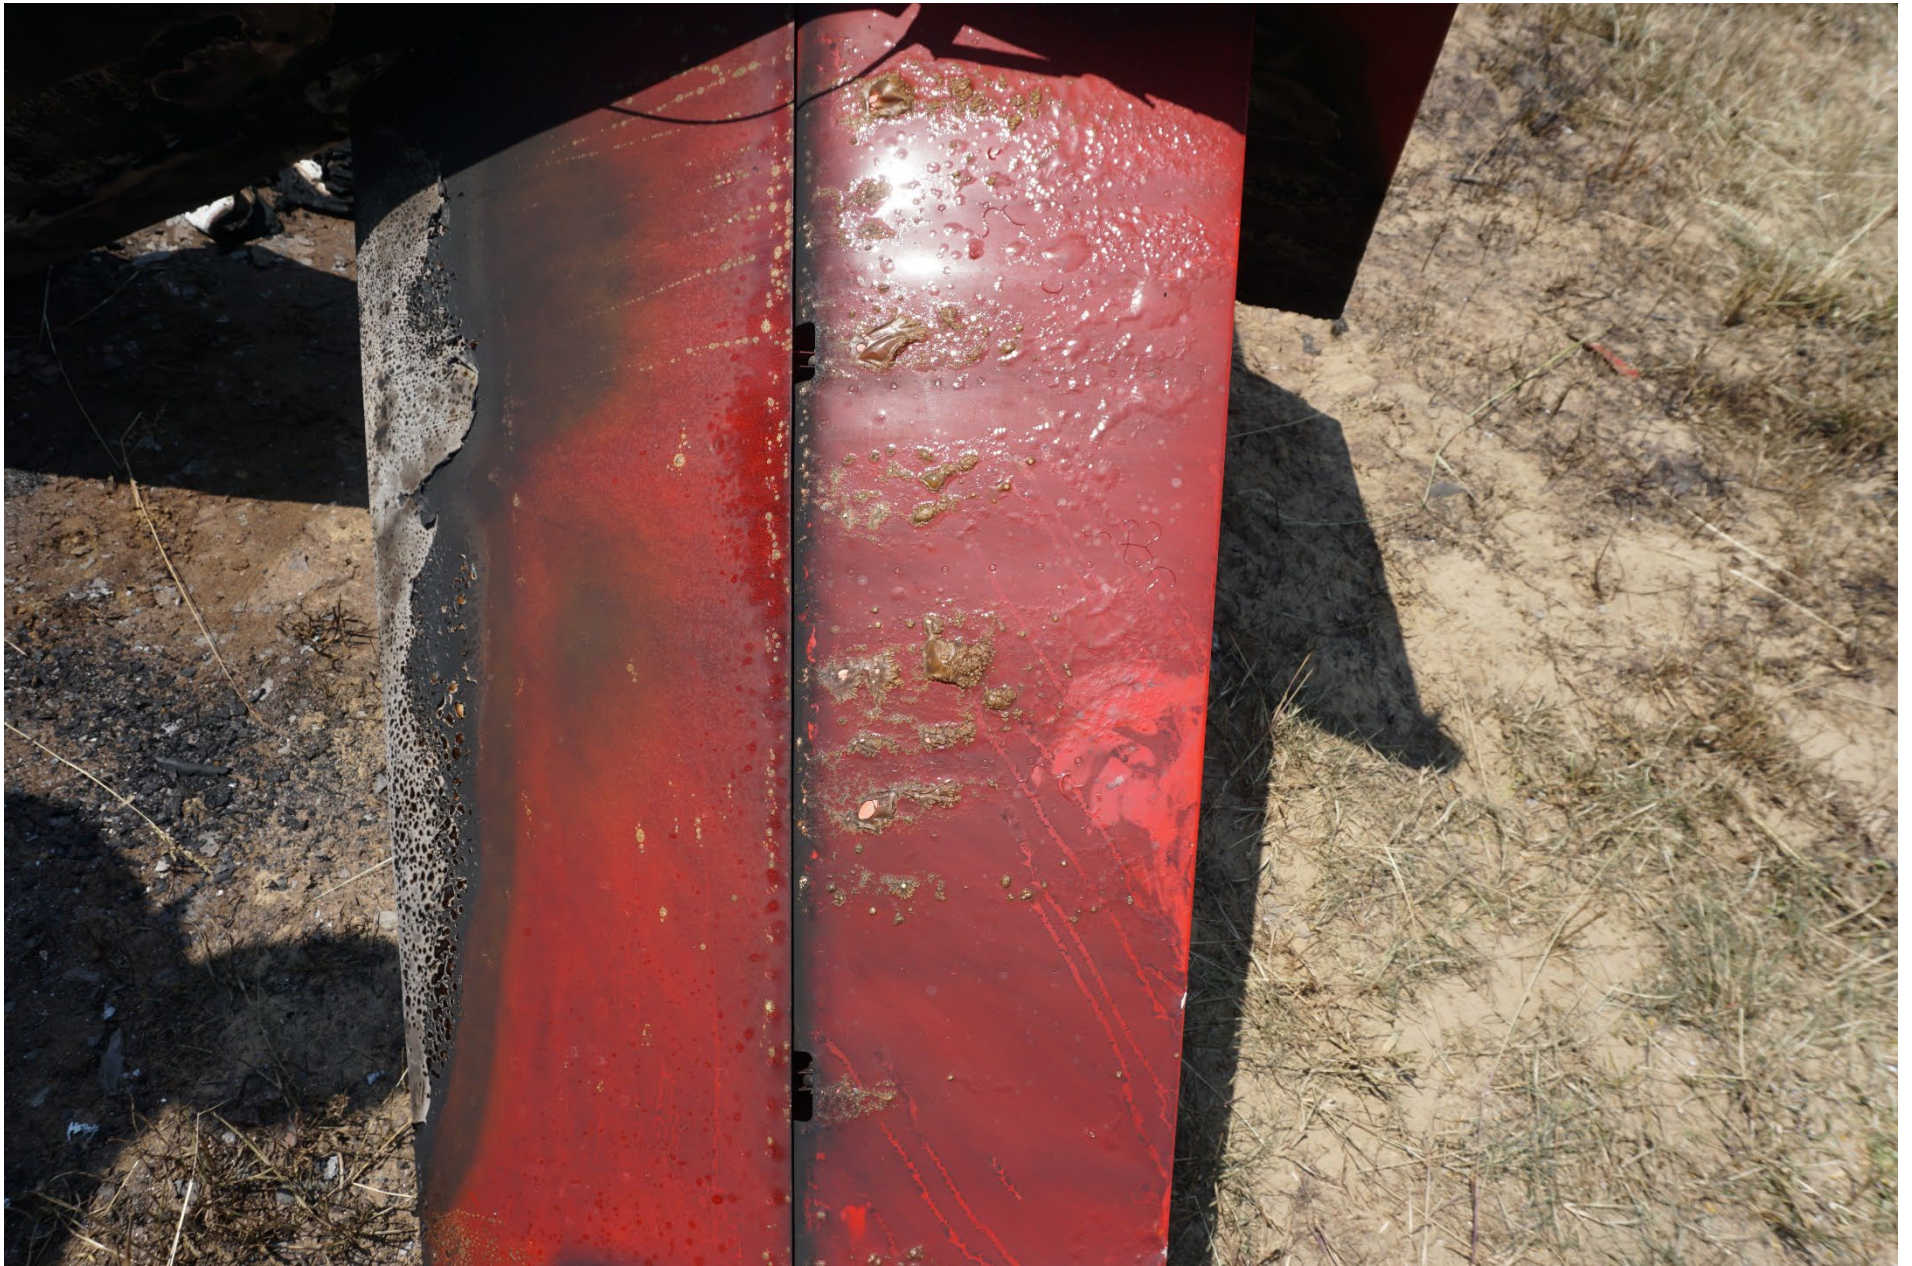
**Photo 5 – View of under right horizontal stabilizer and elevator showing burnt oil streaks.**

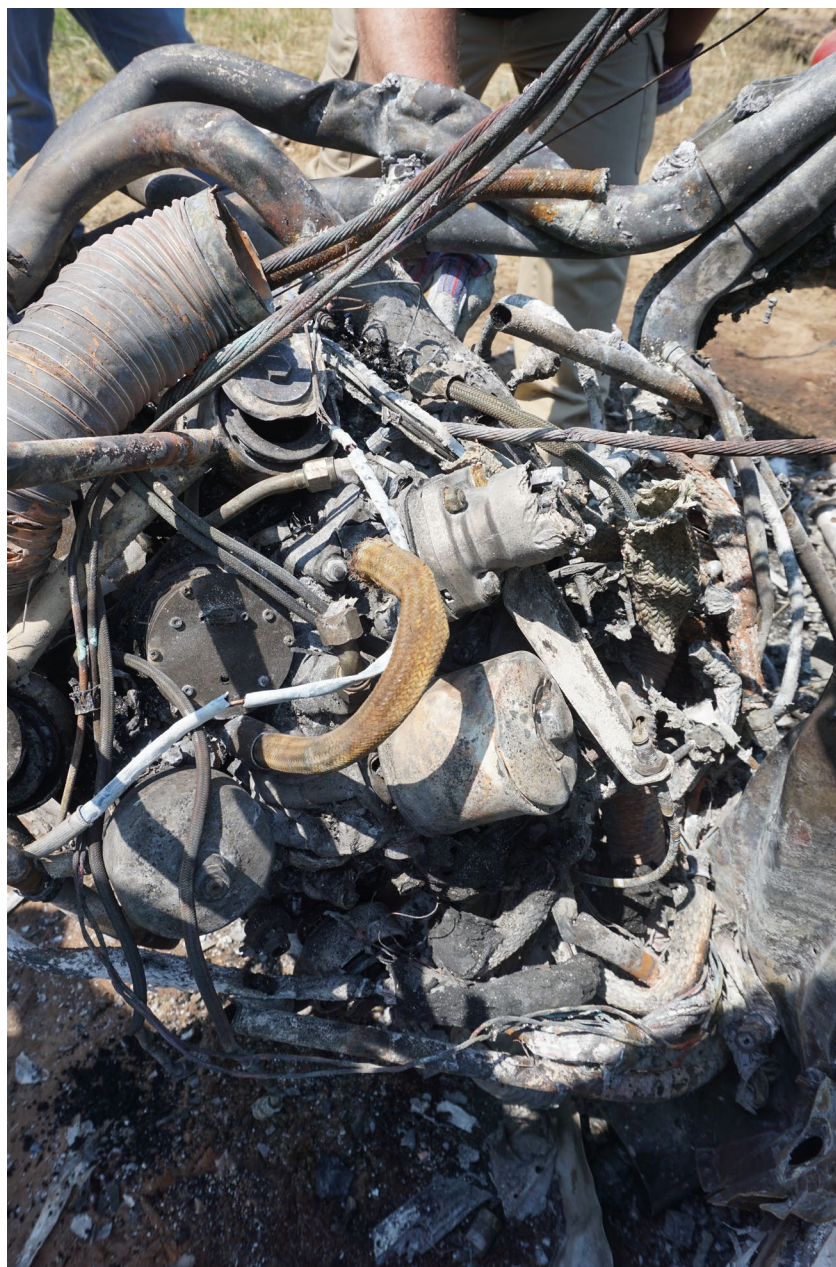
**Photo 6 – View of fire damaged oil and fuel lines on accessory section.**
