# National Transportation Safety Board

ERA21FA233

## **BME FIRE TANK EXAMINATION**

Specialist's Factual Report

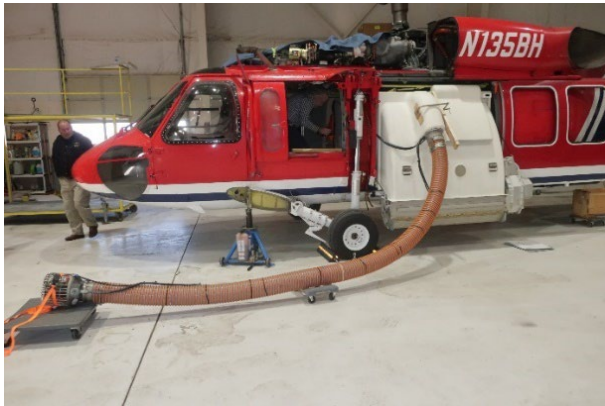
**Figure 1.** Left side of the helicopter showing the water tank installation and snorkel configuration.

The water tank, snorkel, and water release gate are combined into a single system that can be placed in the cabin area of a UH-60 helicopter (Figures 1 and 2). It is secured in place by a square tube steel external frame that attaches to the helicopter's existing upper cargo tie down points and to the existing floor tie-down points (Figures 3 and 4). The tank is constructed of half inch honeycomb panel with two ply carbon face sheet and Nomex core. The molded front section that contains the snorkel attachment port, motorized water gate assembly (Trotter Controls), and vent was designed and manufactured by Leading Edge Composites. Leading Edge Composites also assembled the tank side panels, integrated the molded front section to the tank, installed the water gate assembly, and associated controls.

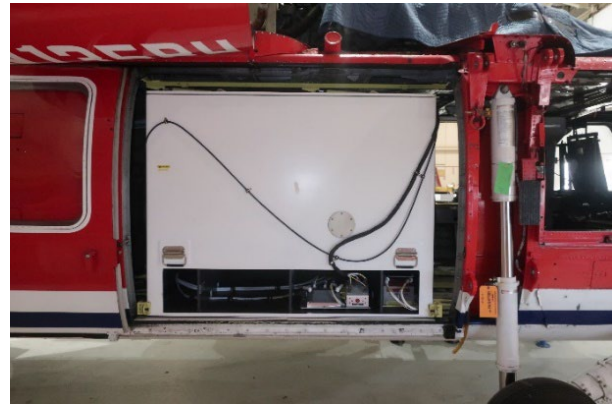
**Figure 2.** Right side of the helicopter showing the back of the water tank.

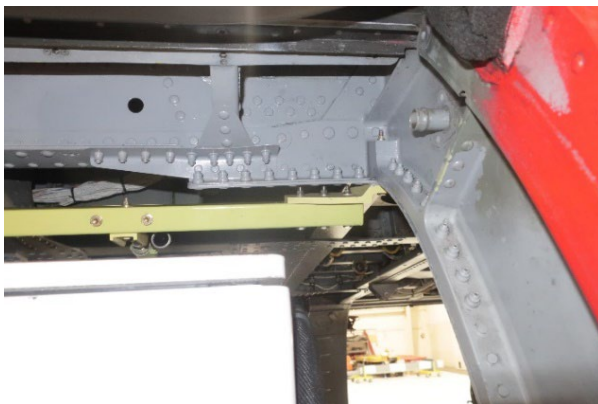
**Figure 3.** Water tank exterior frame right forward upper tie down attachment (typical of the top 4 corners).

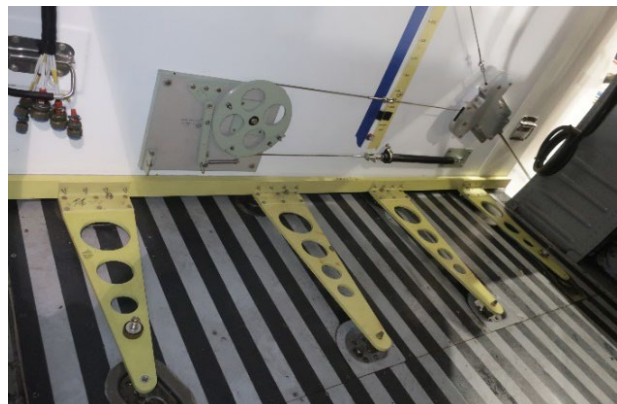
**Figure 4.** Water tank external frame attached to floor deck tie downs.

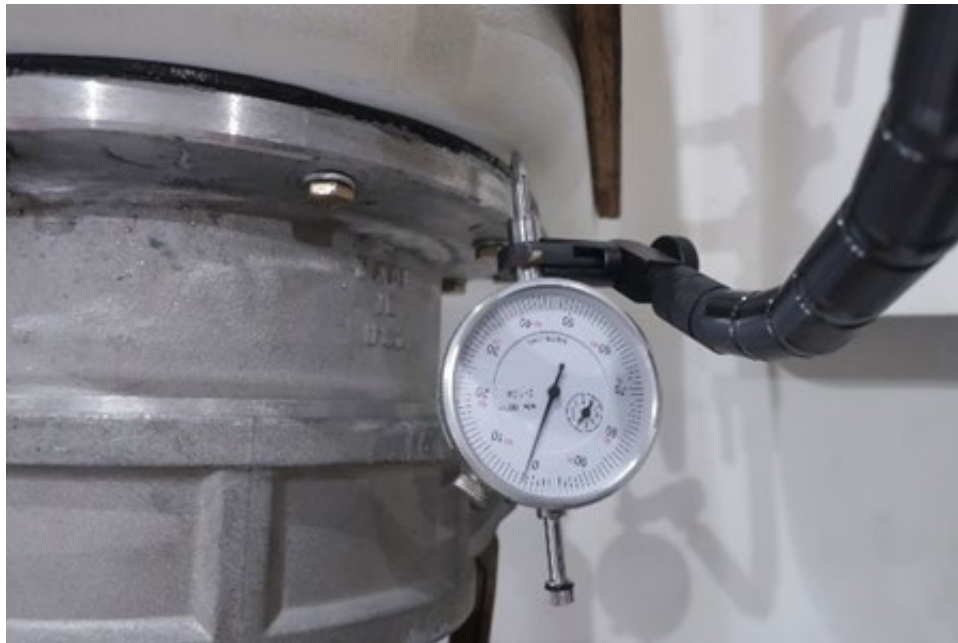
**Figure 9.** Dial gauge placement at position B.

The tank port had been fastened in place with 12 AN4 bolts and torqued. The snorkel was attached to the tank using the snorkel fixture cam-locks as designed. A dial gauge was positioned at various points around the tank port (Figure 8). The snorkel was placed on a wheeled dolly and manually pulled in one of 3 directions (forward, lateral, and aft (Figure 7 and Table 1). The deflection of the tank port structure was measured using a dial gauge (Figure 9) as the snorkel was manually pulled away from the port and then released back to a static position.

| Location | Pull Direction | Deflection (inch) |
|---|---|---|
| Position B | Aft | 0.006 |
| | Lateral | 0.003 |
| | Forward | 0.005 |
