## FACTUAL REPORT - ATTACHMENT 9

Hose Test Report

ERA21FA233

## Hose Test for Project ST7314DE-R

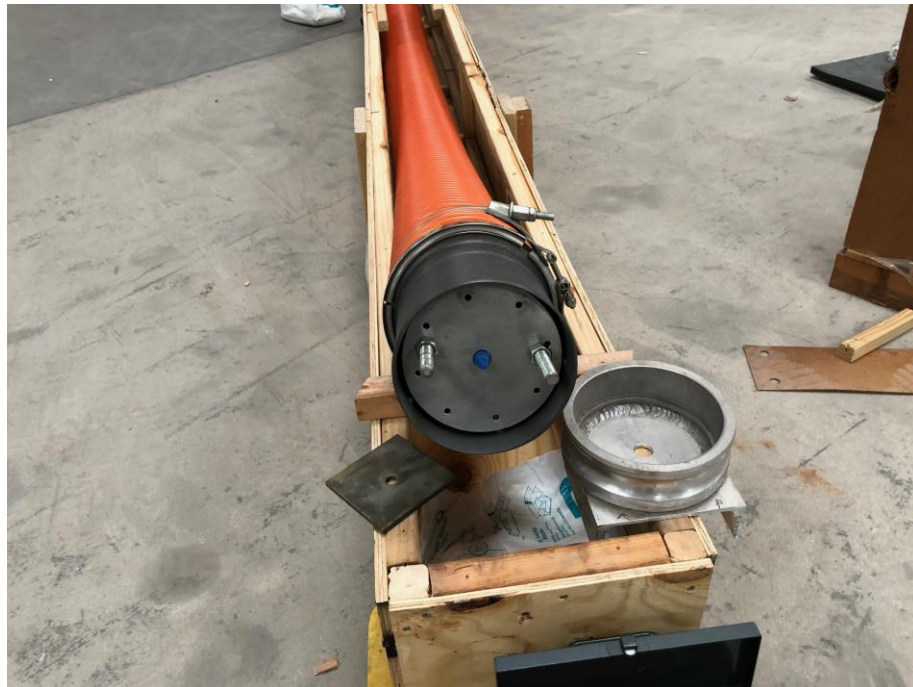
2 aluminum plates were fabricated and added to the lower nozzle. The two threaded rods extending from the plates will allow the assembly to be attached to a fixed support on the ground.

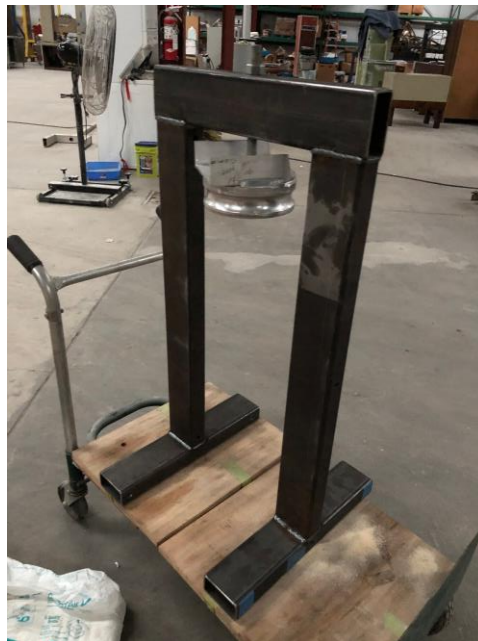
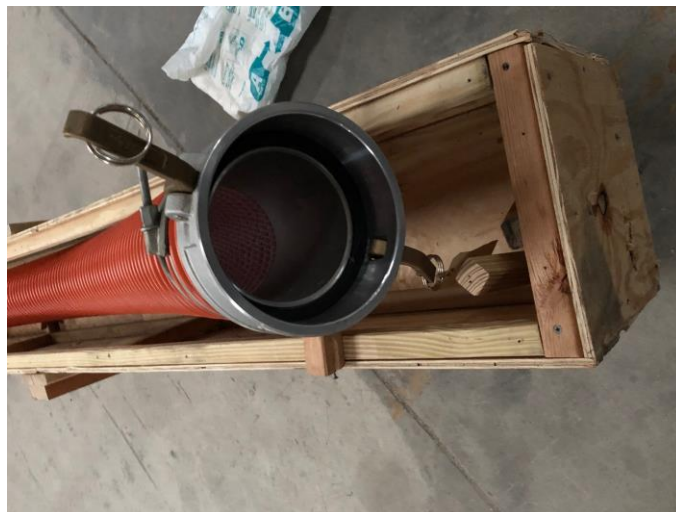
An upper support was fabricated with an adapter to allow the upper end of the hose assembly to attach to the adapter.

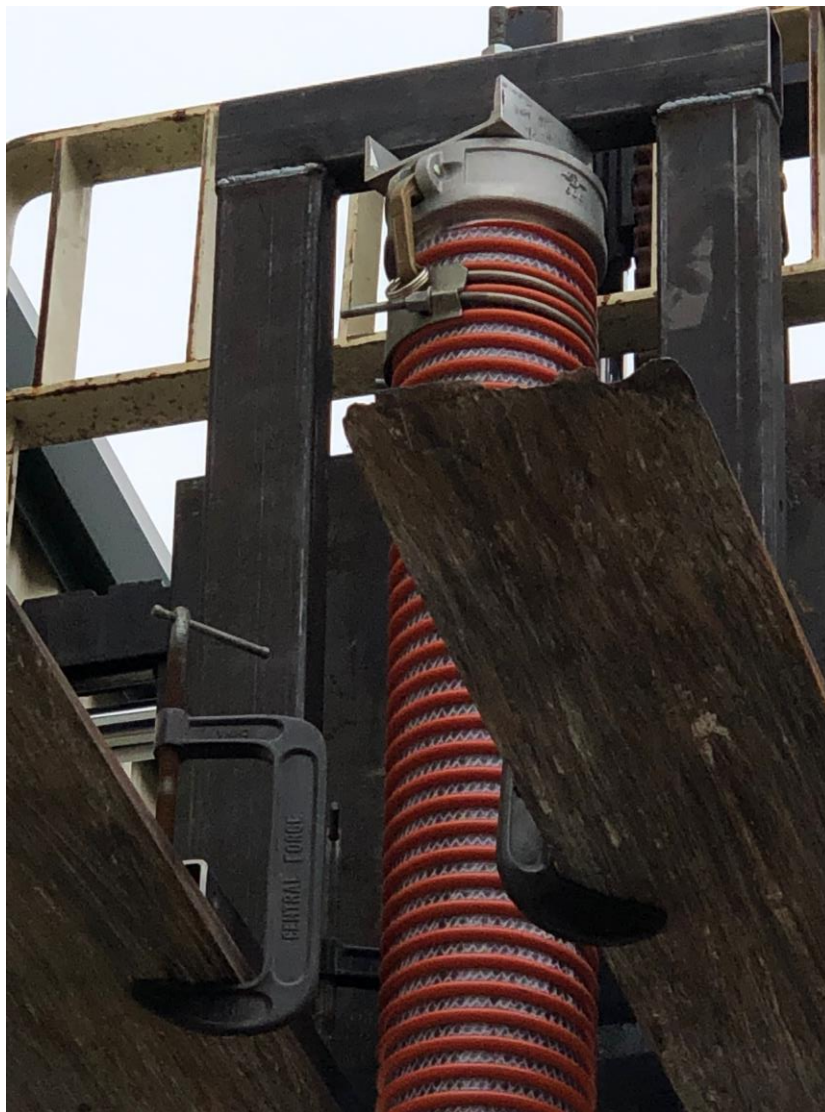
The upper assembly was attached to the forks of a forklift:

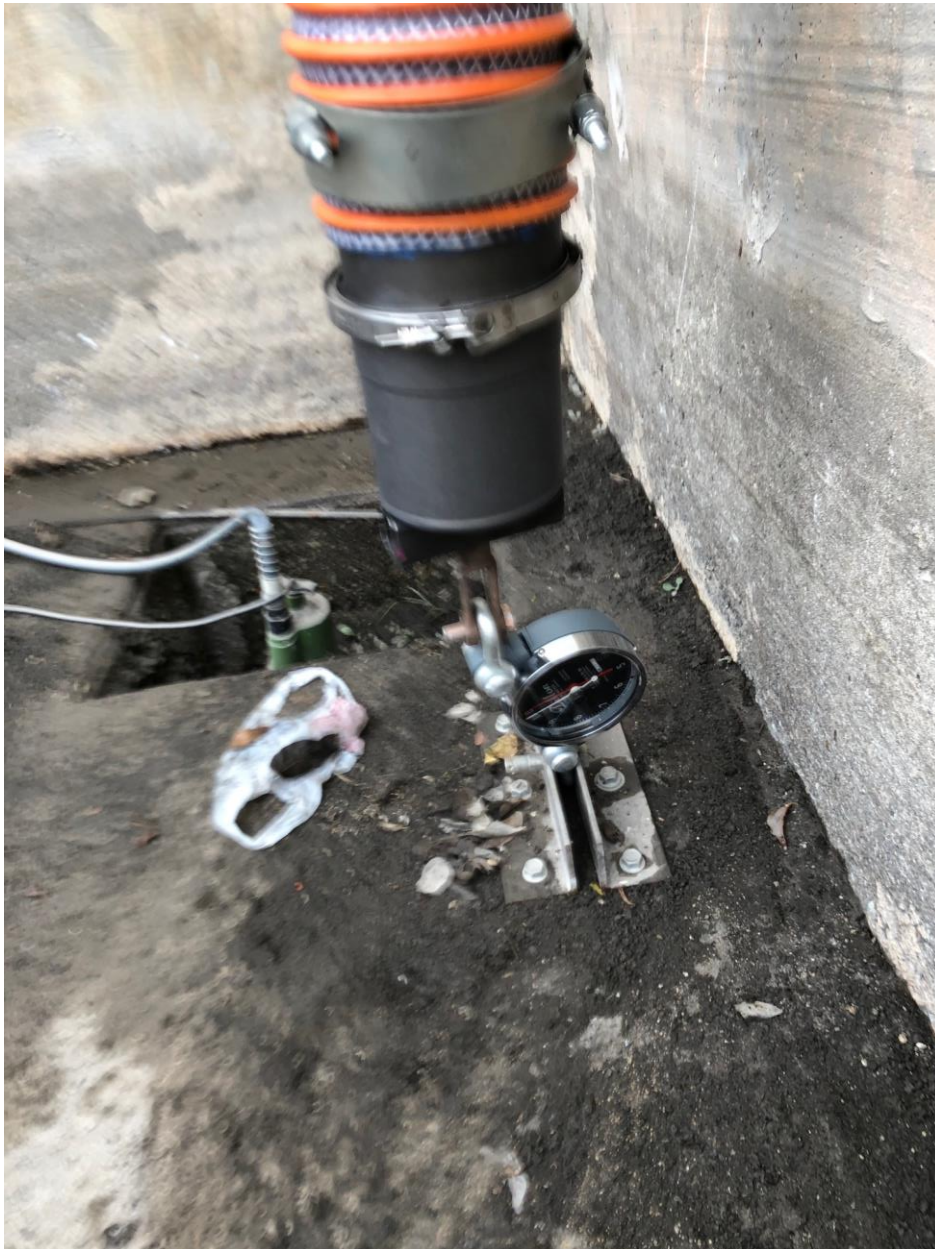
The two threaded rods were attached to a beam. In the center of the beam is a clevis. The clevis is attached to the upper end of the dynamometer. The lower end of the dynamometer is attached to two angles that are attached to the concrete slab.

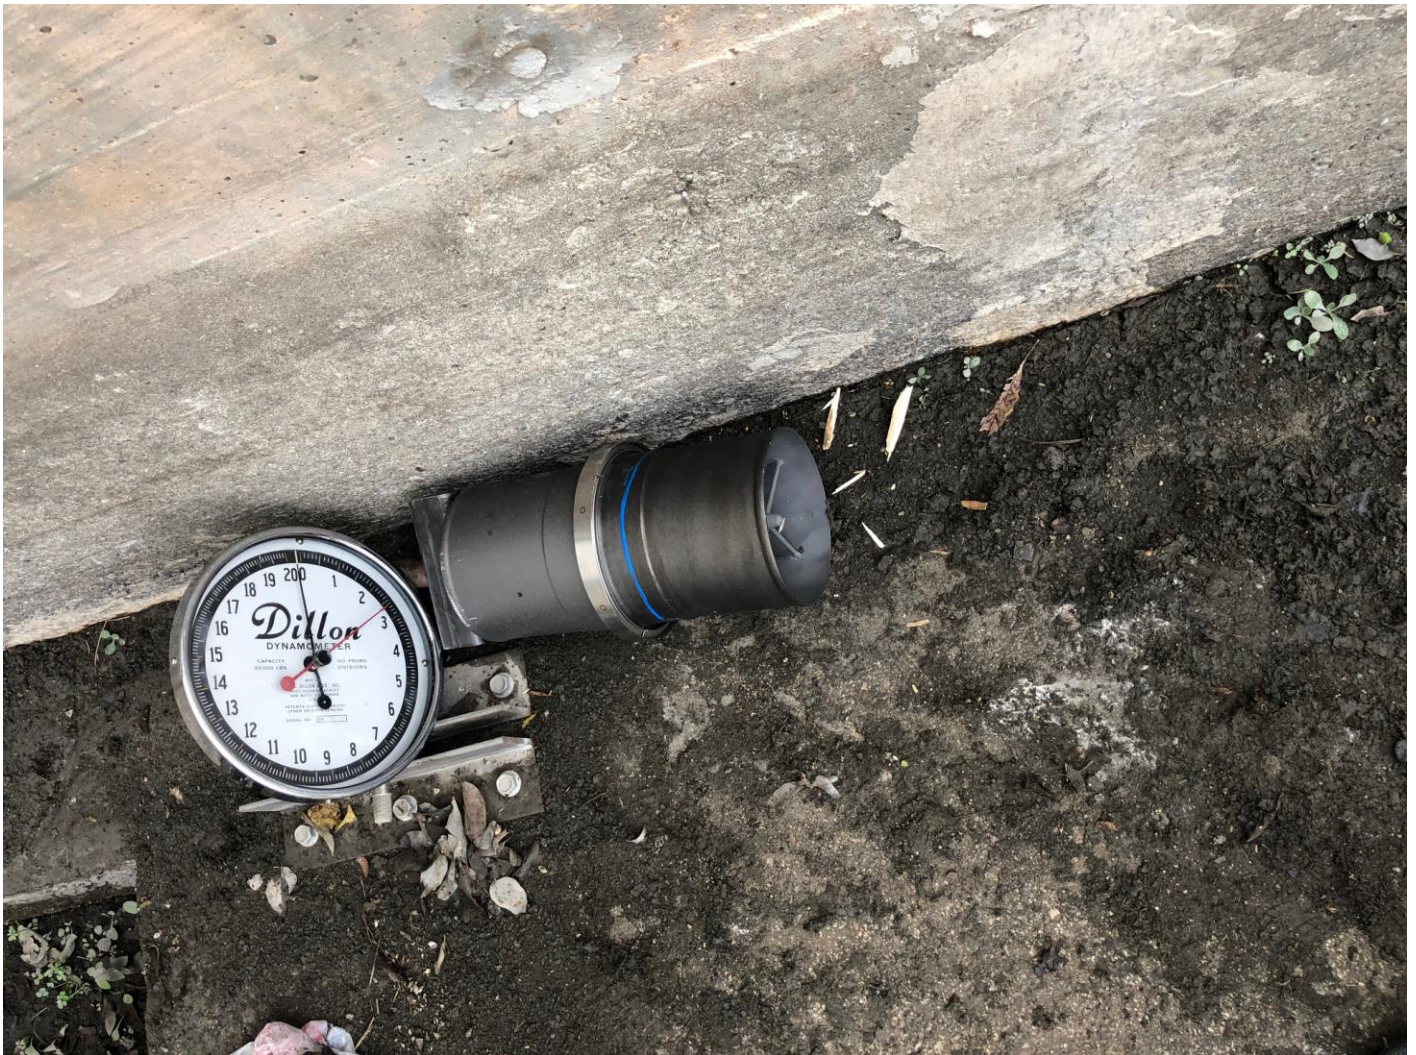
The test was conducted December 11, 2019 at RKG's San Antonio facility. At an applied load of 2,500 lb, the hose slipped off the lower nozzle assembly.

The failure load from testing is reported in the test results section of this report and was 2.500 lb.
