# National Transportation Safety Board

ERA21FA346

## AIRCRAFT PERFORMANCE GROUP STUDY

Location: Farmington, Connecticut  
Date: September 2, 2021  
Time: 0951 Eastern Daylight Time (EDT)  
1351 Coordinated Universal Time (UTC)  
Airplane: Cessna Citation XLS+, N560AR, line number 560XL-6026

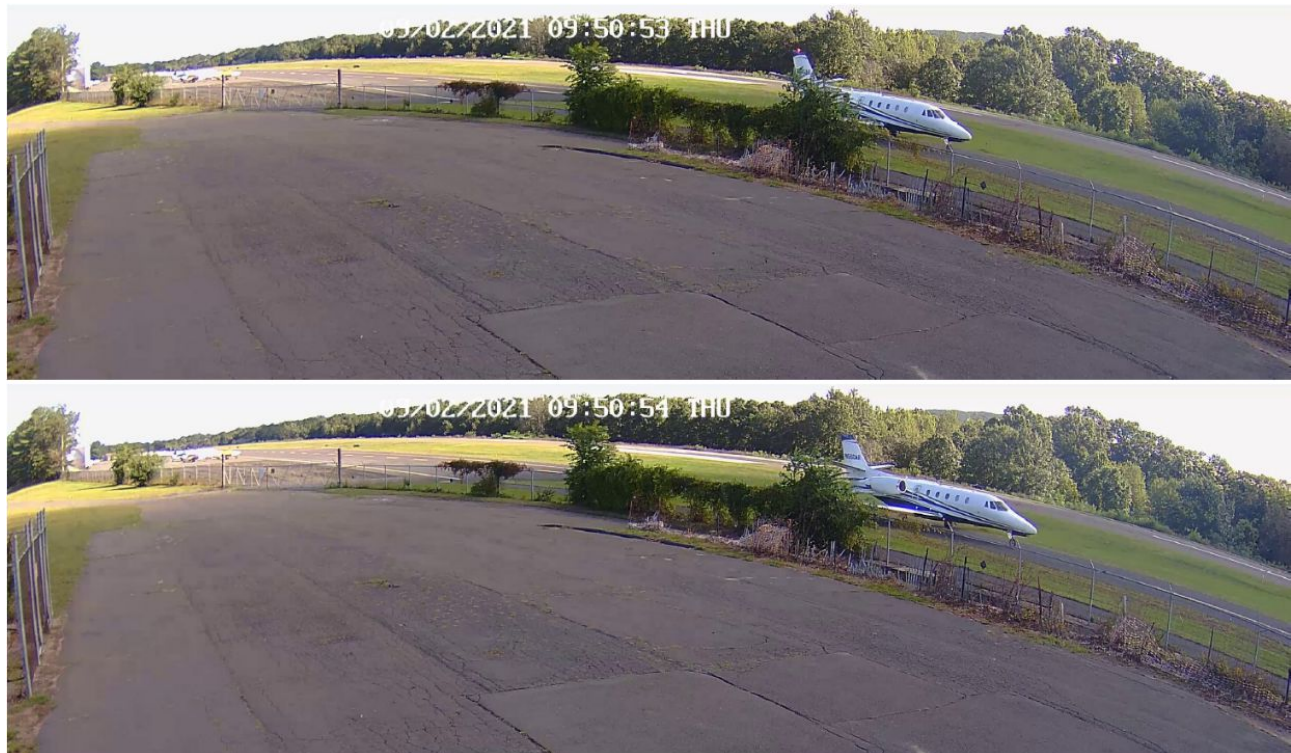
**"Airport" Camera (N560AR taxi segment), Attachment 3**

Figure 1: Exemplar cropped and enlarged image sequence extracted from "Airport" surveillance camera recording. N560AR is taxiing toward the approach end of runway 2, moving left to right.

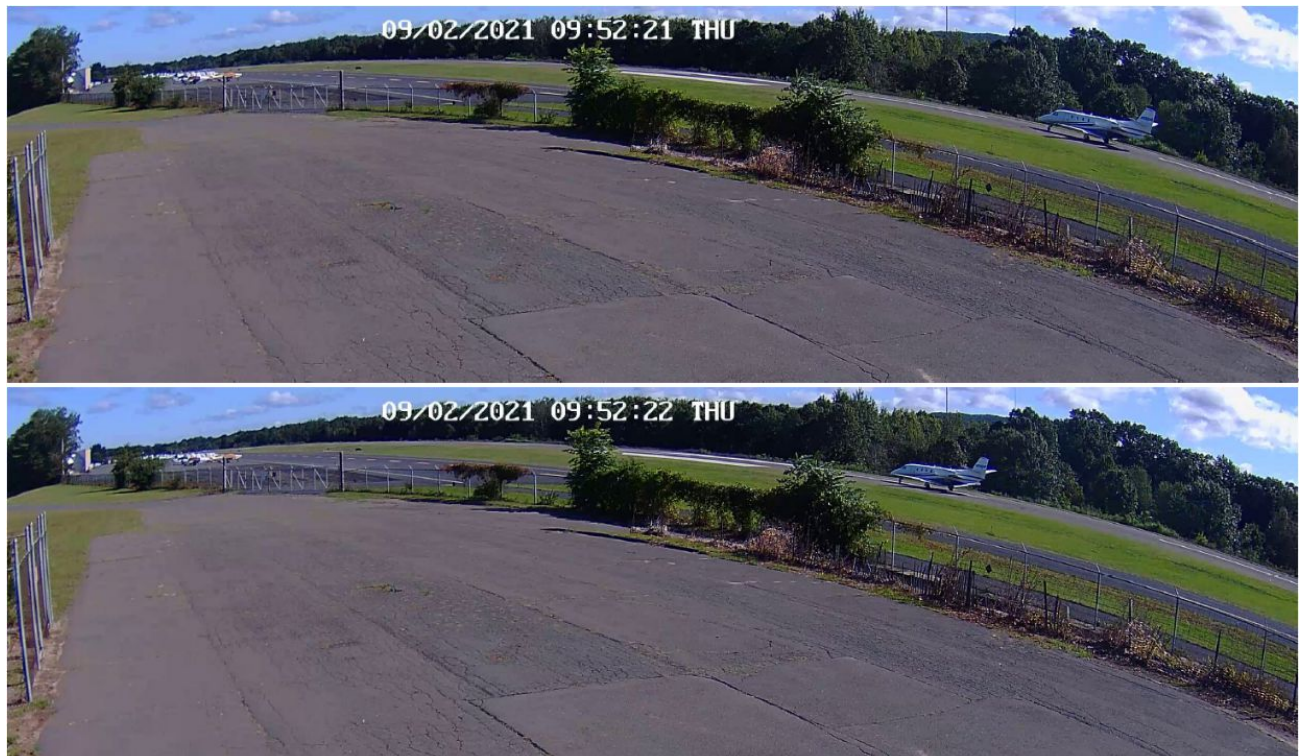
**"Airport" Camera (N560AR takeoff ground roll segment), Attachment 4**

Figure 2: Cropped and enlarged image sequence extracted from "Airport" surveillance camera recording. N560AR during takeoff roll toward the departure end of runway 2, moving right to left.

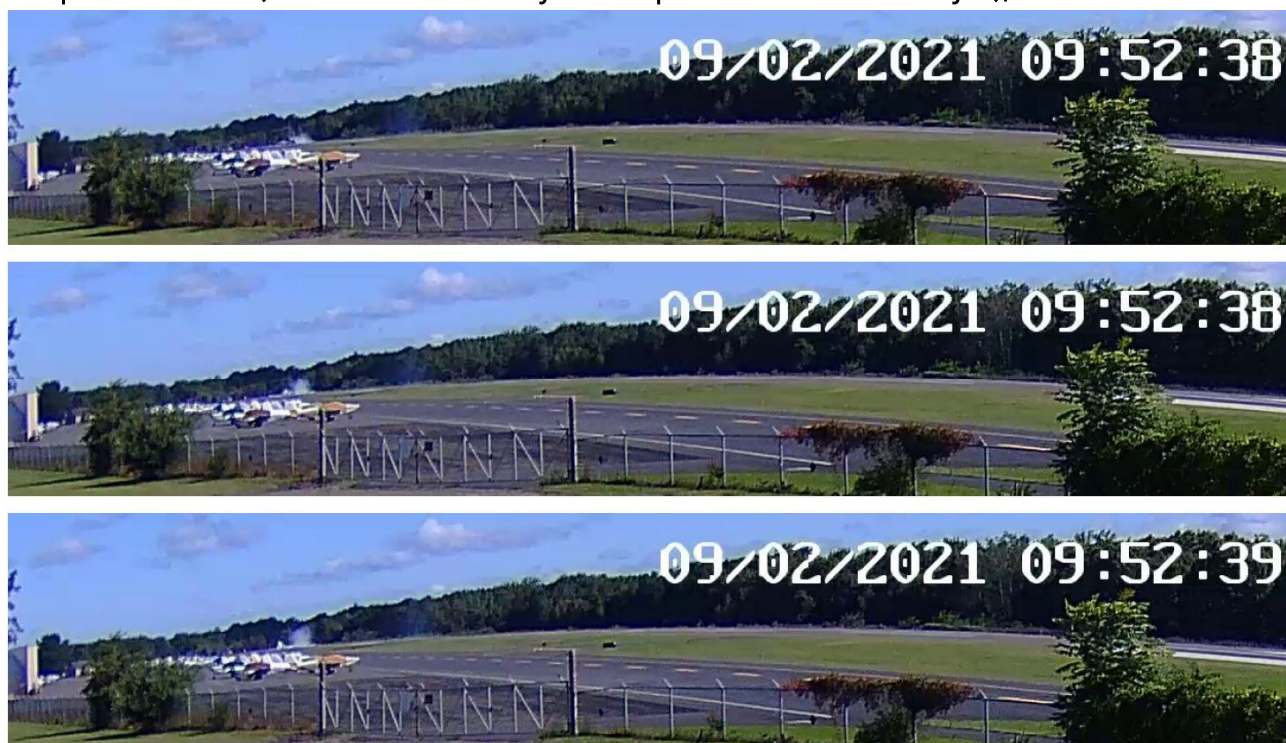
"Airport" Camera (N560AR near or beyond departure end of runway 2), Attachment 5

Figure 3: Cropped and enlarged image sequence extracted from "Airport" surveillance camera recording. N560AR (visible on left of each image) during takeoff near departure end of runway 2.

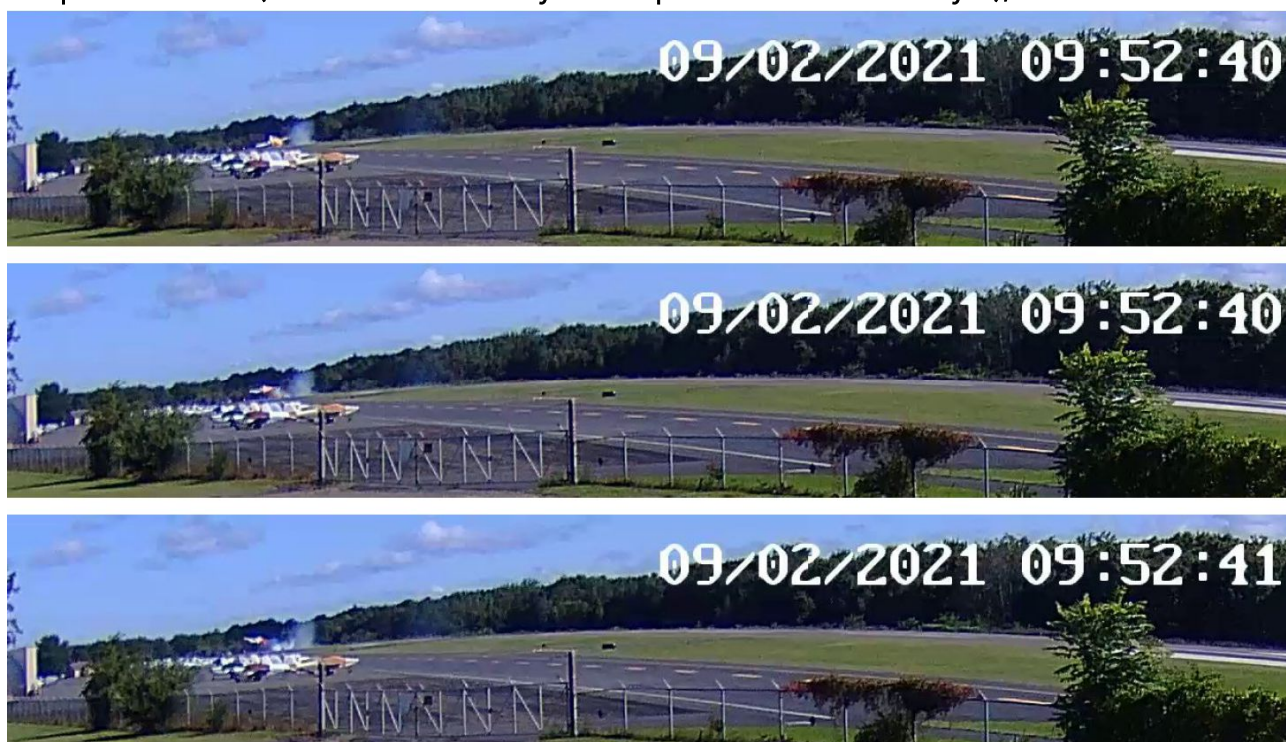
"Airport" Camera (N560AR near or beyond departure end of runway 2), Attachment 5

Figure 4: Cropped and enlarged image sequence extracted from "Airport" surveillance camera recording. N560AR (visible on left of each image) during takeoff beyond runway 2 departure end.

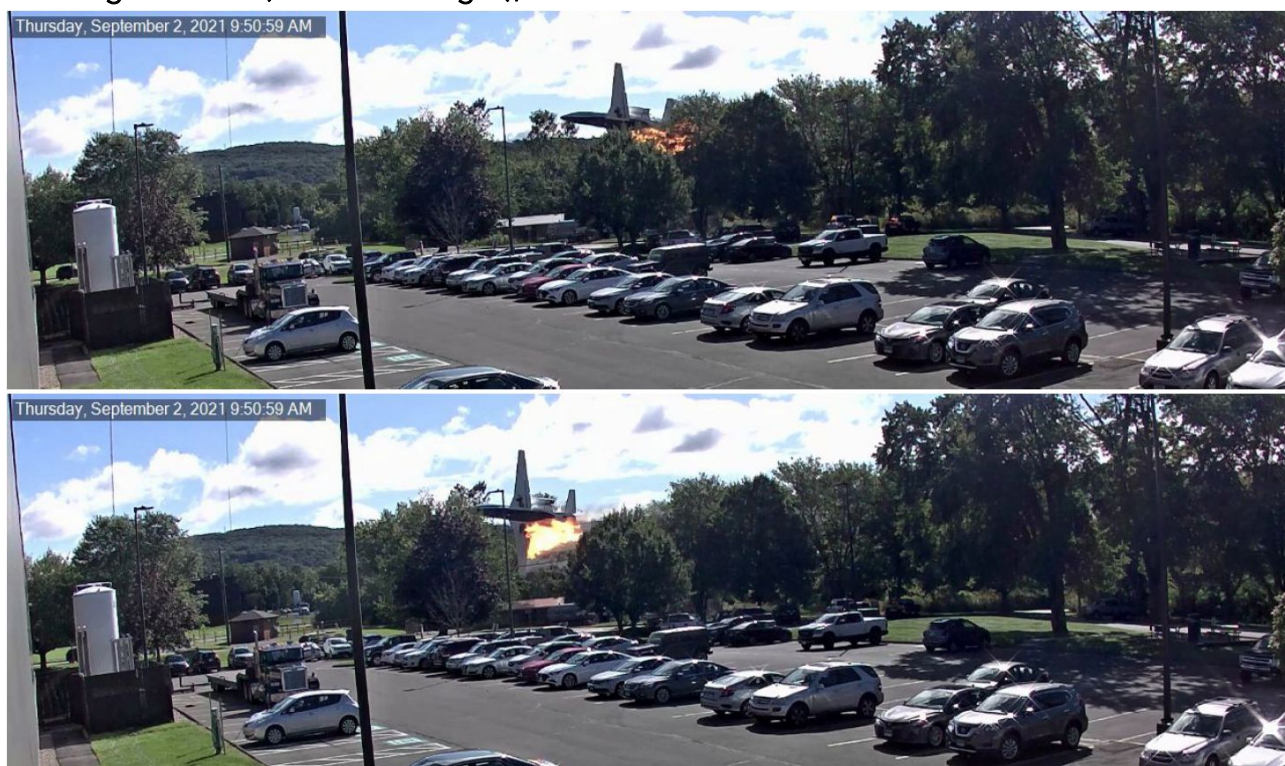
**"Parking" Camera (N560AR in flight), Attachment 6**

Figure 5: Cropped and enlarged image sequence extracted from "Parking" surveillance camera recording. N560AR is visible in the center of each image.

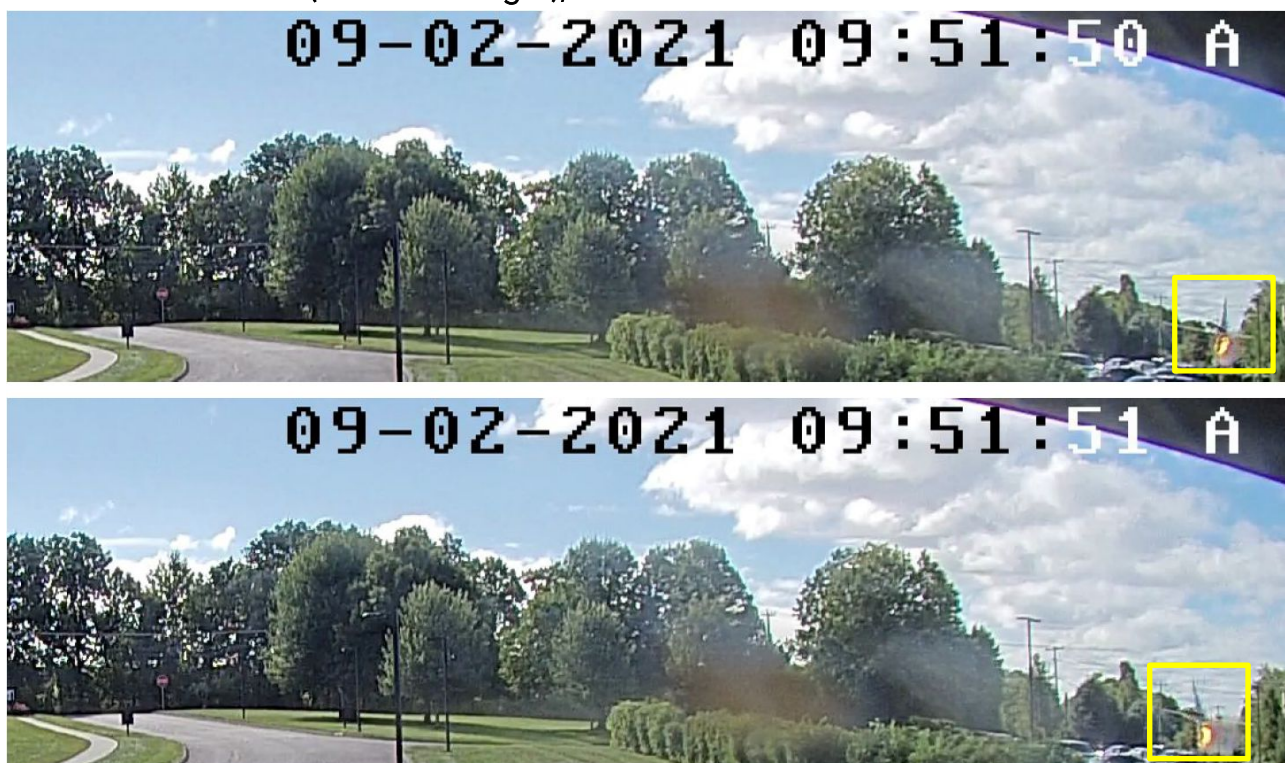
**"Main Drive" Camera (N560AR in flight), Attachment 7**

Figure 6: Cropped and enlarged image sequence extracted from "Main Drive" surveillance camera recording. N560AR is visible in the lower right of each image.

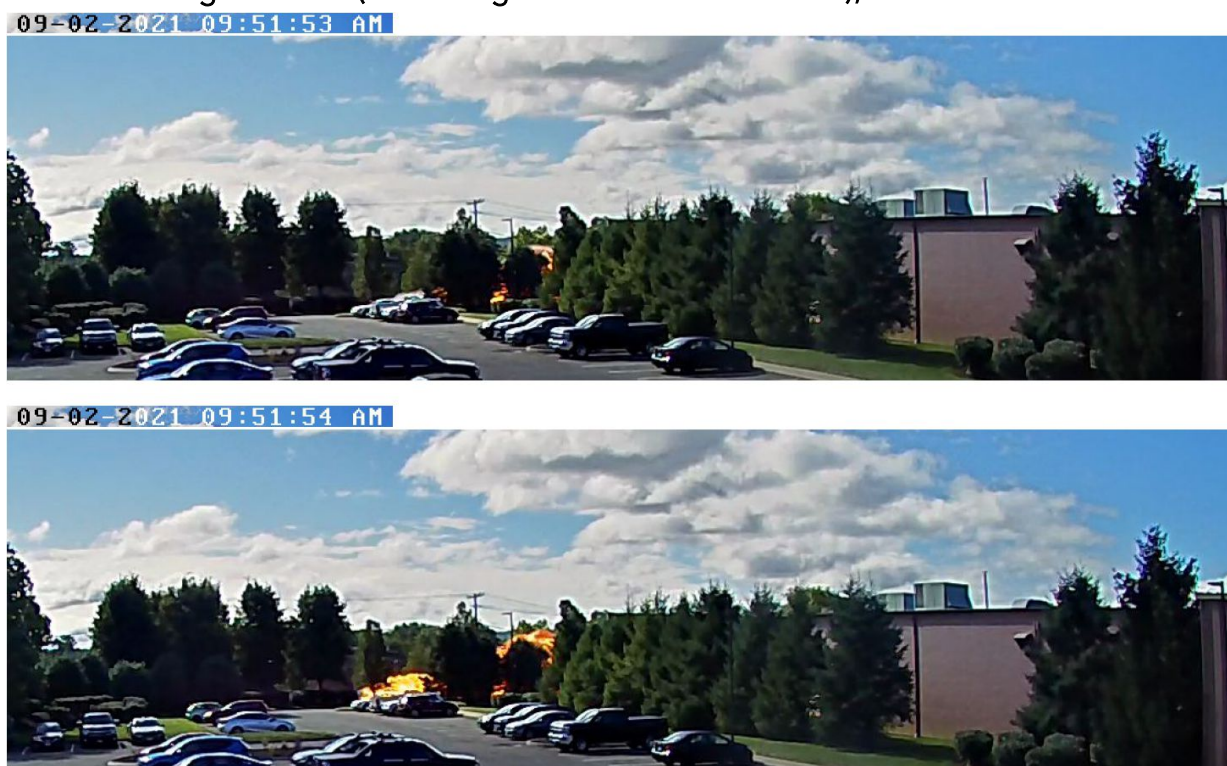
## "Office Parking" Camera (N560AR ground contact evidence), Attachment 8

Figure 7: Cropped and enlarged image sequence extracted from "Office Parking" surveillance camera recording. Ground contact evidence is visible in the center of each image.
