## **NATIONAL TRANSPORTATION SAFETY BOARD**

### **Specialist's Factual Report**

# **METEOROLOGY**

ERA21FA354

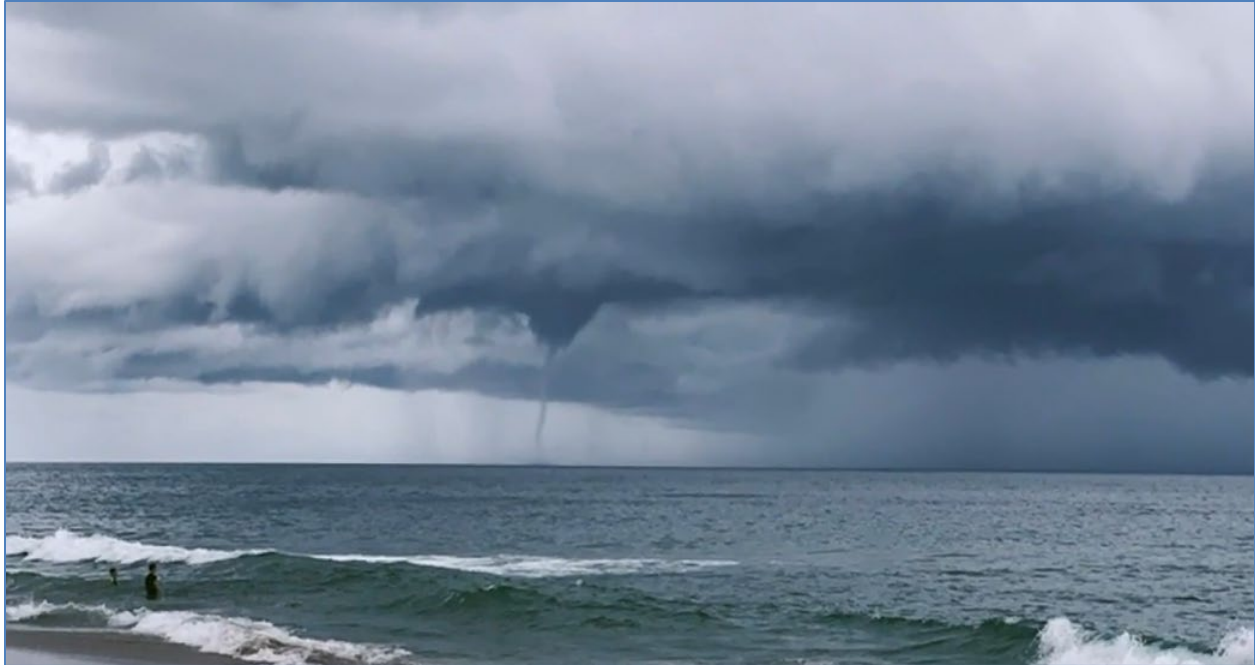
A waterspout was photographed at approximately 1520 EDT off the coast of Cape Cod on September 9, 2021, near Duck Harbor in Wellfleet, MA (figure 25). According to the witness the waterspout occurred prior to heavy rain moving over the area and lasted several minutes before dissipating. The image below is the photograph looking southward.

**Figure 22 - Waterspout photographed near Duck Harbor around 1520 EDT.**
