## Air Safety Investigations Aircraft Incident/Accident Technical Report

| <b>Aircraft Incident/<br/>Accident Information</b> | Year: 1977 | Make: Beechcraft | Model: C23 |
| | Serial number: M-1902 | | Registration: N3342L |
| Senior Air Safety Investigator: Peter J. Basile | | Report #: ASI-21-CQ-T | Report date: 01-03-22 |

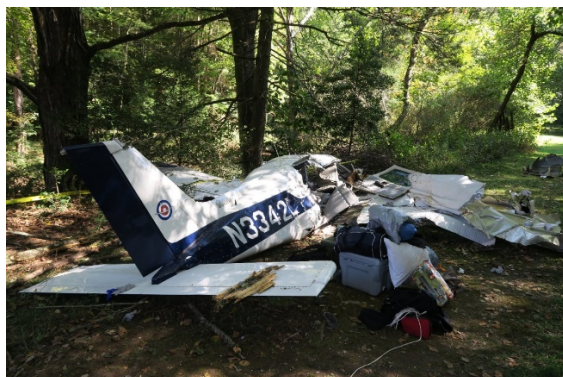
On-site, ASI-21-CQ-008

The aircraft descended through trees in a left-wing-low, nose-down flight attitude. The right wing struck a large tree and separated approximately 6' of the outboard right wing including the right aileron. The inboard portion of the right wing remained attached to the fuselage. The right flap remained attached to the wing. The right main landing gear was impact fractured and found under the left wing; it remained loosely attached to the airframe via the brake line. The left wing remained attached to the aircraft. The left aileron and left flap remained attached to the wing. The left main landing gear was impact fractured and found under the left wing.

The aircraft impacted soil and came to rest upright. The cabin sustained significant impact compression damage. The cabin floor was bent upward and aft; the cabin roof was compressed downward. The instrument panel was crushed and folded underneath the front of the aircraft. The engine came to rest inverted and pointed to the right. Several pieces of propeller cut tree limbs were observed at the site.

The left and right side of the tail cone exhibited impact related compression damage. The left and right stabilator remained attached to the tail. The leading edge of the left stabilator exhibited tree impact damage near the tip. The stabilator trim tab remained attached to the stabilator. The vertical stabilizer exhibited minimal impact damage at the dorsal. The rudder remained attached to the vertical stabilizer.

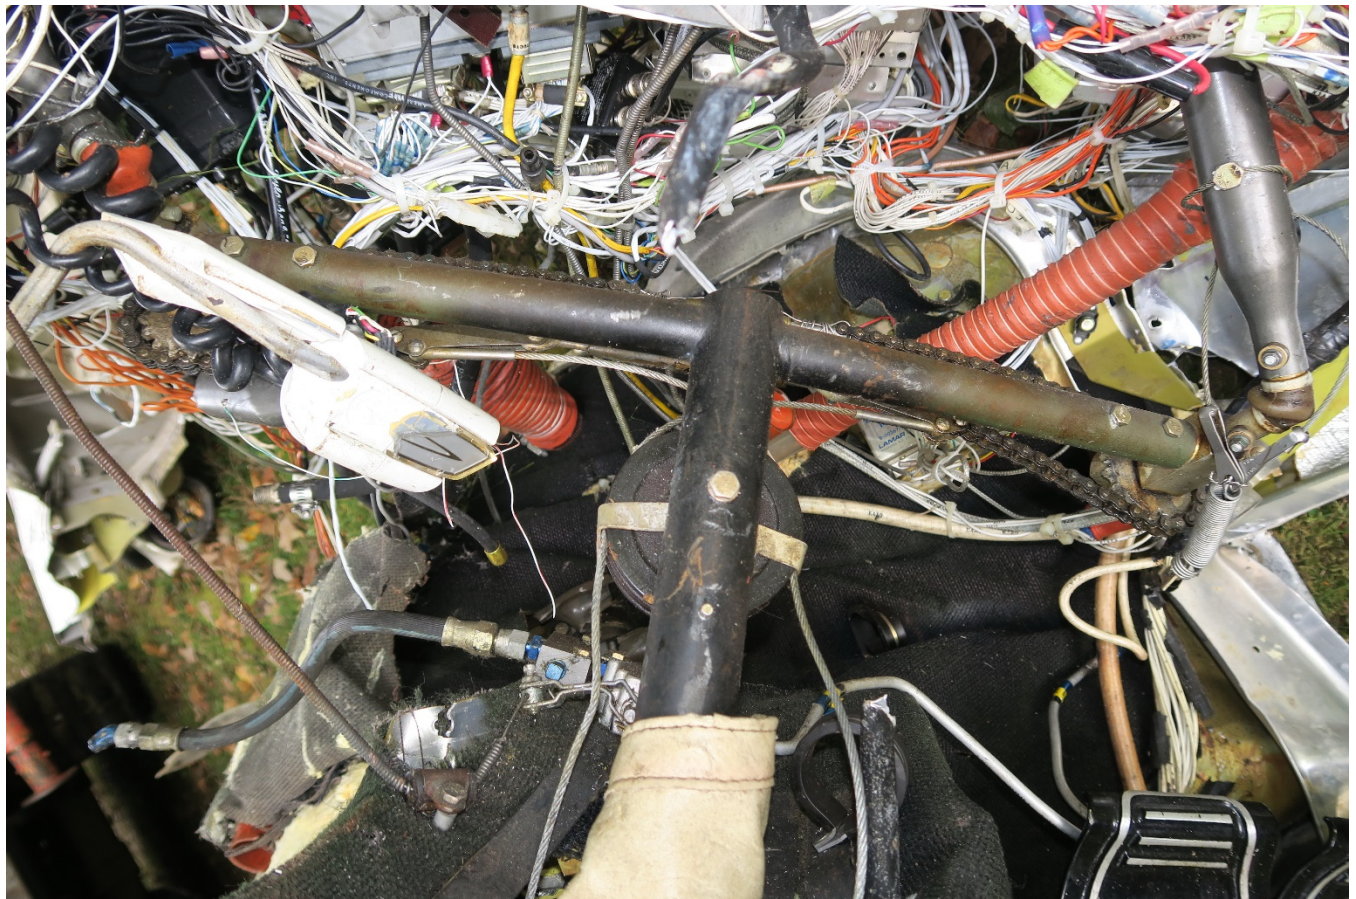
On-site, ASI-21-CQ-142

Flight control cable continuity was established for all flight controls. The left and right aileron cables were continuous from the bellcrank to the control column. The rudder and stabilator cables were continuous from the tail to the rudder torque tubes and the control column. The stabilator trim cables were continuous from the tail to the forward cabin floor assembly.

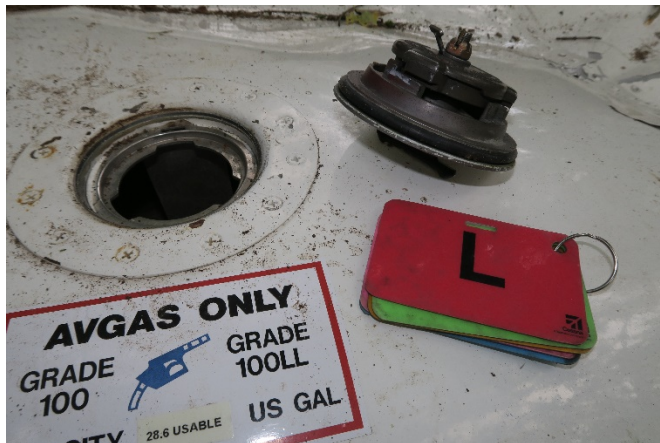
On-site, ASI-21-CQ-105

The left and right fuel cap remained attached to their respective wings. Both fuel tanks were breached.

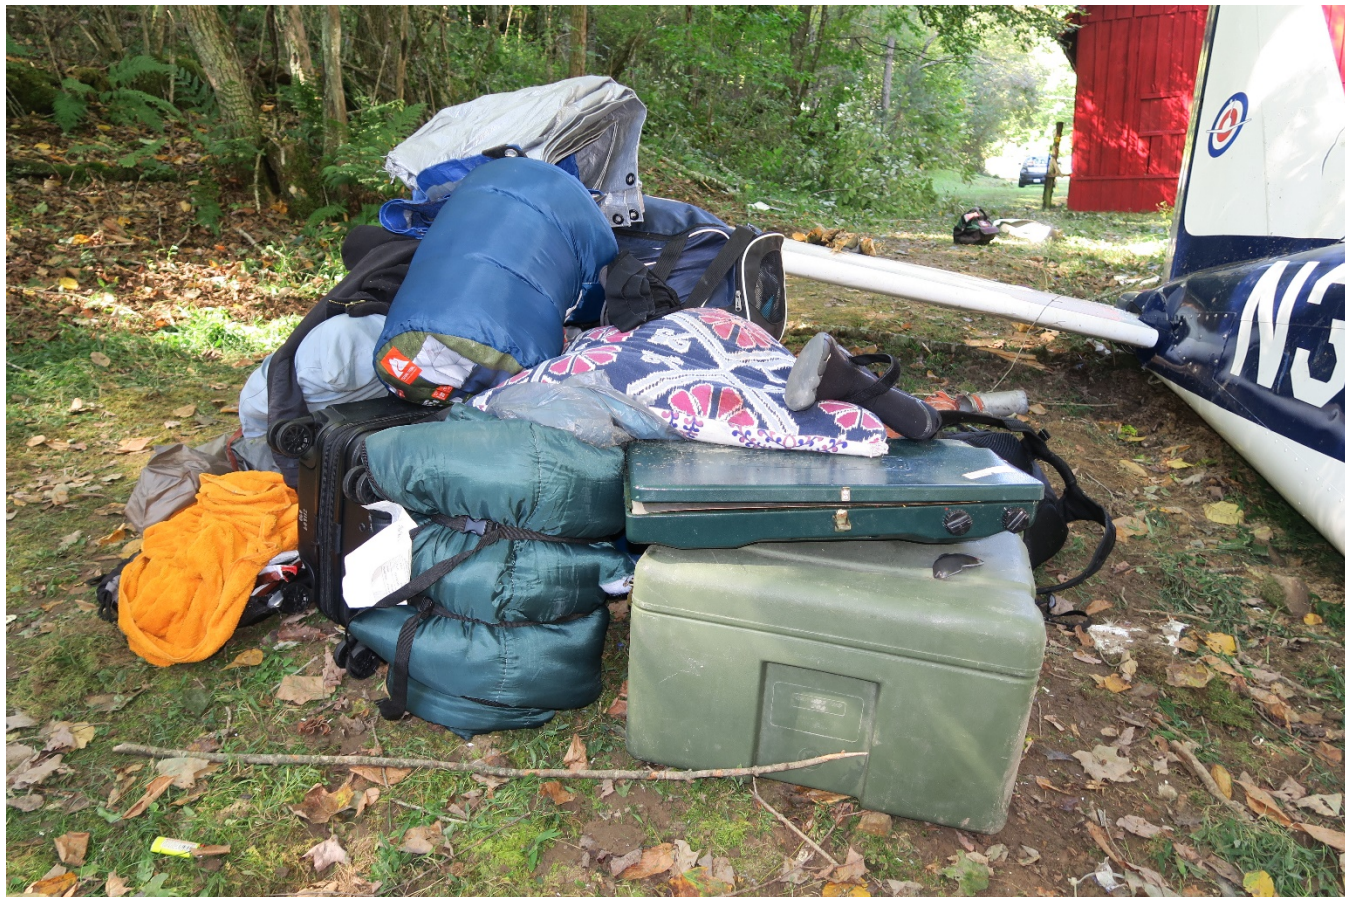
On-site, ASI-21-CQ-032

The camping gear found in the aircraft was weighed using a household bathroom scale. The total cargo weighed 252.8 lbs.

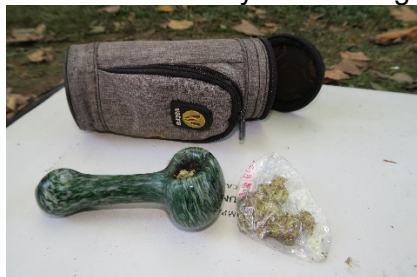
On-site, ASI-21-CQ-061

There were two marijuana pipes found in the personal effects. One was found by first responders, the other was found by the investigative team and turned over to the police.
