**Photo 1 – Airplane at Accident Site (courtesy FAA)**

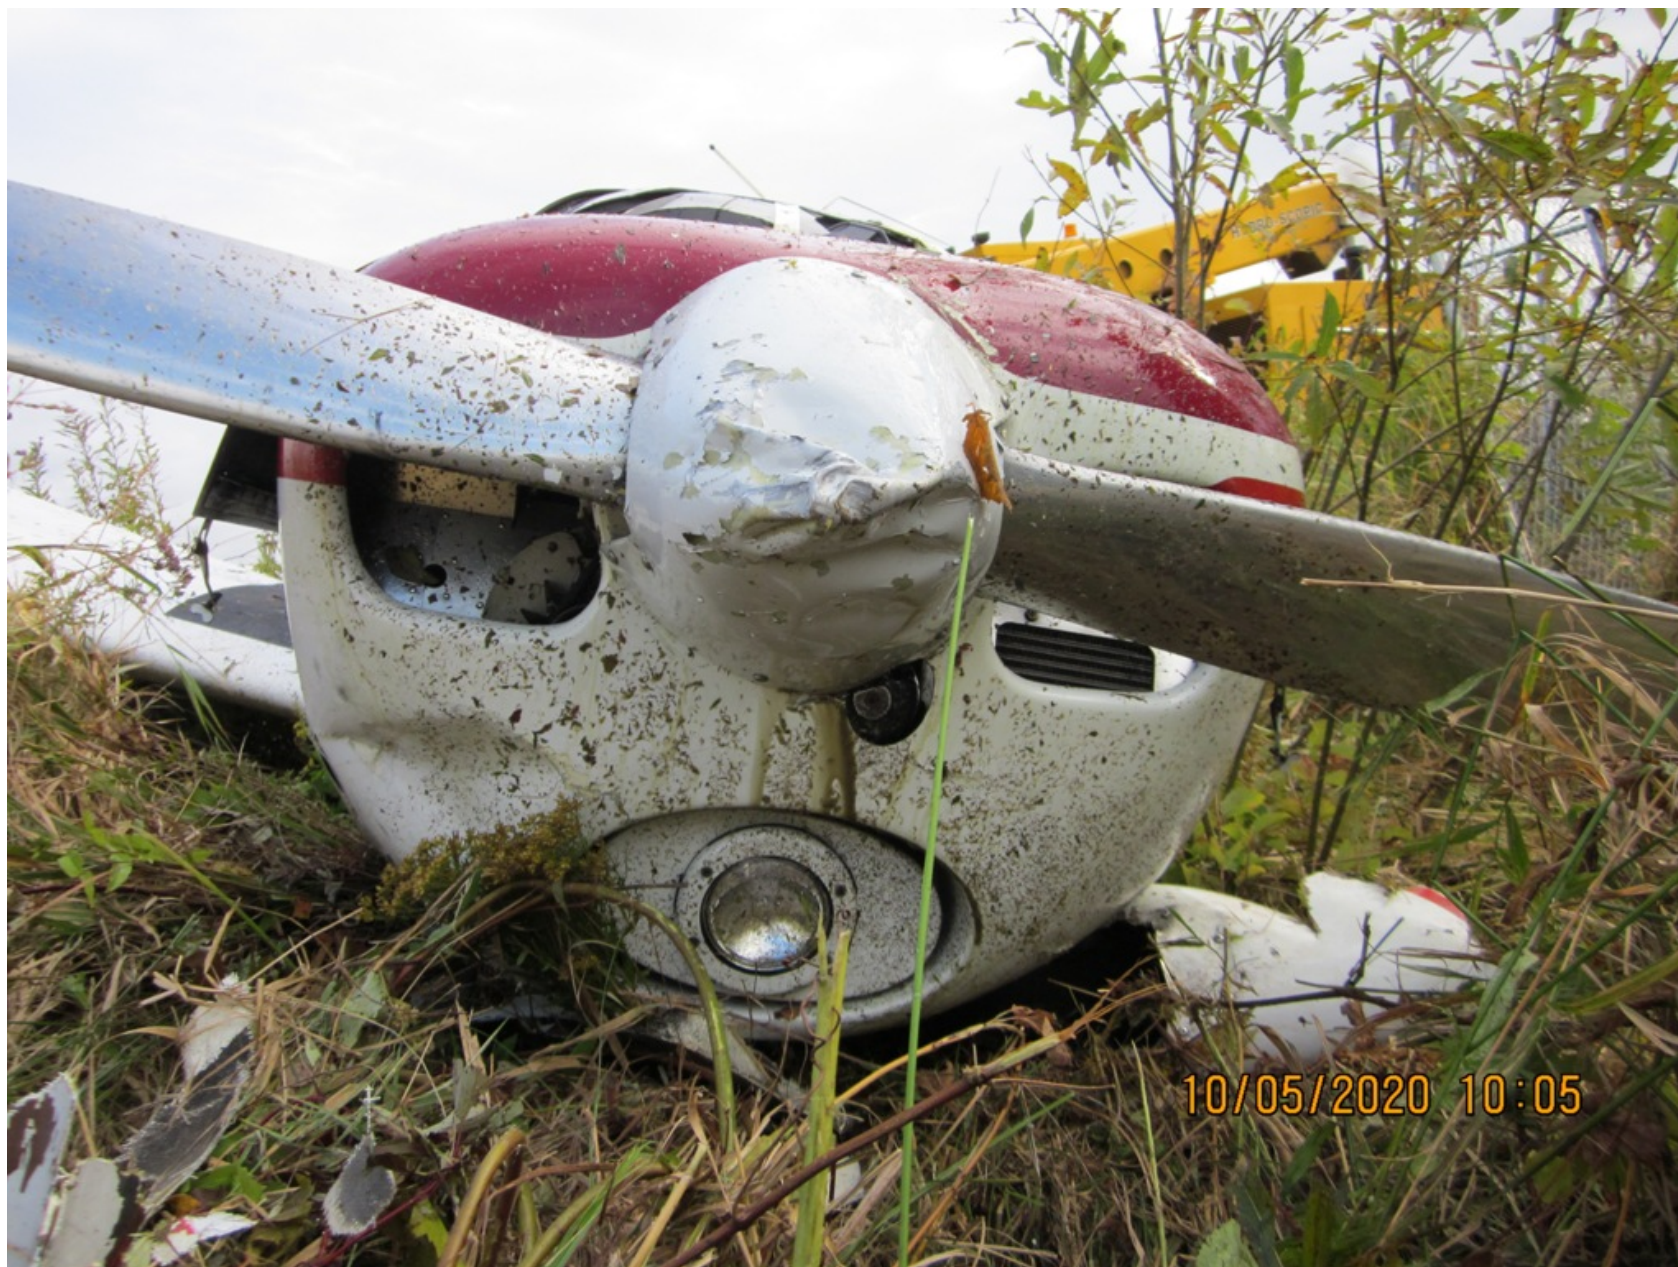
**Photo 2 – View of the Oil Leak at Nose Cone (courtesy FAA)**

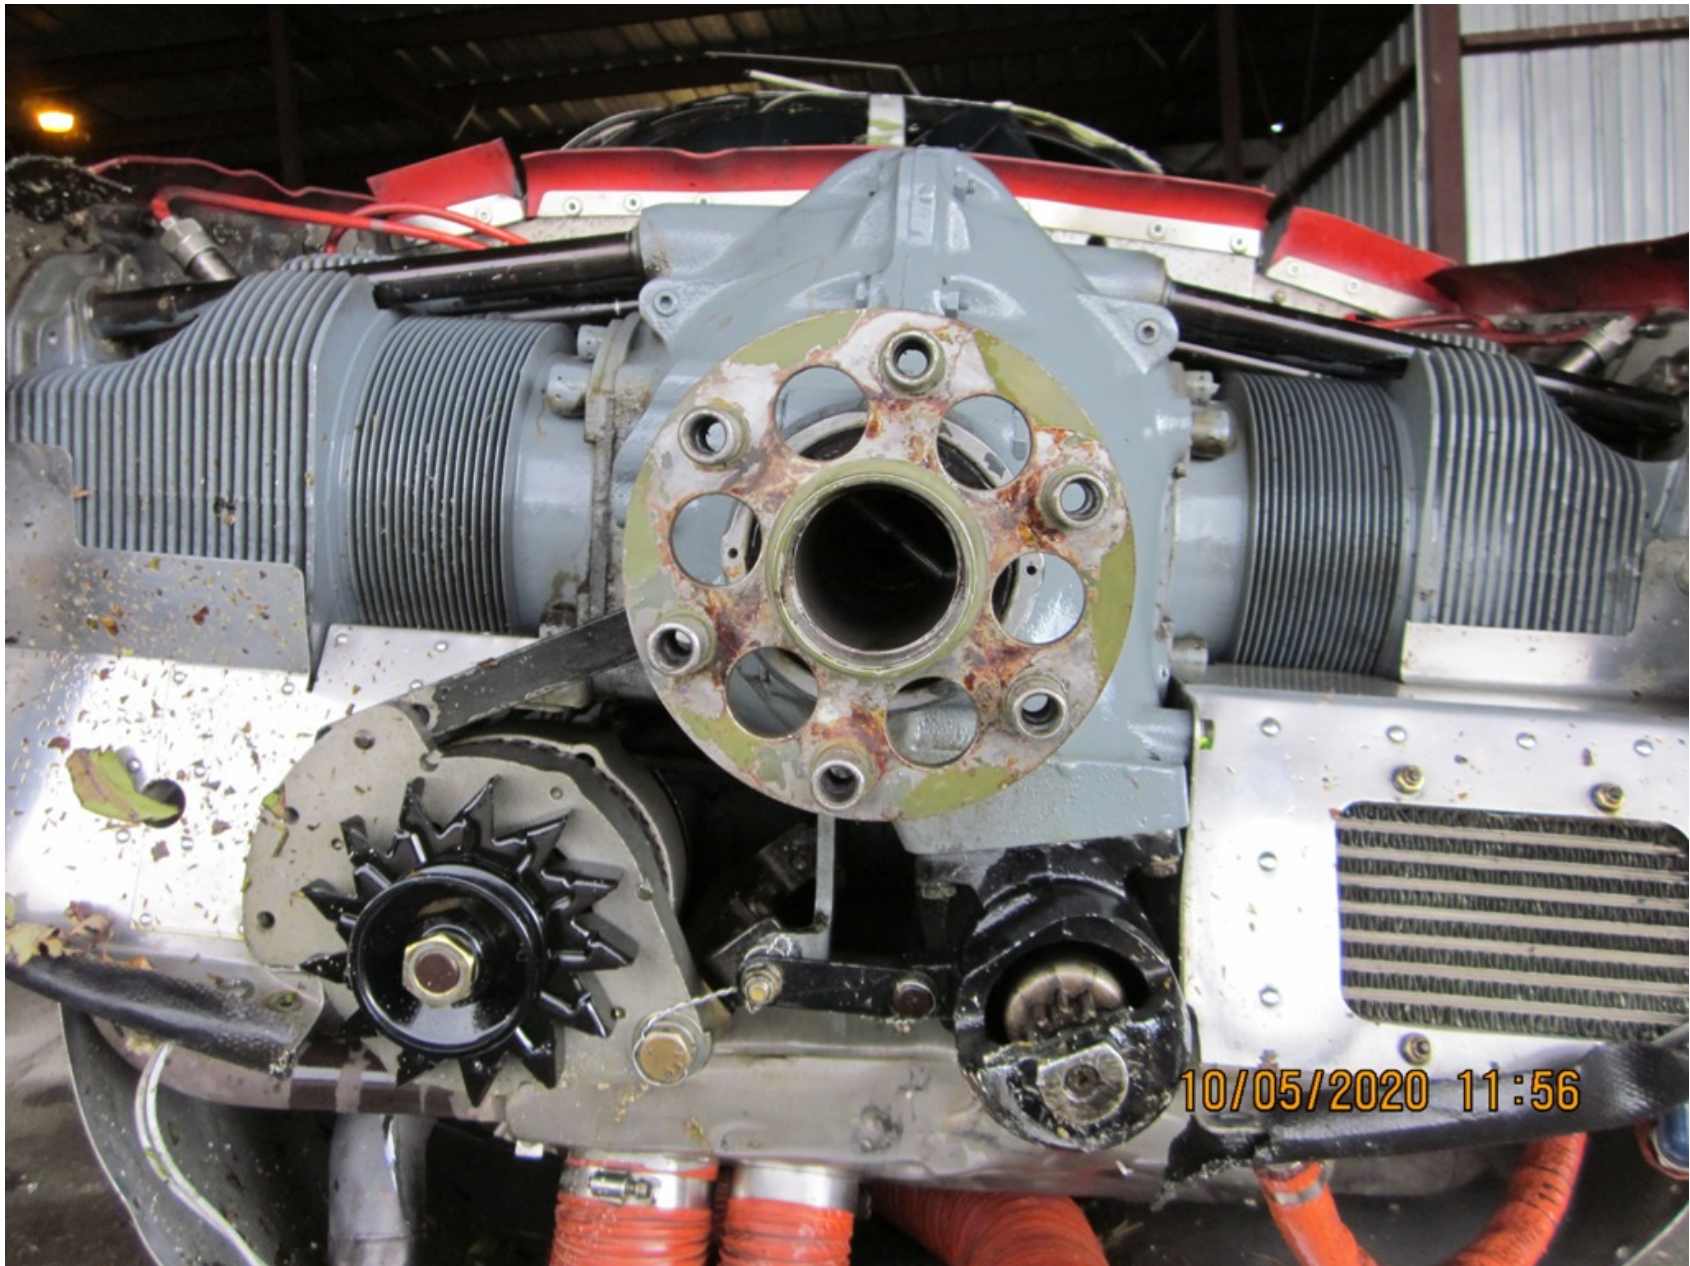
**Photo 3 - View of Crankshaft with Crankshaft Plug Missing (courtesy FAA)**

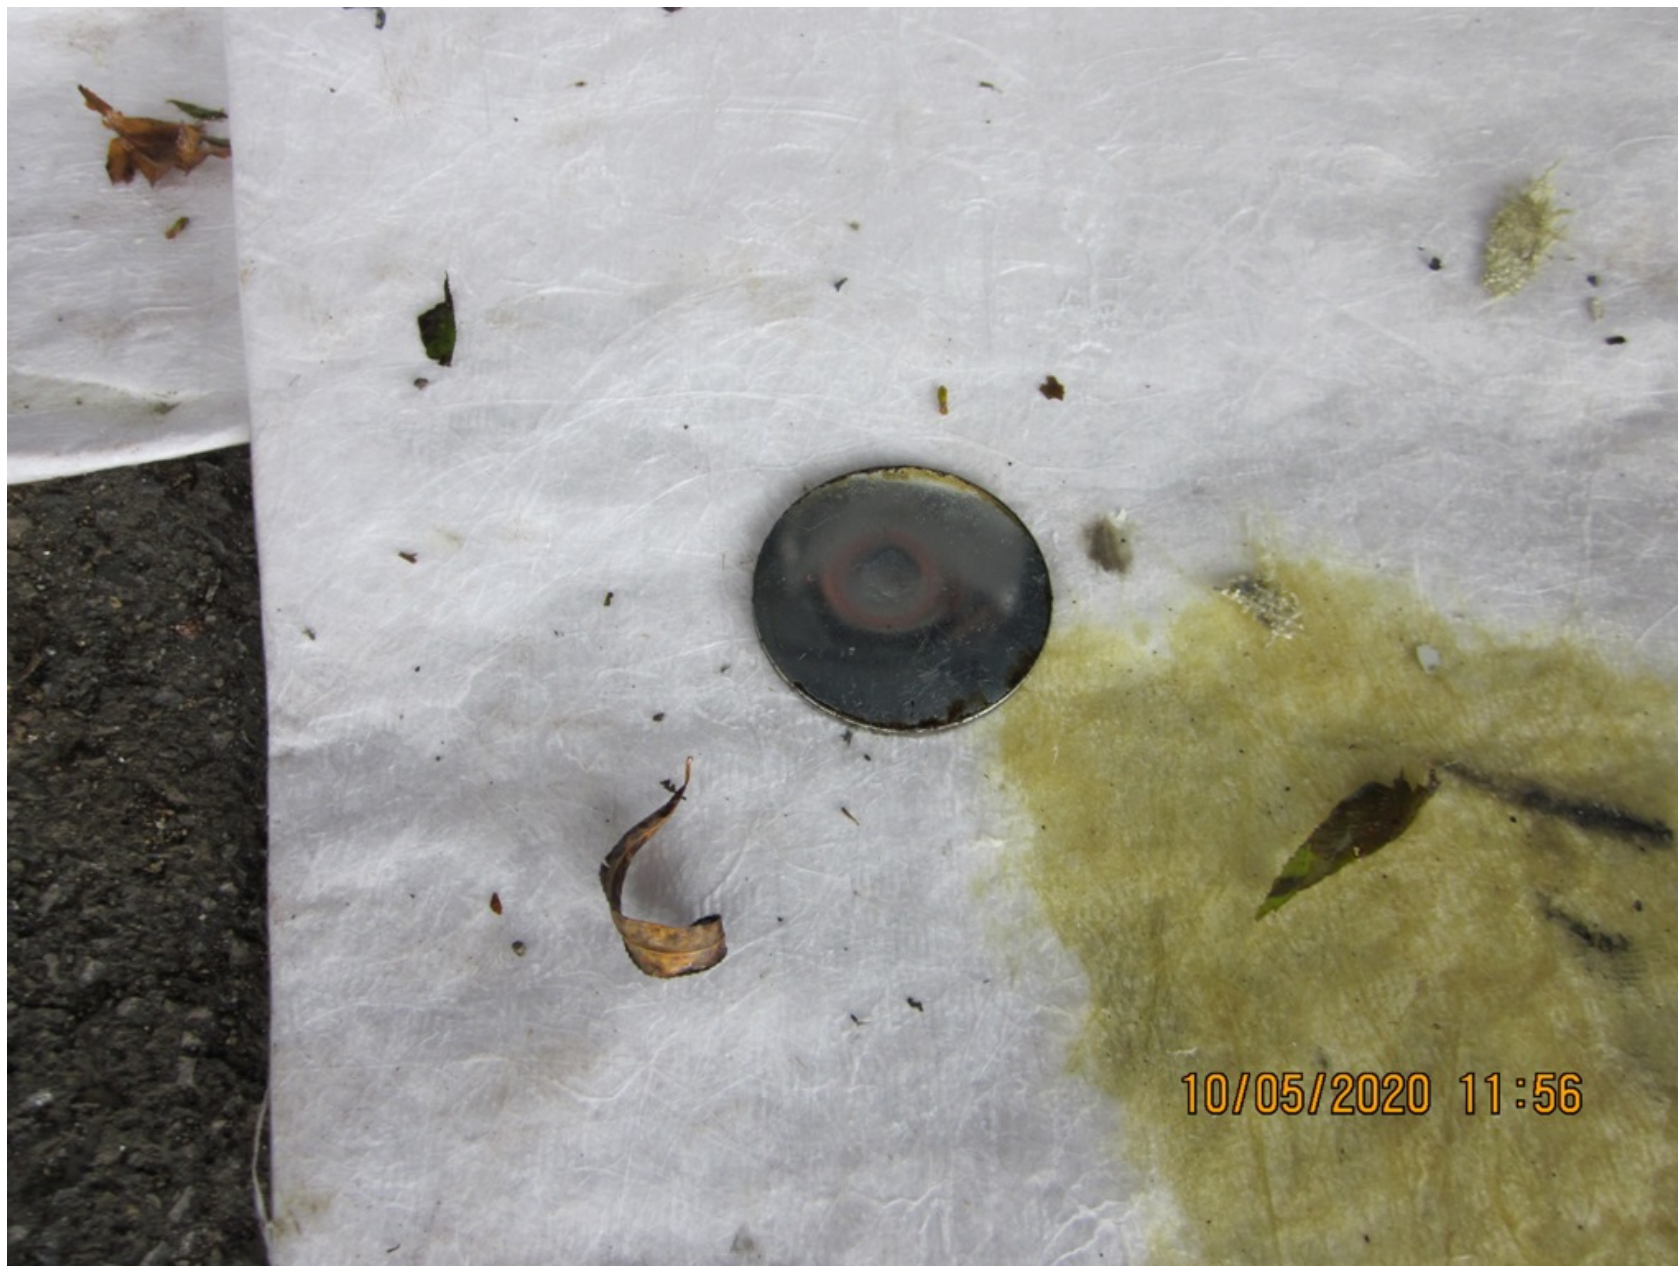
**Photo 4 – Crankshaft Plug (courtesy FAA)**
