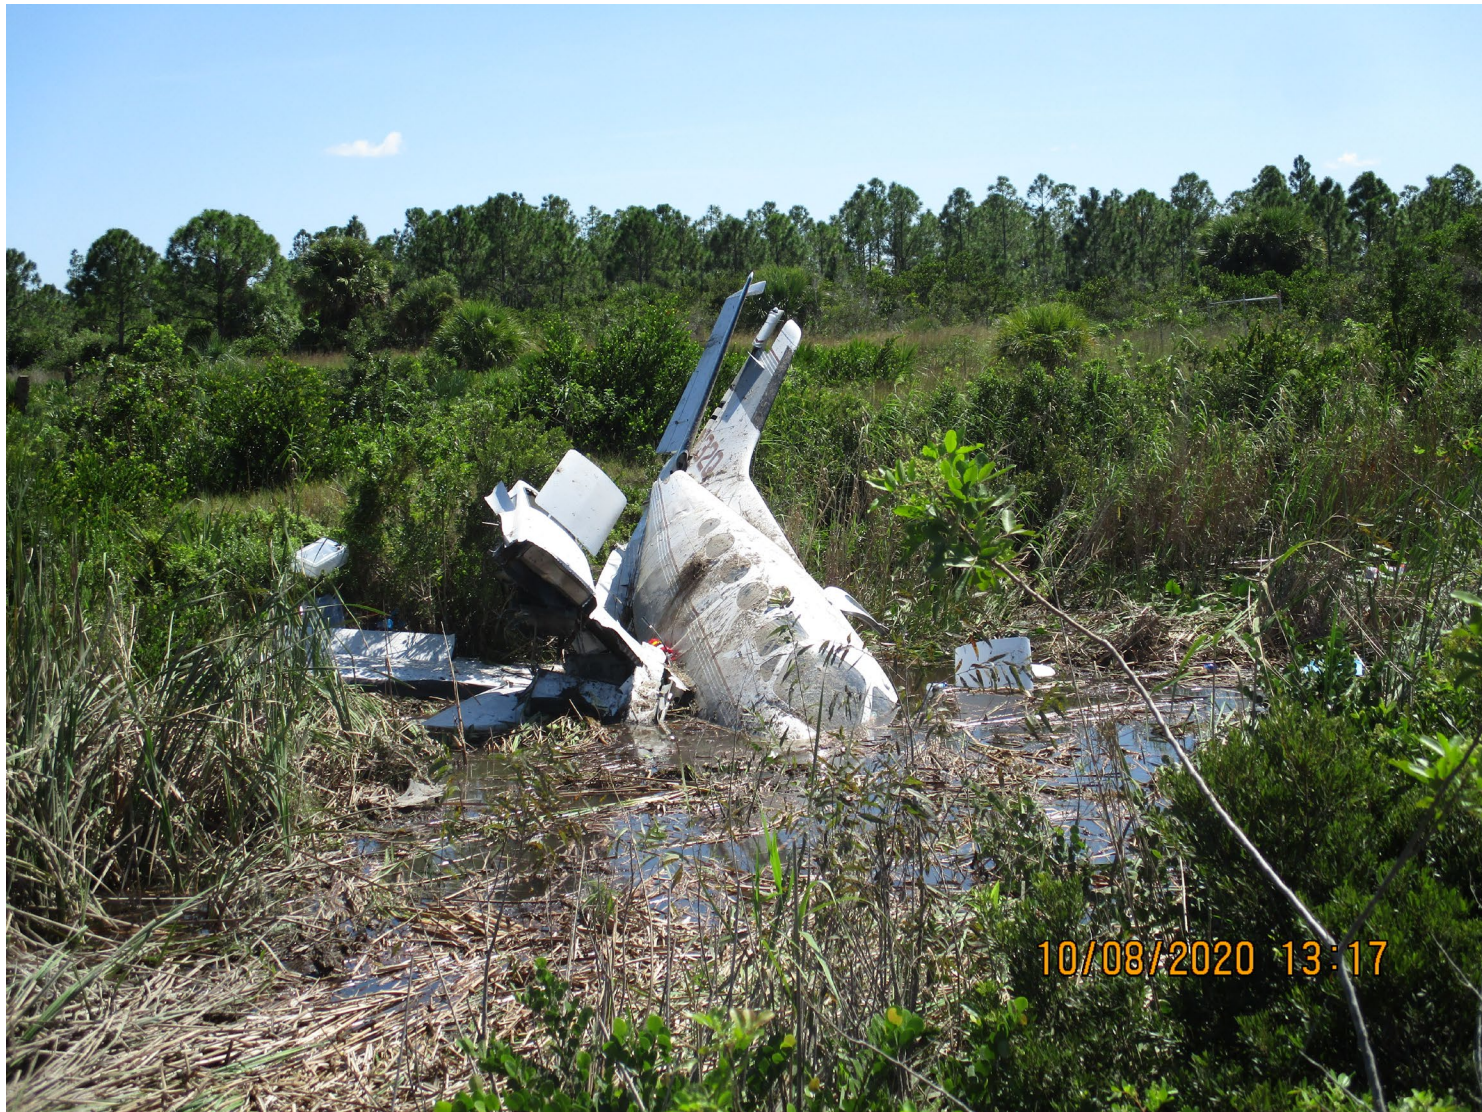
**Photo 1 – Overall view of airplane wreckage partially submerged in water. (Courtesy of FAA)**

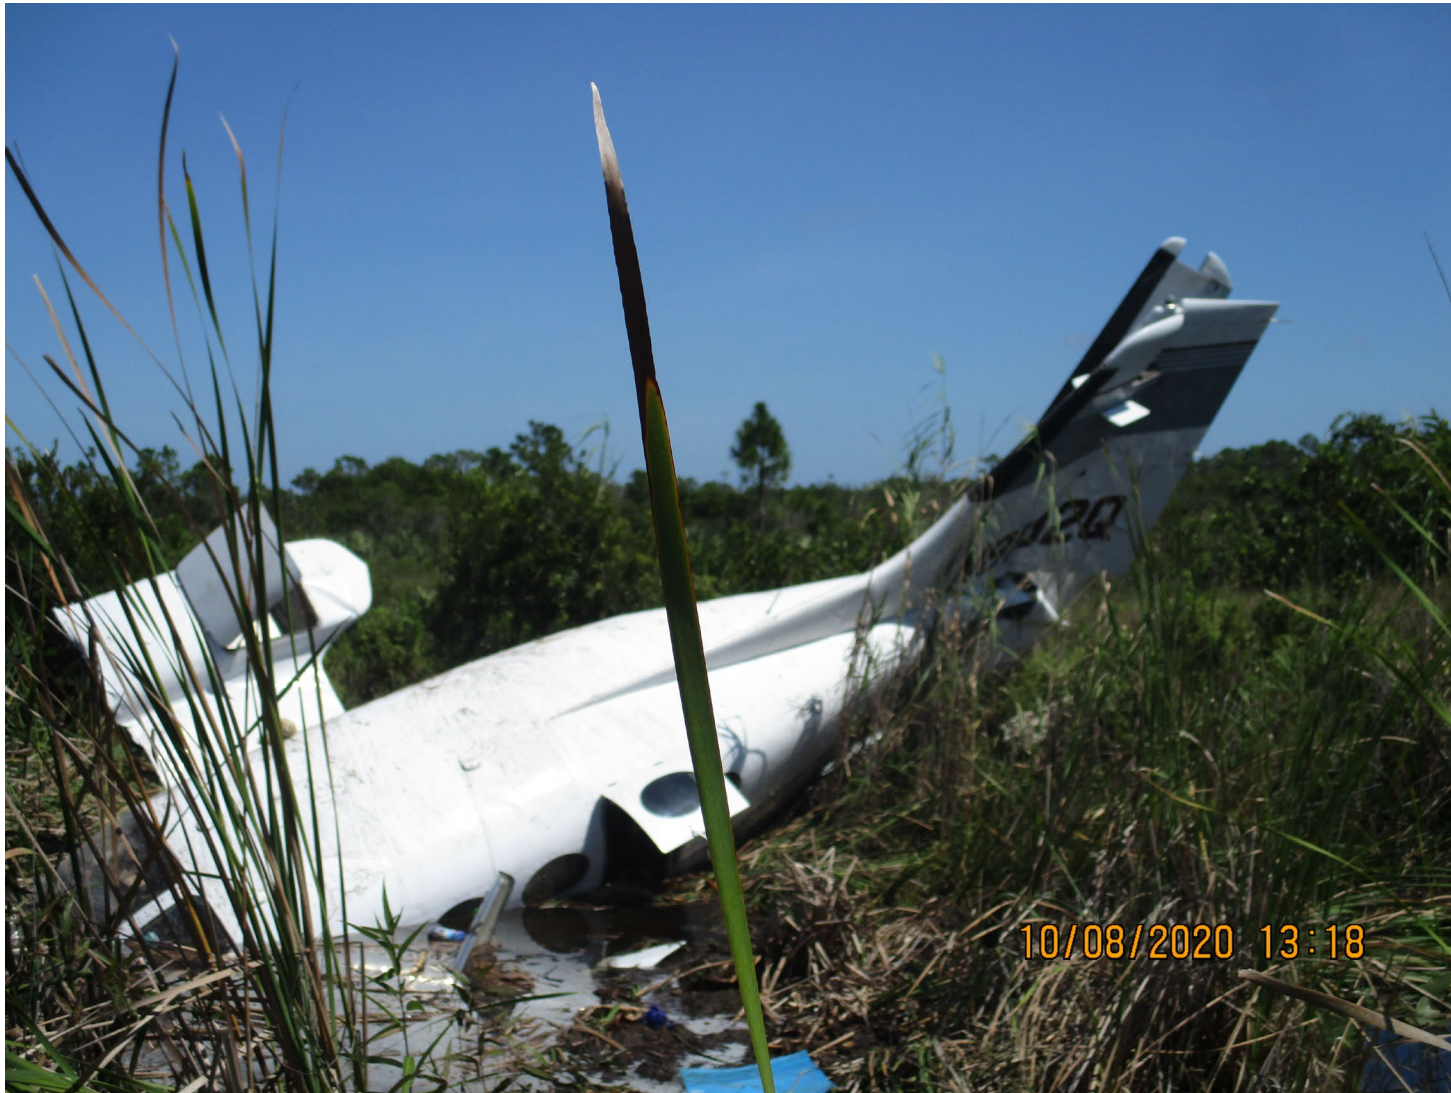
**Photo 2 – Left side view of airplane wreckage partially submerged in water. (Courtesy of FAA)**

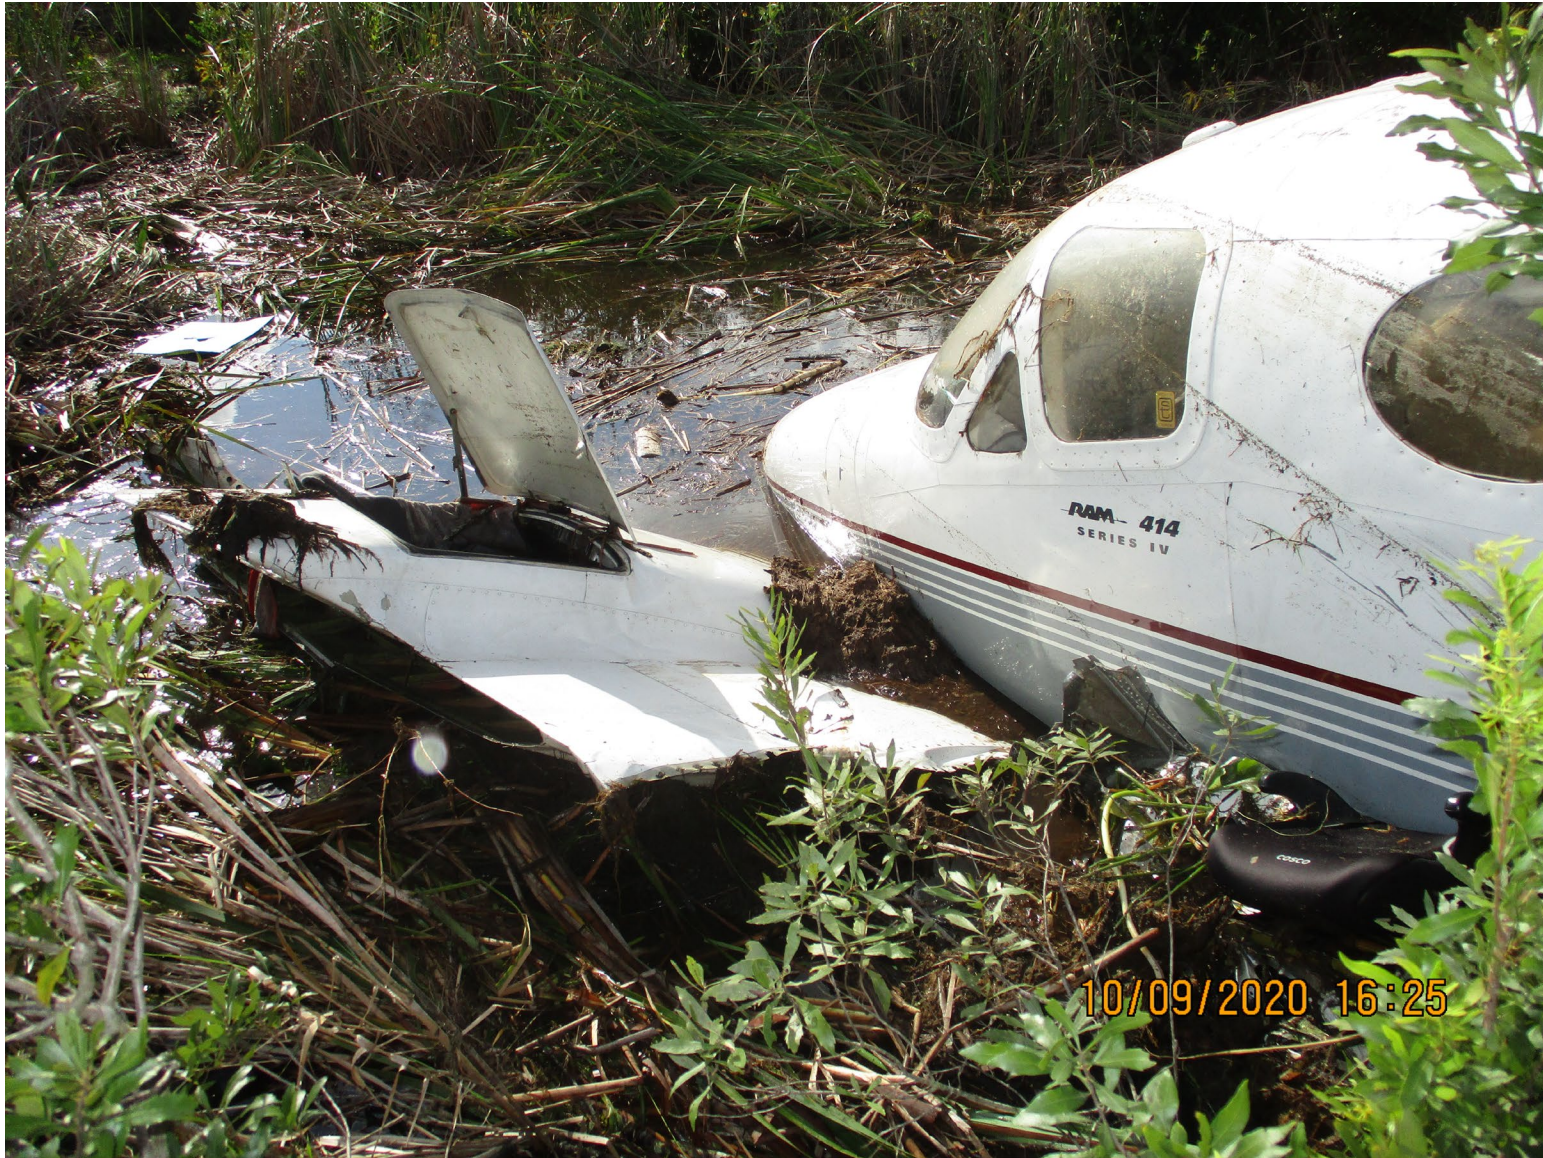
**Photo 3 – Closeup of left side of airplane resting in water. (Courtesy of FAA)**

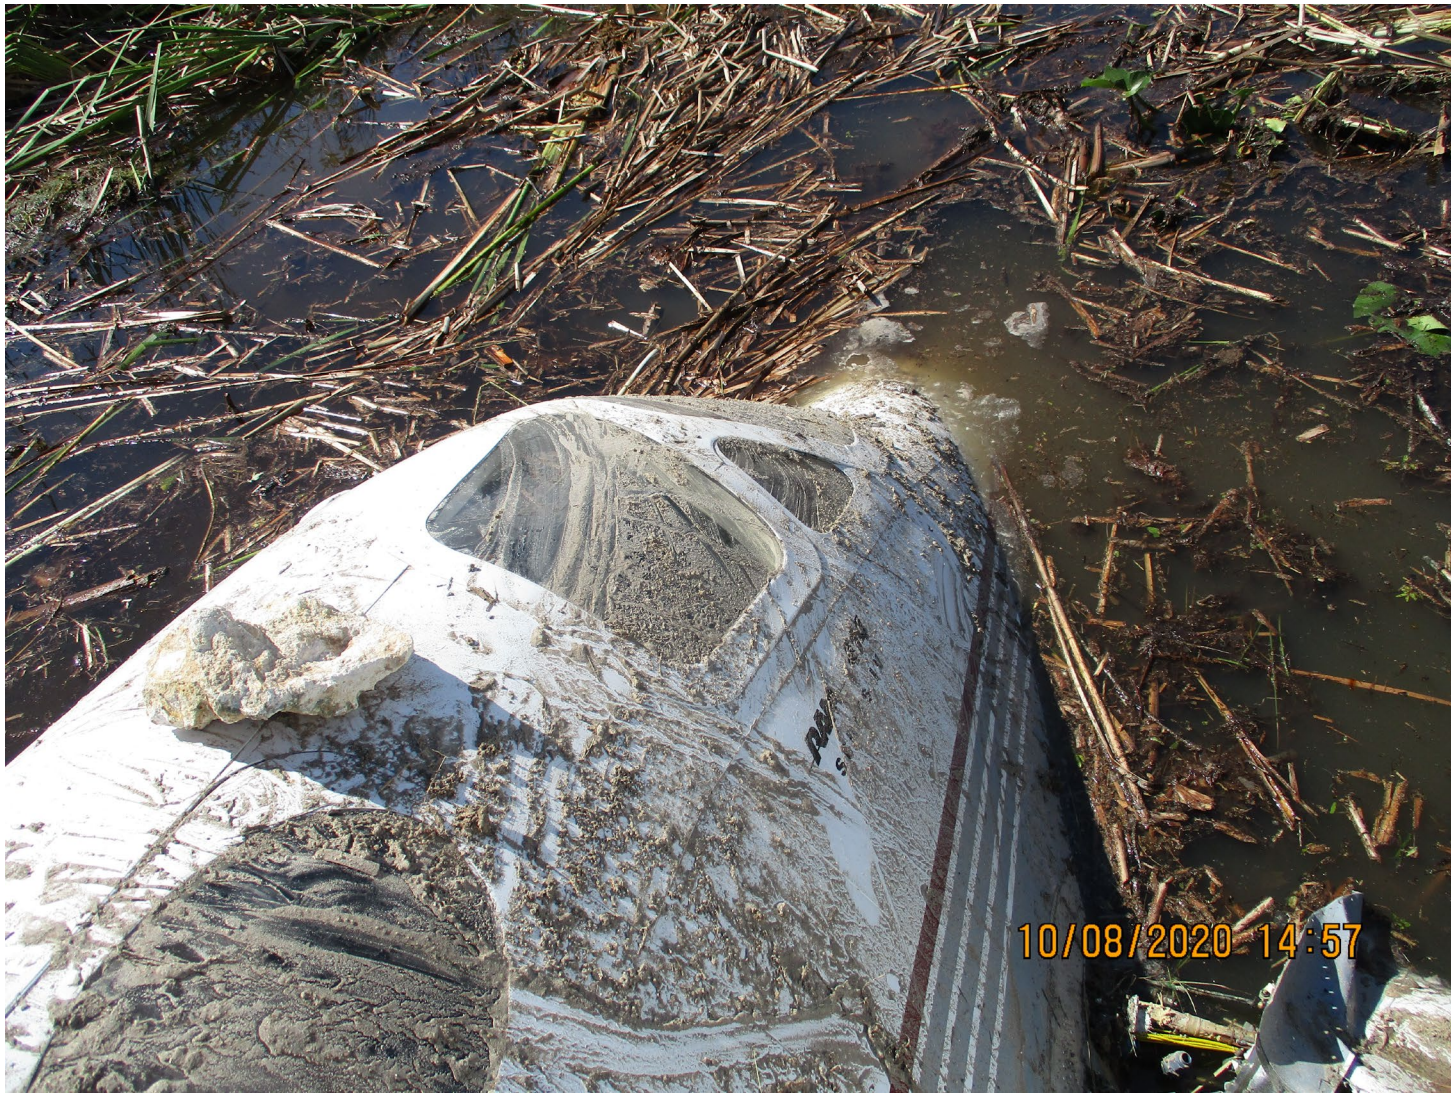
**Photo 4 – Right forward view of airplane wreckage partially submerged in water. (Courtesy of FAA)**

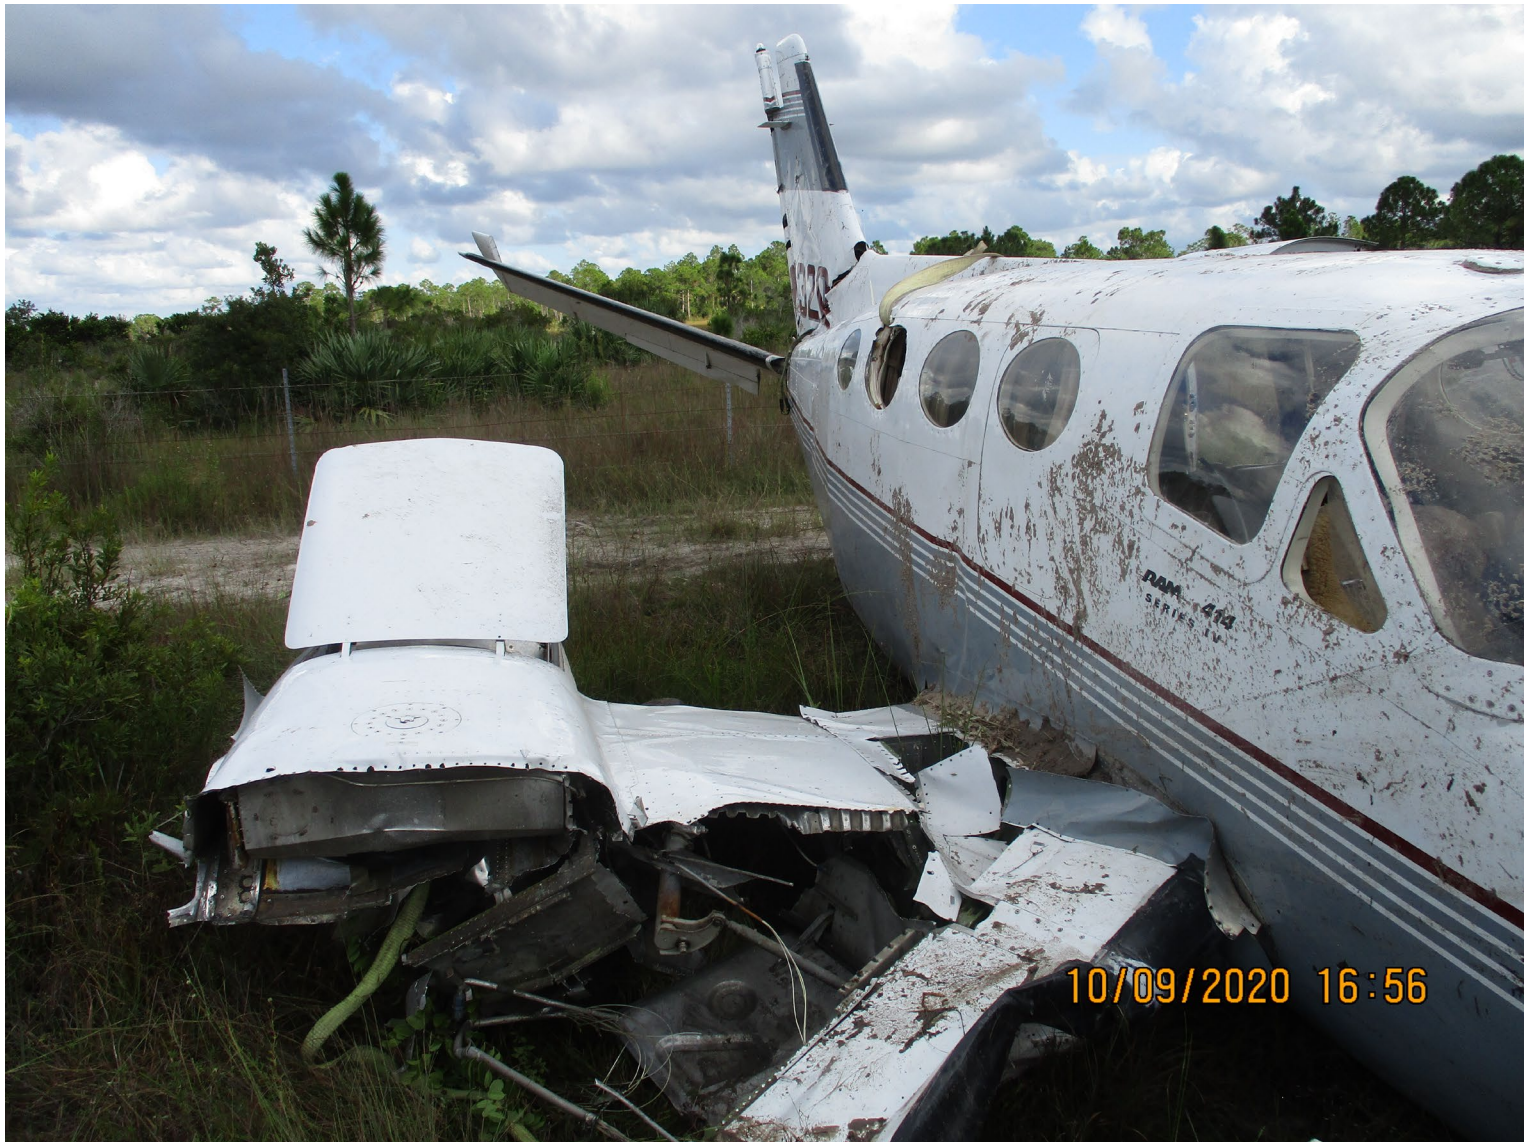
**Photo 5 – View of right side of airplane damage after partial recovery from water. (Courtesy of FAA)**

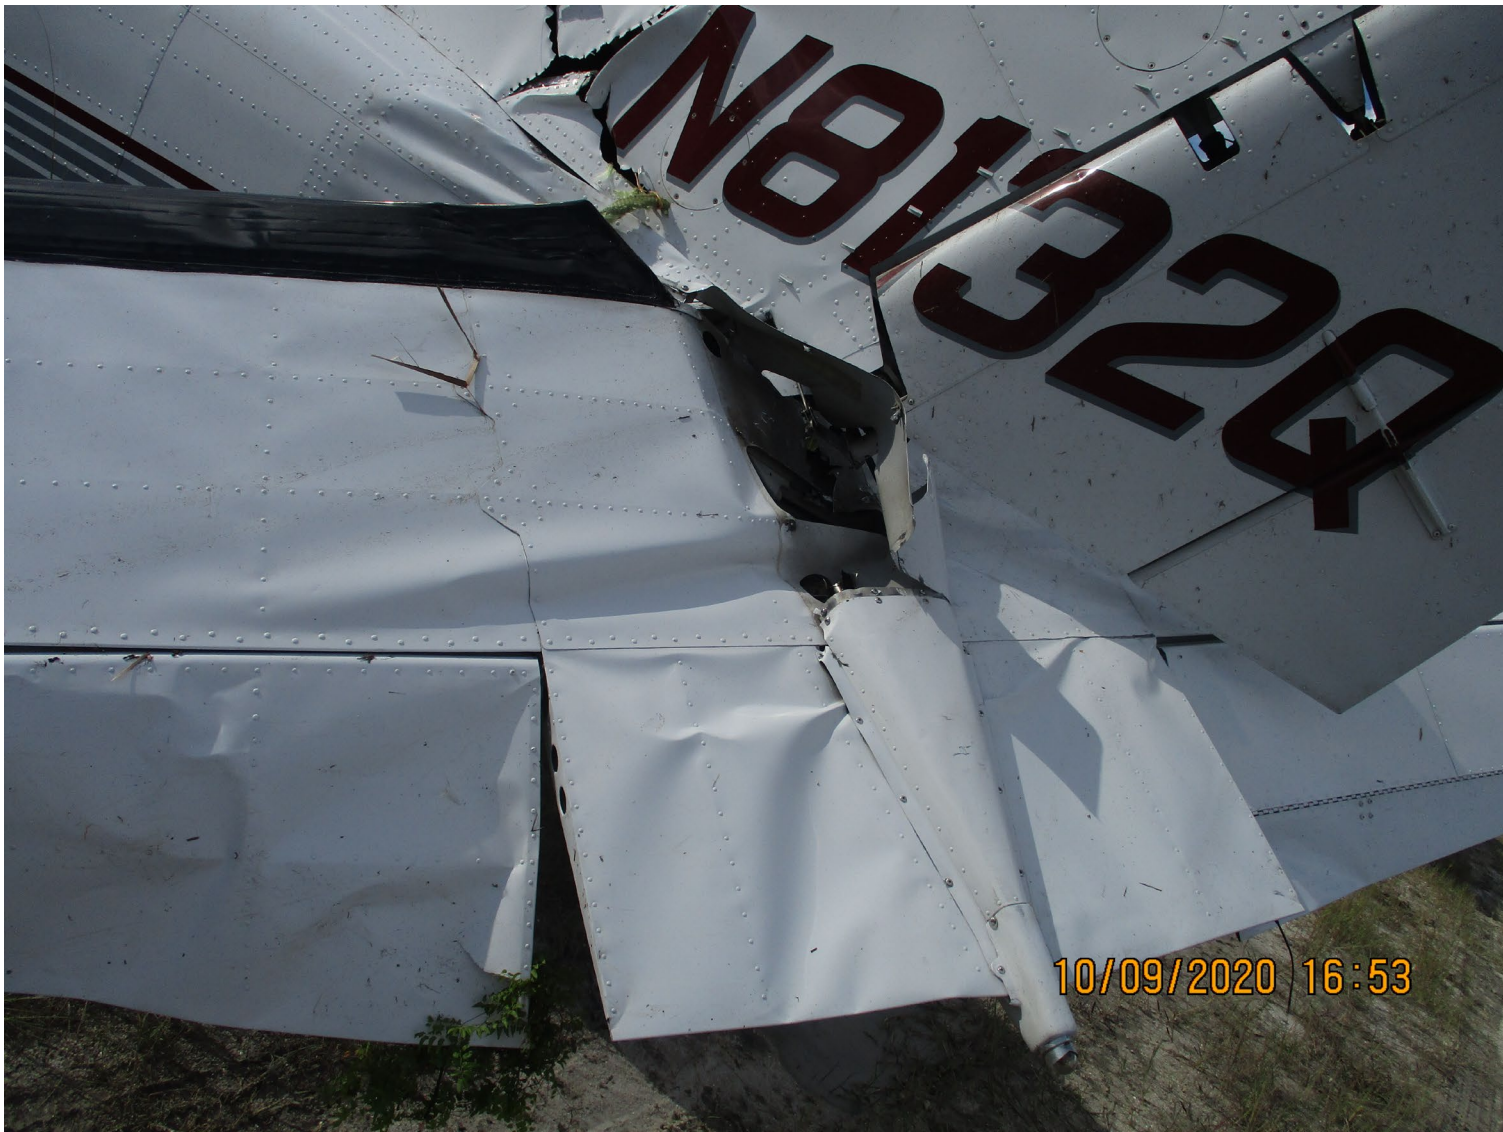
**Photo 6 – View of left side of rudder and elevator damage. (Courtesy of FAA)**

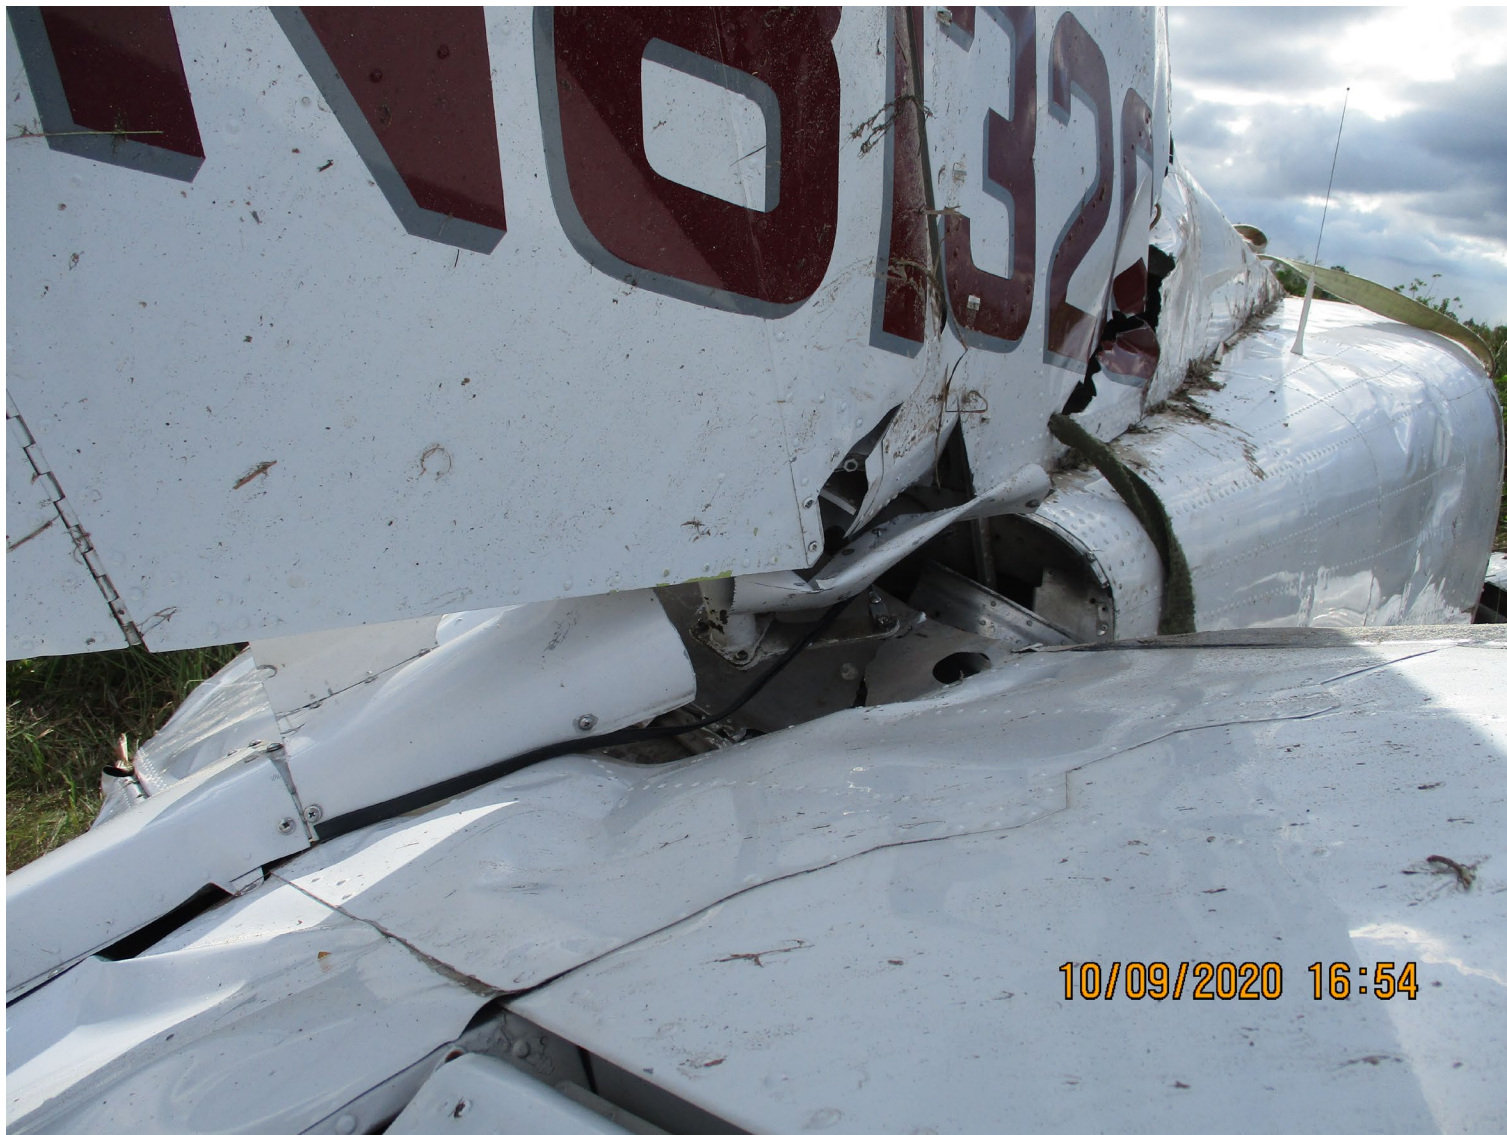
**Photo 7 – View of damage to the right-side vertical stabilizer and elevator. (Courtesy of FAA)**

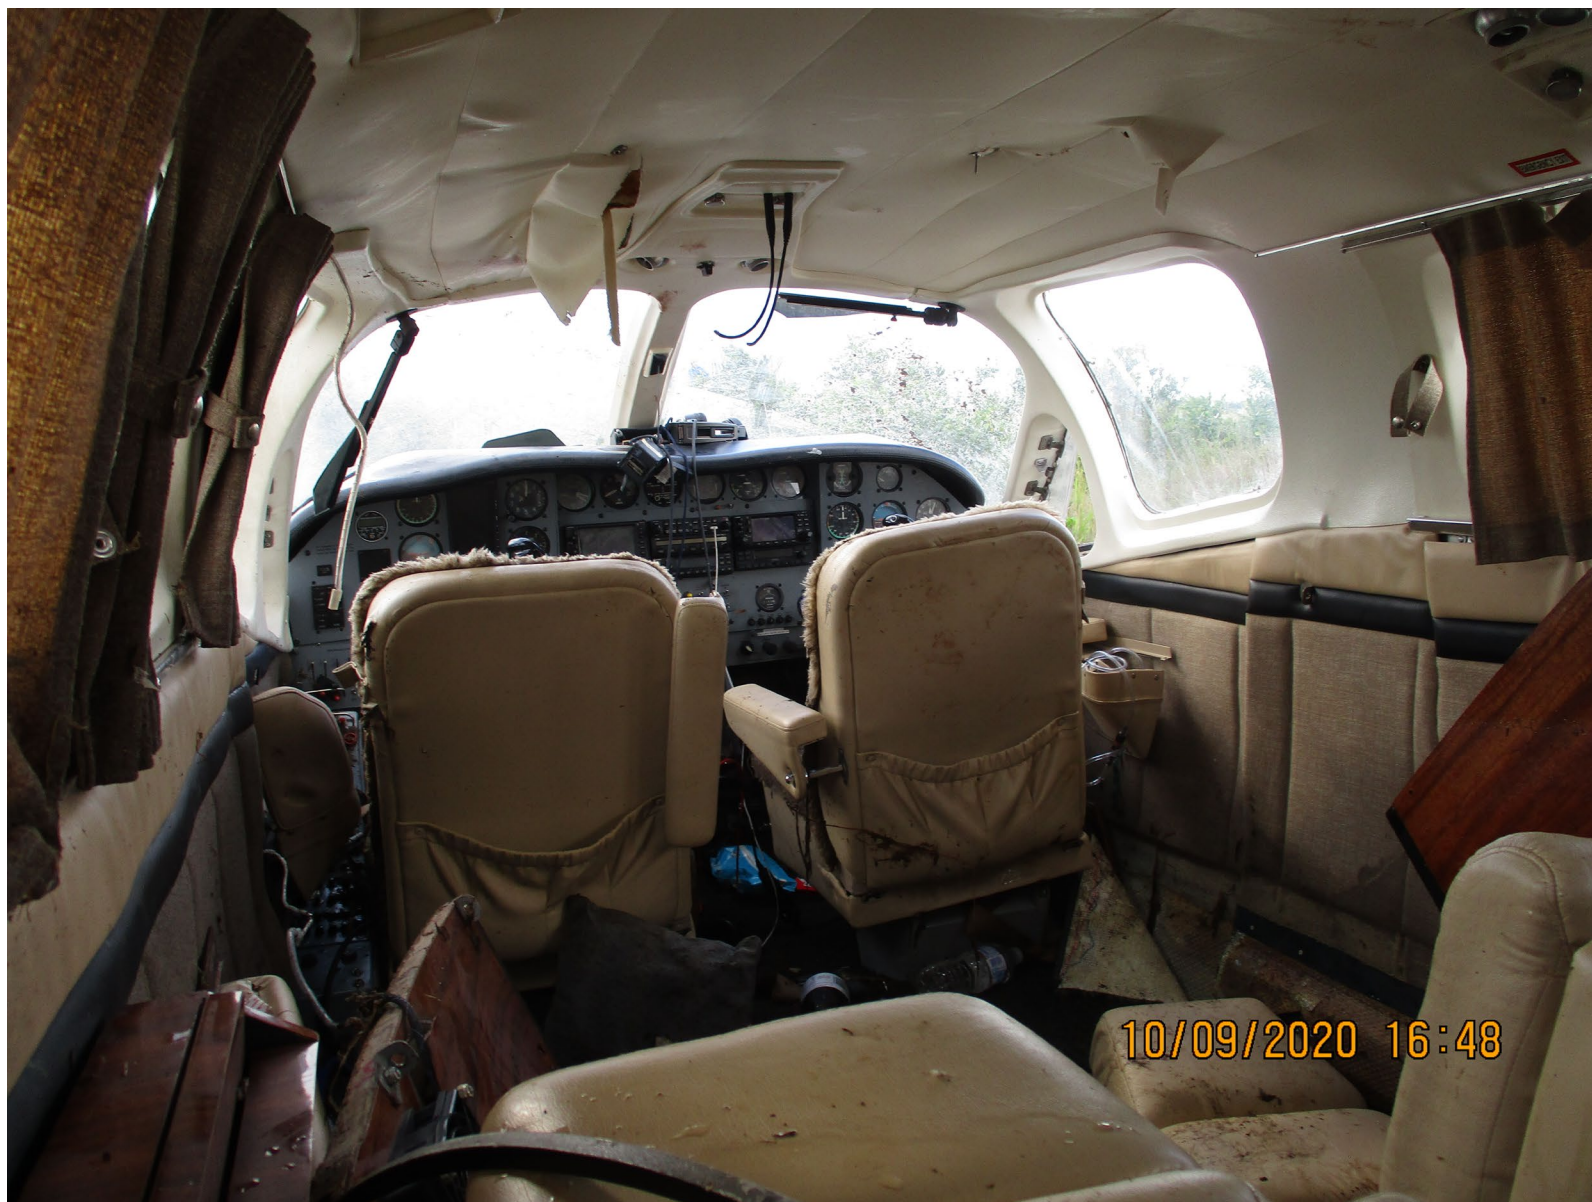
**Photo 8 – View of cockpit and cabin interior damage. (Courtesy of FAA)**

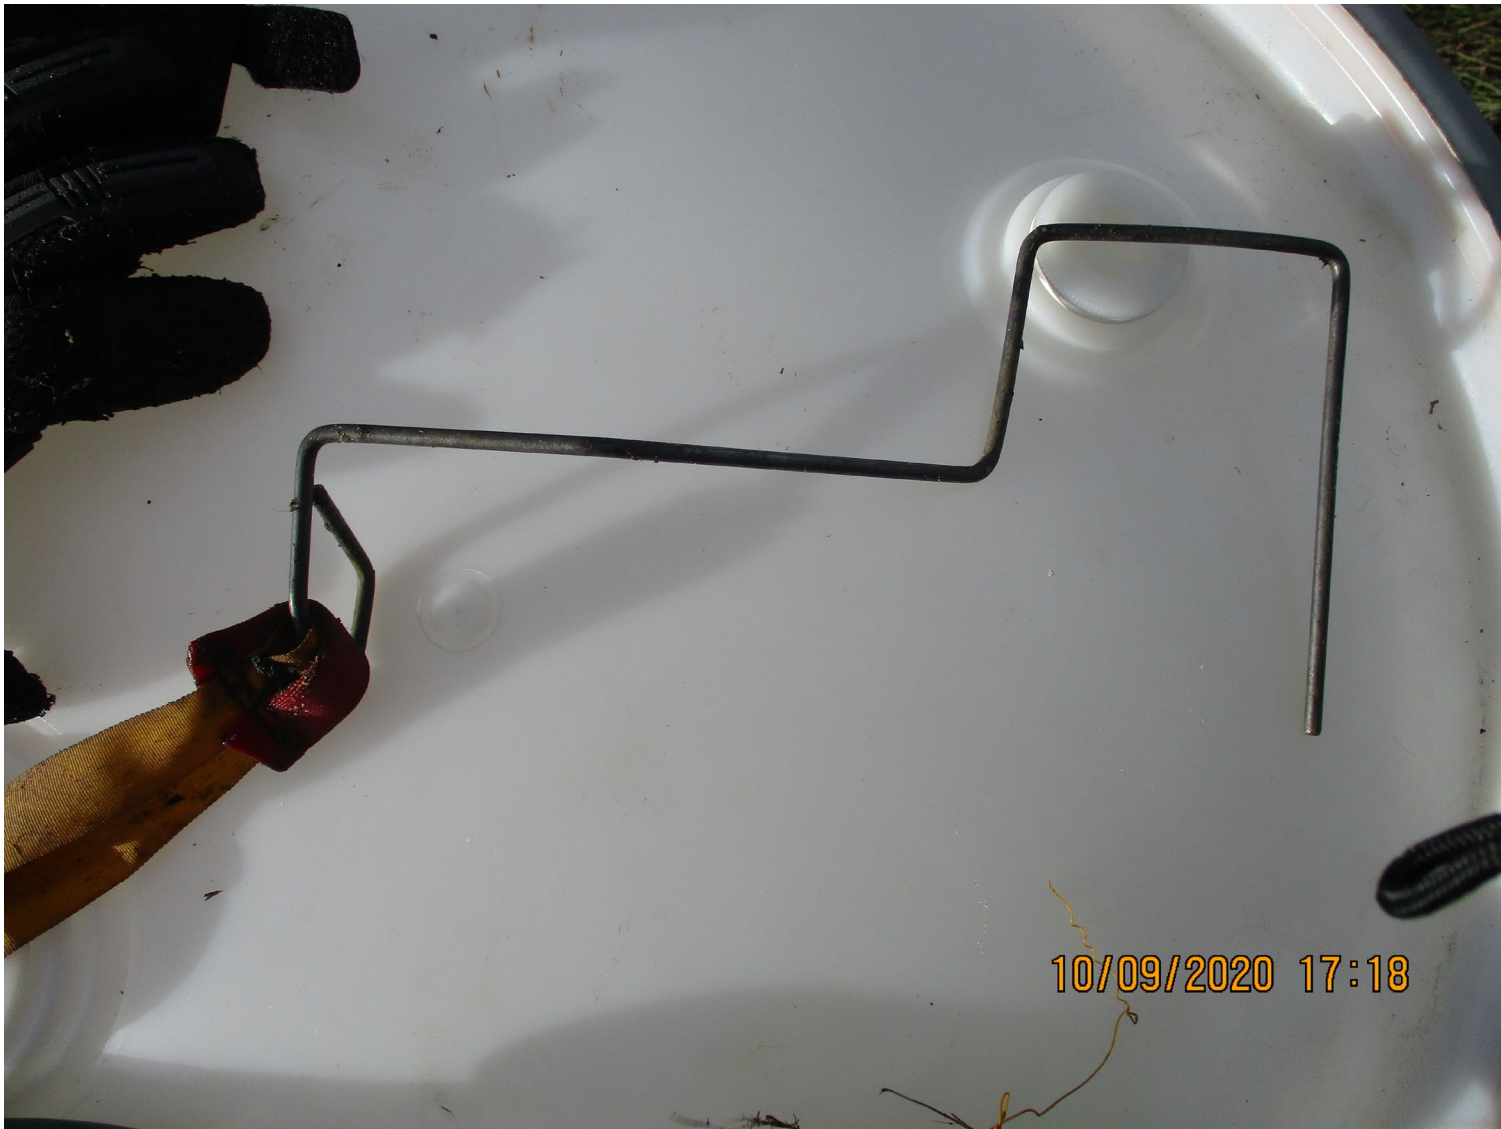
**Photo 9 – Photograph of control lock discovered on cockpit floor. (Courtesy of FAA)**

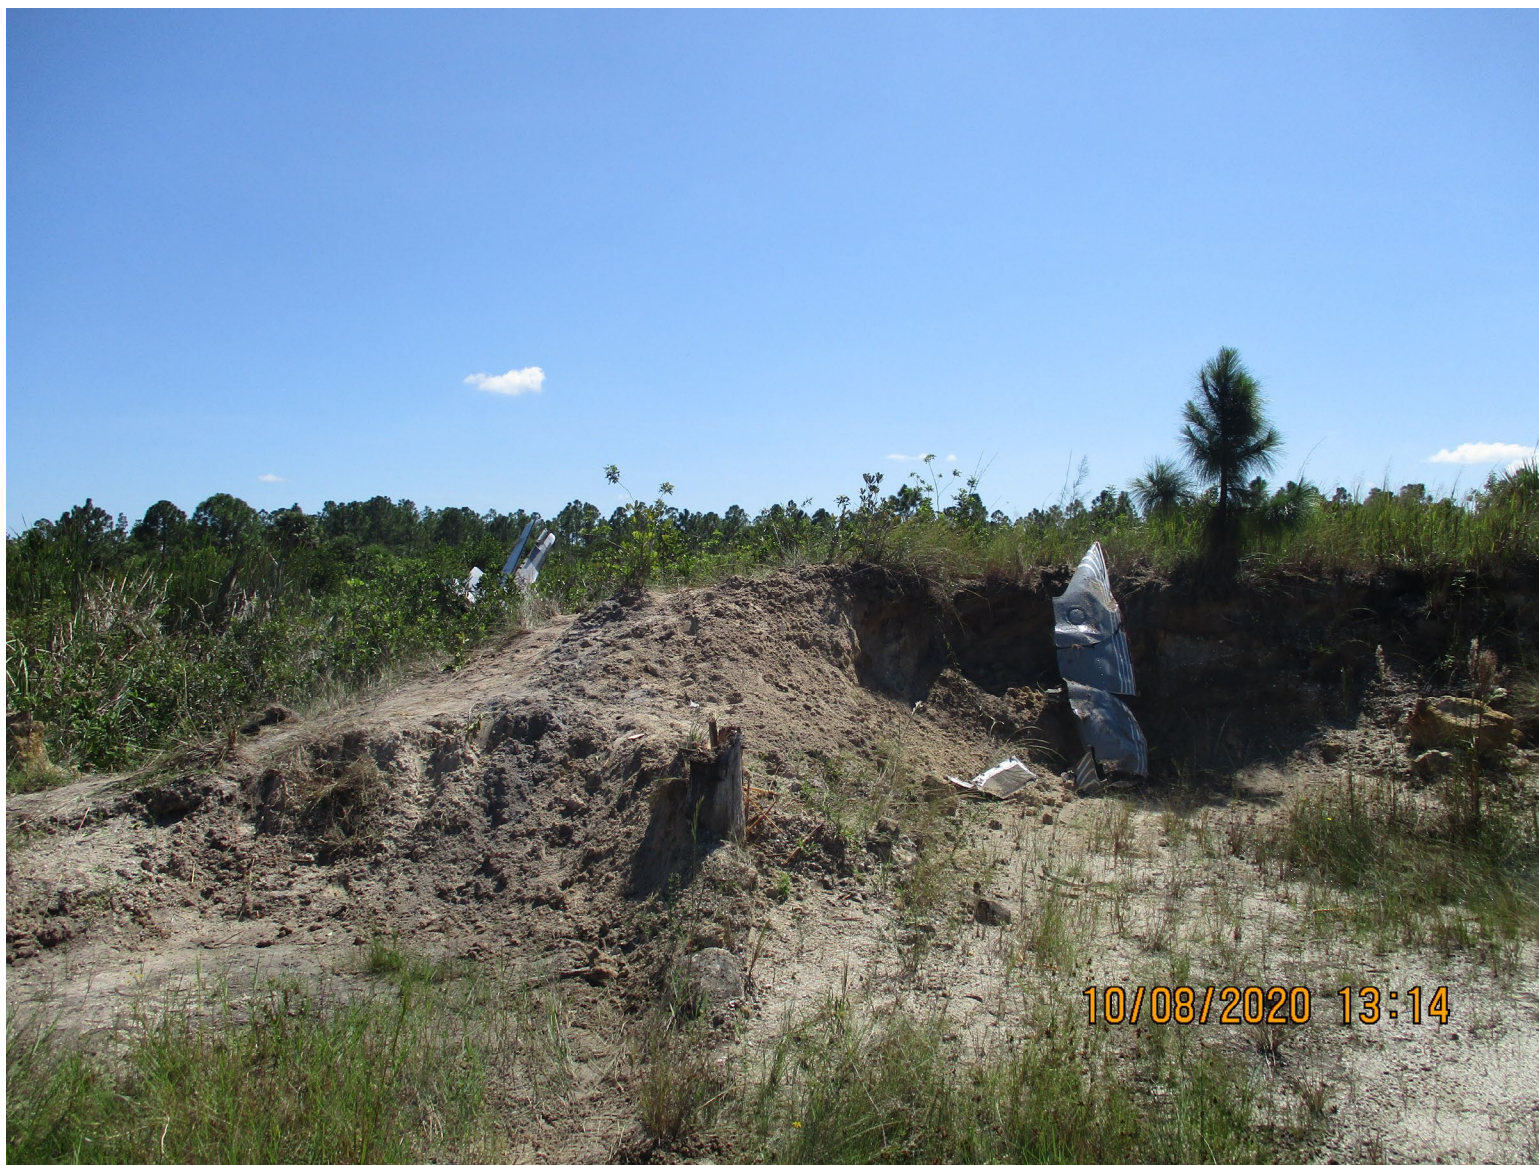
**Photo 10 – View of dirt mound that was impacted by the right wing. Note main wreckage in background. (Courtesy of FAA)**

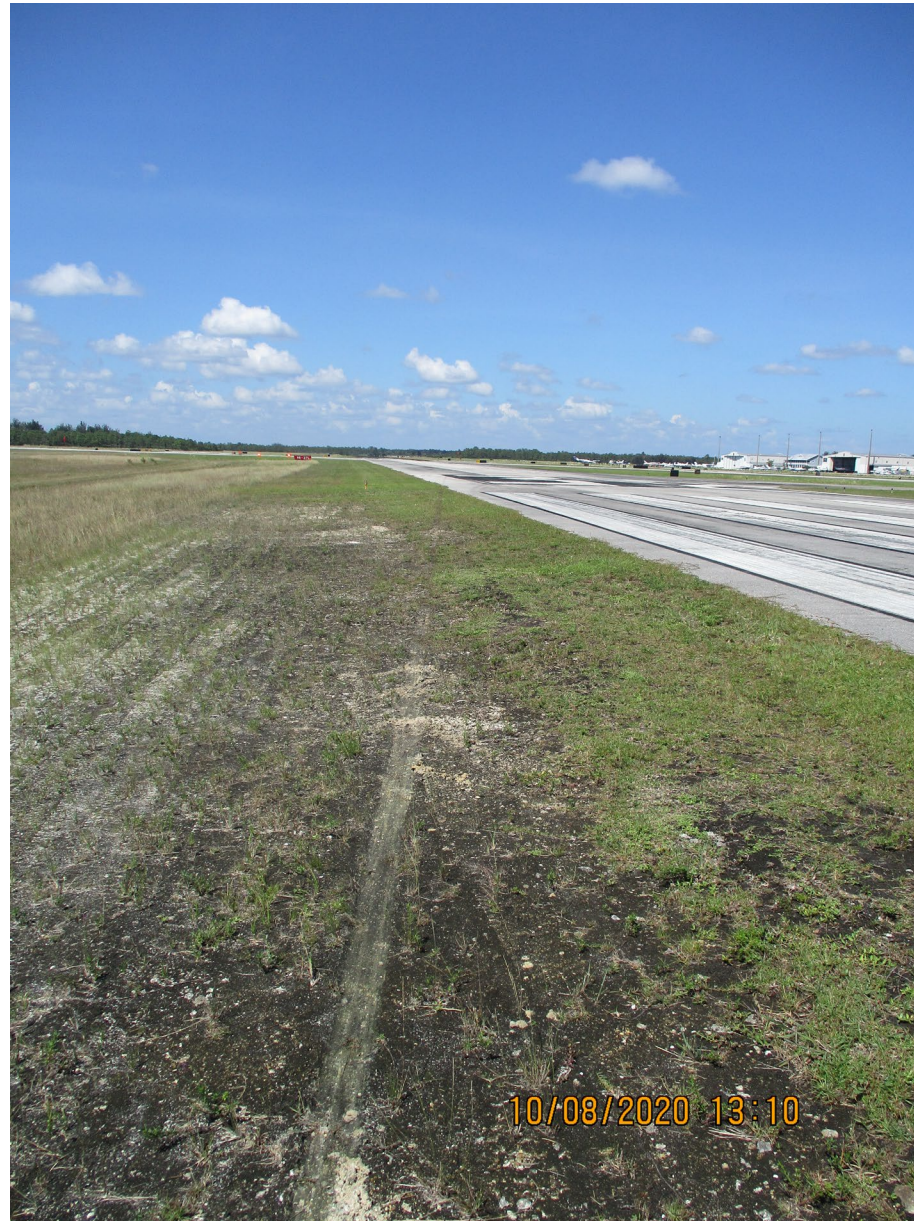
**Photo 11 – View of tire skid marks looking back towards runway 14. (Courtesy of FAA)**

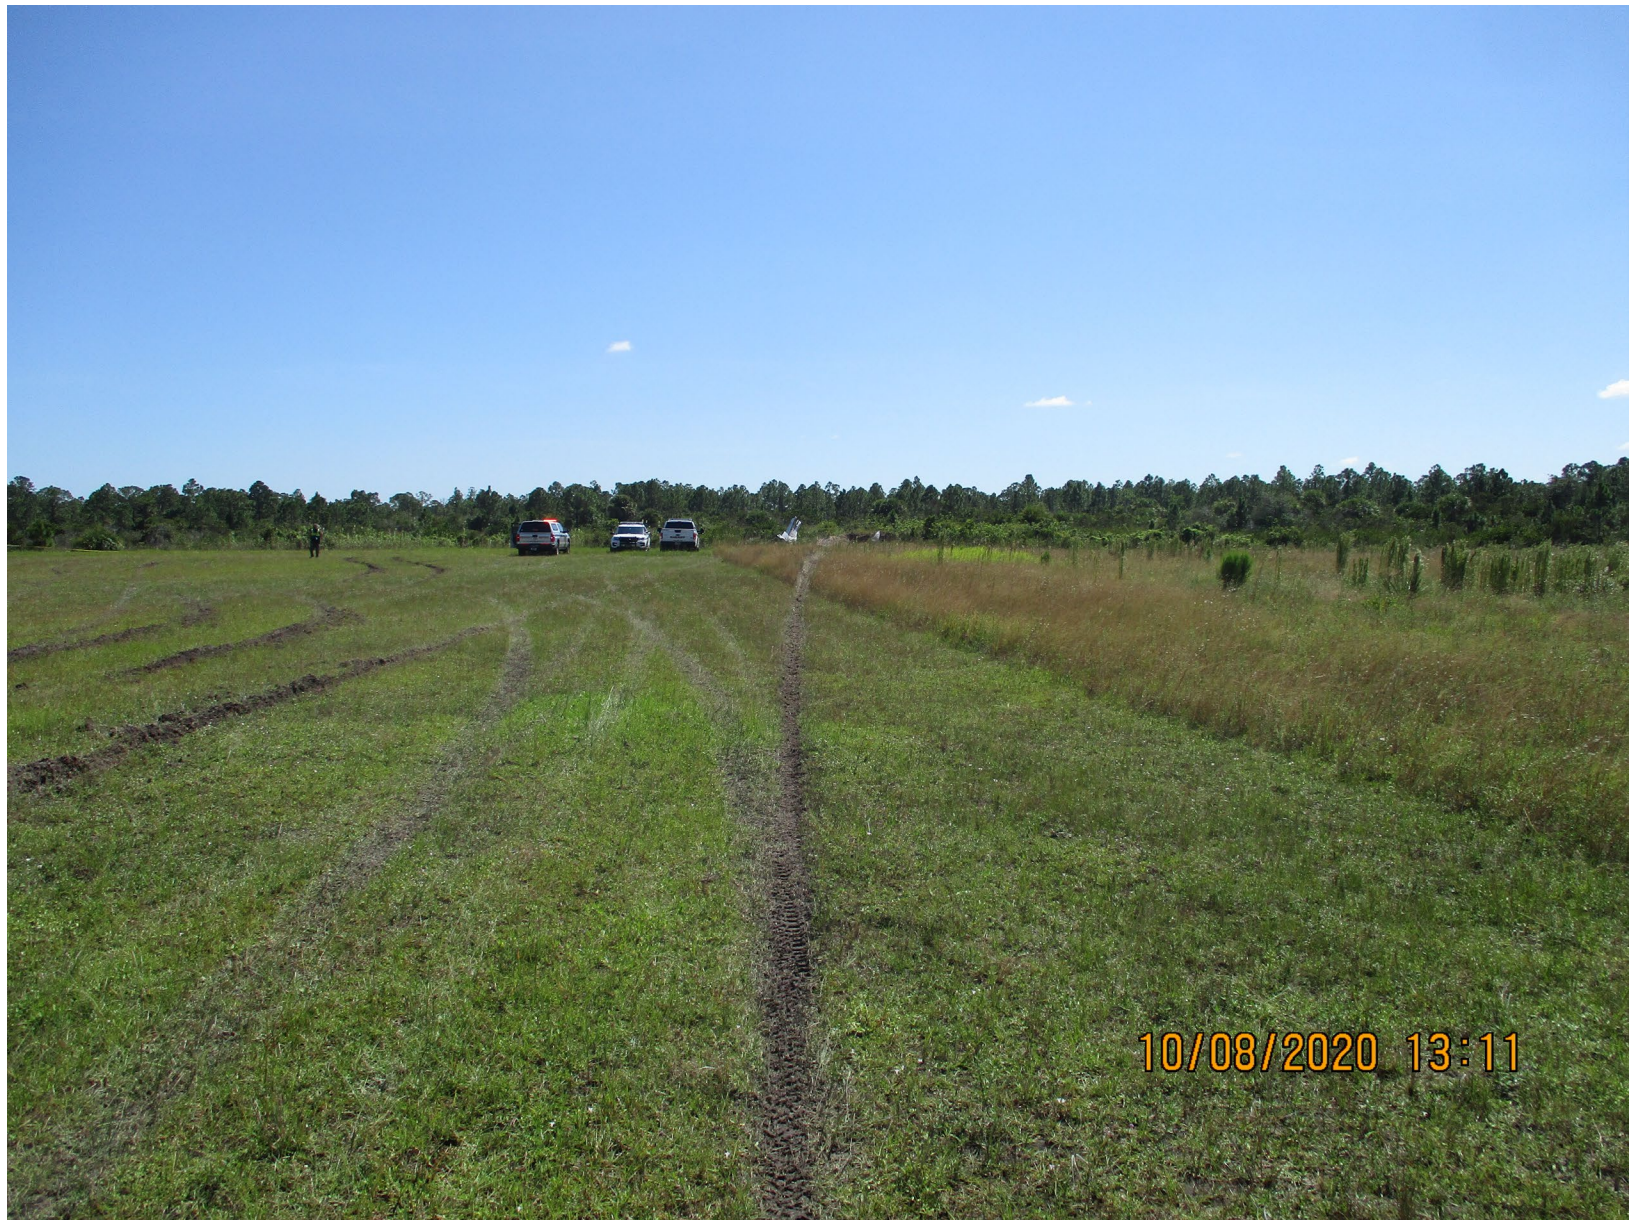
**Photo 12 – View of airplane tire skid marks in grass looking towards wreckage site. (Courtesy of FAA)**
