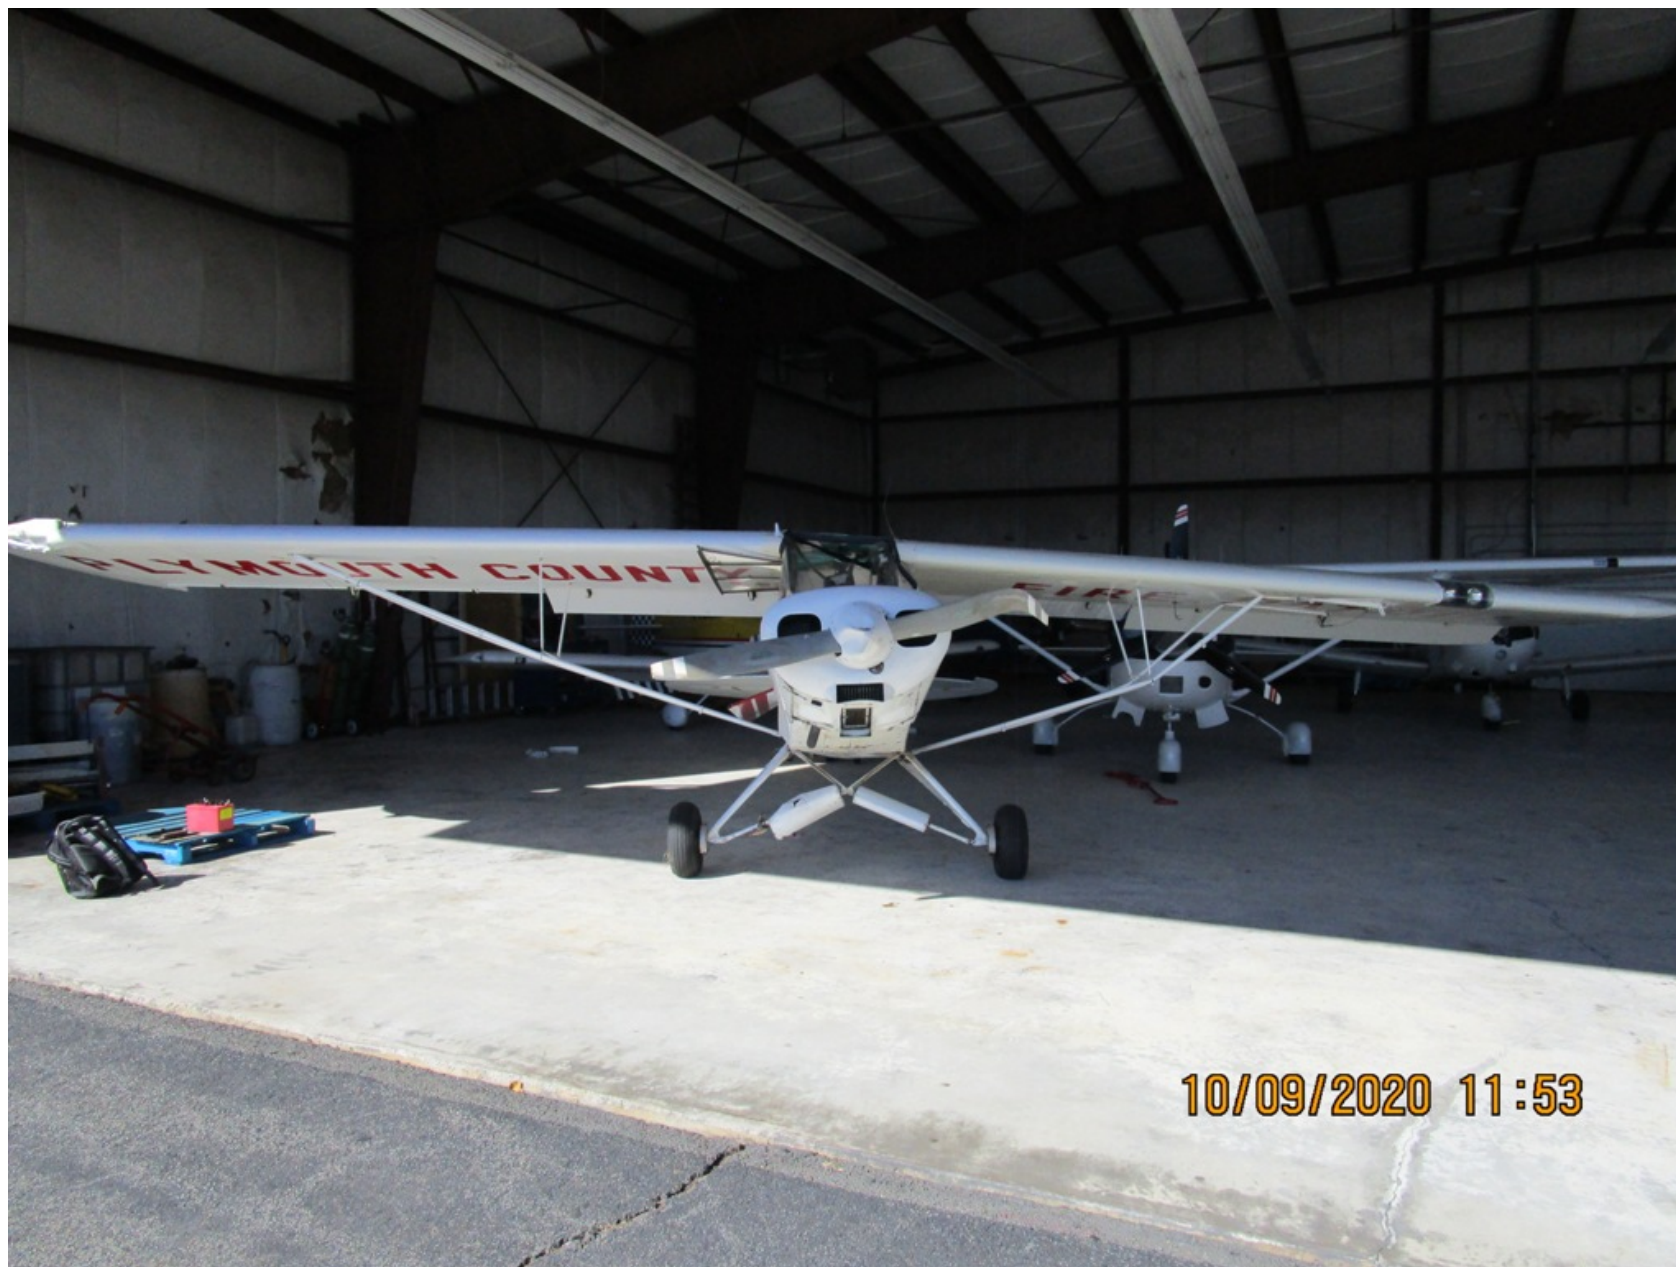
**Photo 1 – Digital Photograph Provided by FAA. Frontal View of the Airplane Following Recovery. Note the Abnormal Position of the Left Wing, Damaged Propeller Blade, and Damage at the Right Wing Tip.**

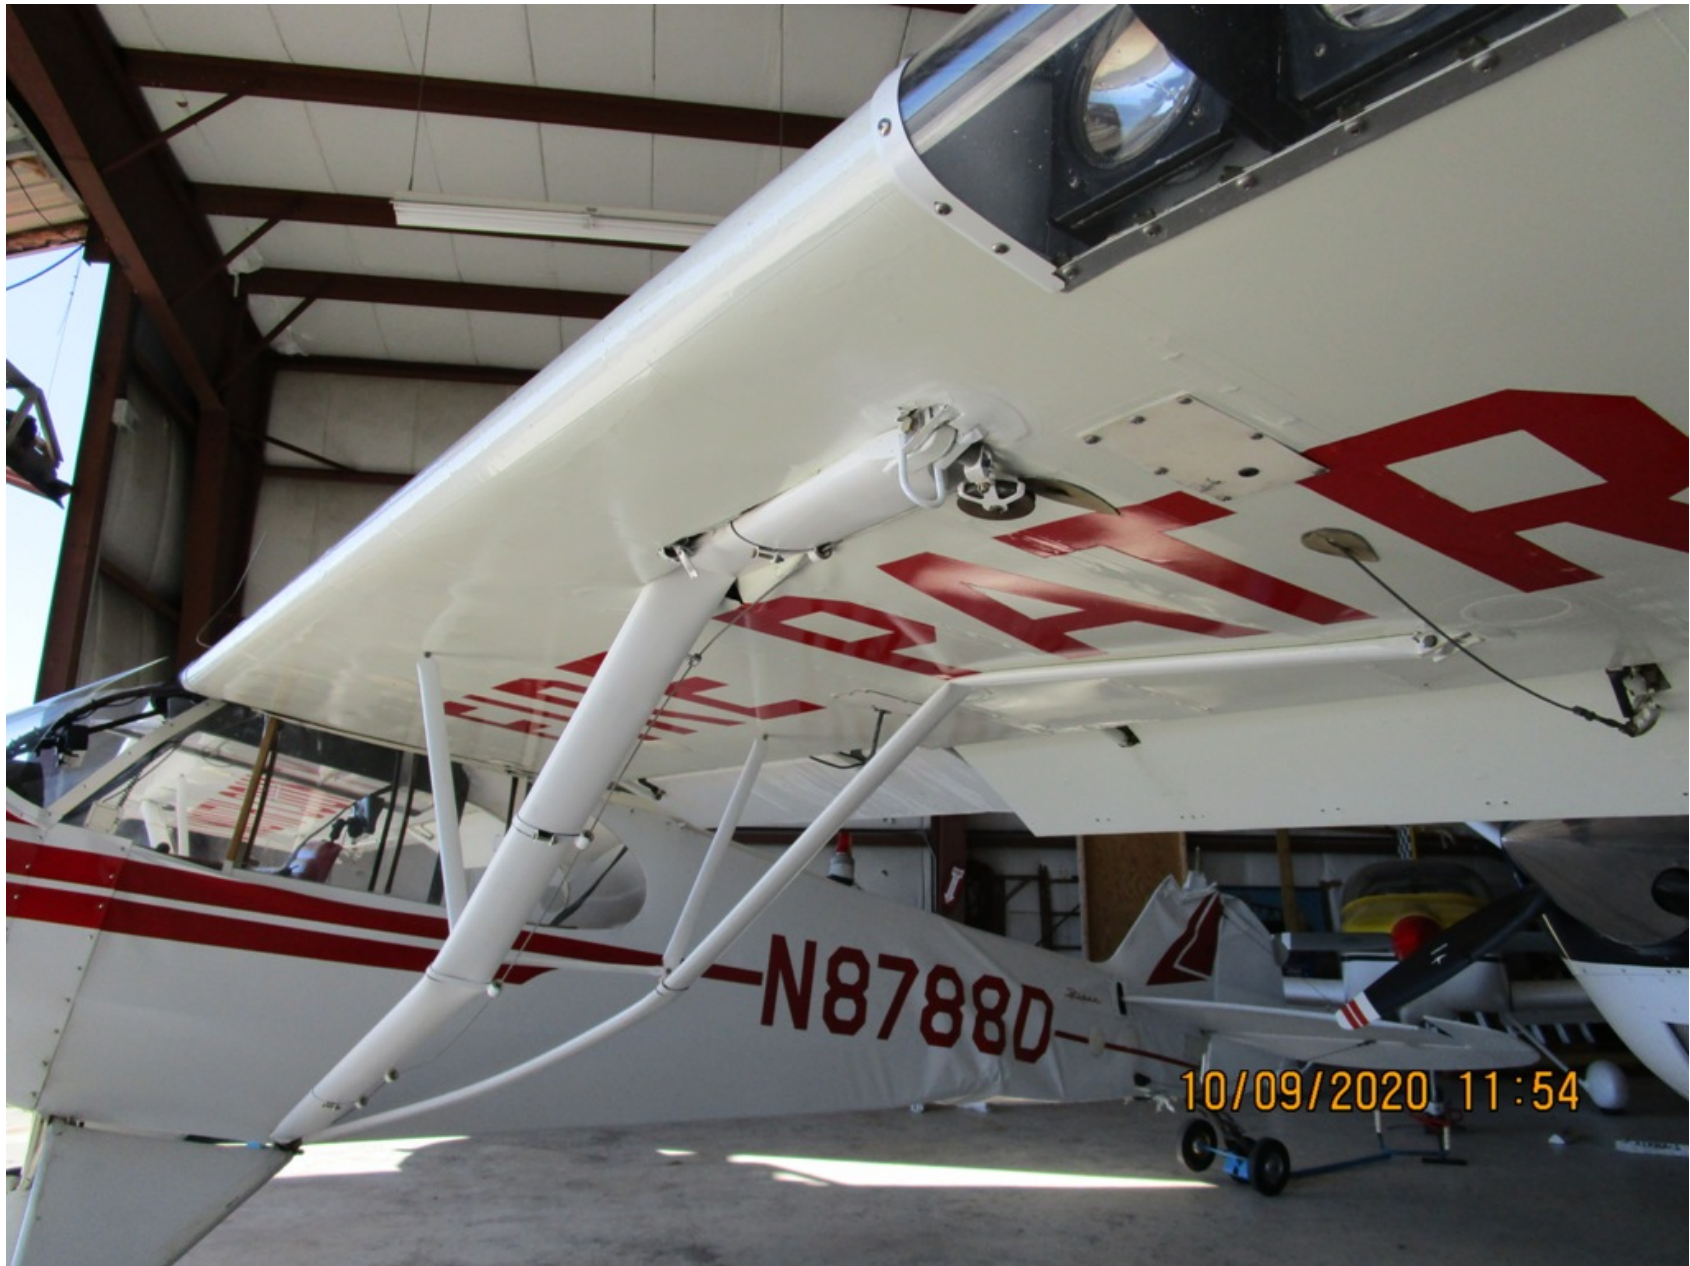
**Photo 2 - Digital Photograph Provided by FAA. Left Side View of the Airplane Following Recovery. Note the Damage to Both Left Wing Lift Struts.**

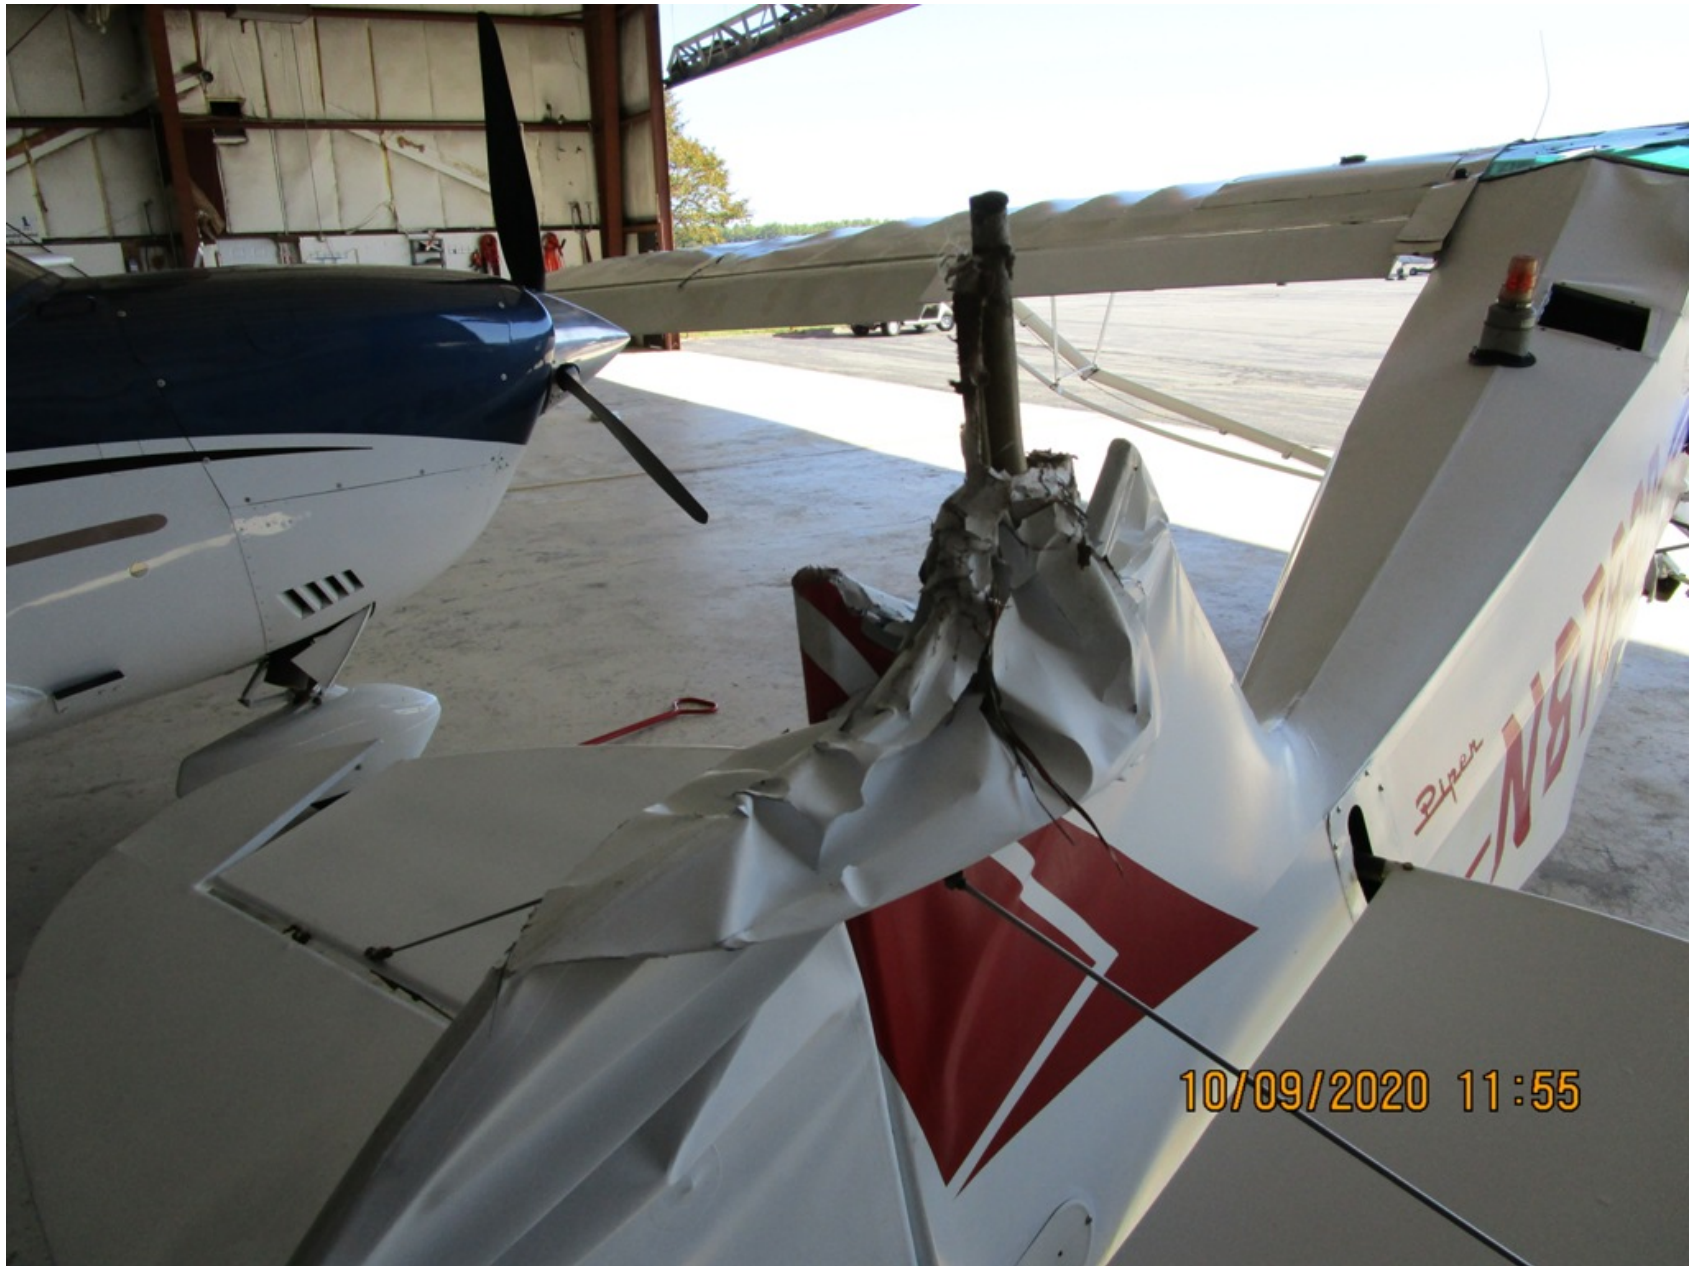
**Photo 3 - Digital Photograph Provided by FAA. Right Rear View of the Airplane Following Recovery. Note the Damage to the Rudder and Vertical Stabilizer.**

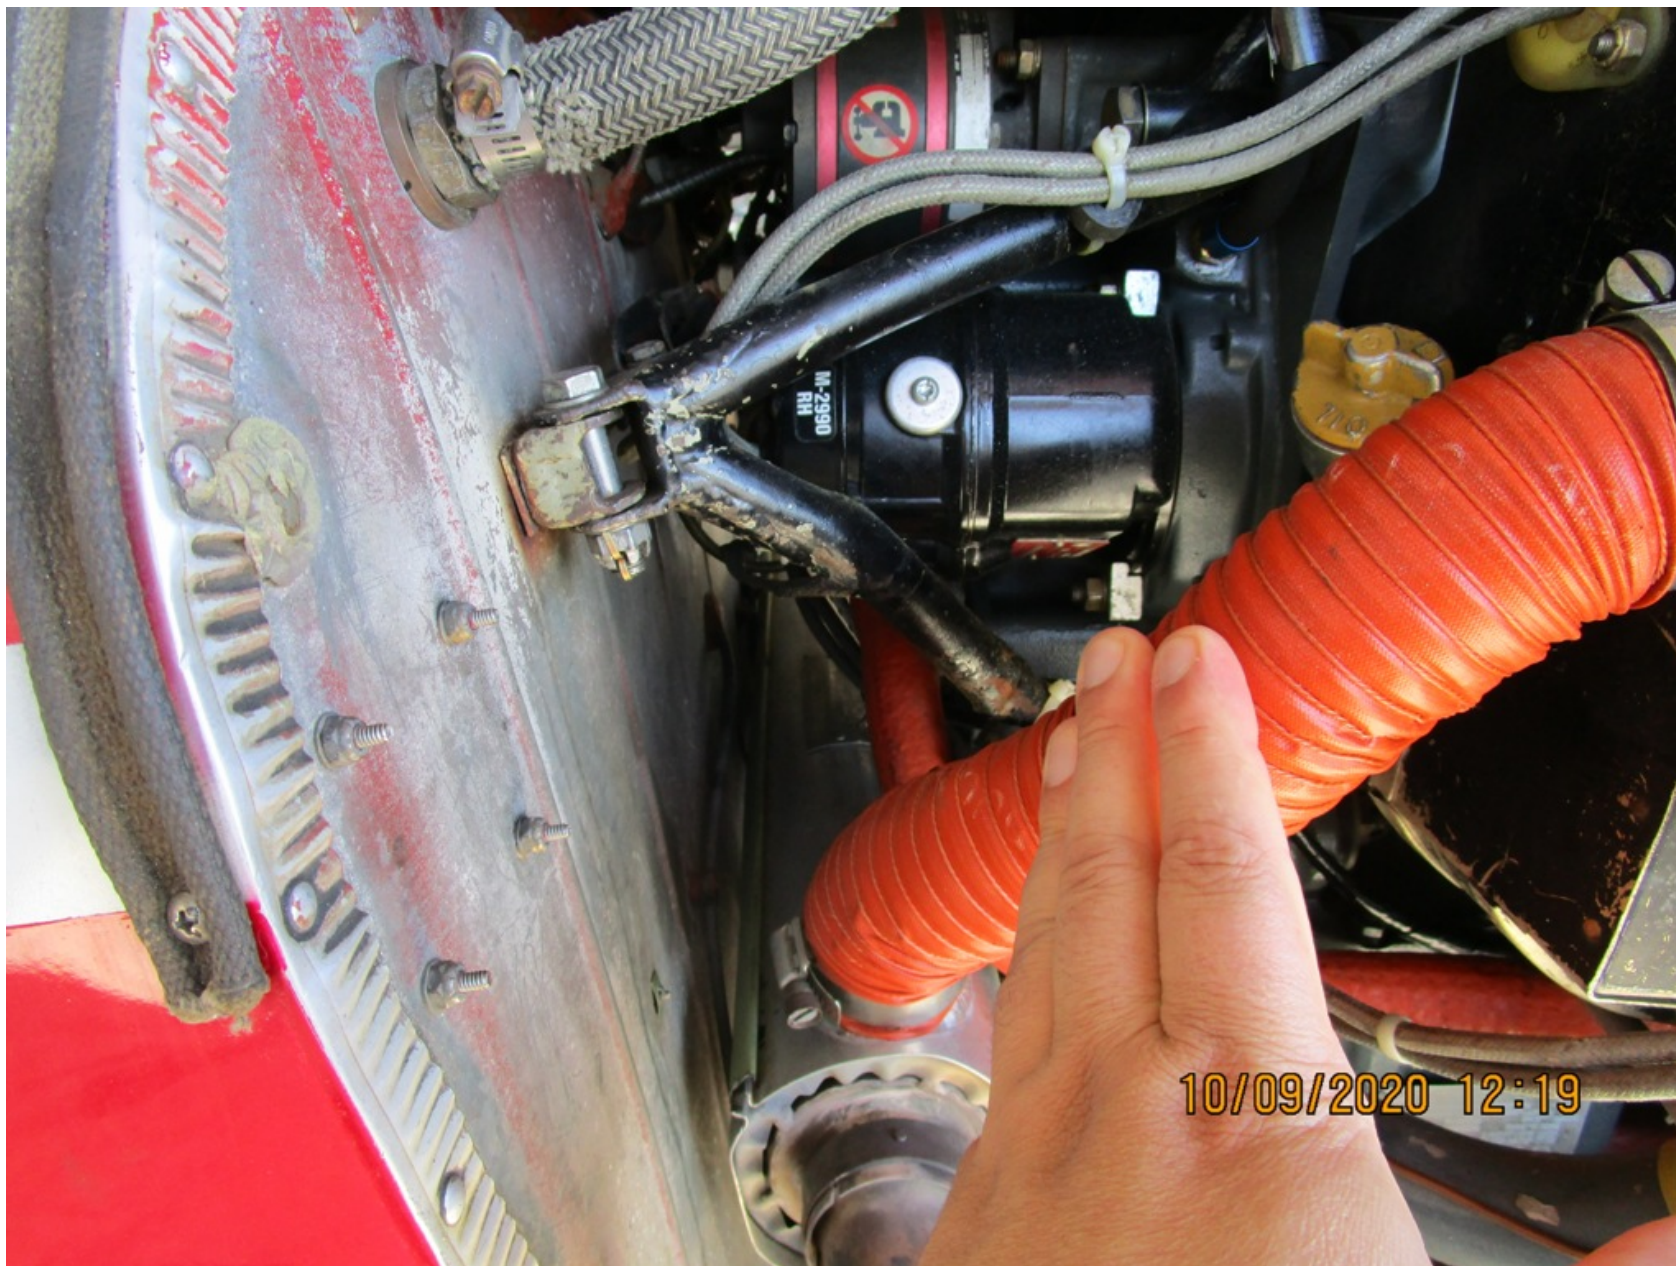
**Photo 4 - Digital Photograph Provided by FAA. Right Side View of the Engine Compartment Following Recovery. Note the Damage to the Engine Mount.**
