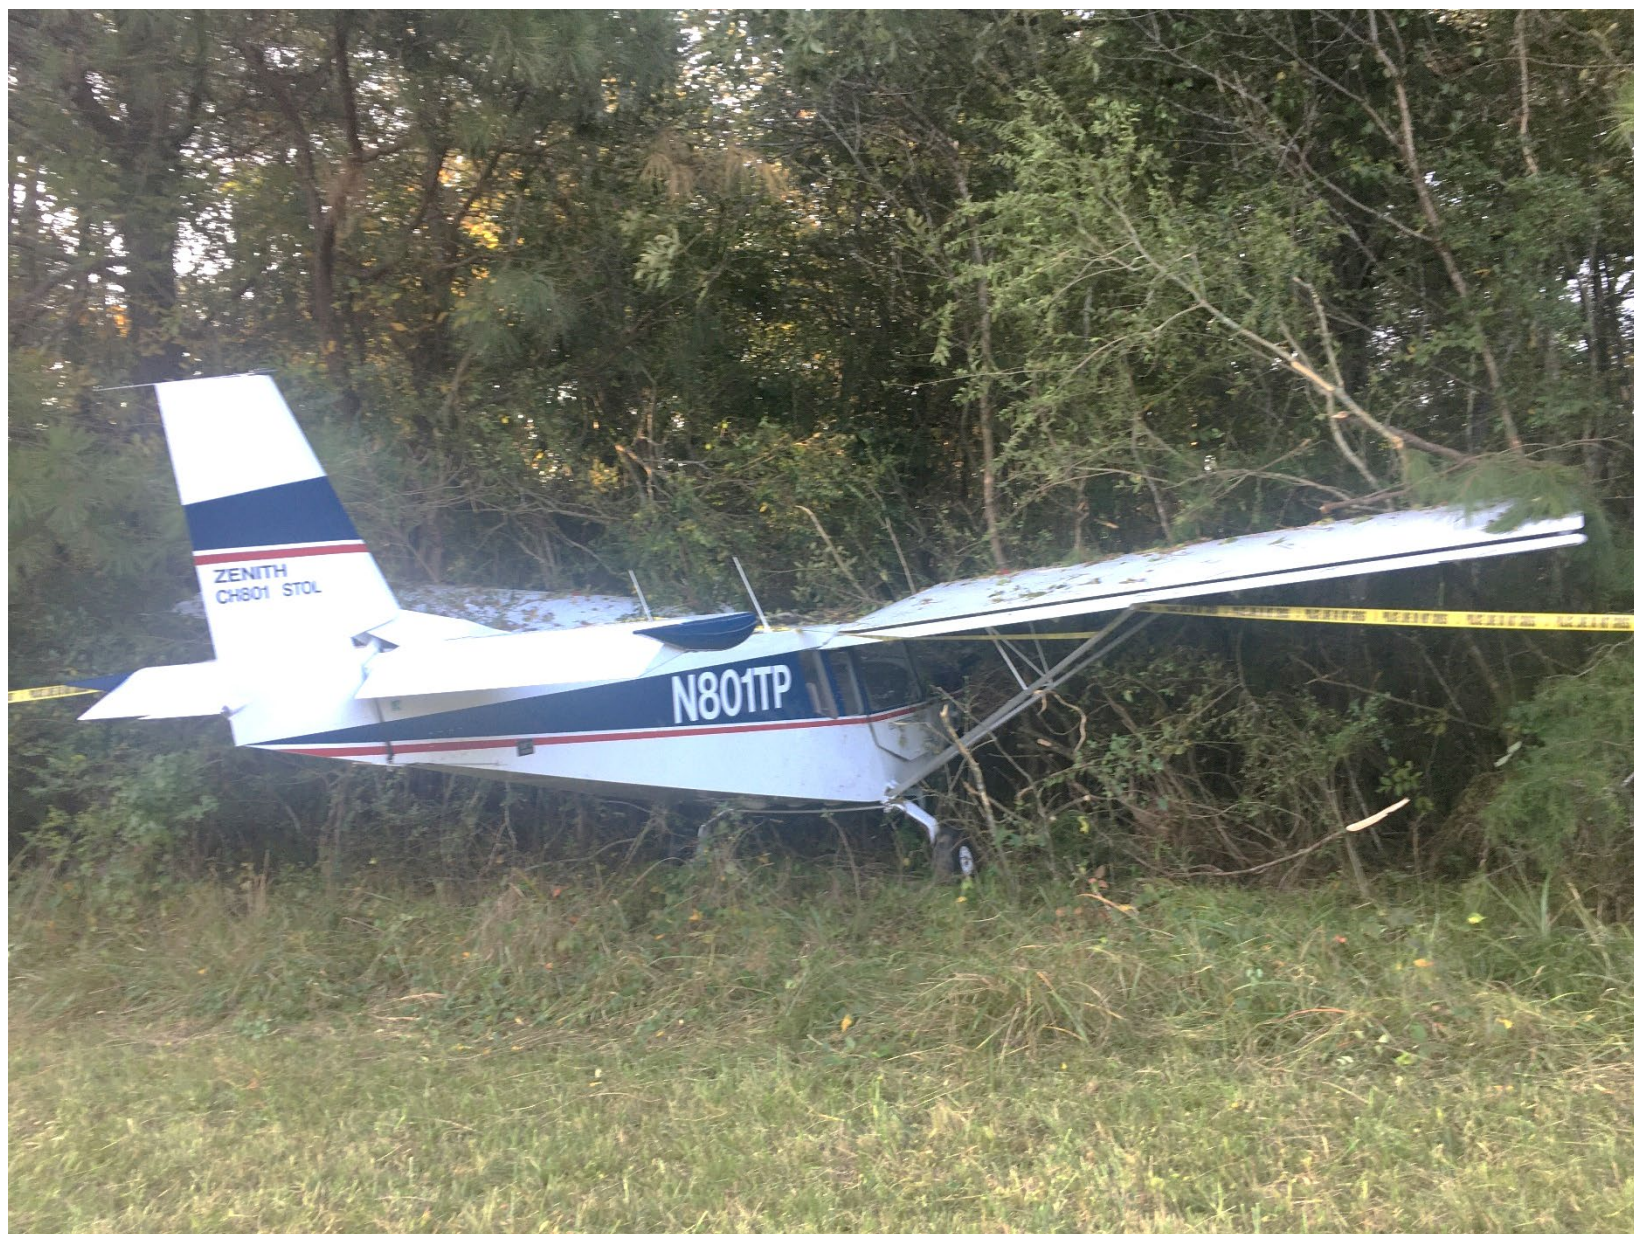
**Photo 1 – View of airplane at the accident site (Photo Courtesy of FAA)**

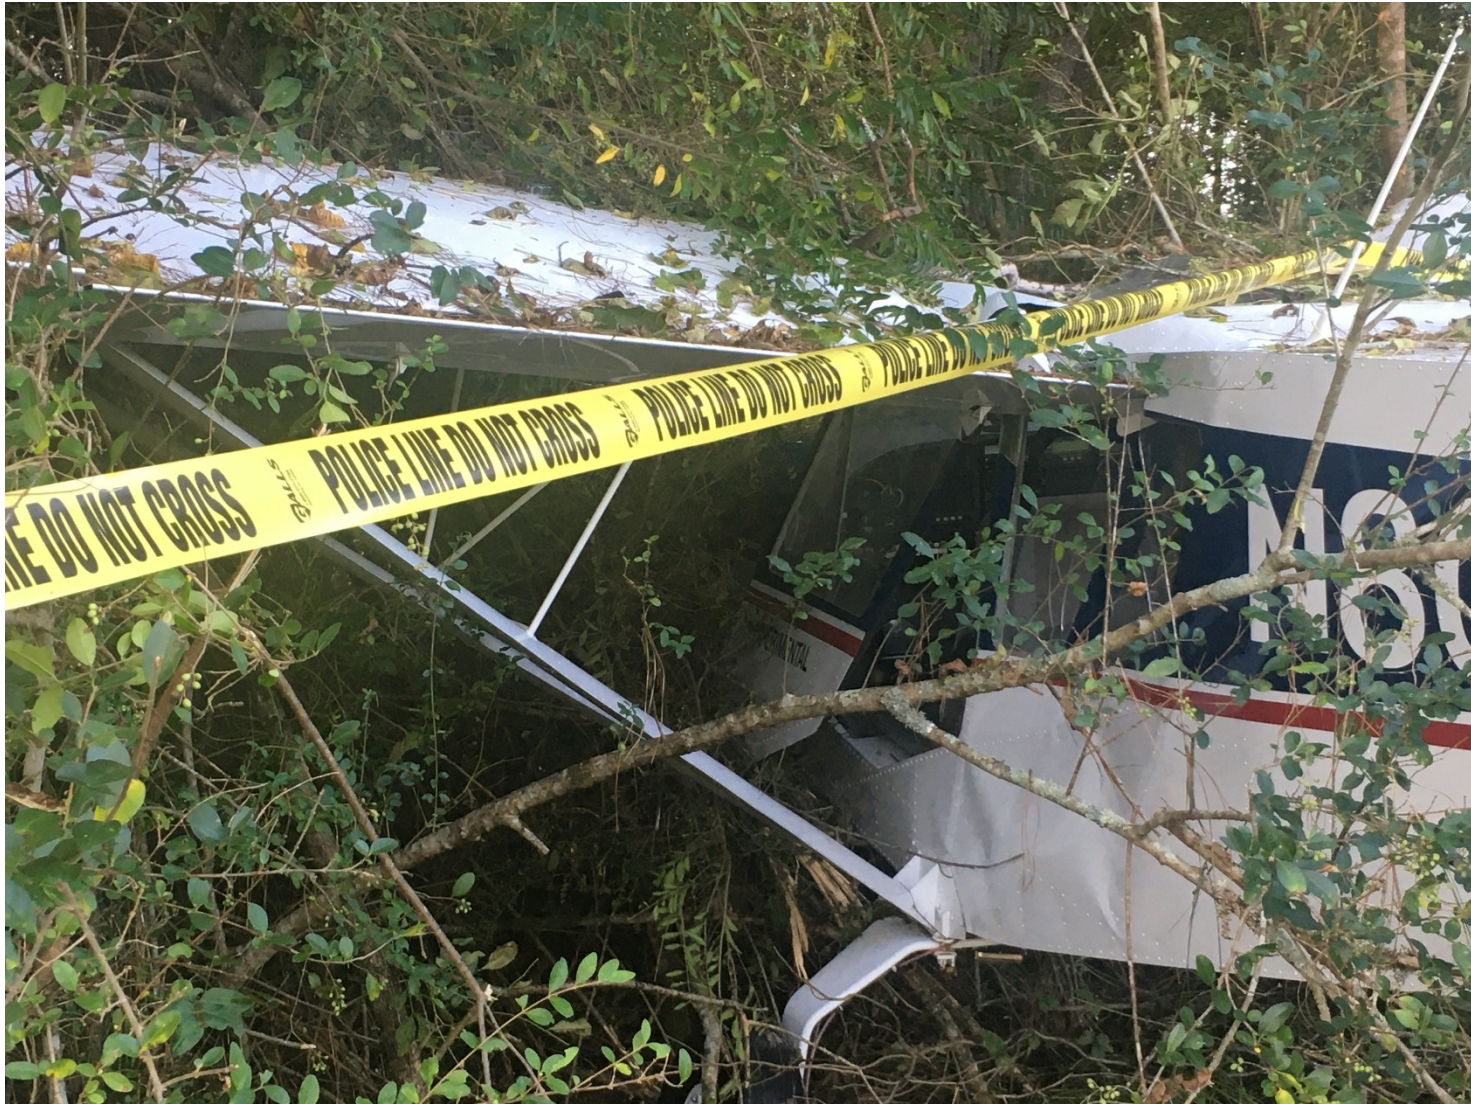
**Photo 2 – Additional view of airplane in brush and trees at the accident site (Photo Courtesy of FAA)**

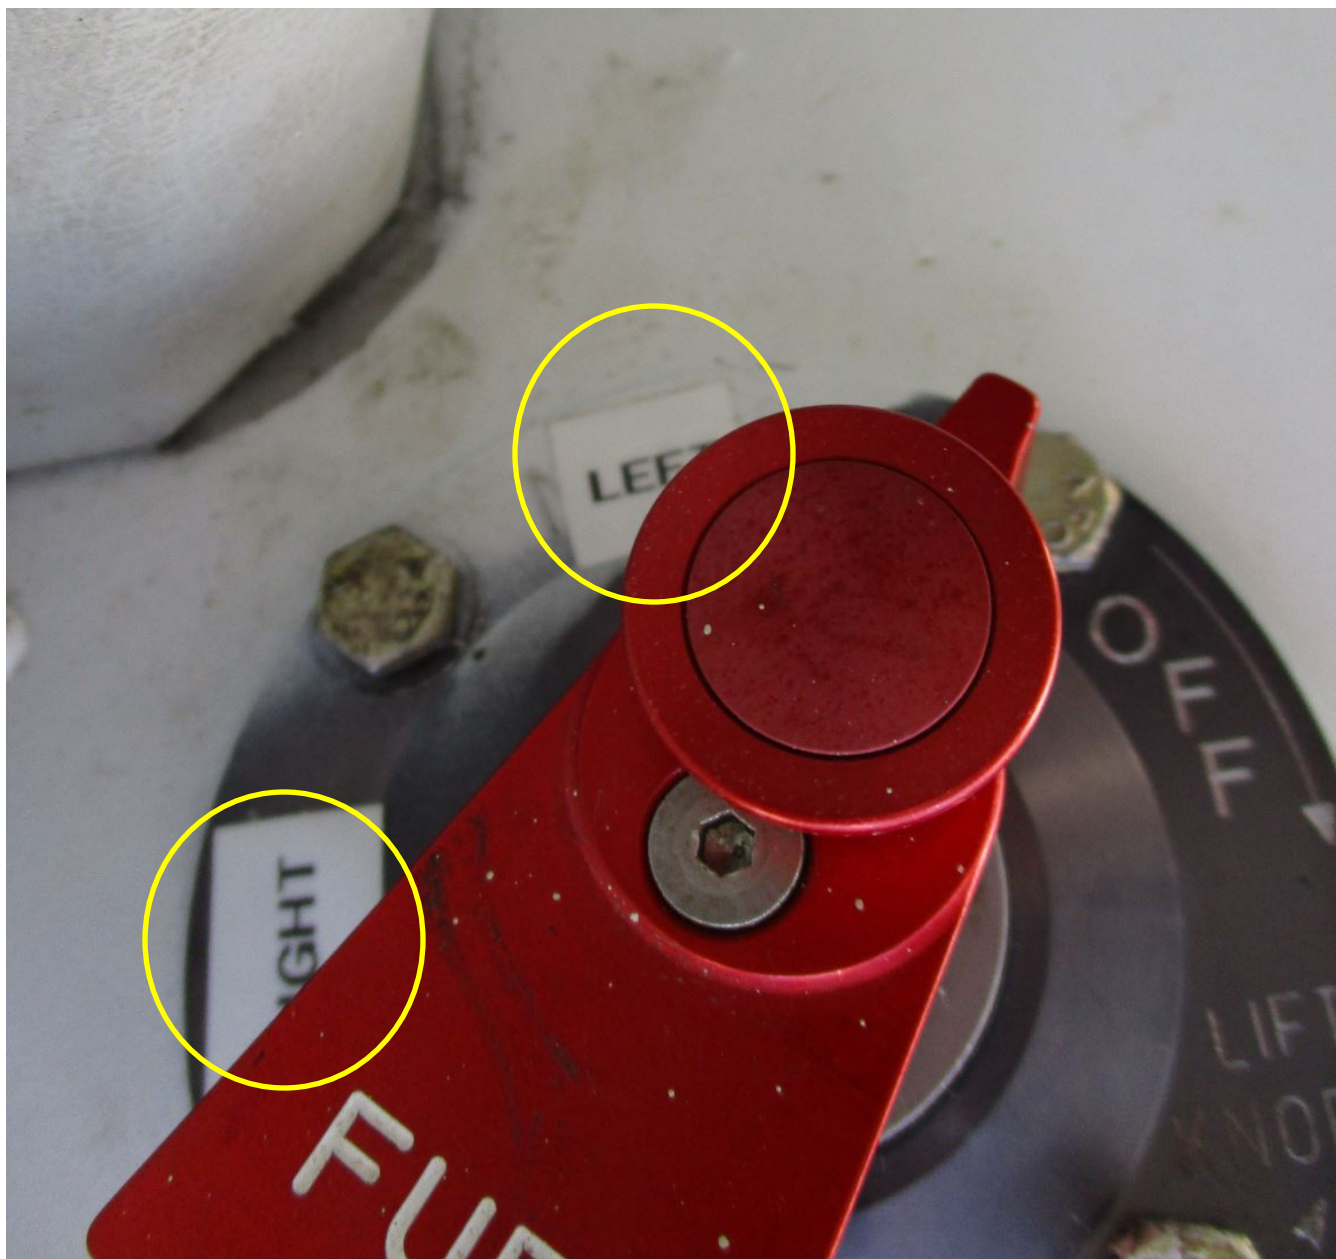
**Figure 1 – View of the fuel selector placards, mislabeled. Left was right, right was left (Photo Courtesy of FAA)**
