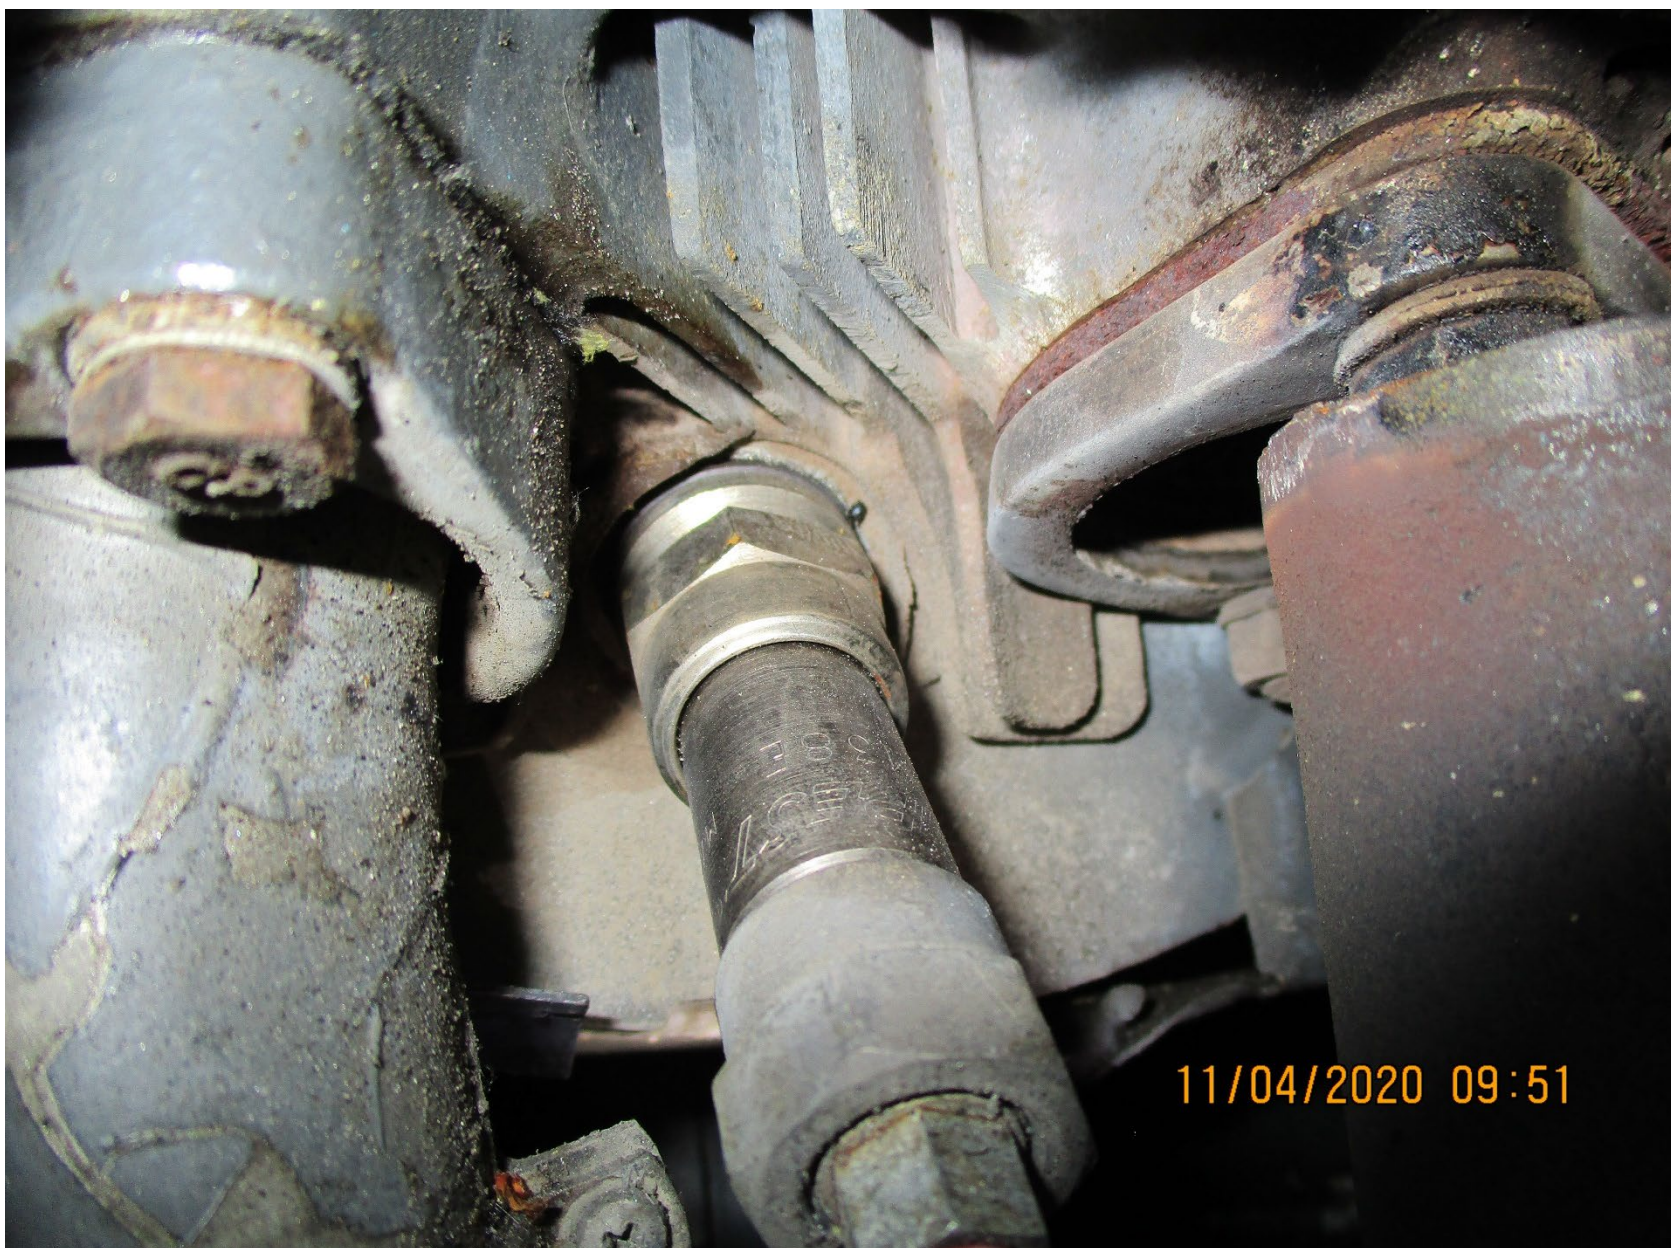
**No. 2 Cylinder Soot on Exhaust Flange (IMG0168 - Photo Courtesy FAA)**

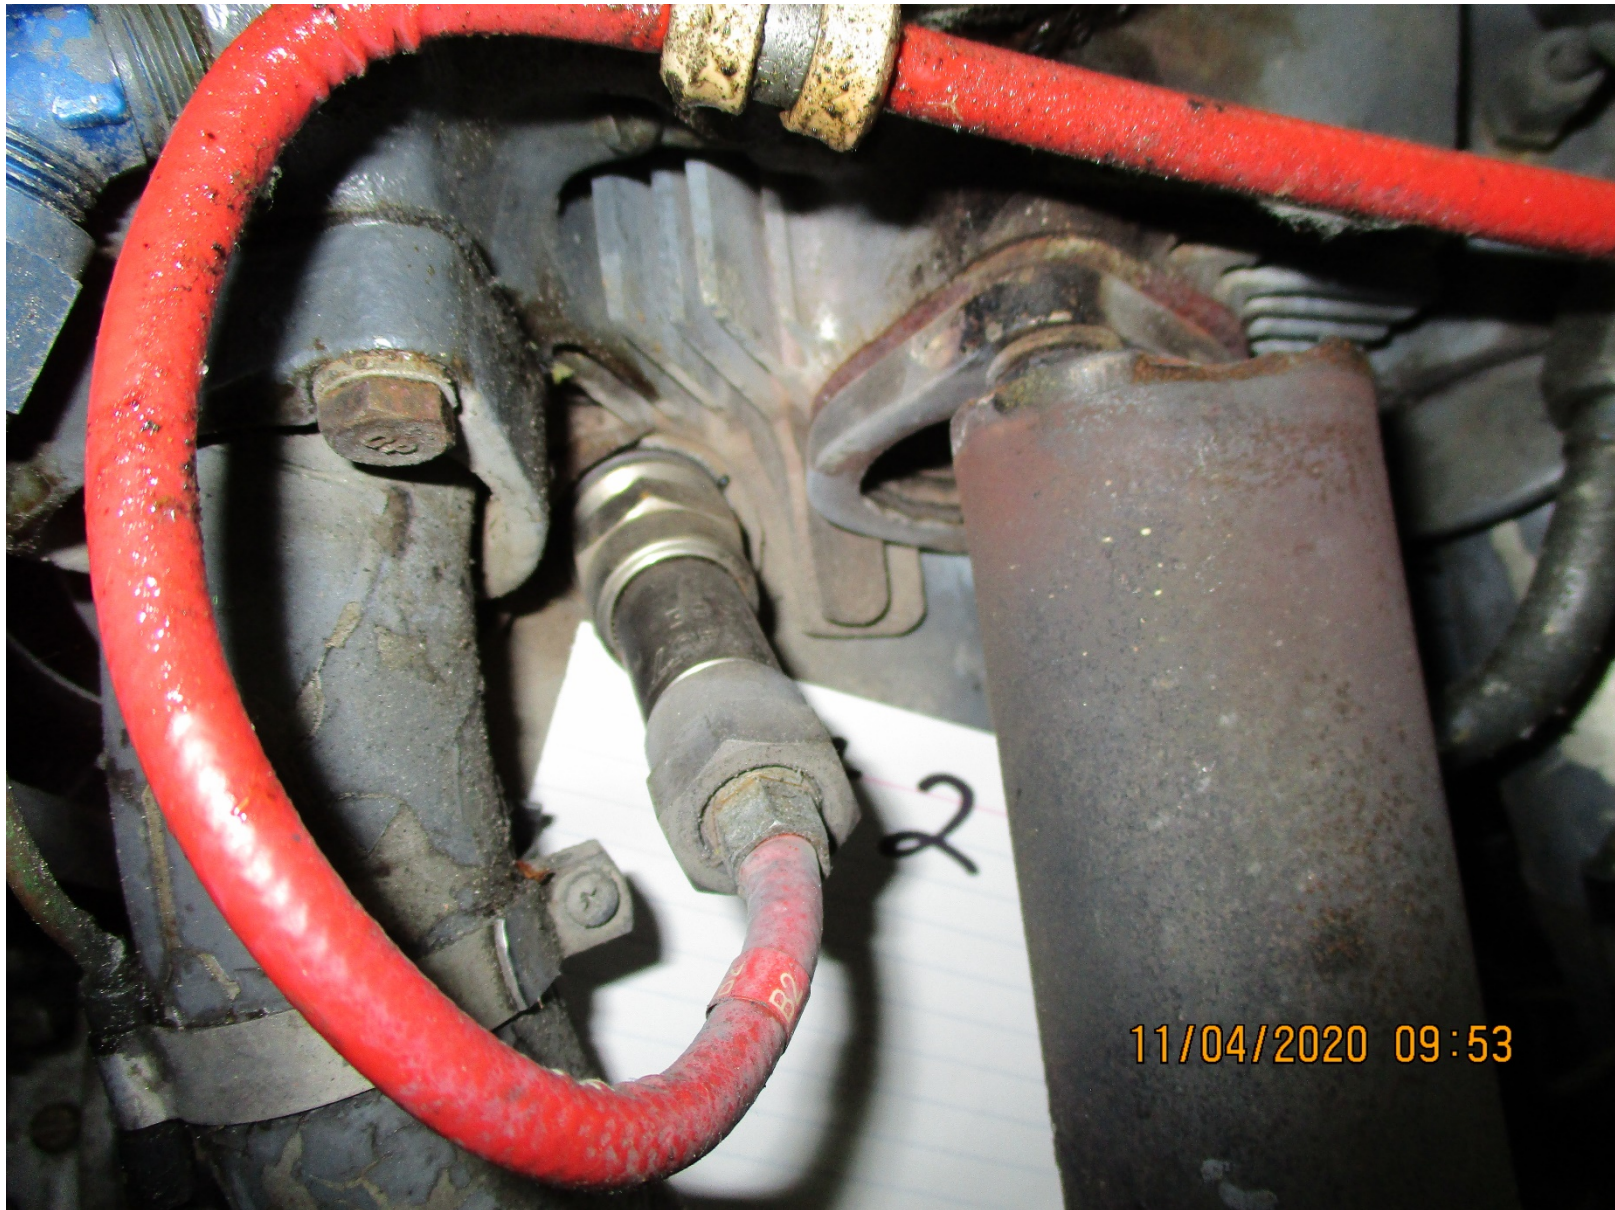
**No. 2 Cylinder Soot on Spark Plug Lead (IMG0171 - Photo Courtesy FAA)**

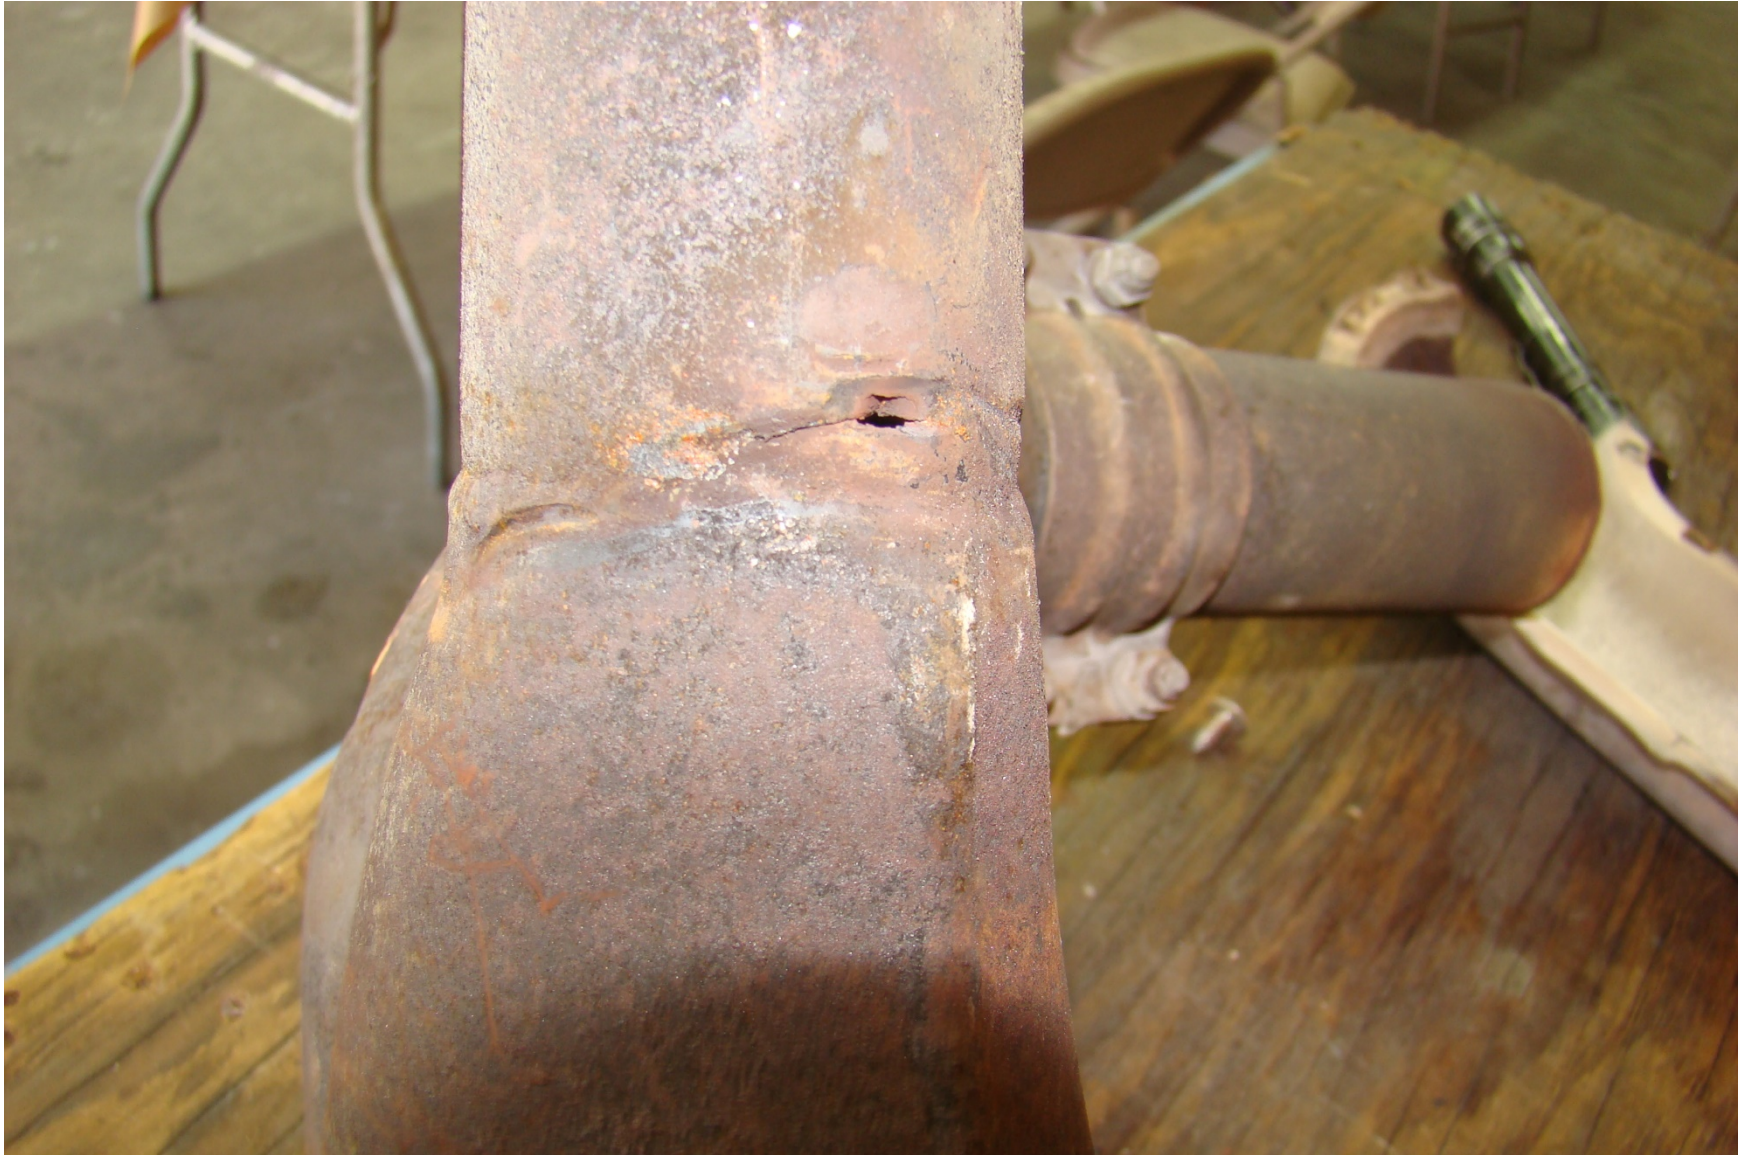
**Left Side Exhaust Riser – Hole/Crack (Photo Courtesy FAA)**

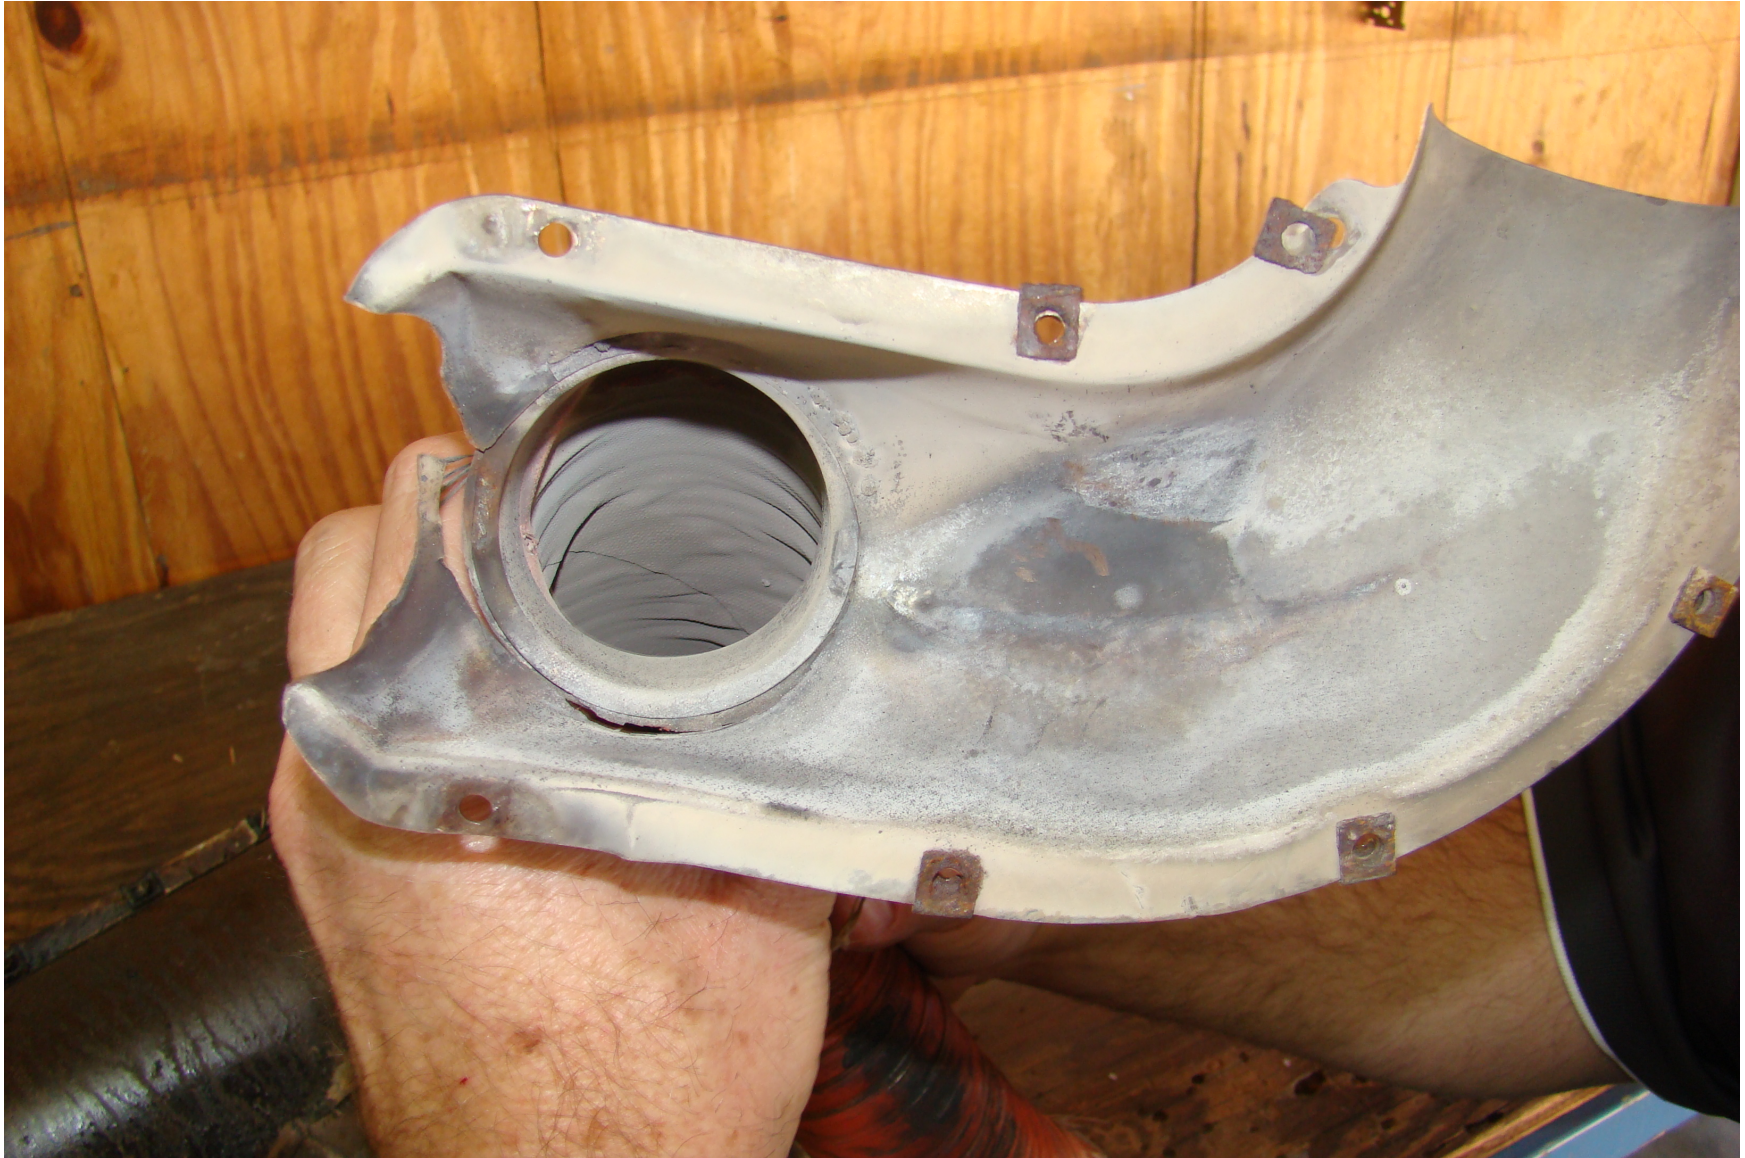
**Soot in Carburetor Heat Muff and Tube (Photo Courtesy FAA)**

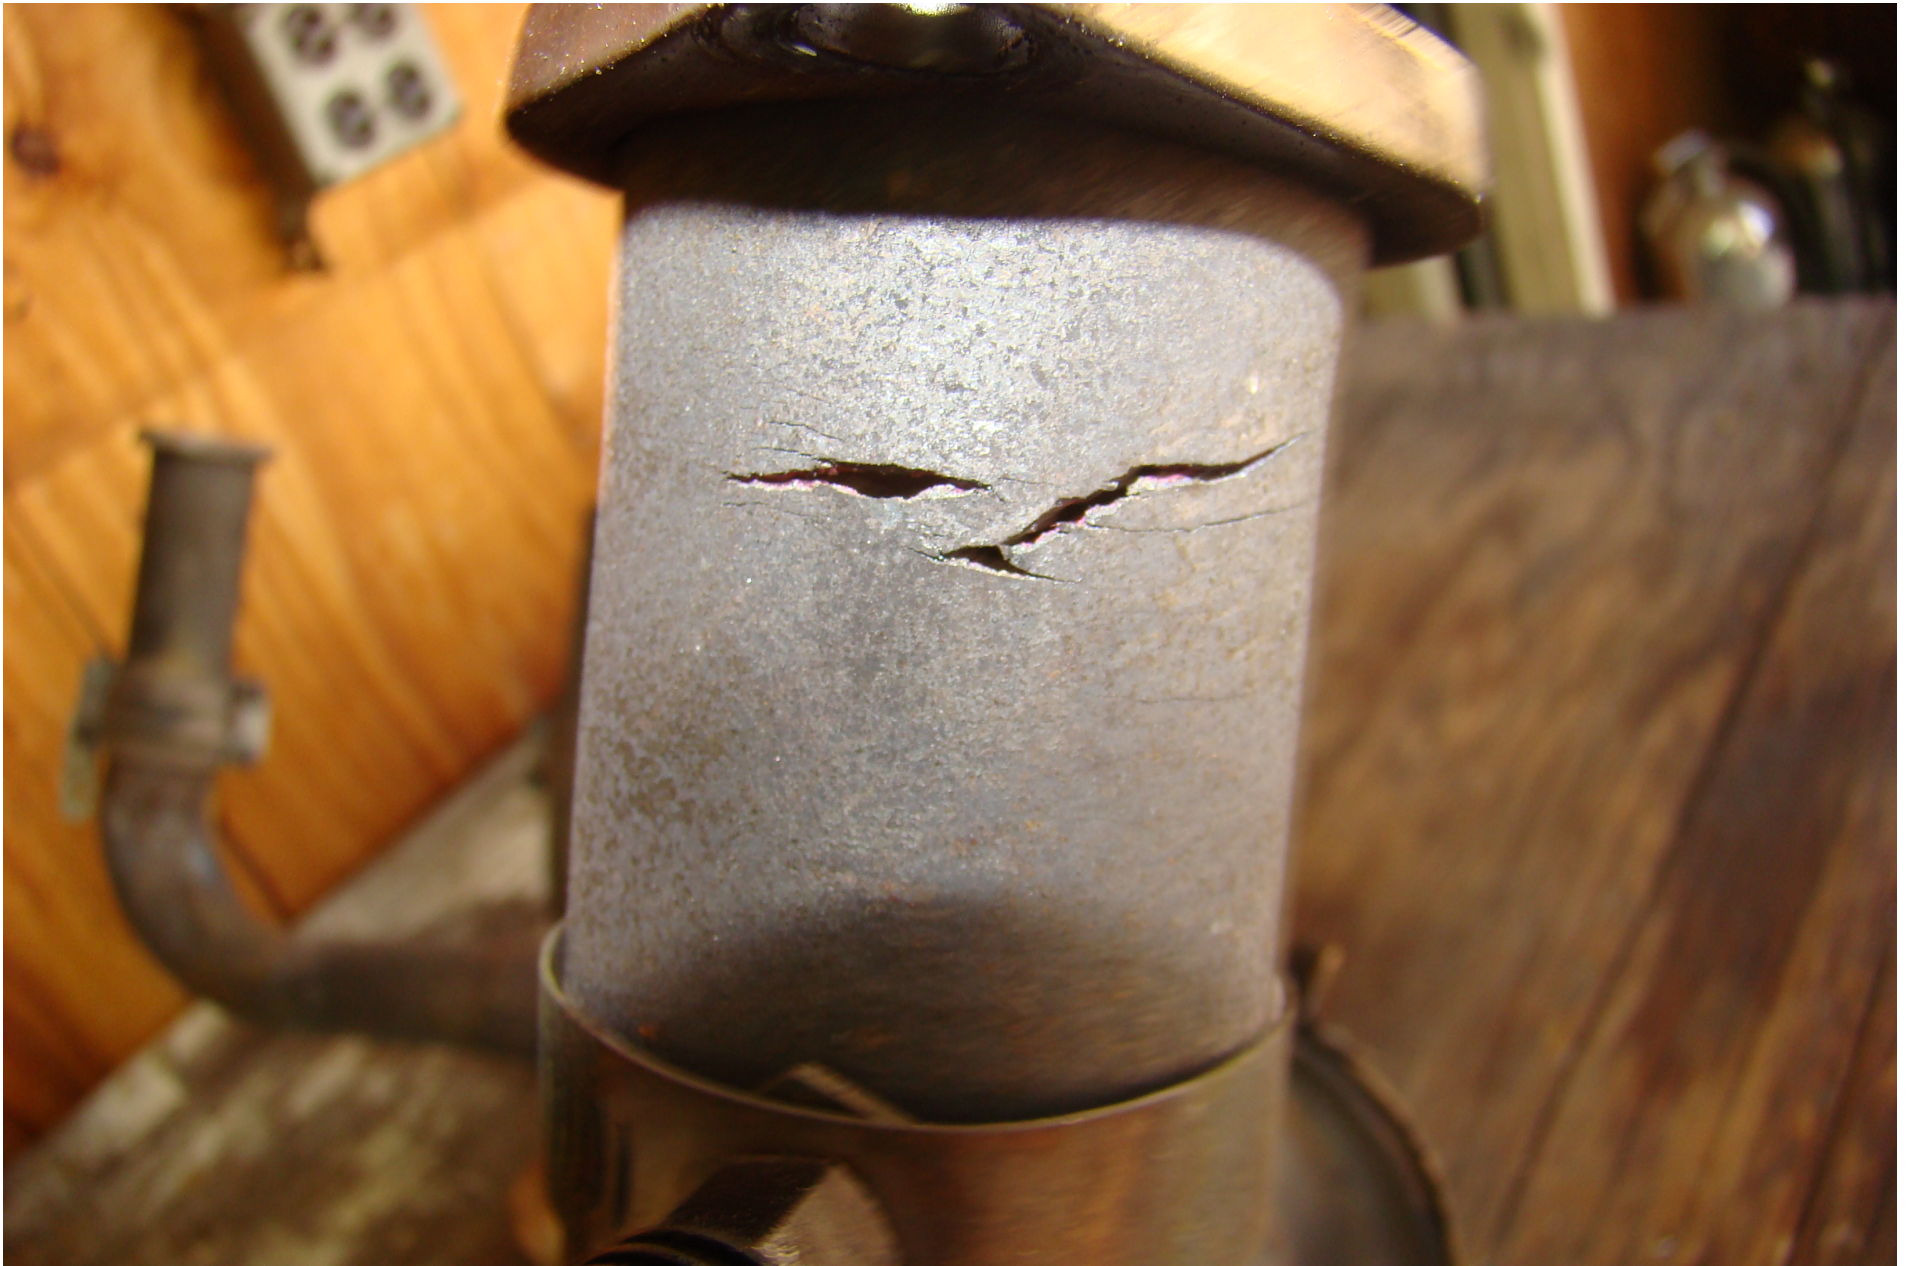
**No. 3 Cylinder Exhaust Tube Cracks (Photo Courtesy FAA)**
