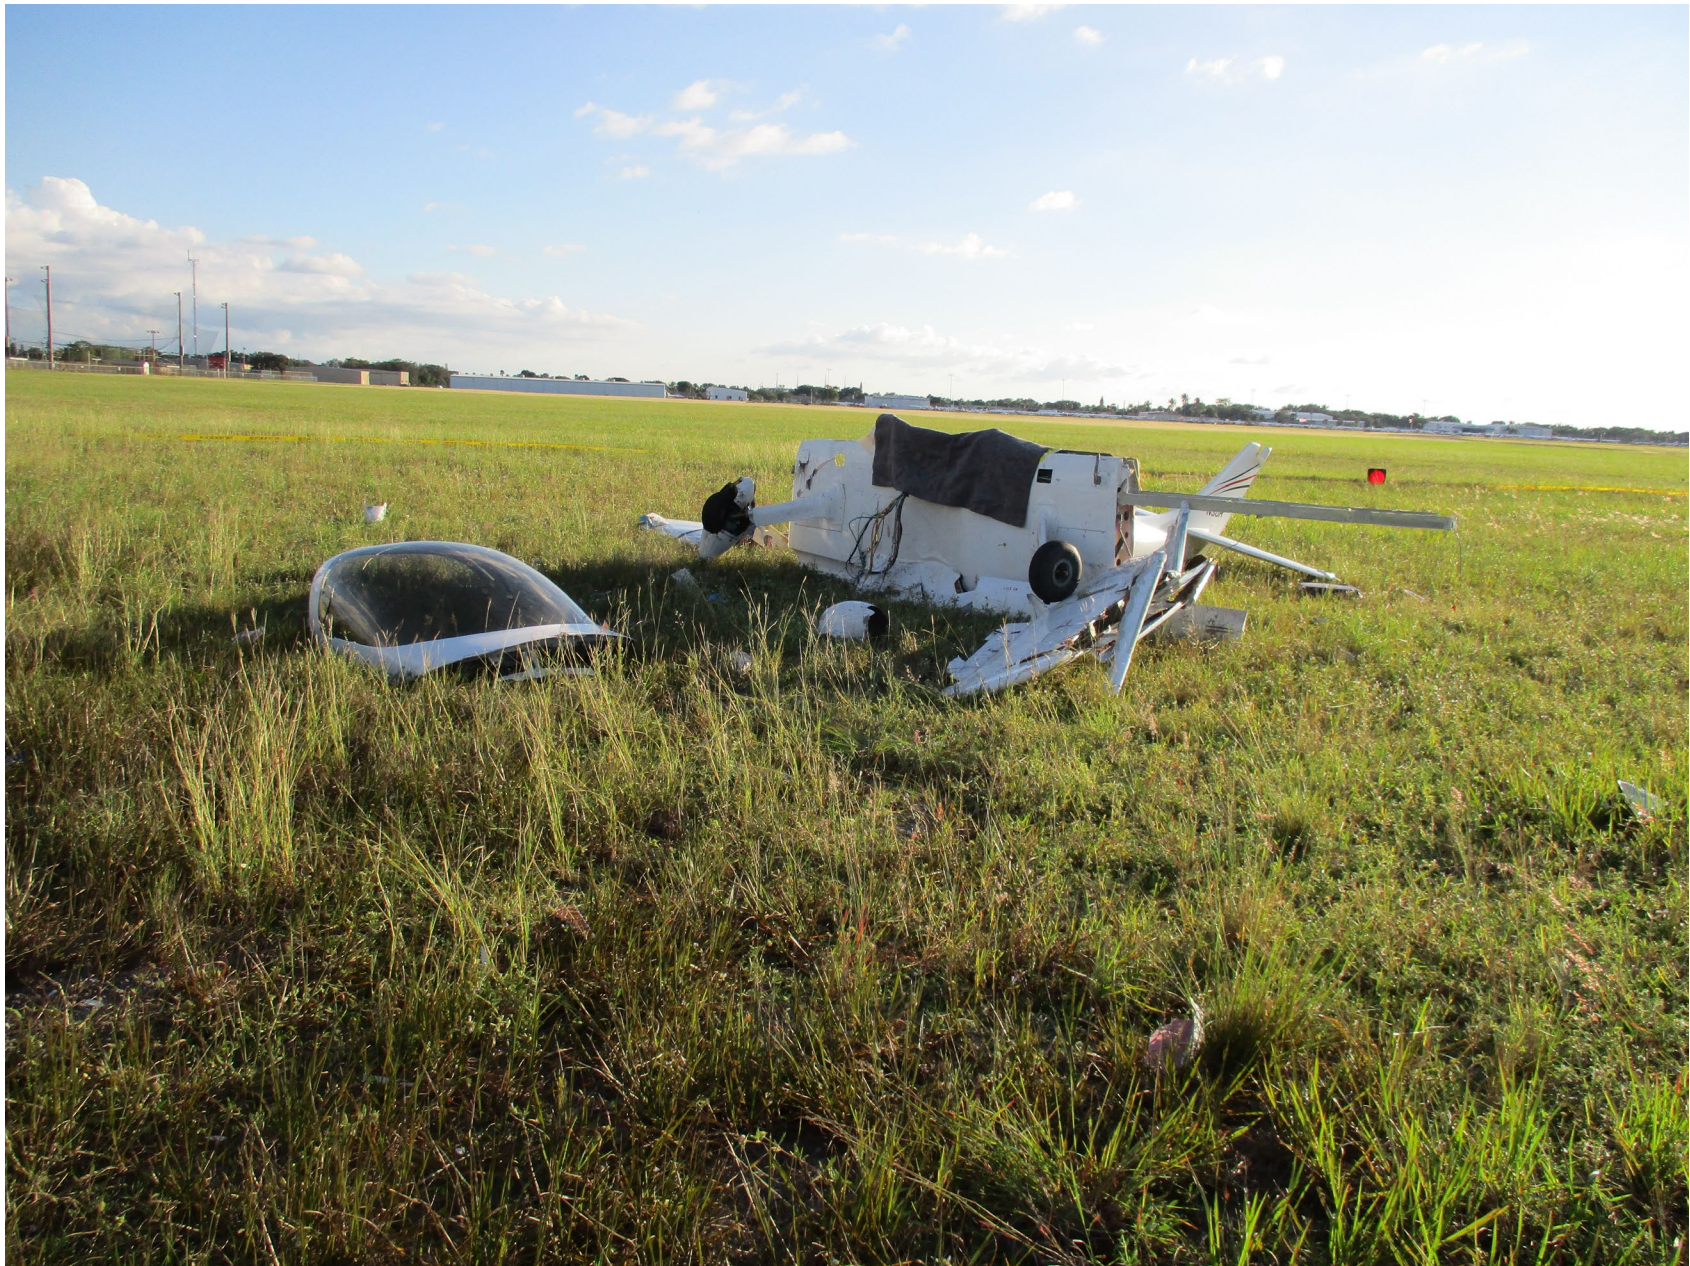
**Photo 1 – Main Wreckage – Courtesy of FAA**

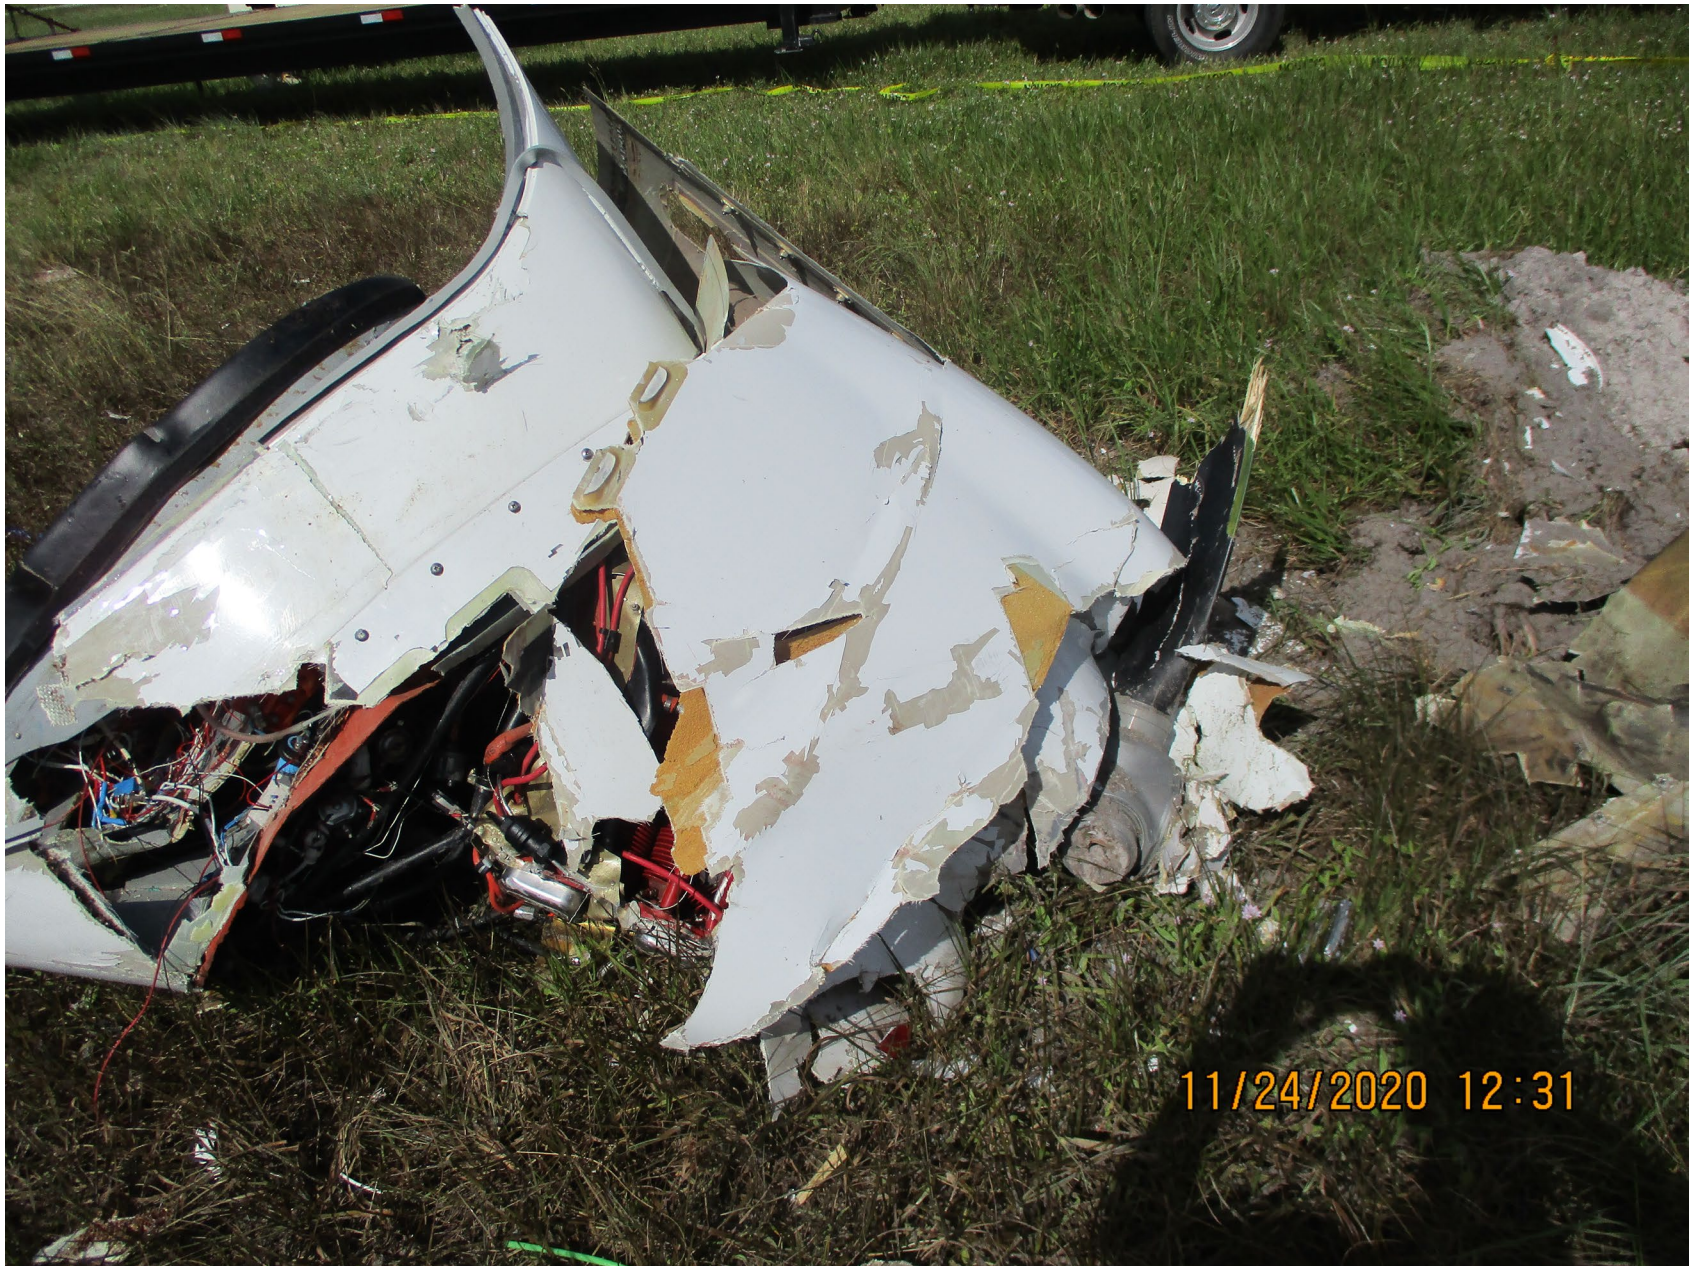
**Photo 2 – Nose Section – Courtesy of FAA**

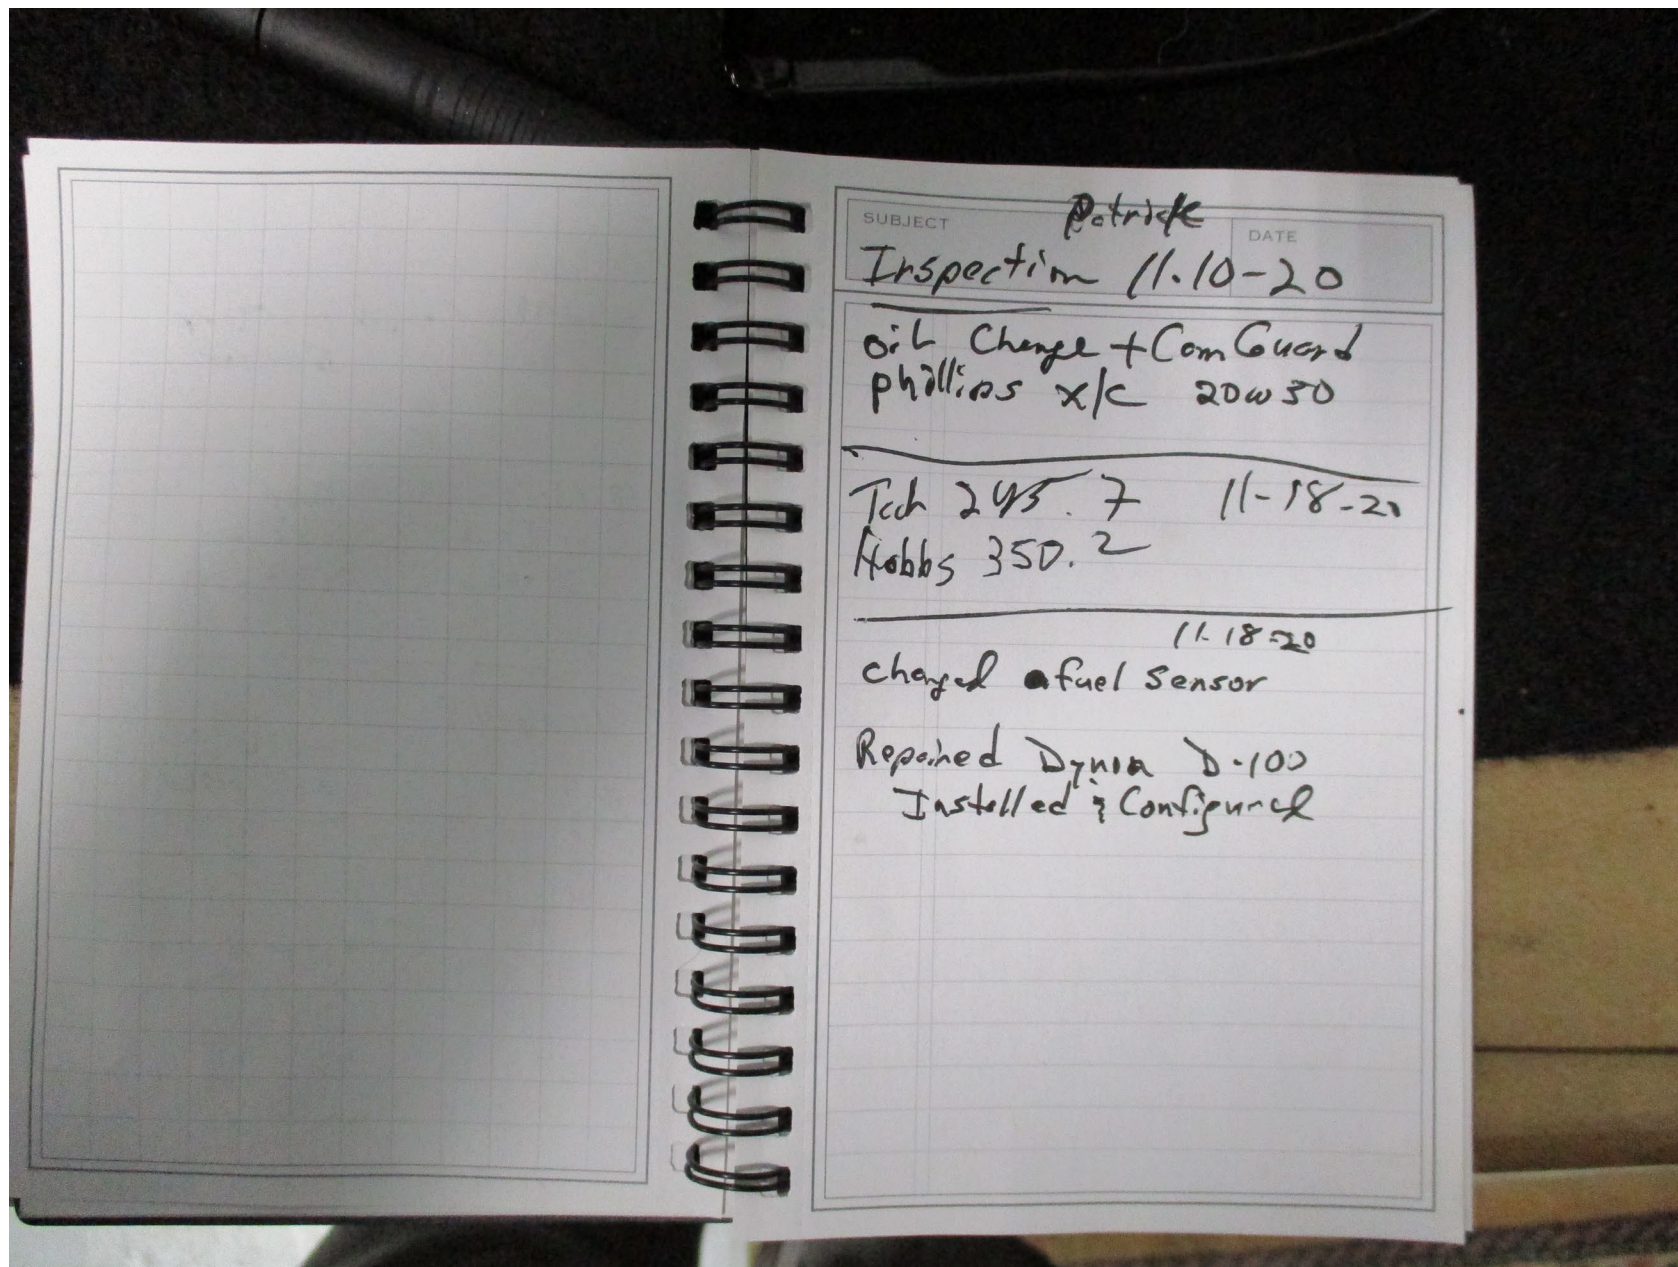
Photo 3 – Notebook Entry with Required Inspection Date and Name – Courtesy of FAA

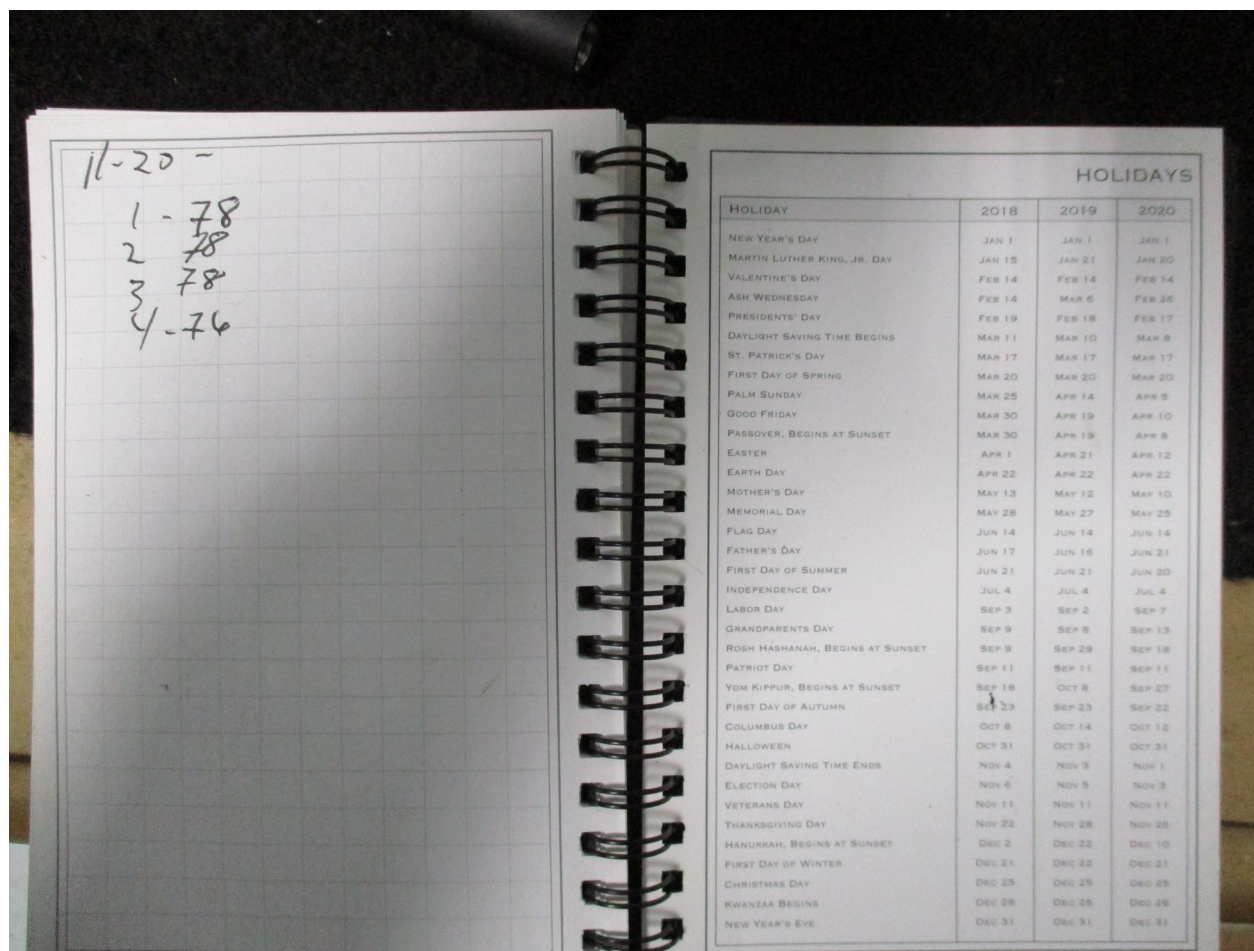
**Photo 4 – Notebook Entry with Partial Date, Cylinder Numbers and Compression – Courtesy of FAA**

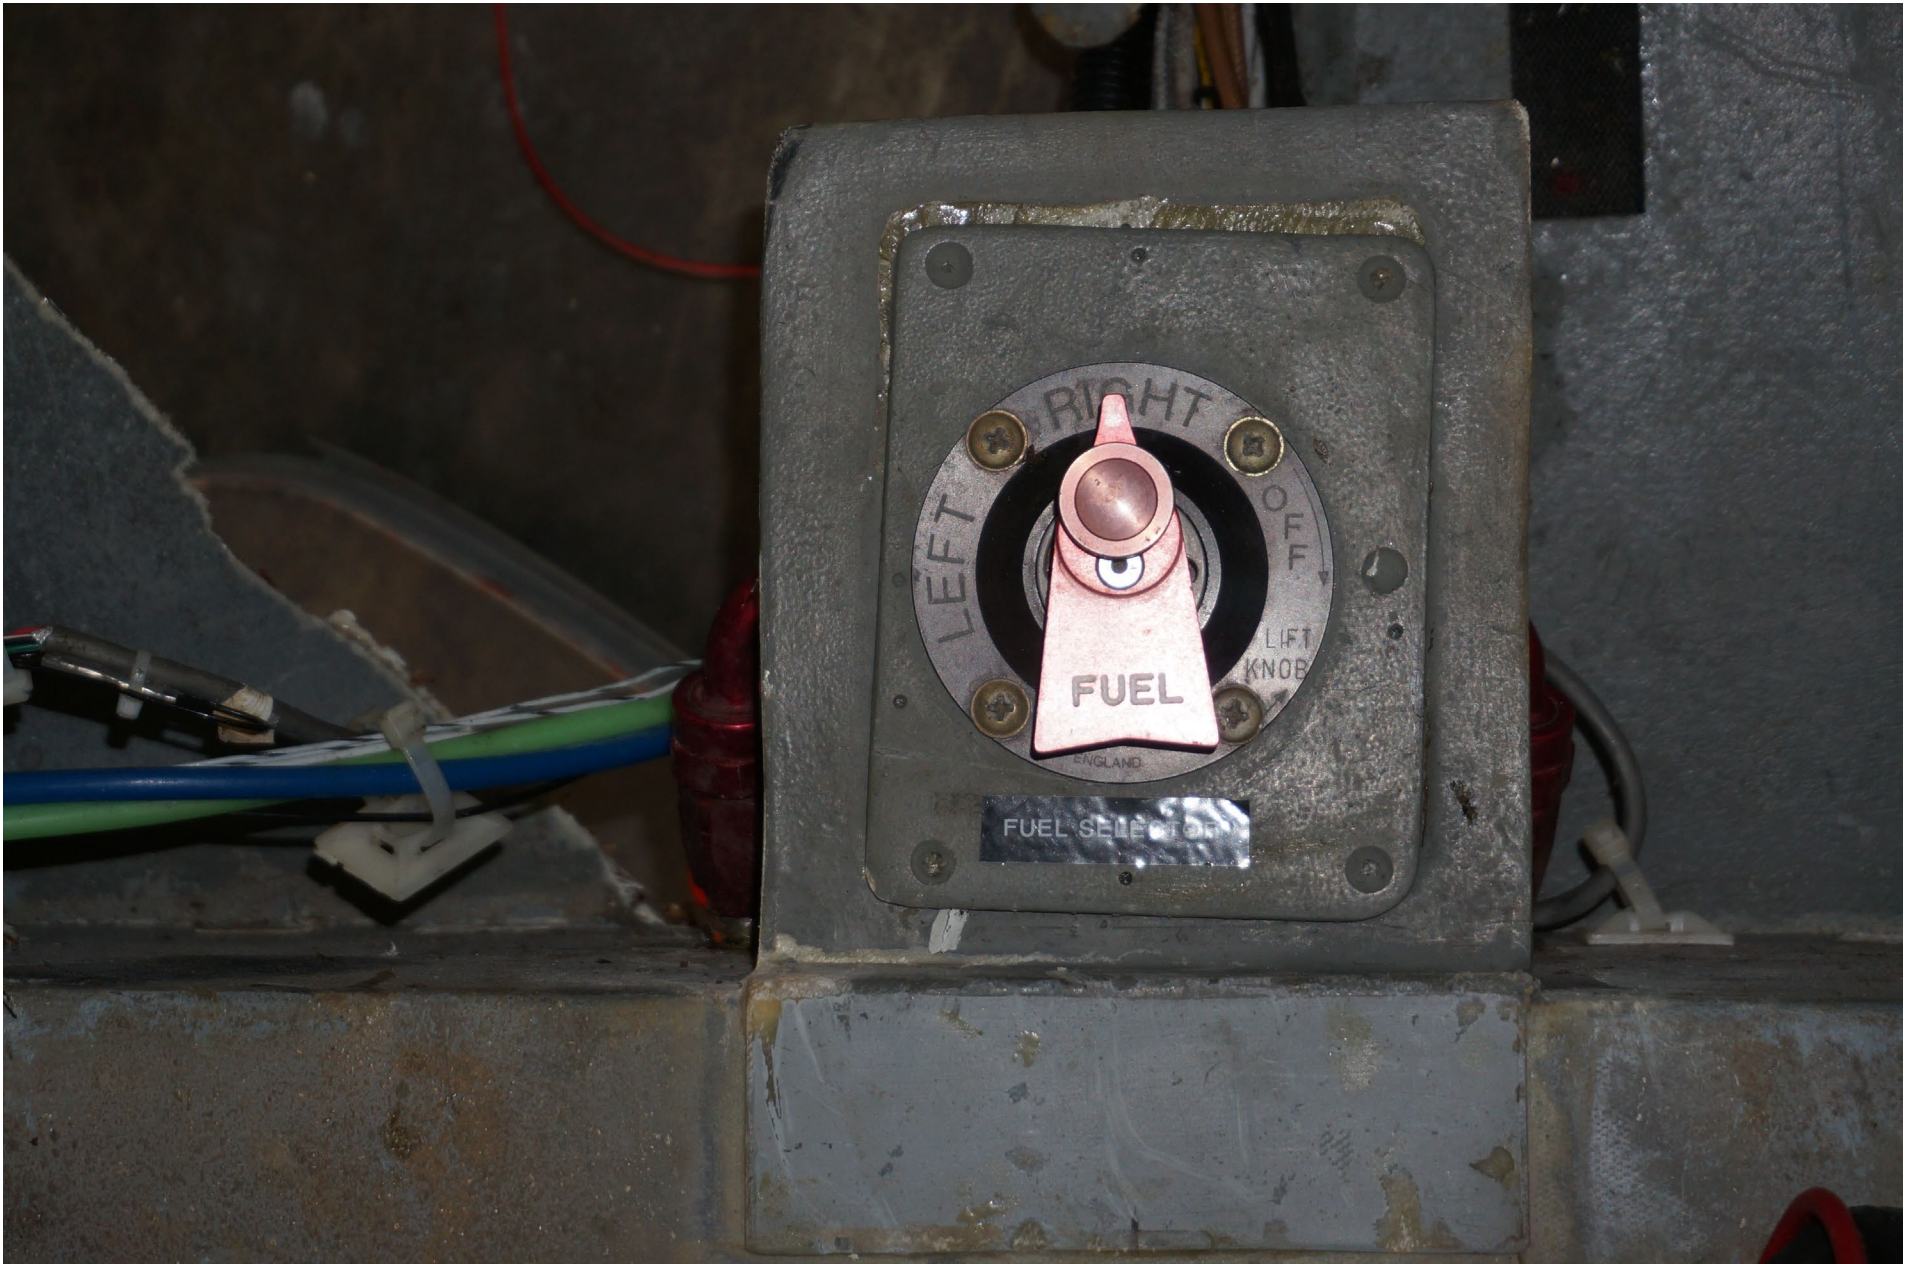
**Photo 5 – Fuel Selector**

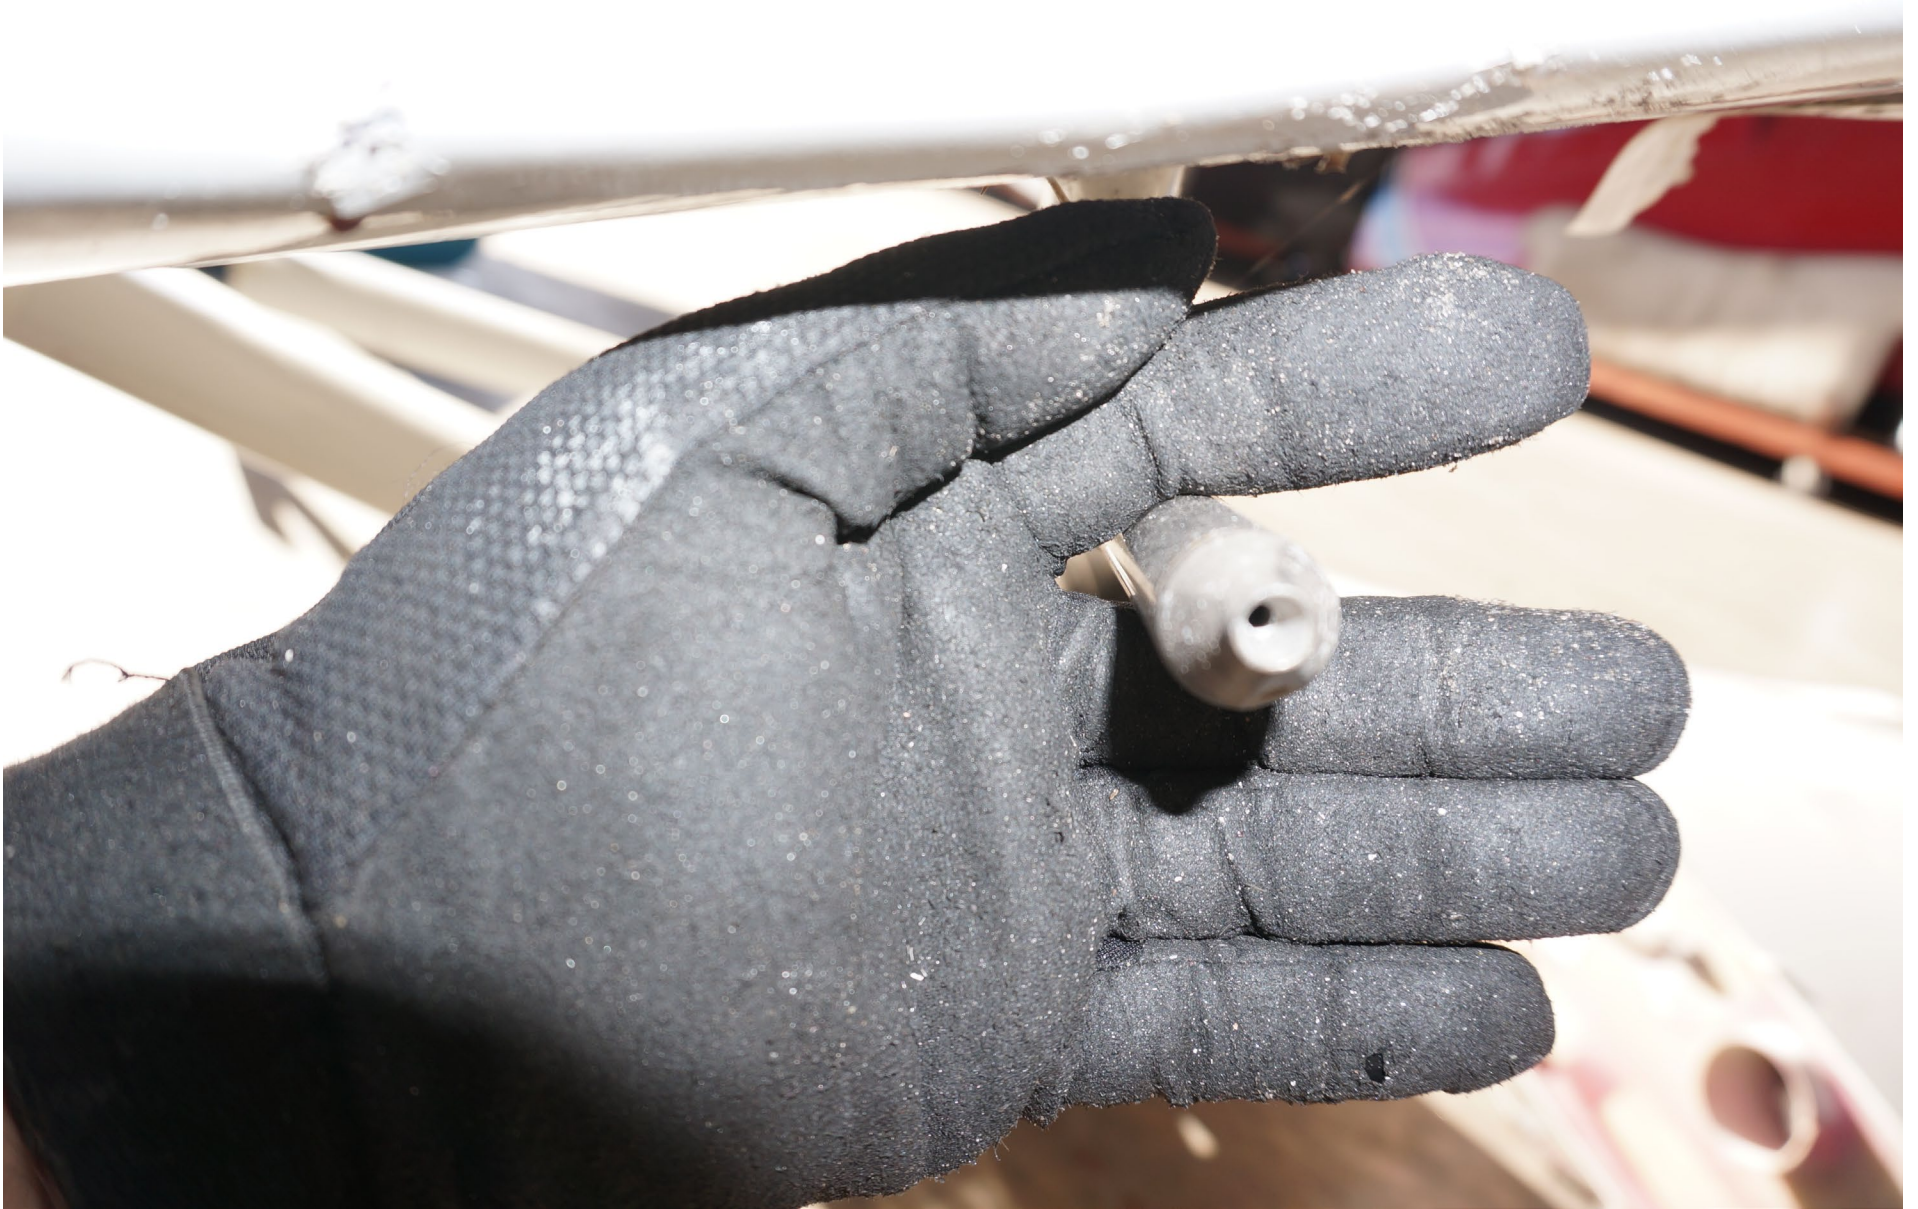
**Photo 6 – Pitot Tube**

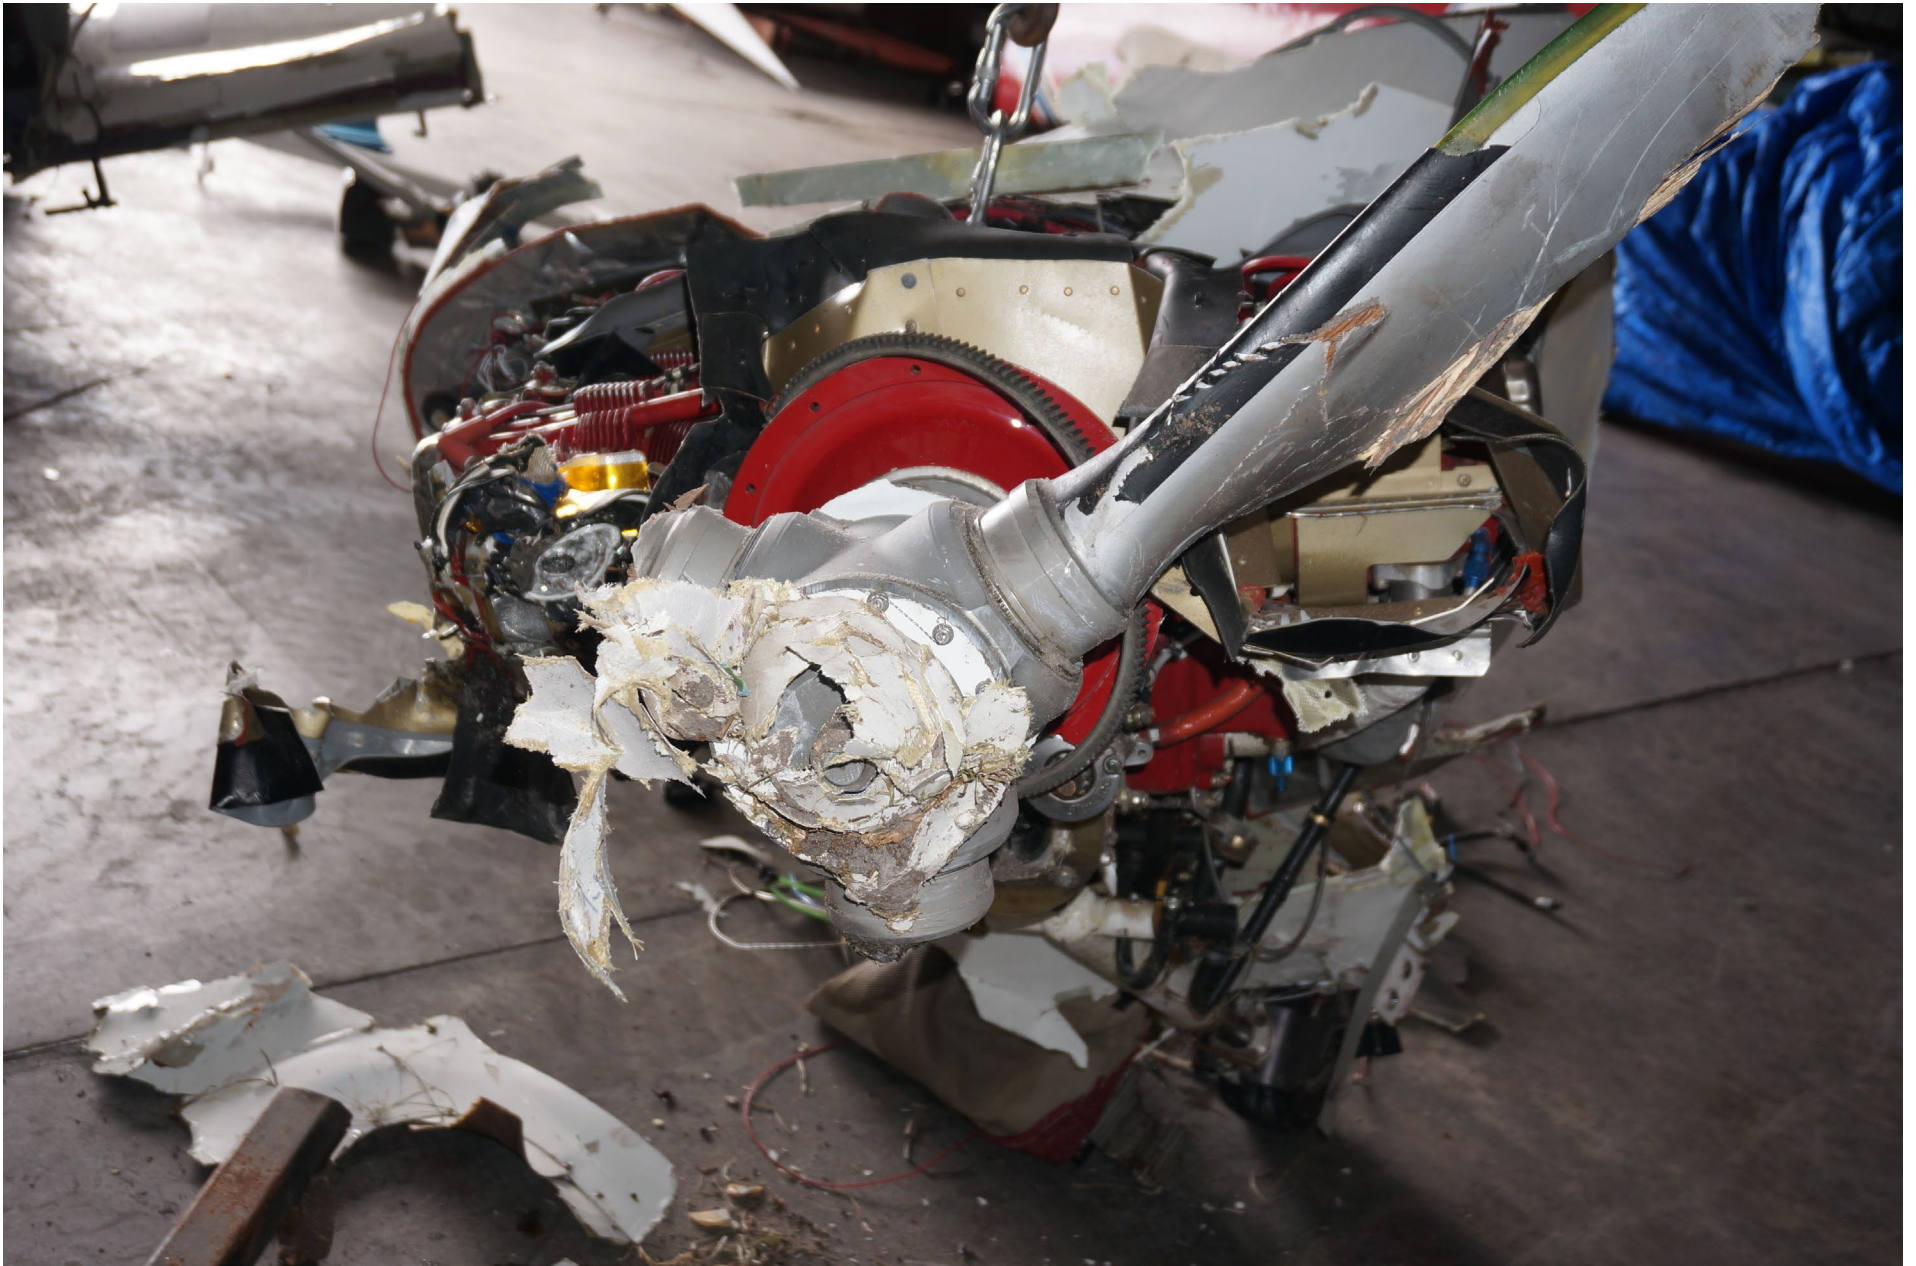
**Photo 7 – Propeller and Front of Engine**

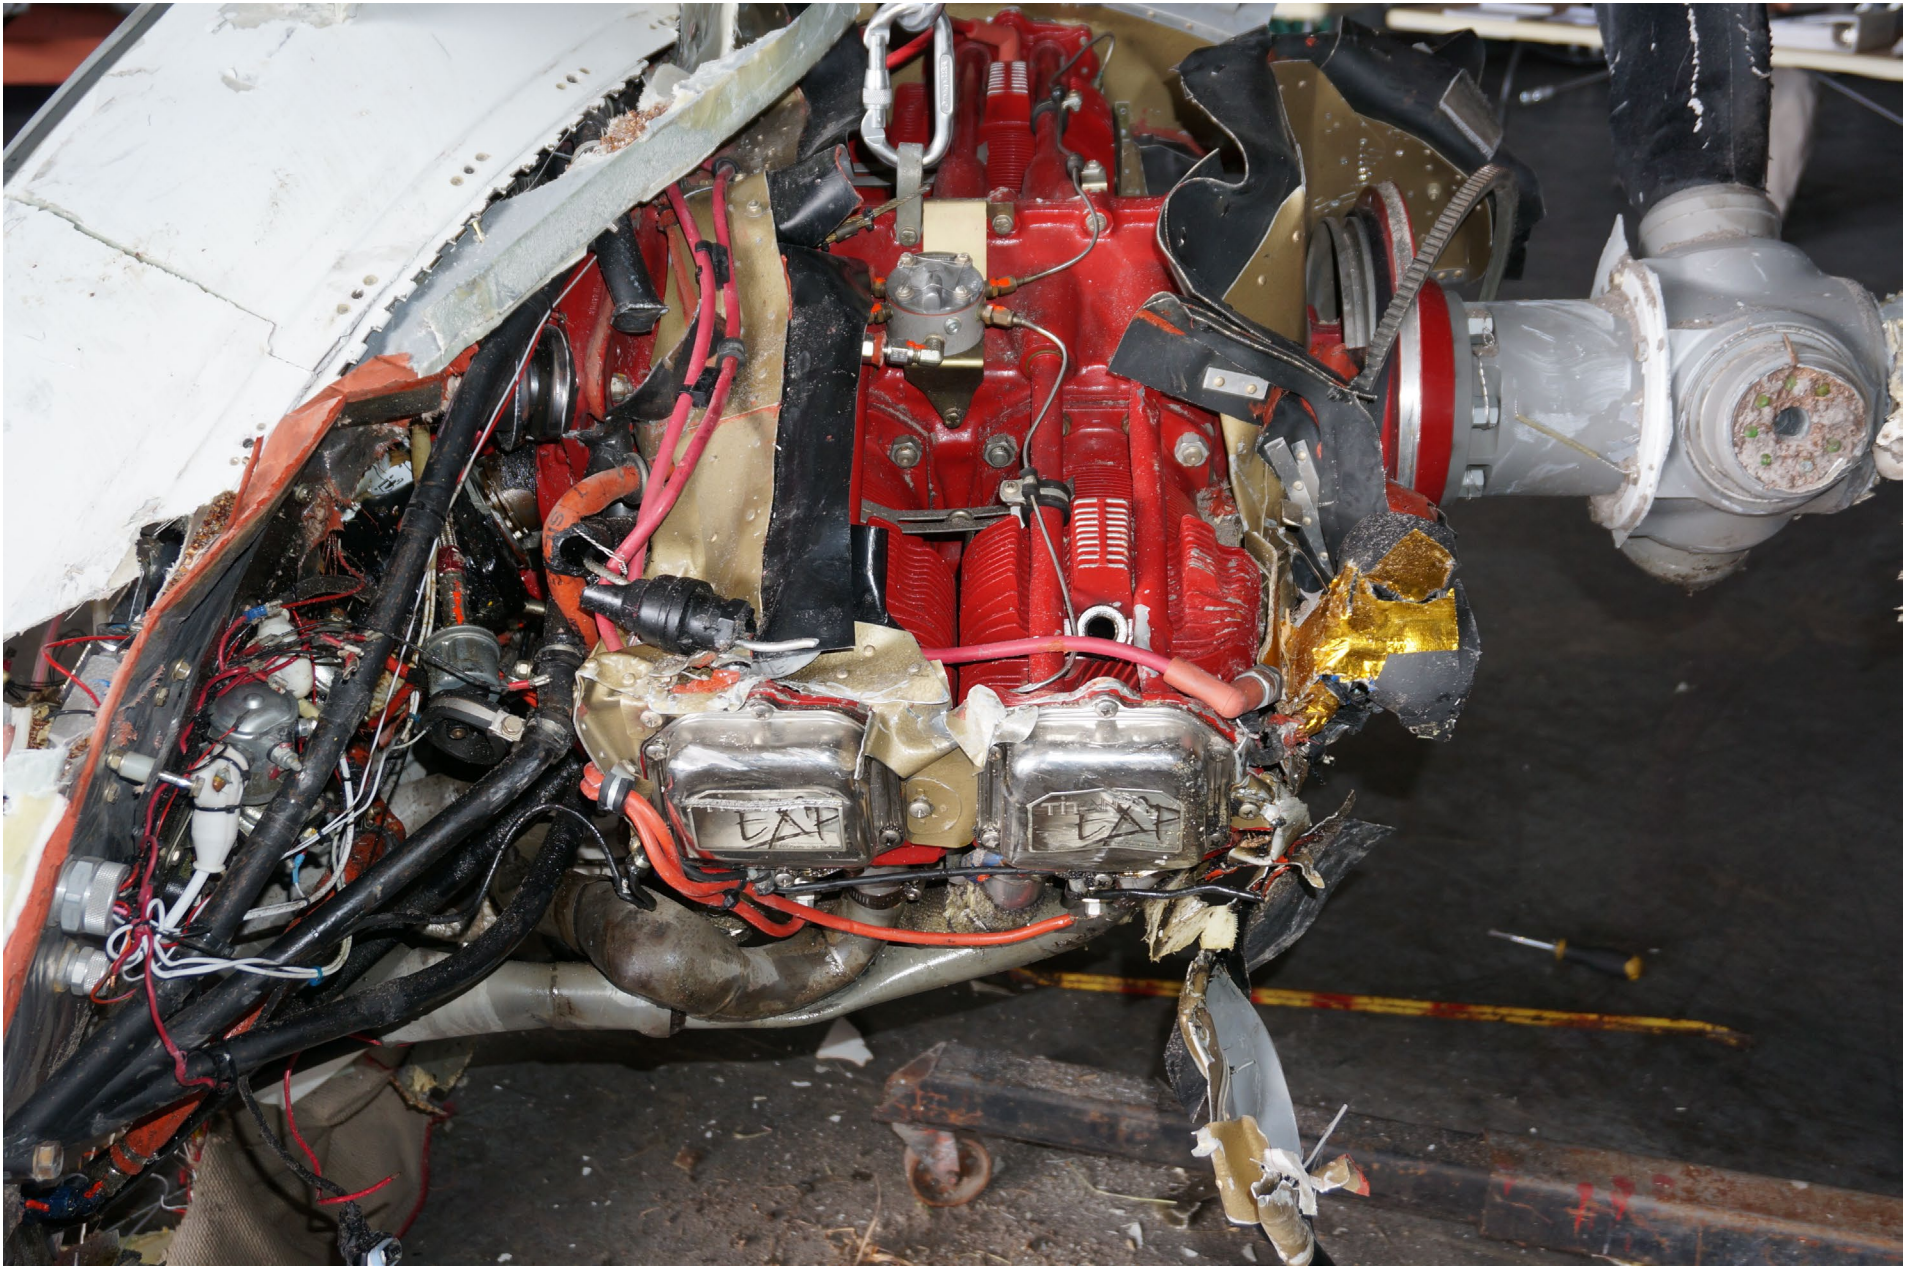
**Photo 8 – No. 1 Cylinder**

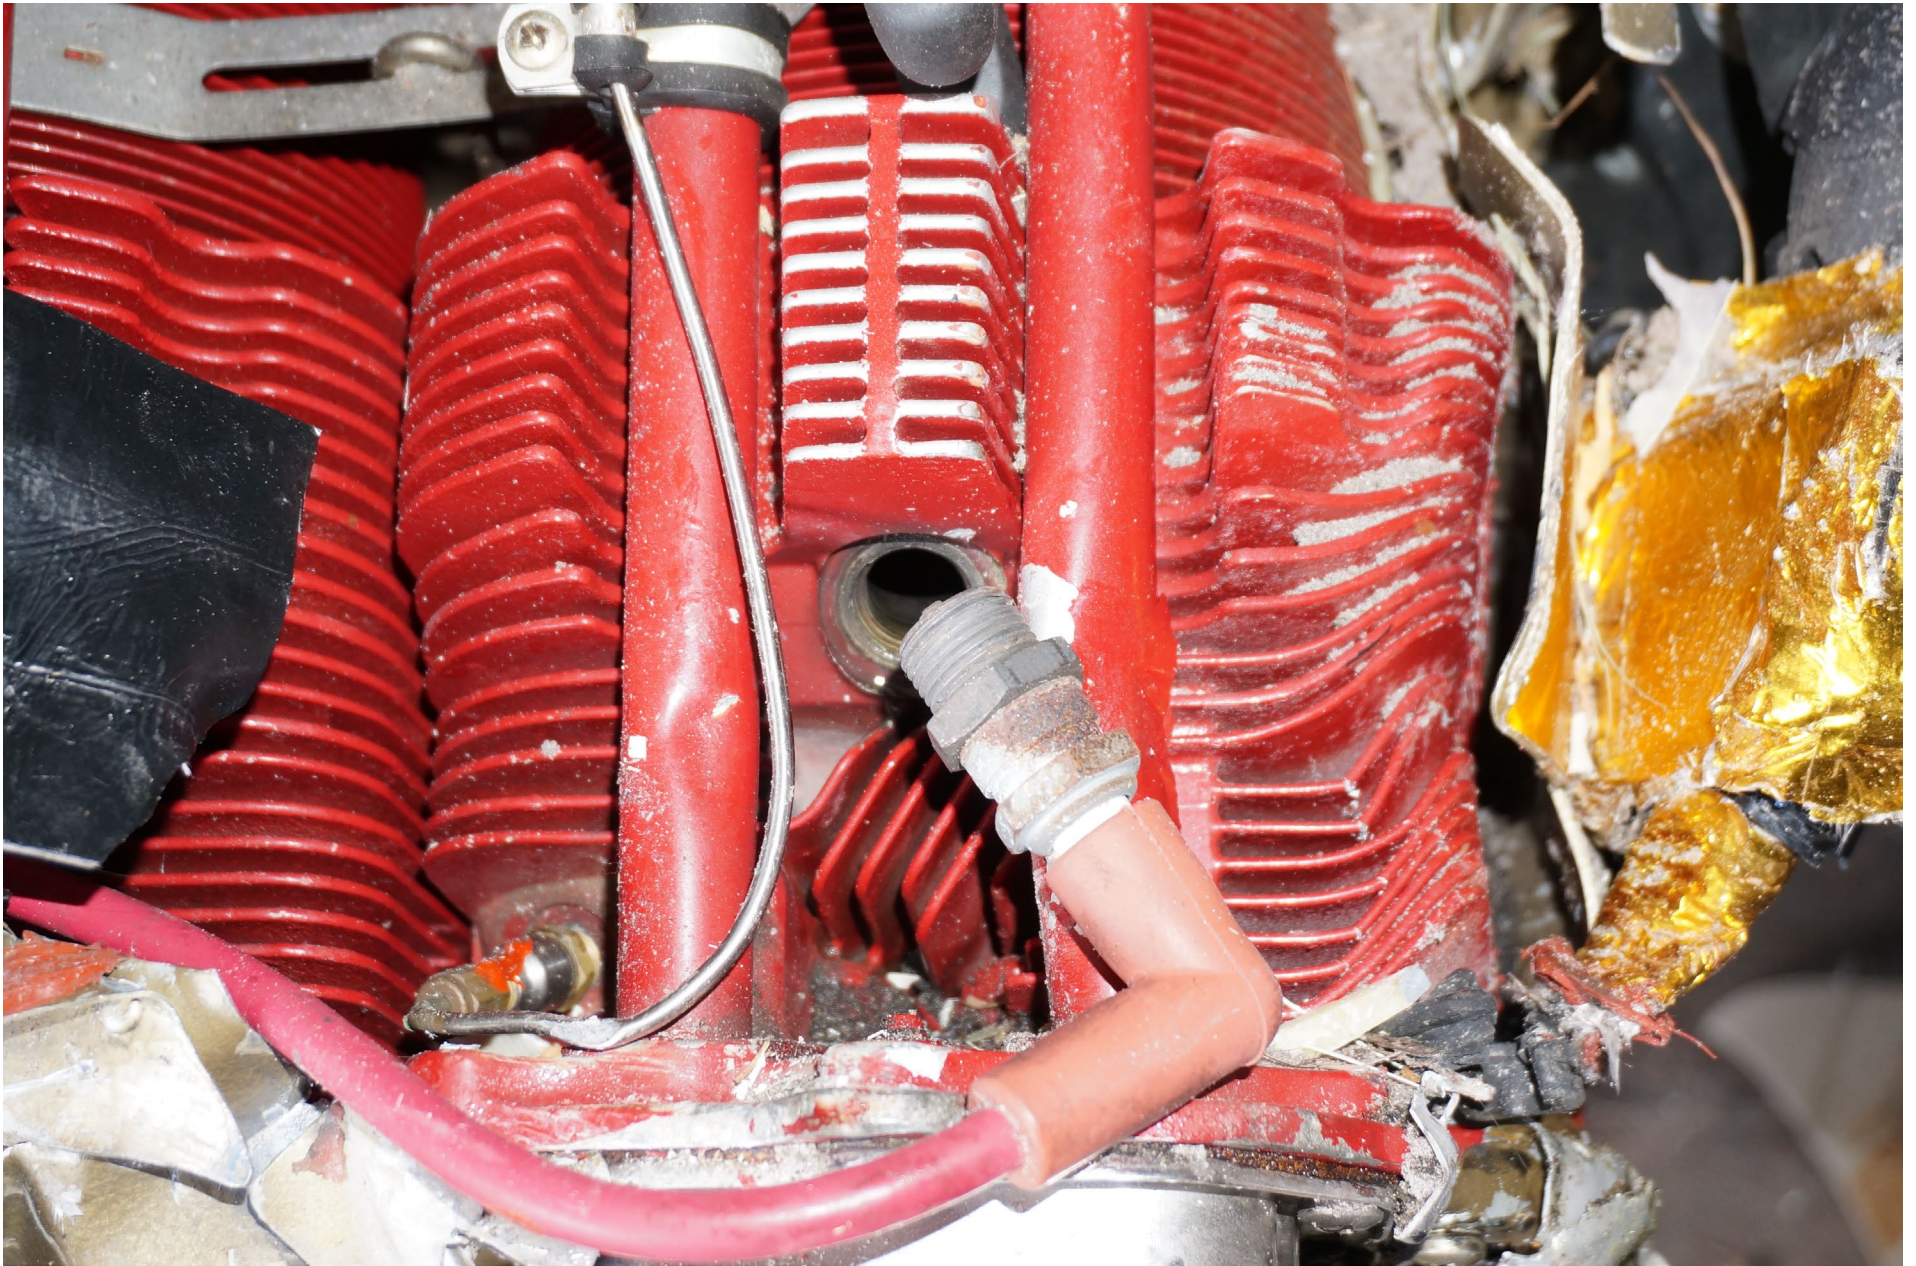
**Photo 9 – No. 1 Top Spark Plug and Adaptor**

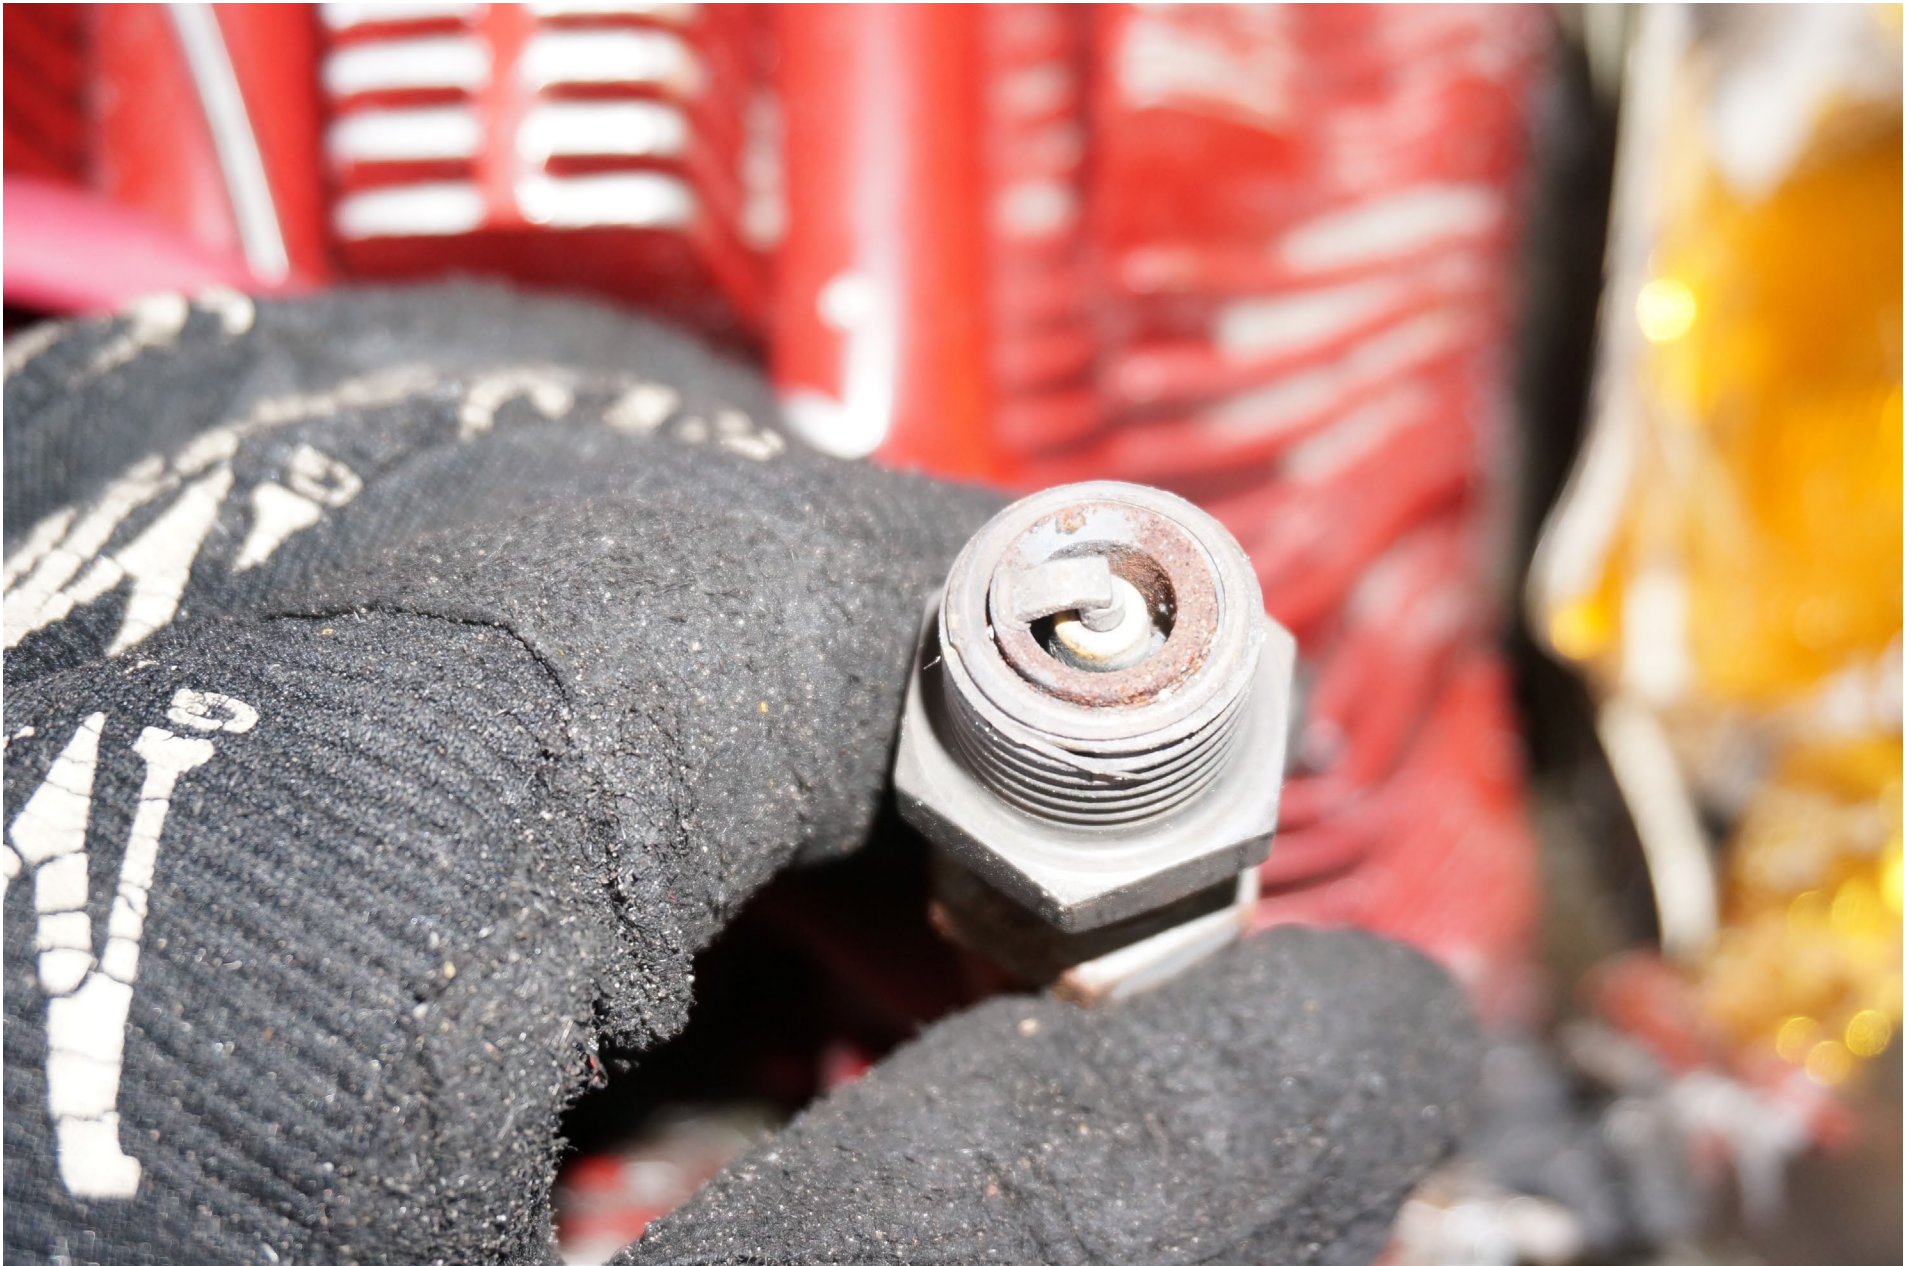
**Photo 10 – Damaged Threads on Adaptor**
