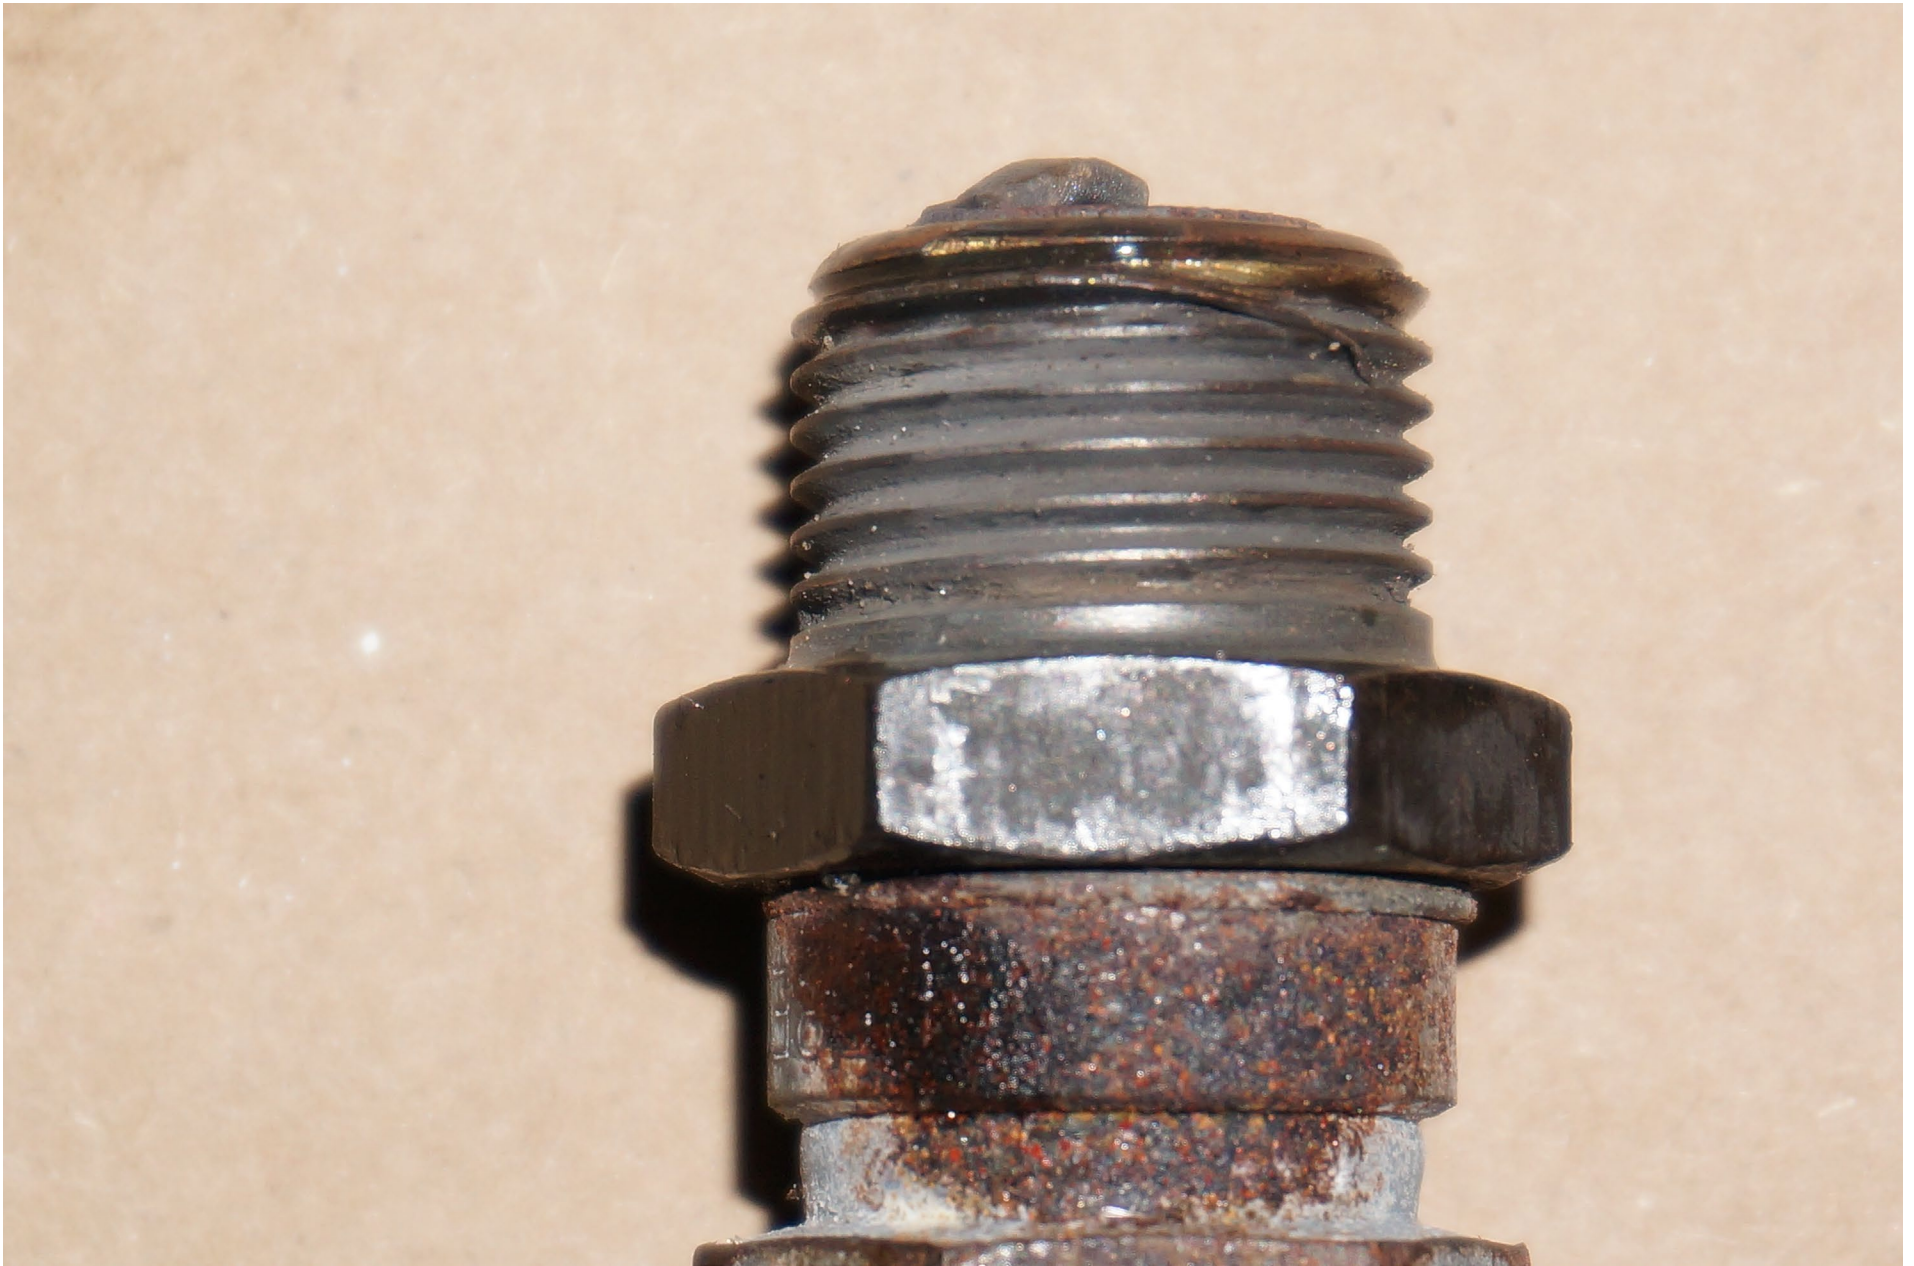
**Photo 11 – Close Up of Damaged Threads on Adaptor**

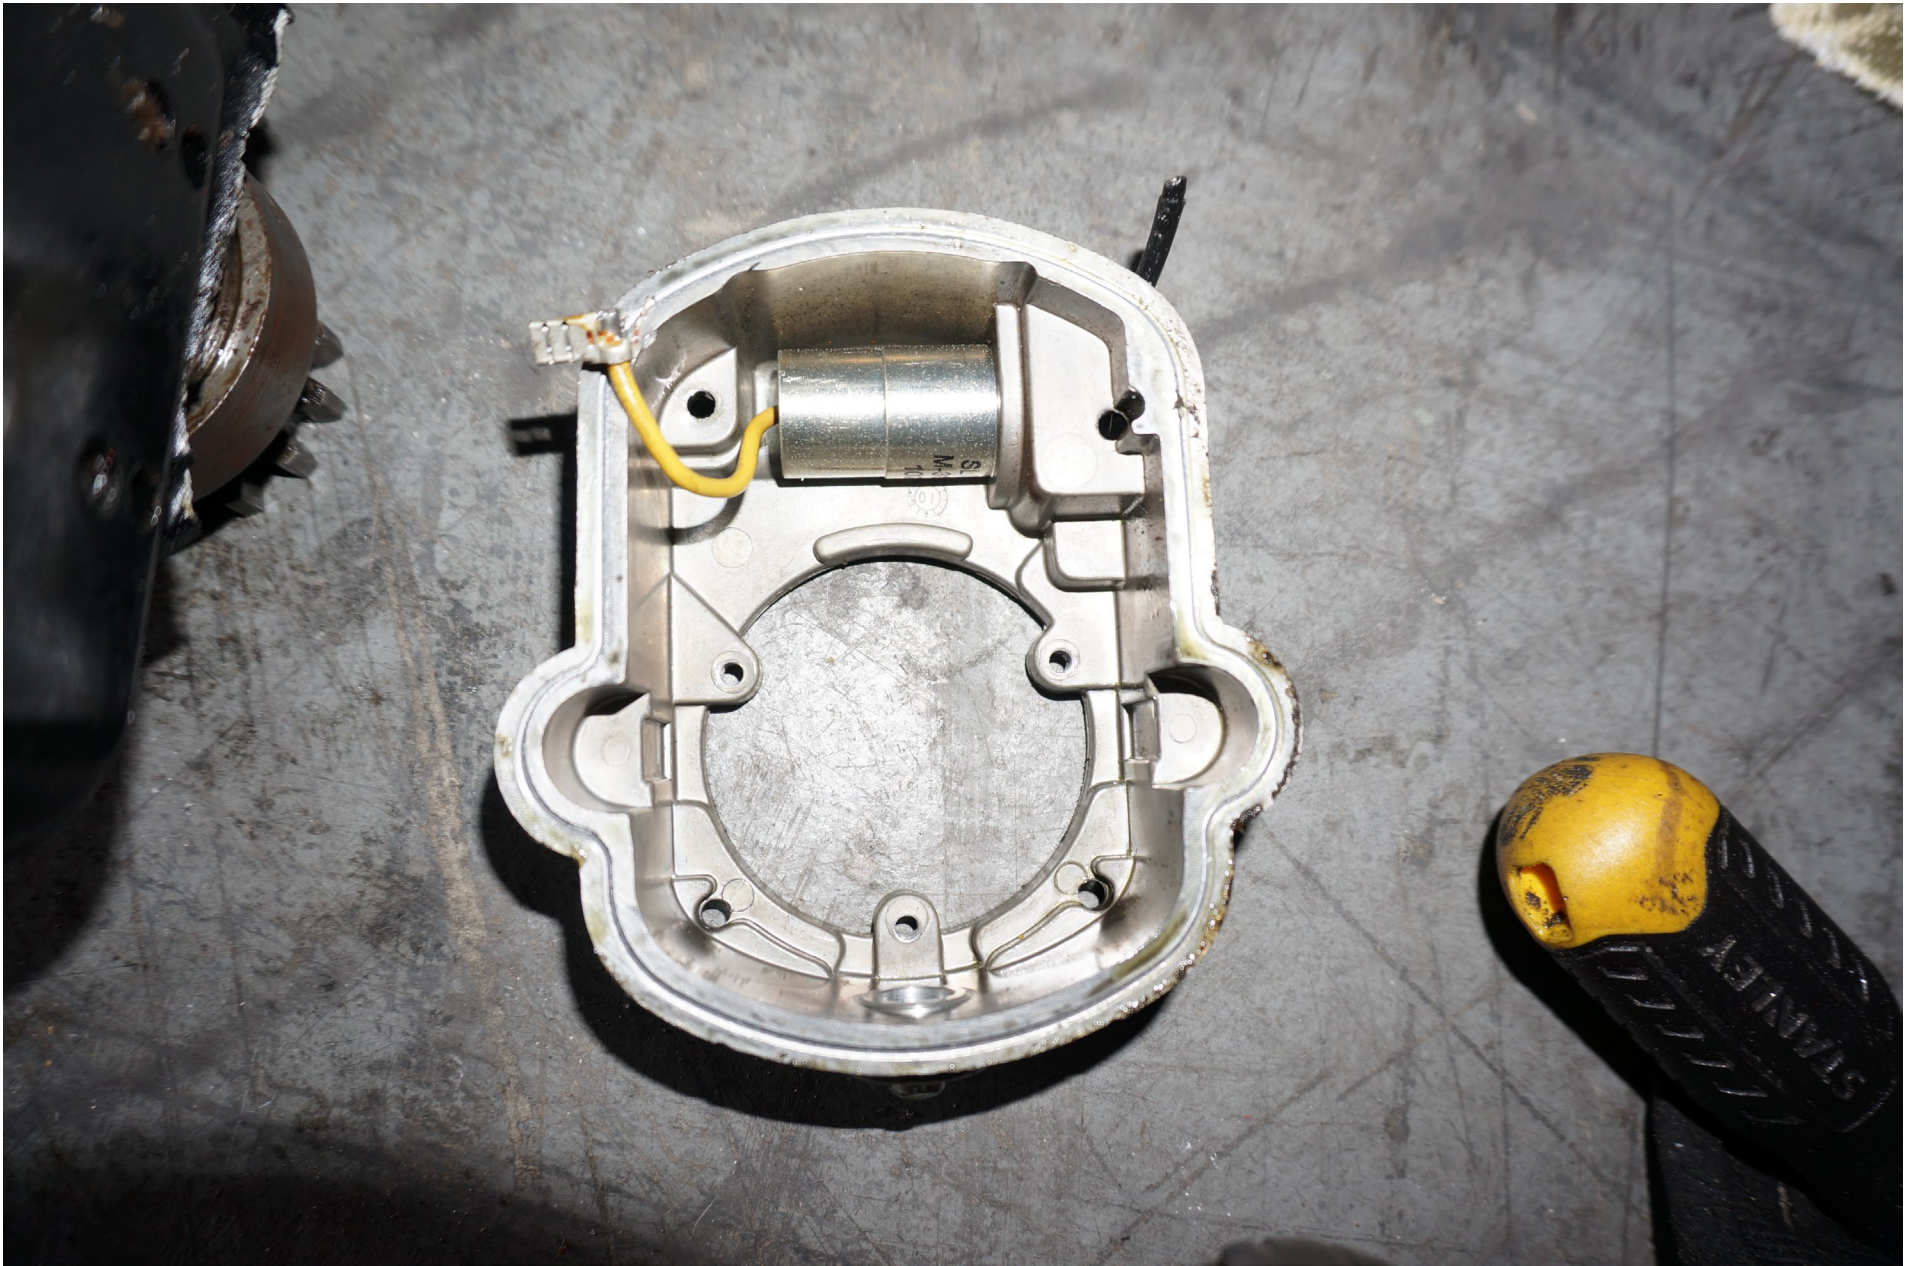
**Photo 12 – Interior of Magneto Cover**

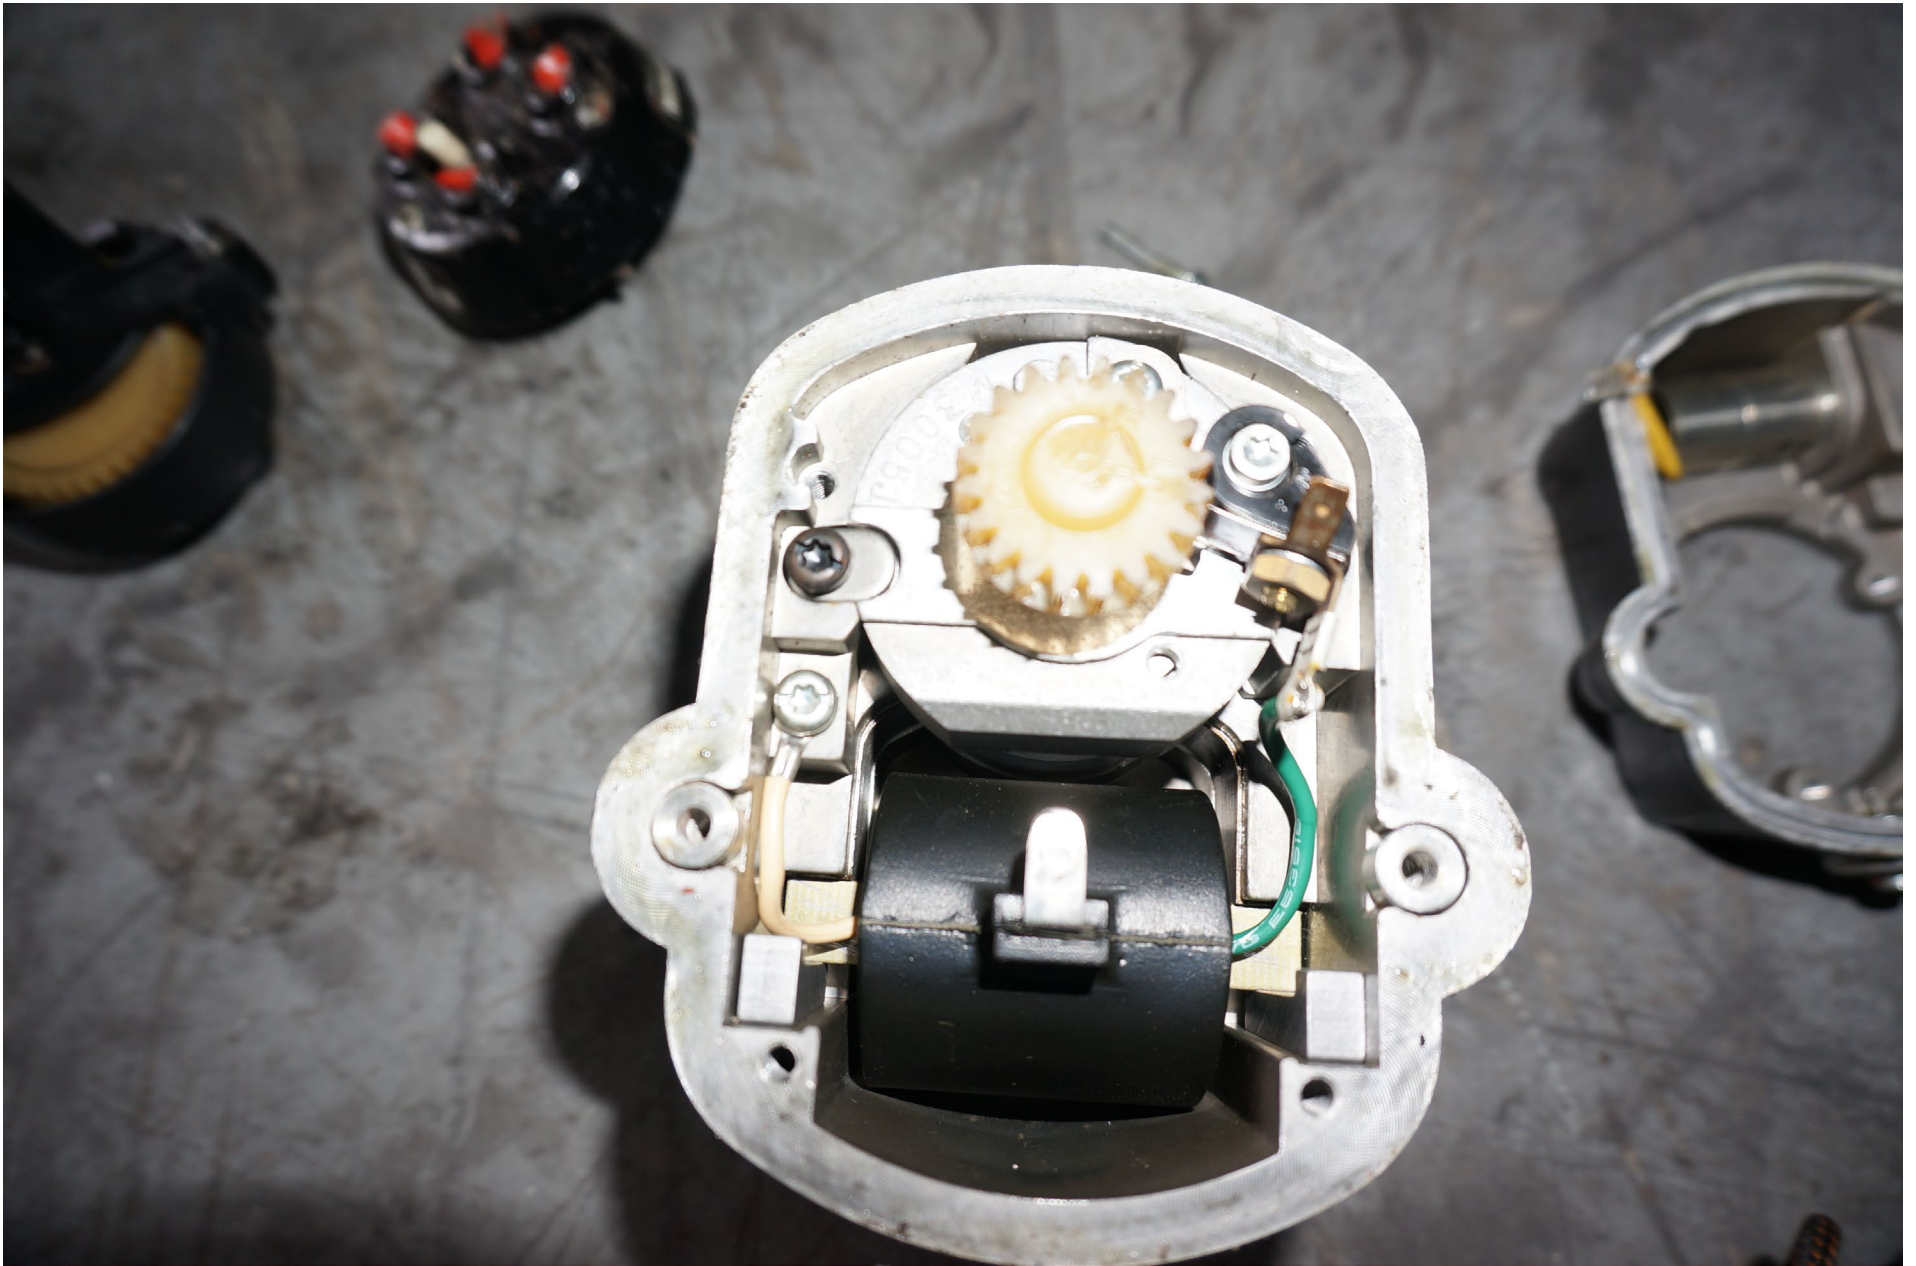
**Photo 13 – Interior of Magneto Case**
