### Carburetor Icing Probability Chart

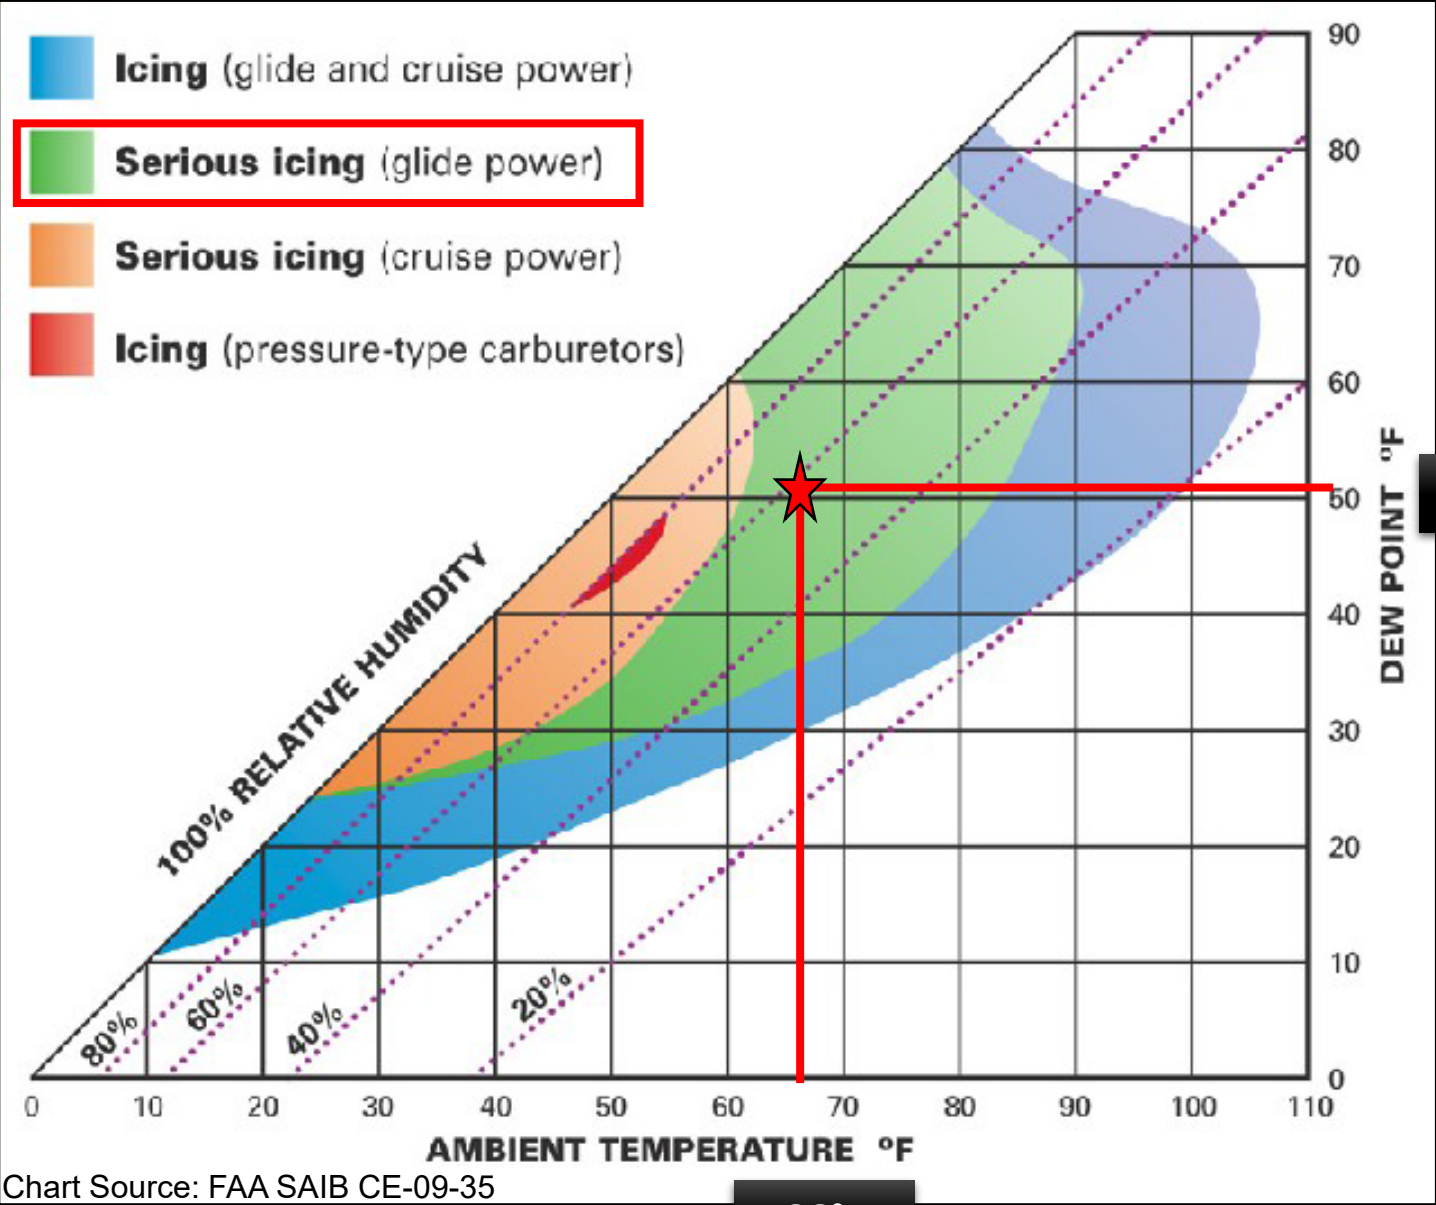
At 1255 central standard time, the weather conditions reported at KJWN, about 7 nm from the accident site was as follows:

METAR KJWN 121855Z AUTO 23010KT  
10SM FEW032 FEW037 SCT047 19/11  
A2984 RMK A01=

Temperature: 66°F (19°C)  
Dewpoint: 51°F (11°C)

51°F

66°F
