**NATIONAL TRANSPORTATION SAFETY BOARD**  
Vehicle Recorder Division  
Washington, D.C. 20594

## **Engine Data Monitor (EDM)**

**Specialist's Factual Report**  
**By Gerald Kawamoto**

Location: Columbia, South Carolina  
Date: January 13, 2021  
Aircraft: Beech F33  
Registration: N266DC  
Operator: Private  
NTSB Number: ERA21LA101

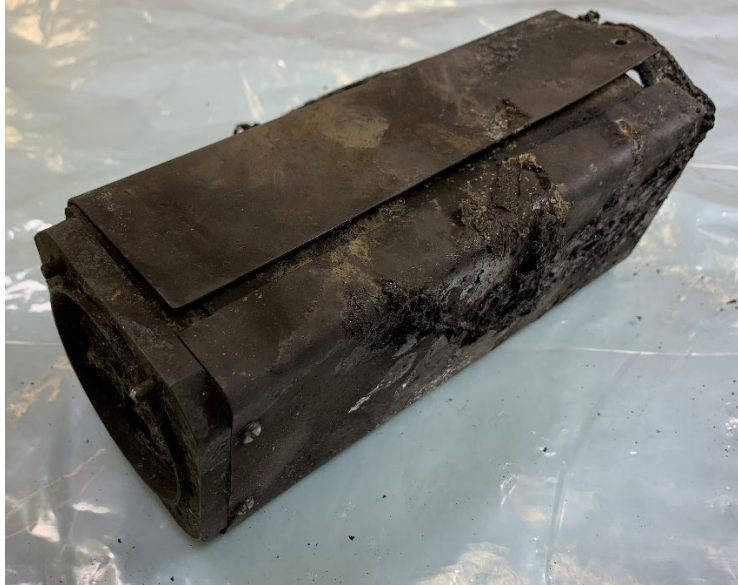
Upon arrival at the Vehicle Recorder Laboratory, an external examination revealed the device had sustained fire damage, as shown in Figure 1. An internal examination revealed fire damage to the internal components, as shown in Figure 2. The non-volatile memory chips were removed, cleaned, readout, and converted to engineering units using laboratory tools.

**Figure 1. Damaged exterior of EDM.**

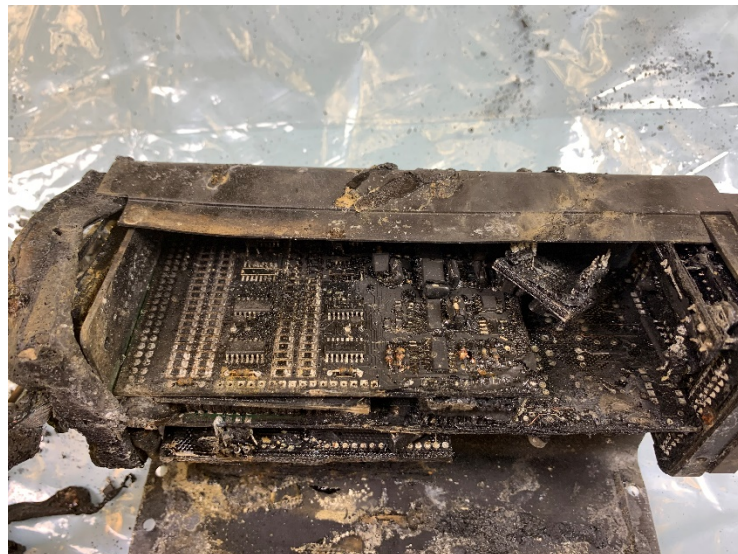
**Figure 2. Damaged interior of EDM.**
