## **MEMORANDUM FOR RECORD**

### **Instrument Examination**

Date: March 17, 2021  
Instrument Examined: N266DC - Directional Gyro  
NTSB Accident #: ERA21LA101

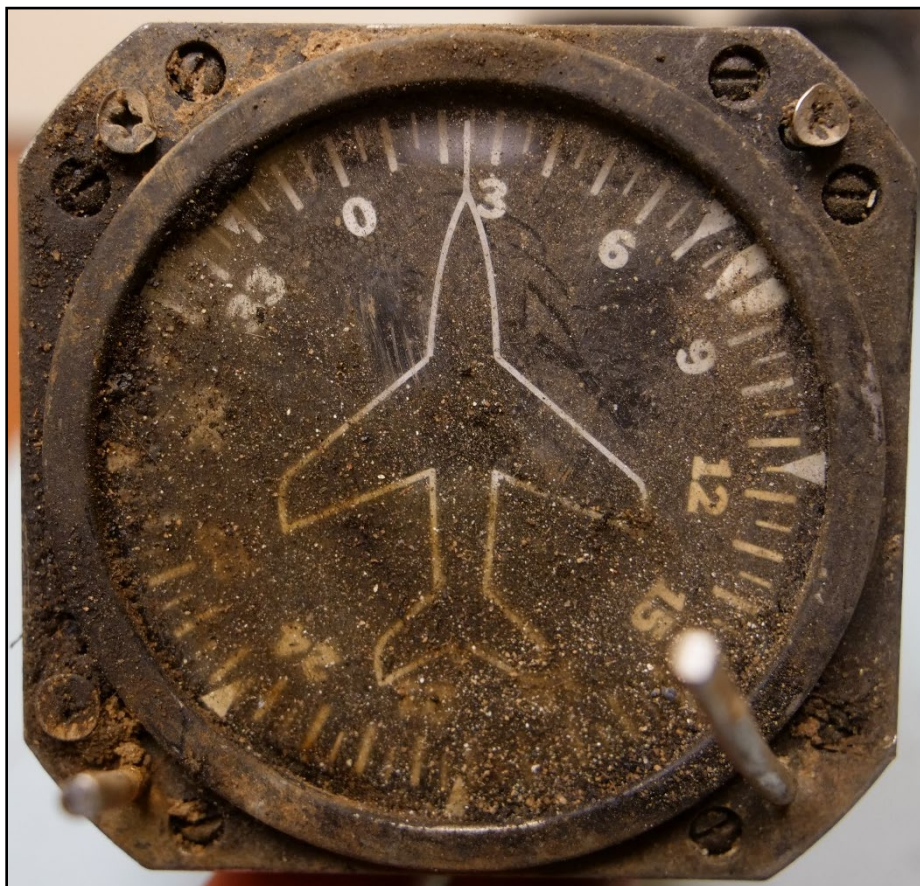
**Photograph 1 – Accident airplane - directional gyro.**

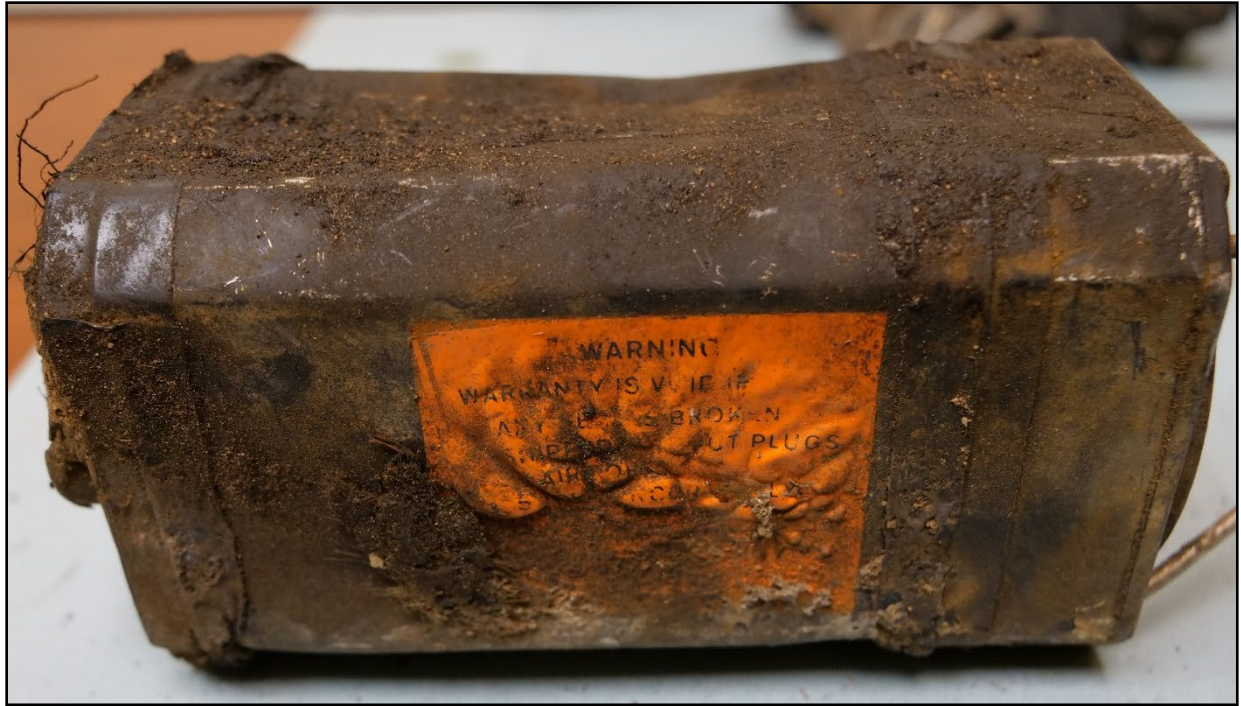
**Photograph 2 – Accident airplane - directional gyro outer case.**

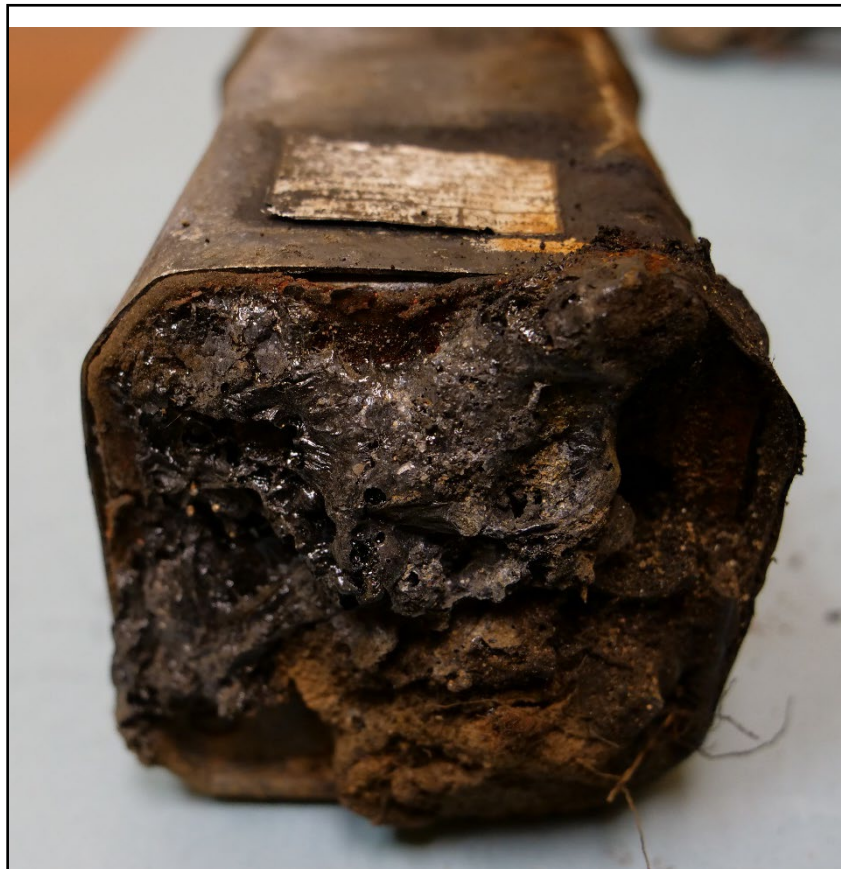
**Photograph 3 – Accident airplane - directional gyro outer case.**

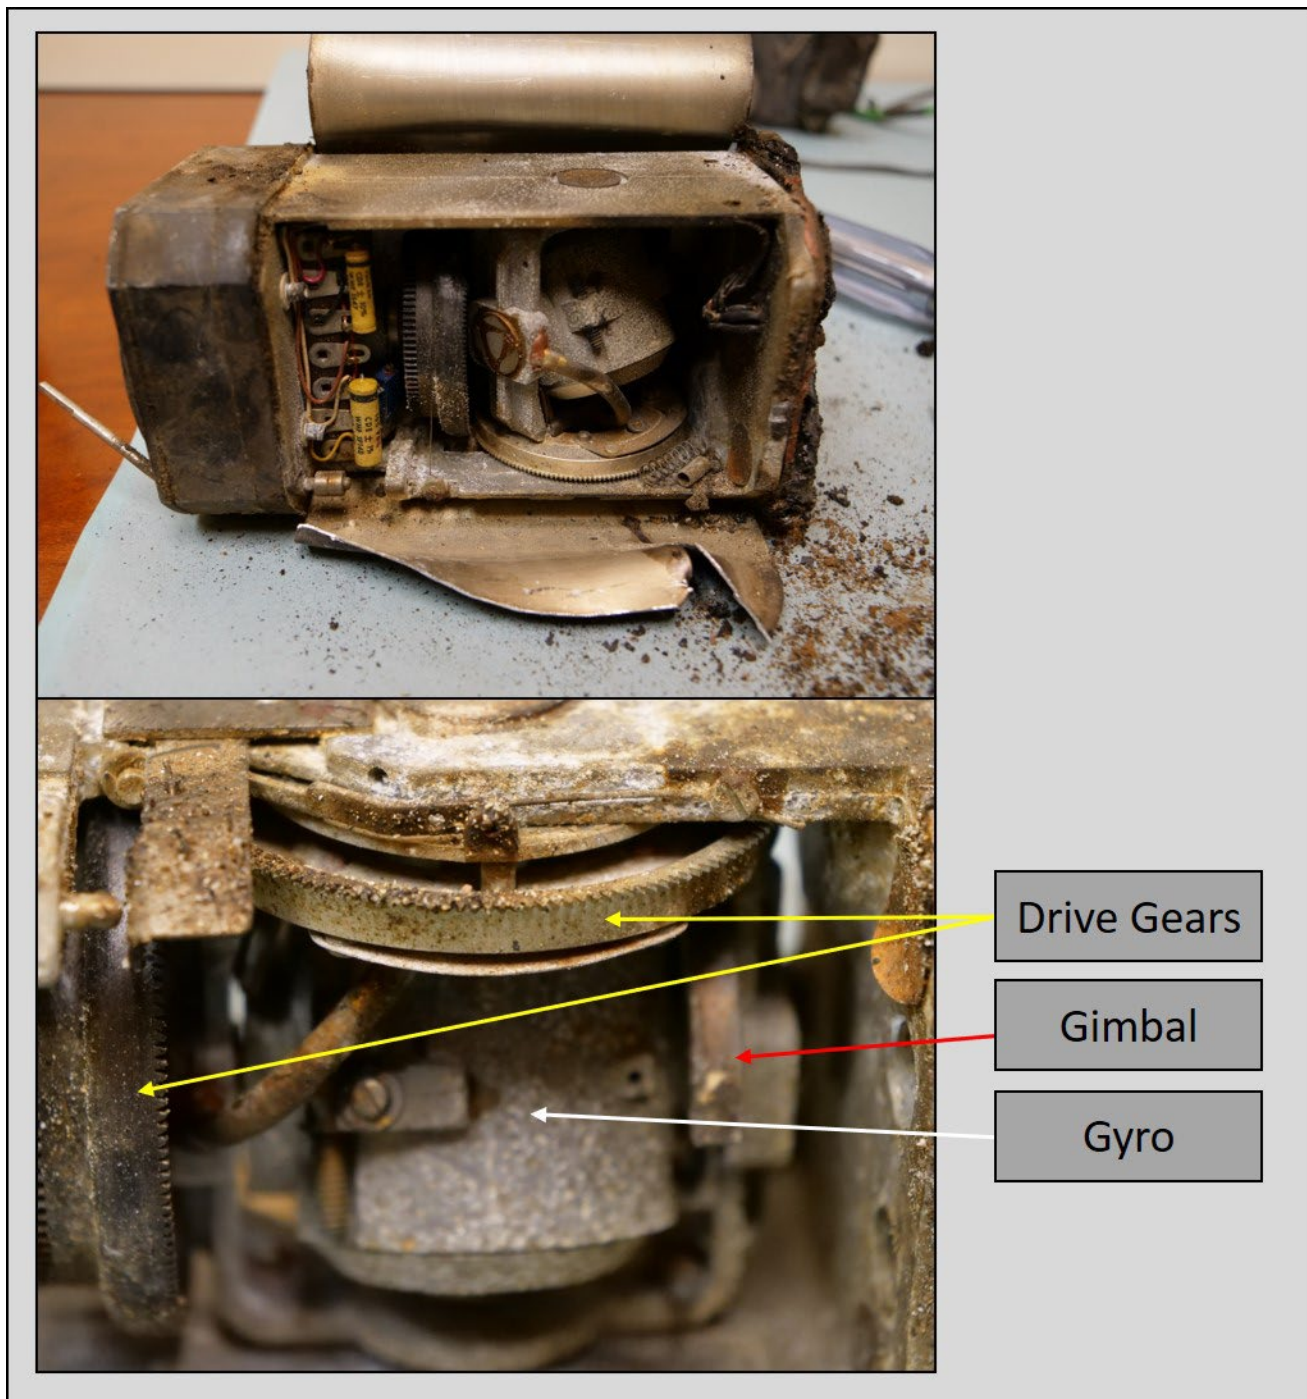
**Figure 1 – Accident airplane - directional gyro inner mechanism.**

The outer DG case was cut open exposing the inner gyro mechanism, drive gears and gimbal. The drive gears rotated freely within the case, and the gyro casing spun within the gimbal freely.

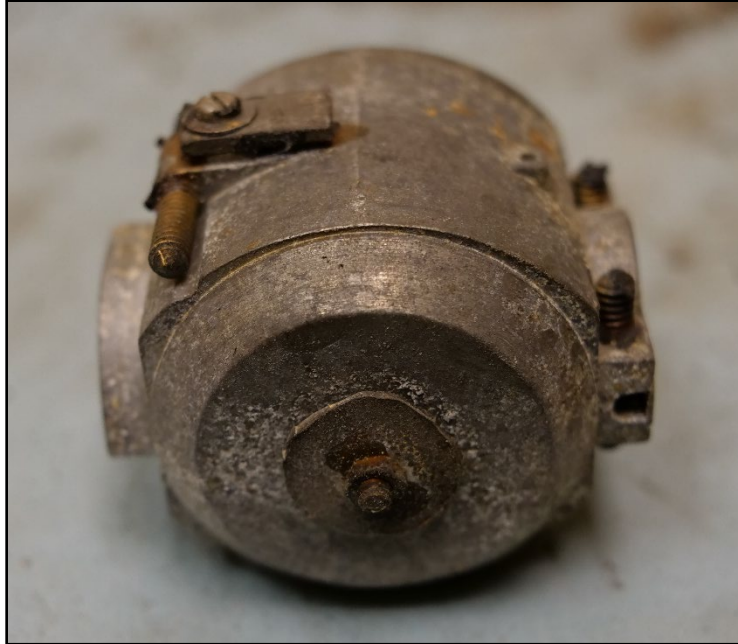
**Photograph 4 – Internal gyro outer case.**

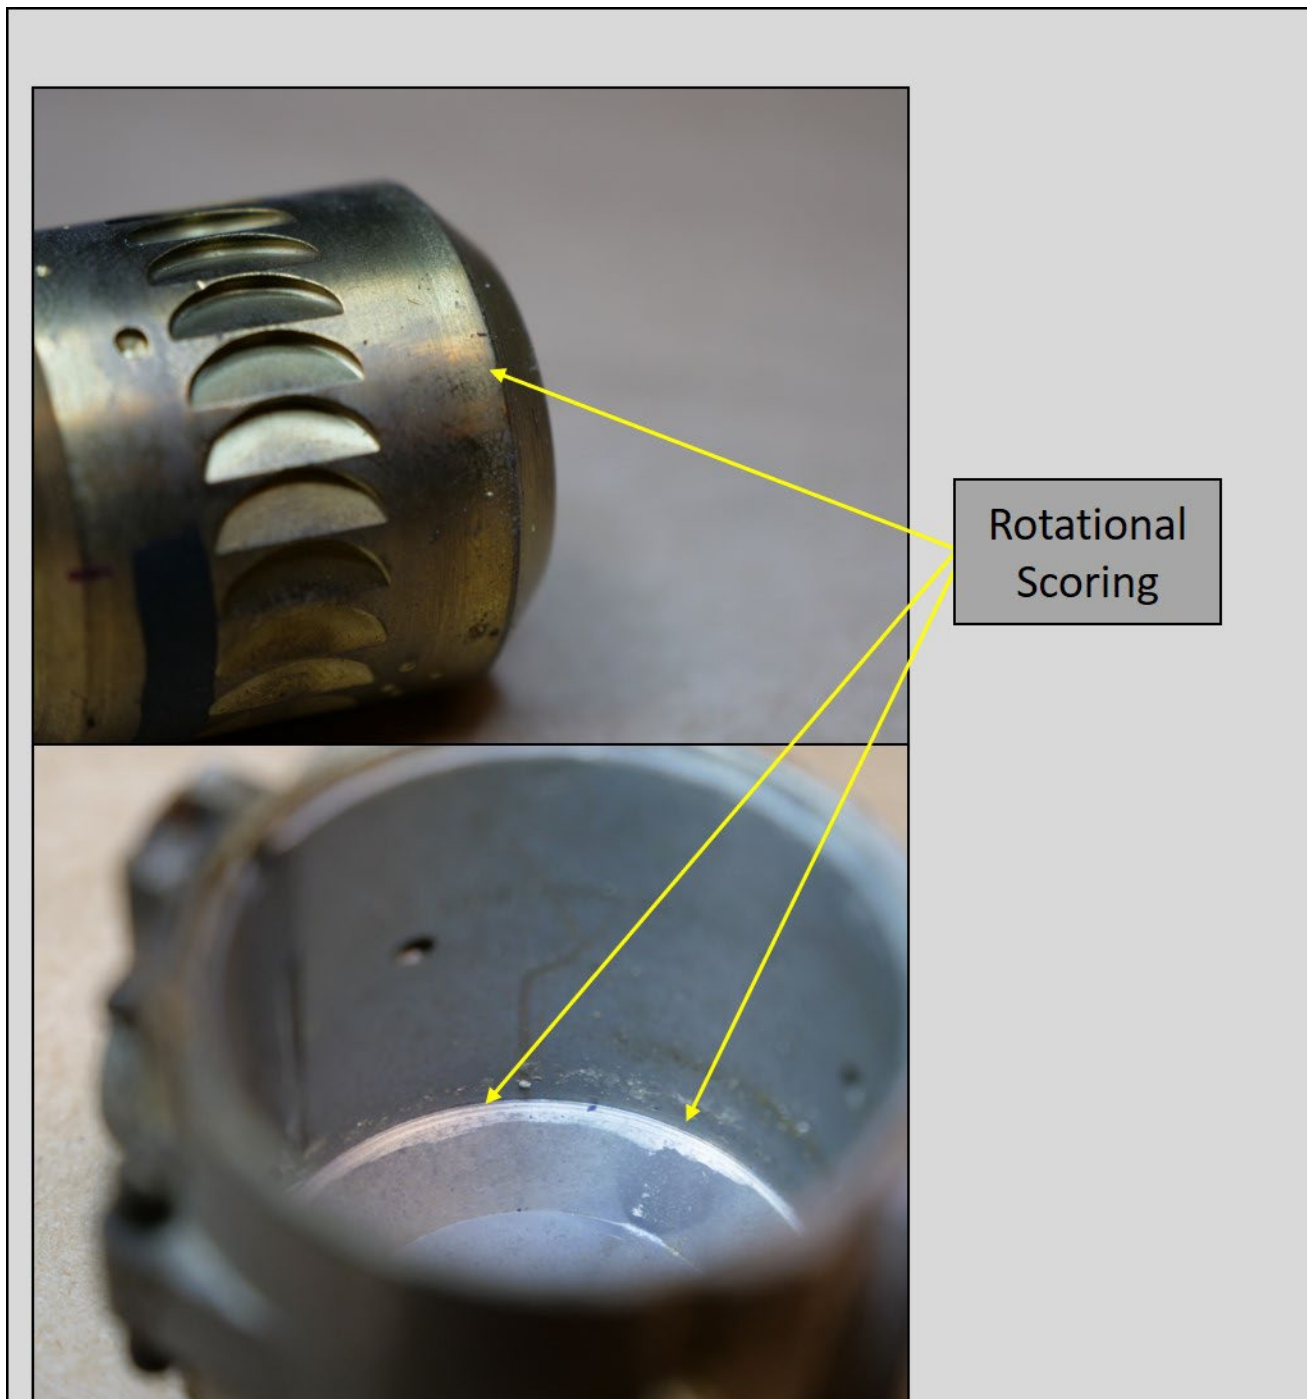
**Figure 2 – Rotational Scoring witness marks.**
