# NATIONAL TRANSPORTATION SAFETY BOARD

## Global Positioning System Device(s)

### Specialist's Factual Report

Location: Palmyra, PA  
Date: April 3, 2021  
Aircraft: Robinson R66  
Registration: N577DD  
Operator: Private  
NTSB Number: ERA21LA171

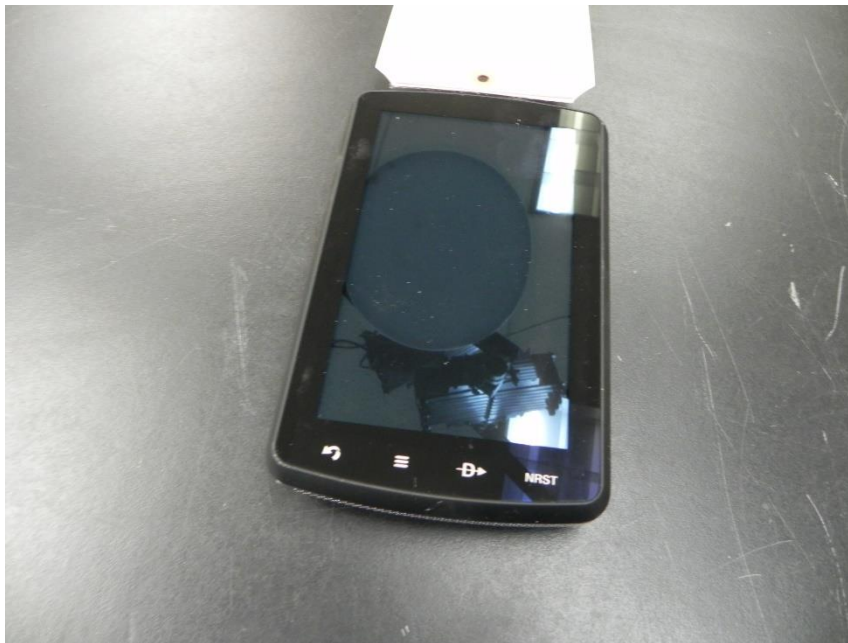
**Figure 1. Photo of one of the 796 devices.**

Two identical devices were sent into the lab. The devices arrived at the Vehicle Recorder Division undamaged. One device is shown in Figure 1. Both devices powered up normally and the data were extracted using the manufacturer's software. Both devices produced a nearly identical dataset, only one device's data is discussed in this report as the other device's data was determined to be redundant.

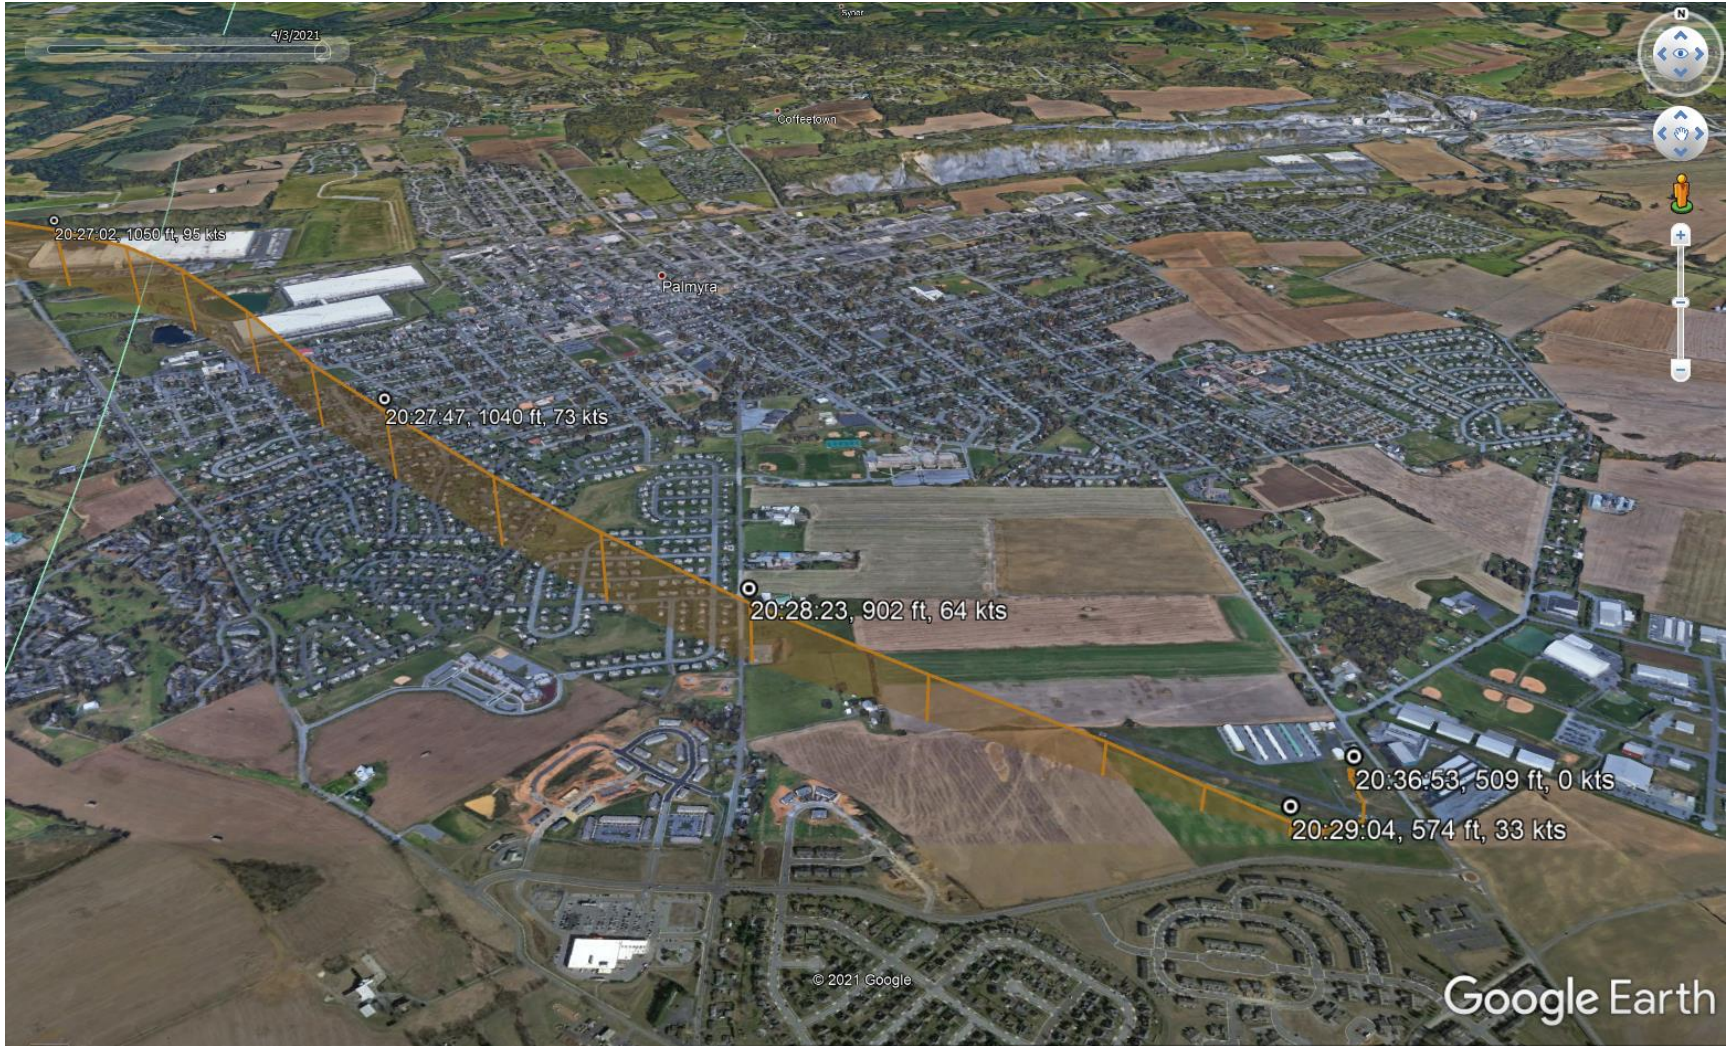
**Figure 3. Google Earth overlay showing the helicopter's approach to 58N.**

Figure 3 is a graphical overlay generated using Google Earth showing the helicopter's approach to 58N.

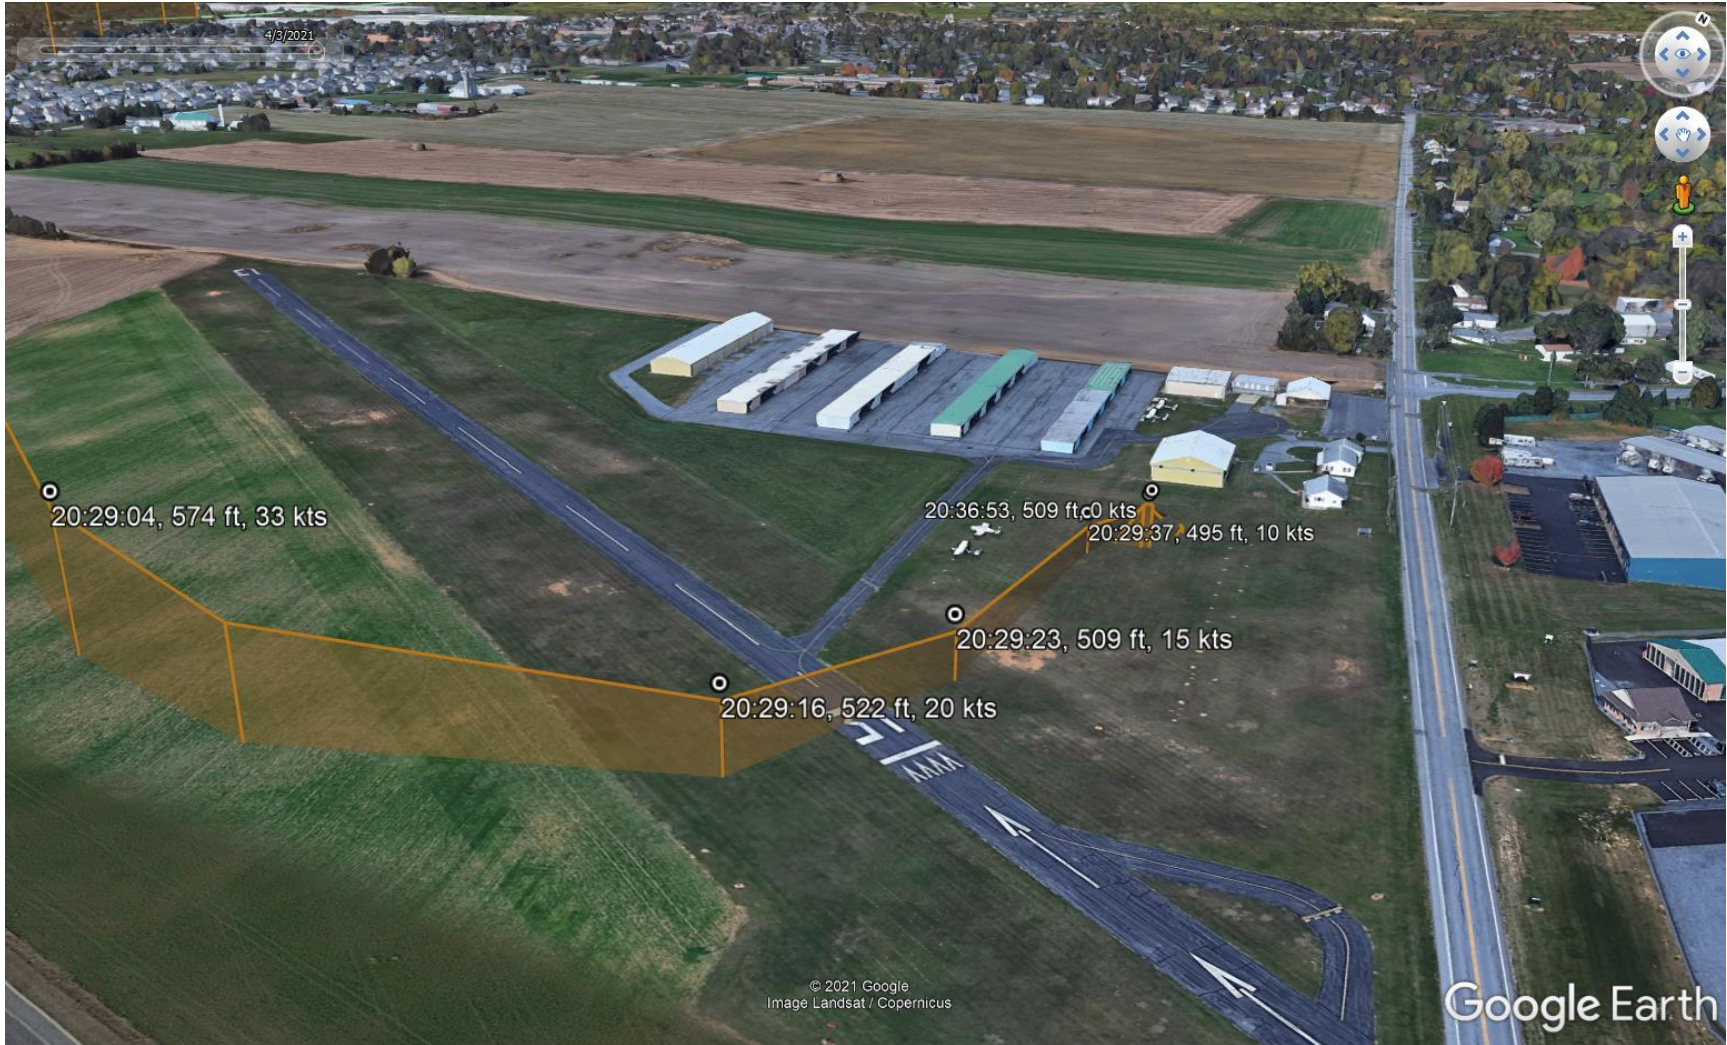
**Figure 4. Google Earth overlay showing a detailed overview of the helicopter's approach segment to 58N.**

Figure 4 is a graphical overlay generated using Google Earth showing the helicopter's descent and turn toward a grassy area at 58N.

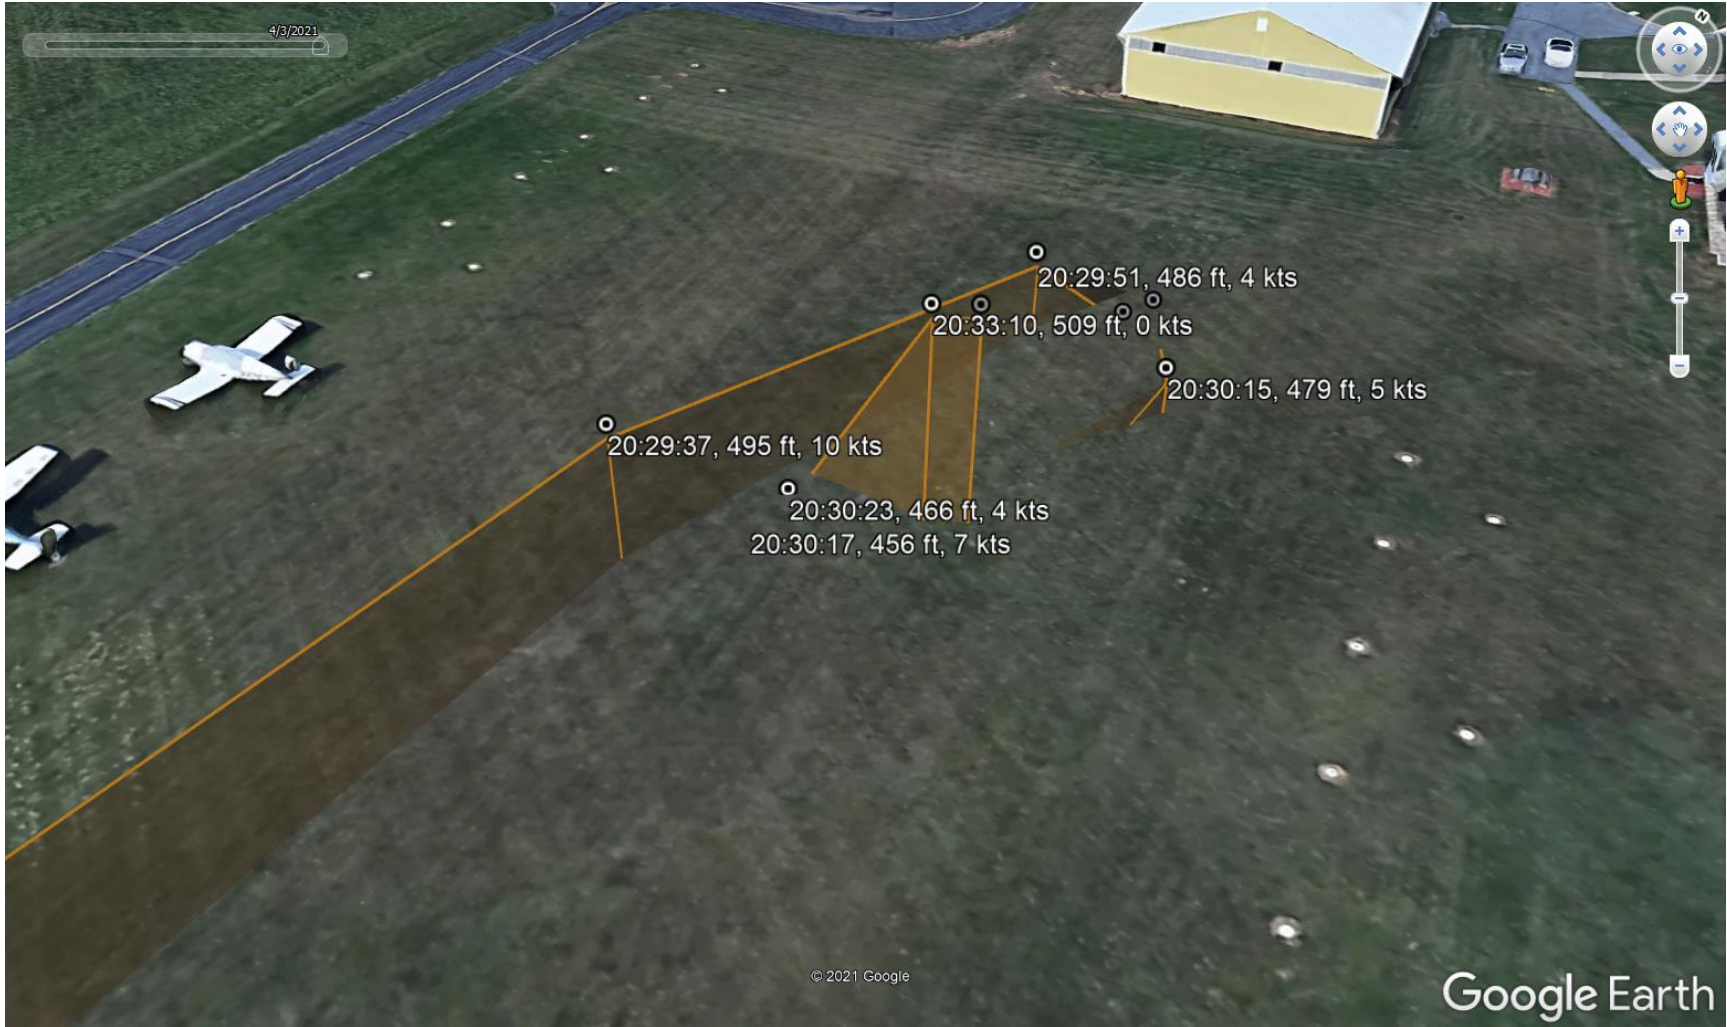
Figure 5. Google Earth overlay showing the final tracklog points of the helicopter's position relative to 58N.

Figure 5 is a graphical overlay generated using Google Earth showing the helicopter's final tracklog points on the property of 58N.

Table 2 is a spreadsheet of the final tracklog points recorded from the 796 device. Note that the values for the ground track are derived and do not necessarily represent the helicopter's heading at any one point in time.
