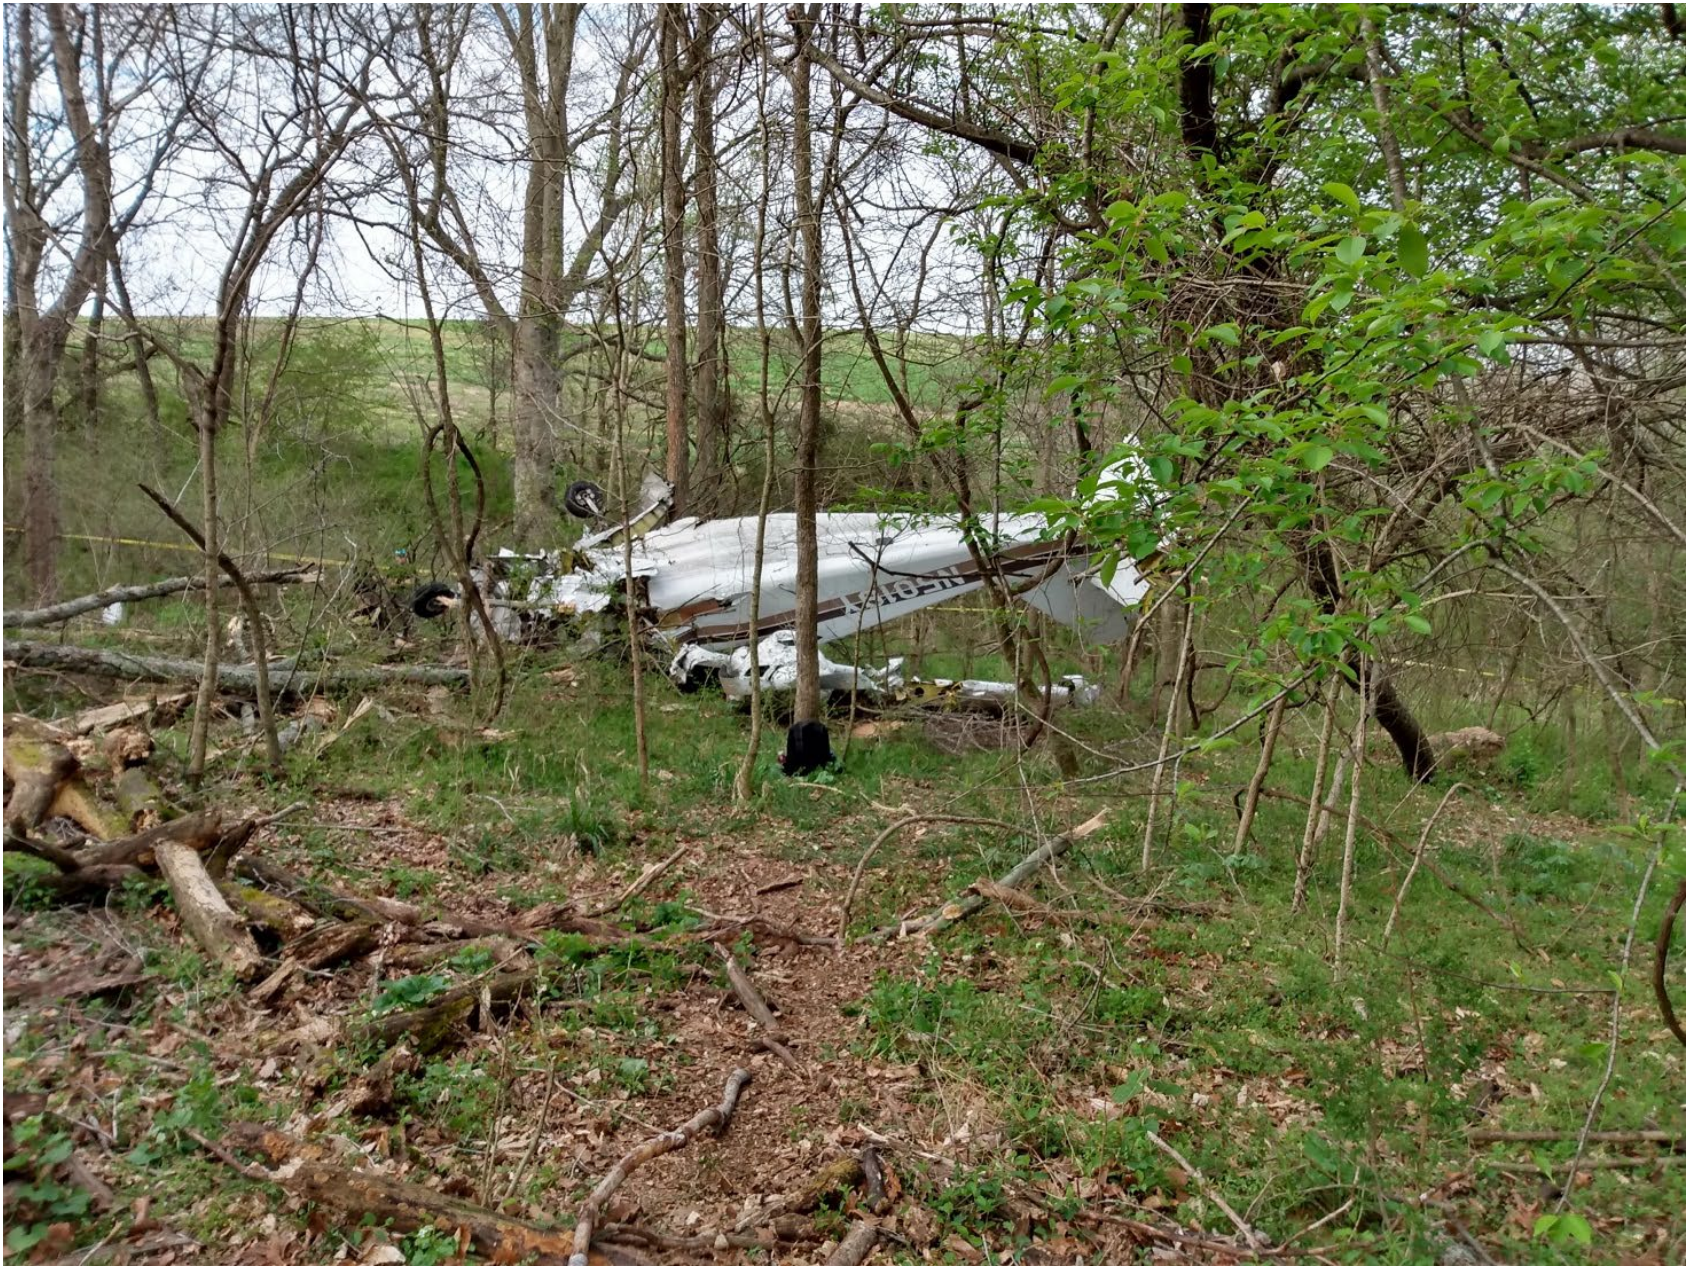
**Photo 1 – View of Airplane as Found (AMF)**

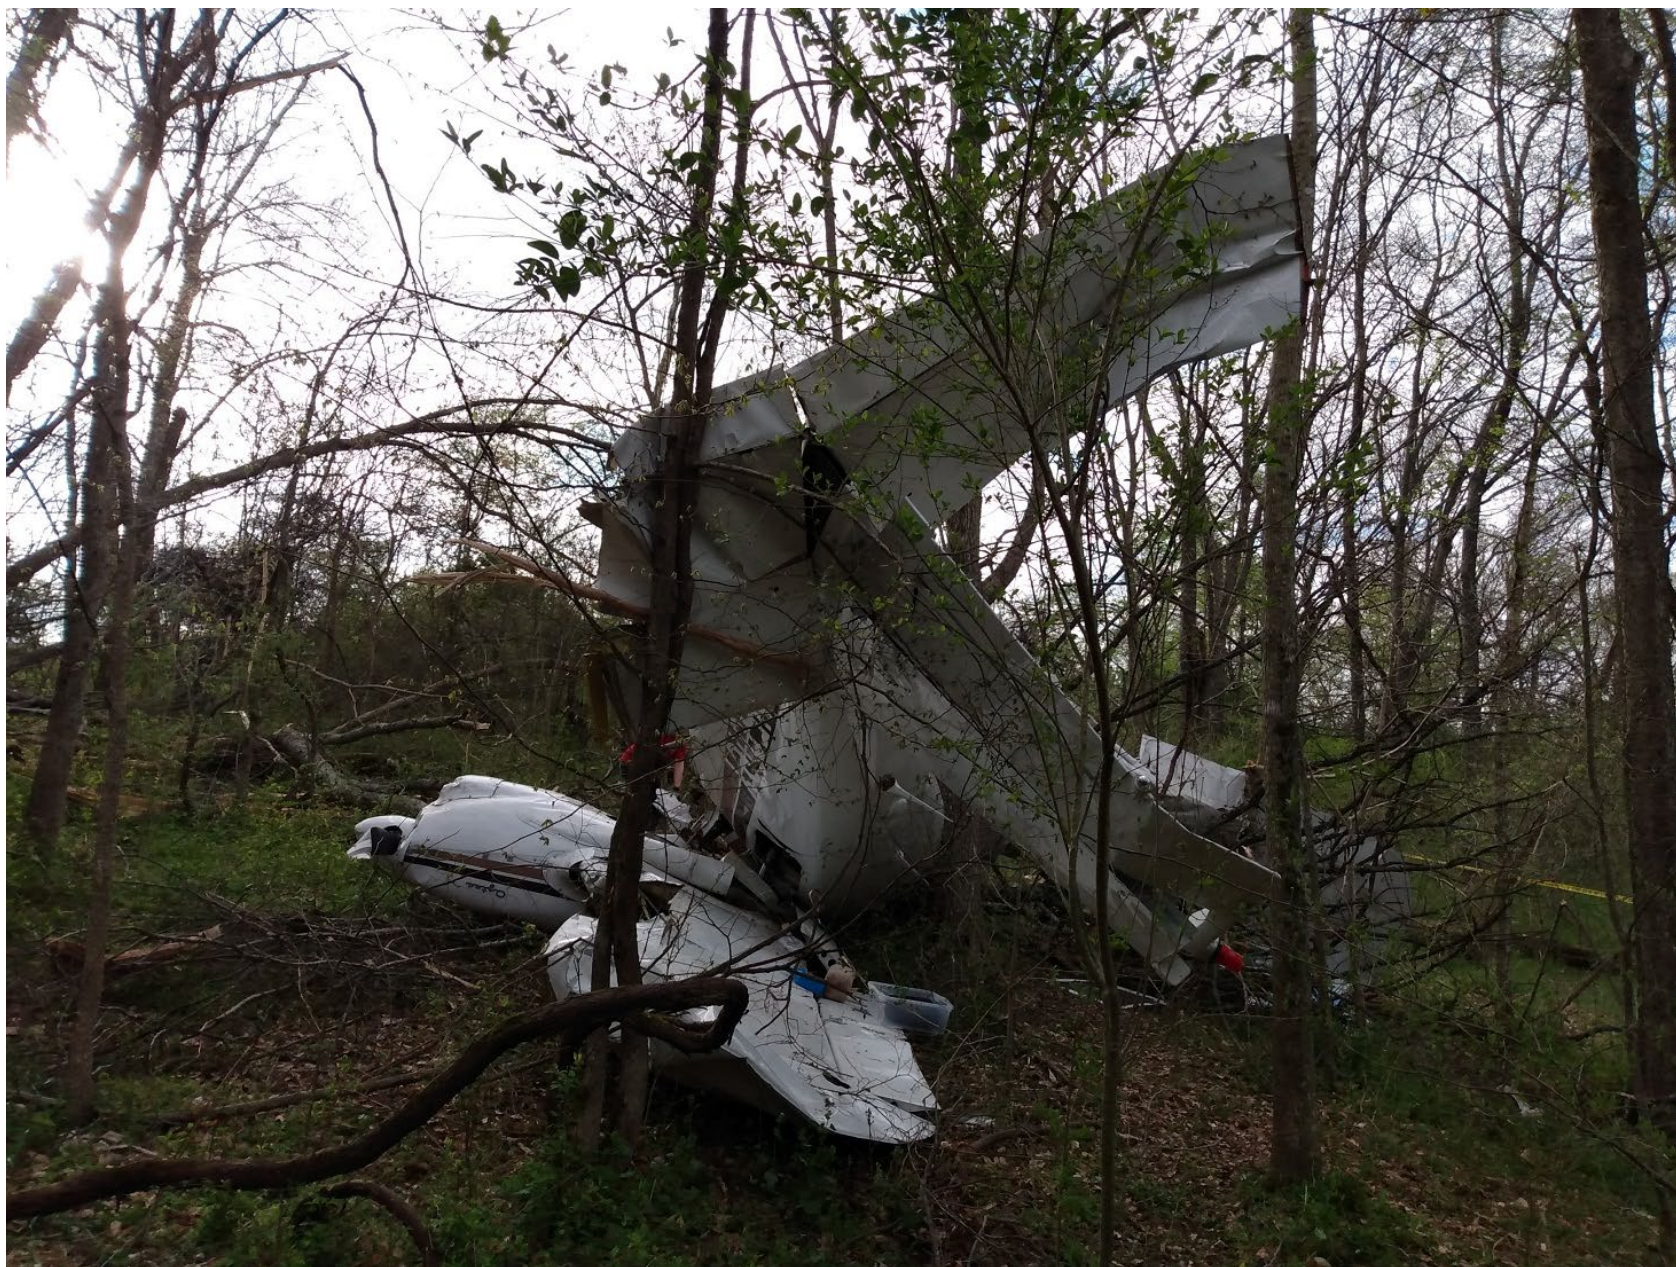
**Photo 2 – View of Tail Section Right Wing and Engine Nacelle (AMF)**

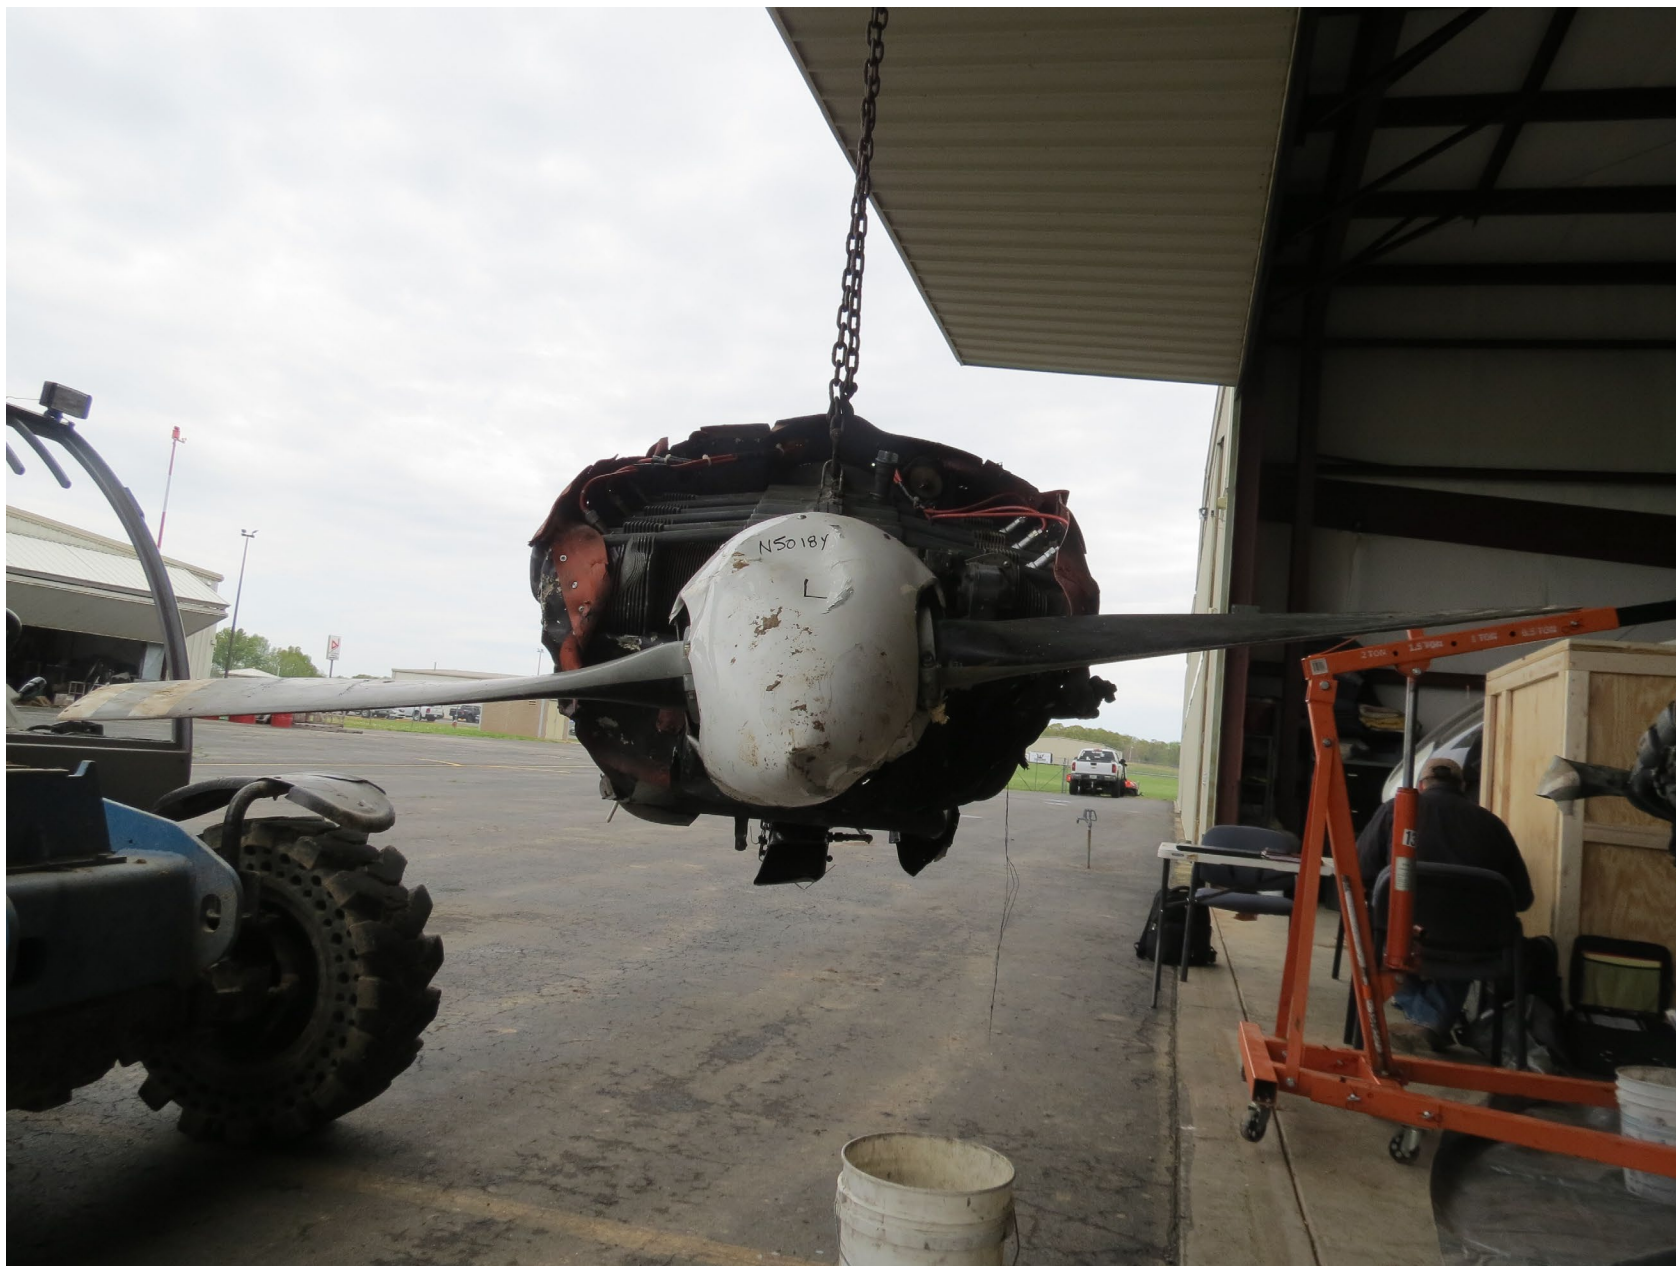
**Photo 3 – View of Left Engine with Propeller Blades in Feathered Position (Lycoming)**

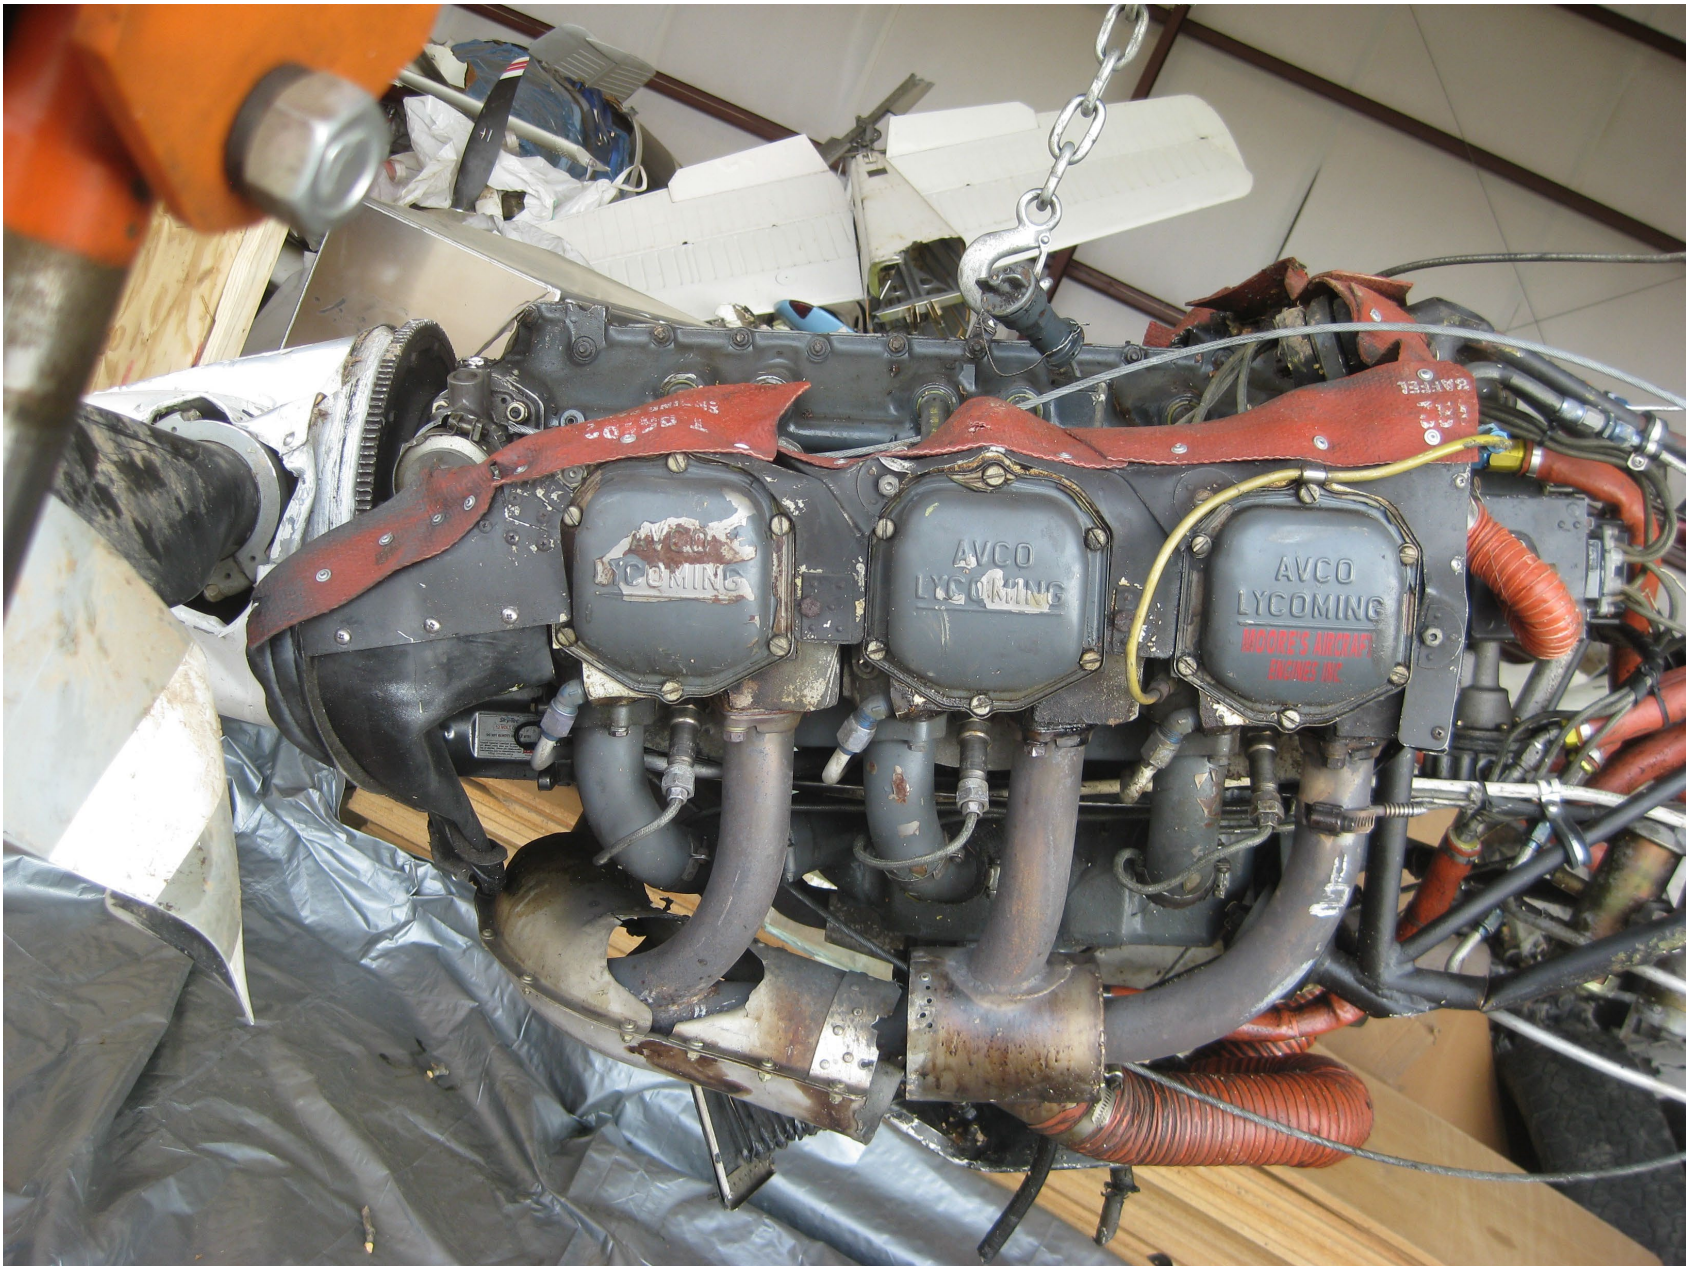
**Photo 4 – View of Right Engine and Curled Propeller Tip (Lycoming)**

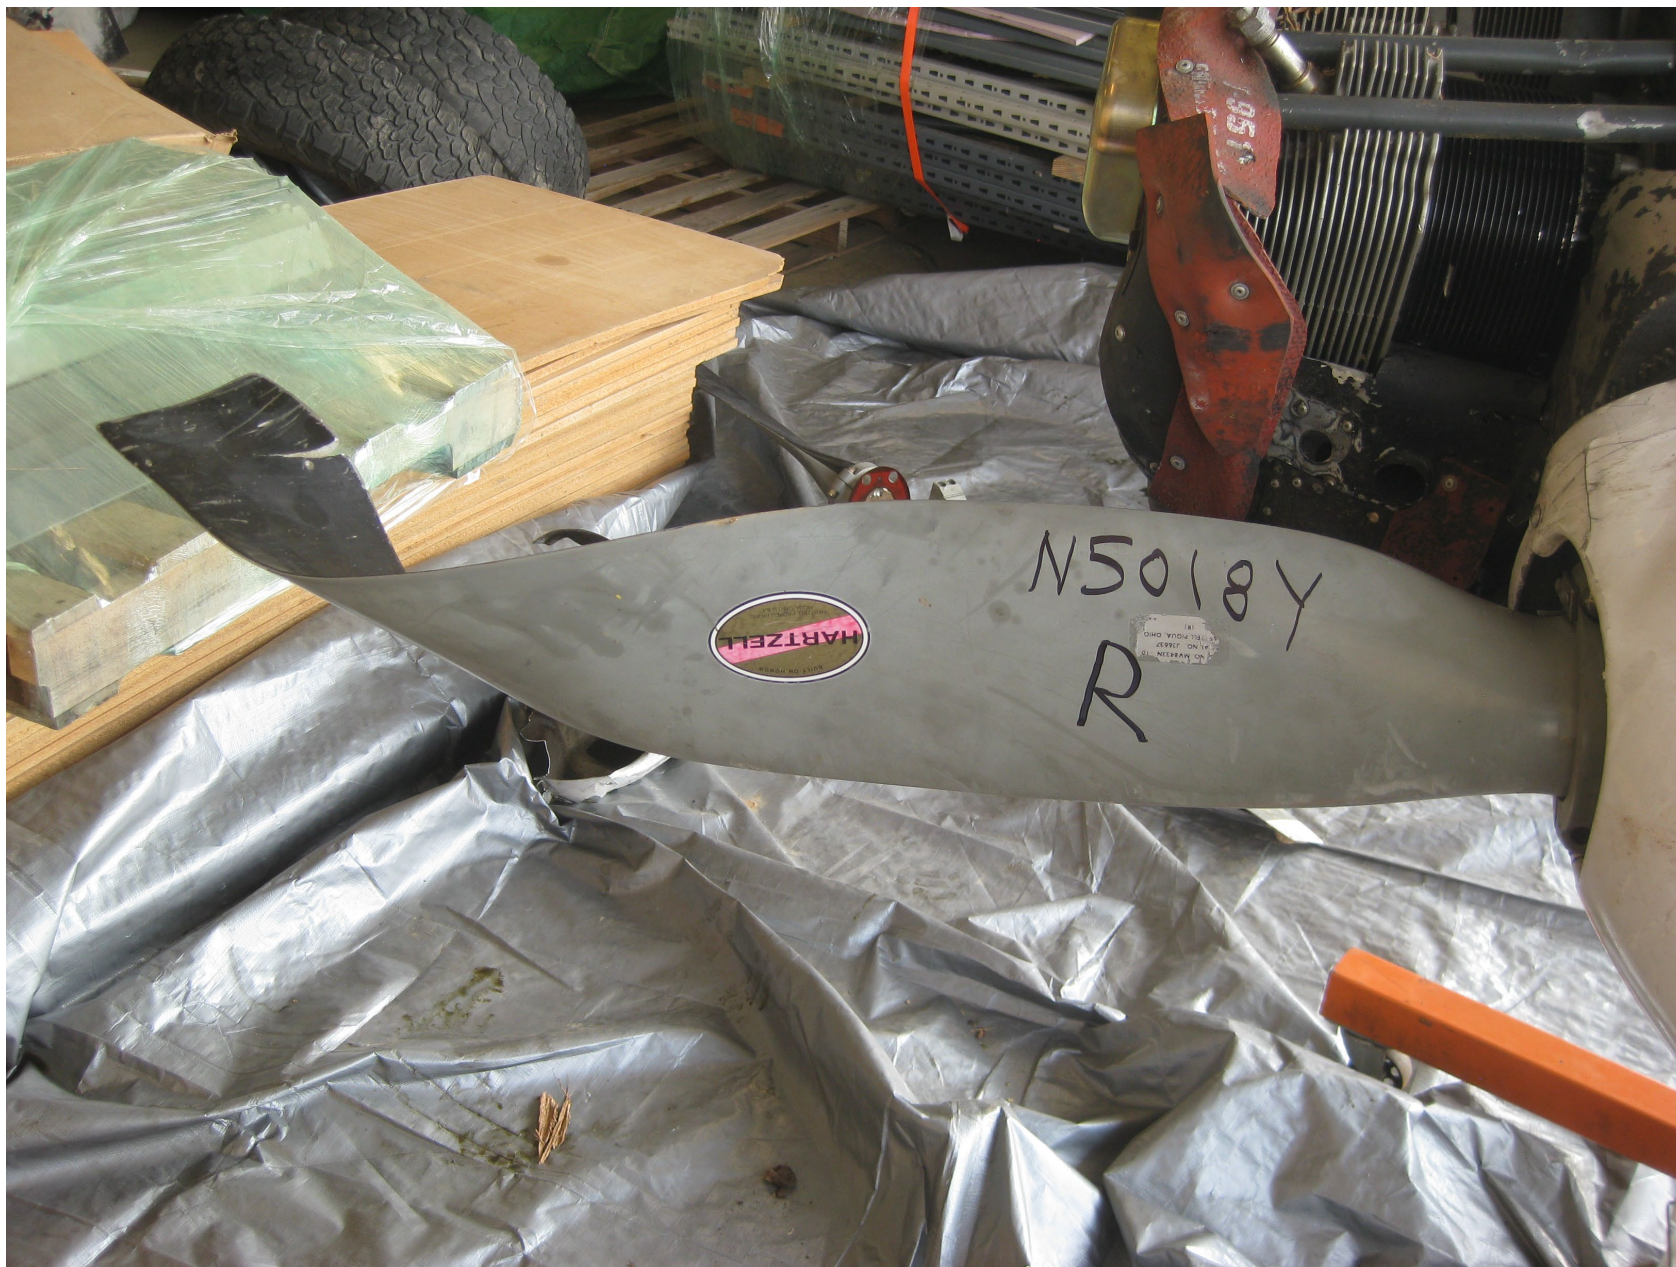
**Photo 5 – View of Right Propeller Blade, Tip Curl, and Tear (Lycoming)**

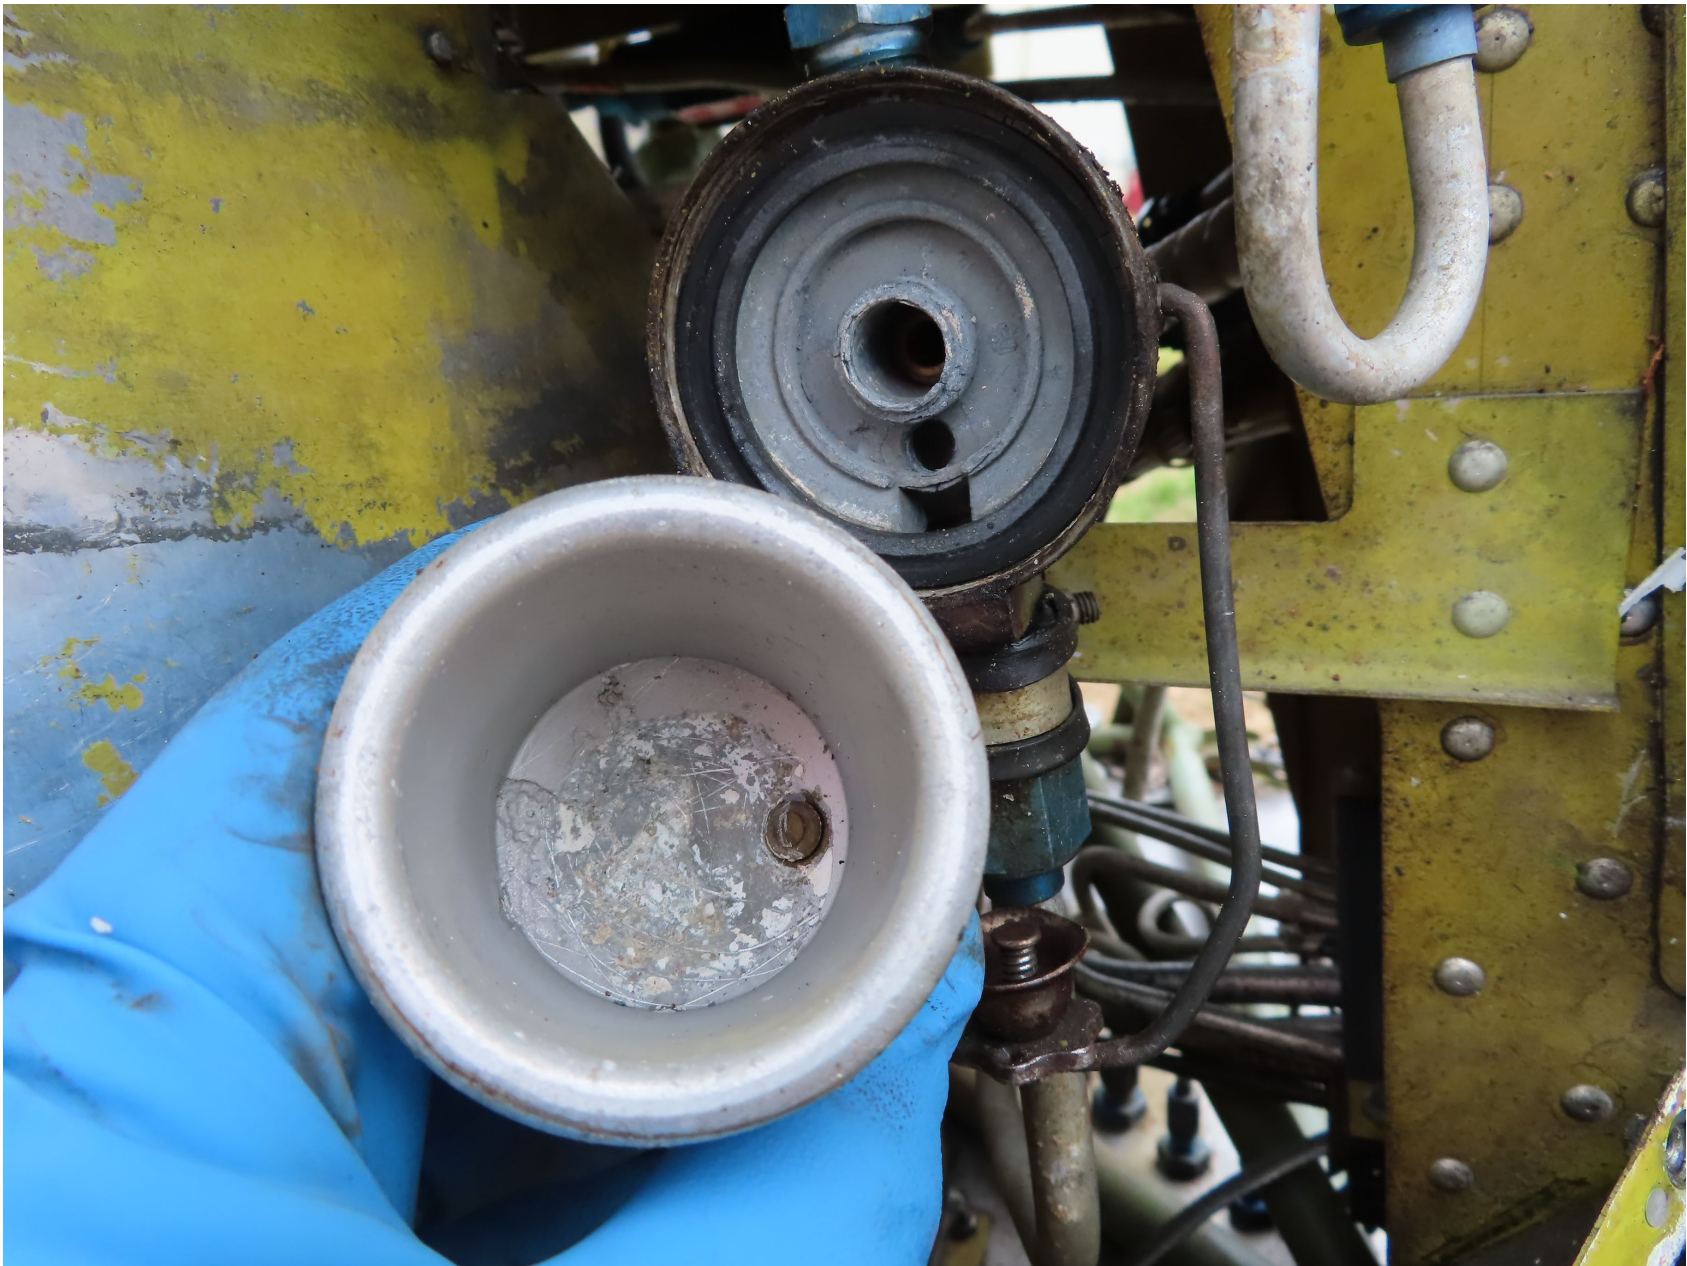
**Photo 6 – Left Wing Gascolator as Found (Piper)**

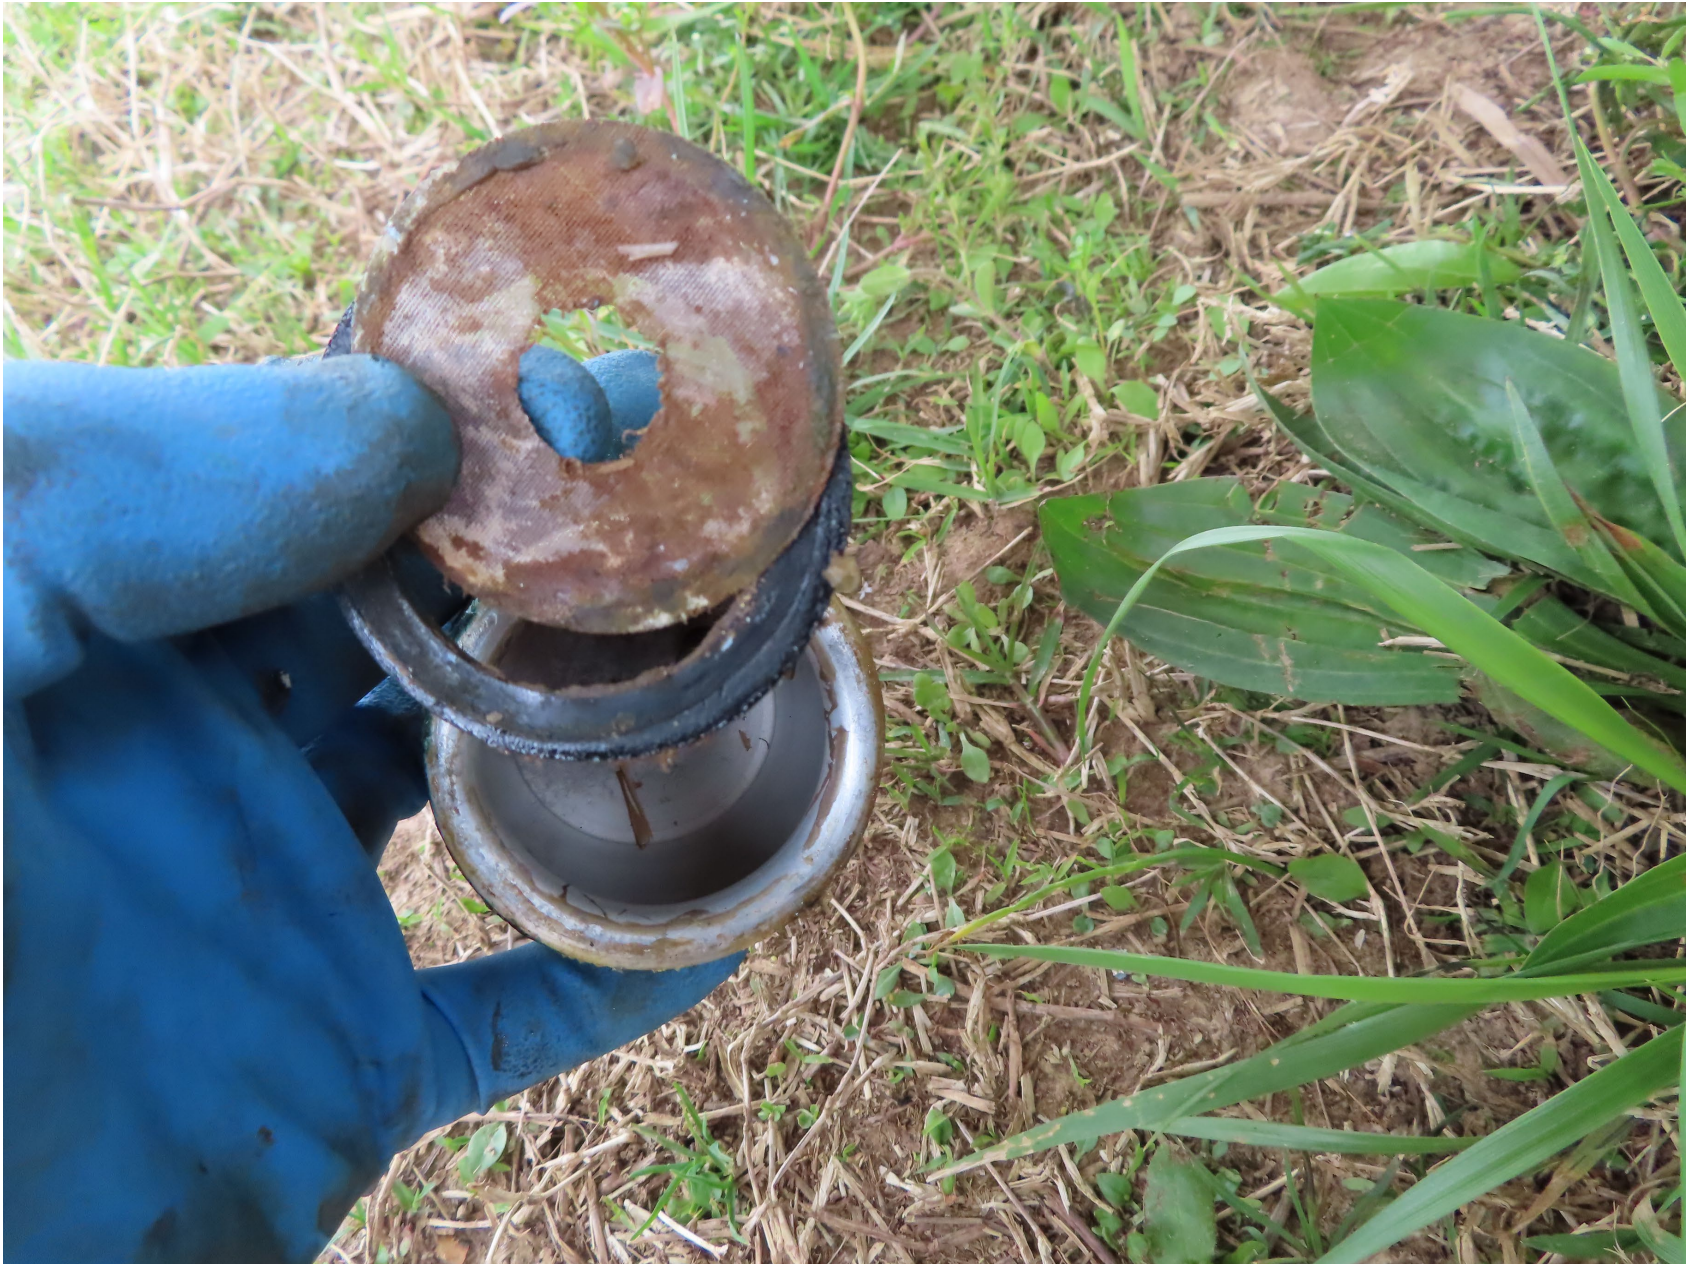
**Photo 7 – Right Wing Gascolator with Occluded Debris Screen as Found (Piper)**

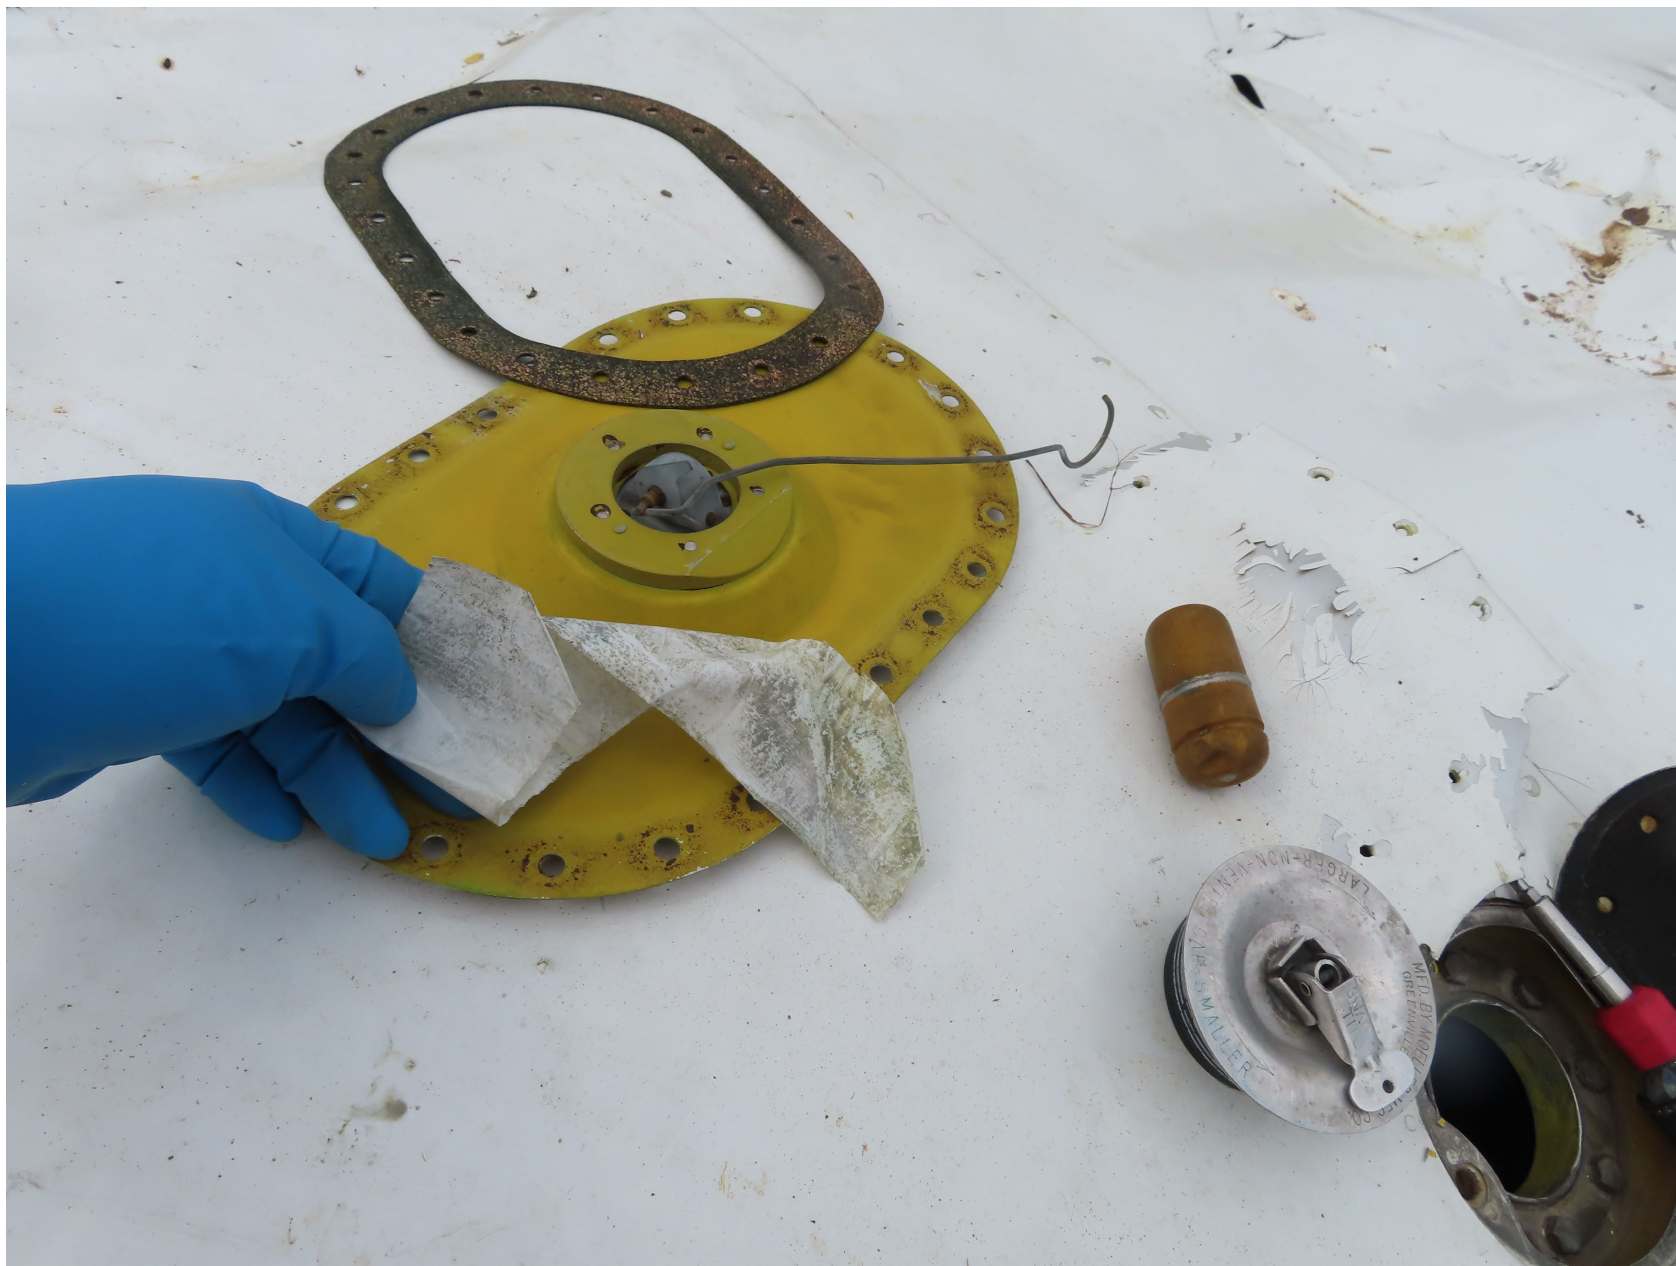
**Photo 8 – View of Duct Tape Strip Found Loose Inside Left Wing Inboard Fuel Cell (Piper)**

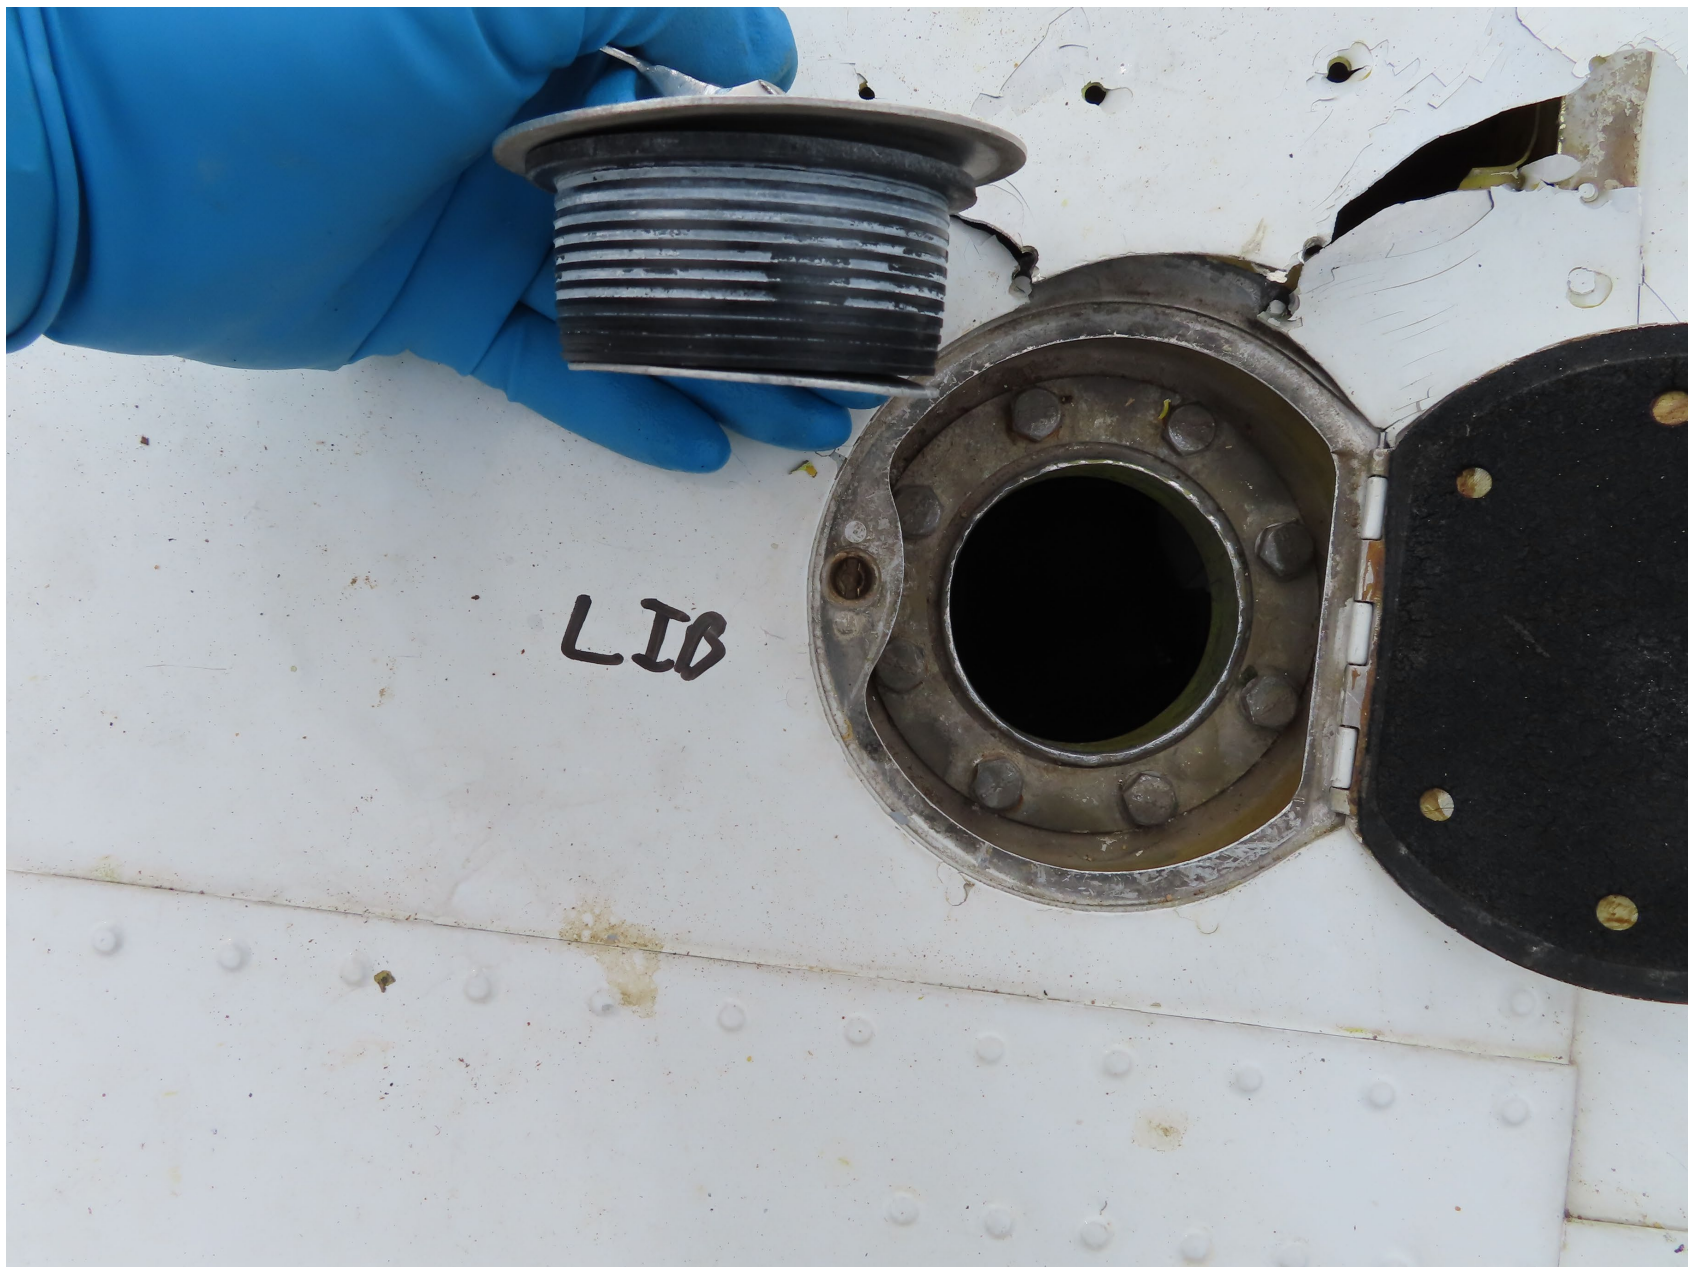
**Photo 9 – View of Duct Tape and Adhesive Residue on Left Inboard Fuel Tank Cap (Piper)**

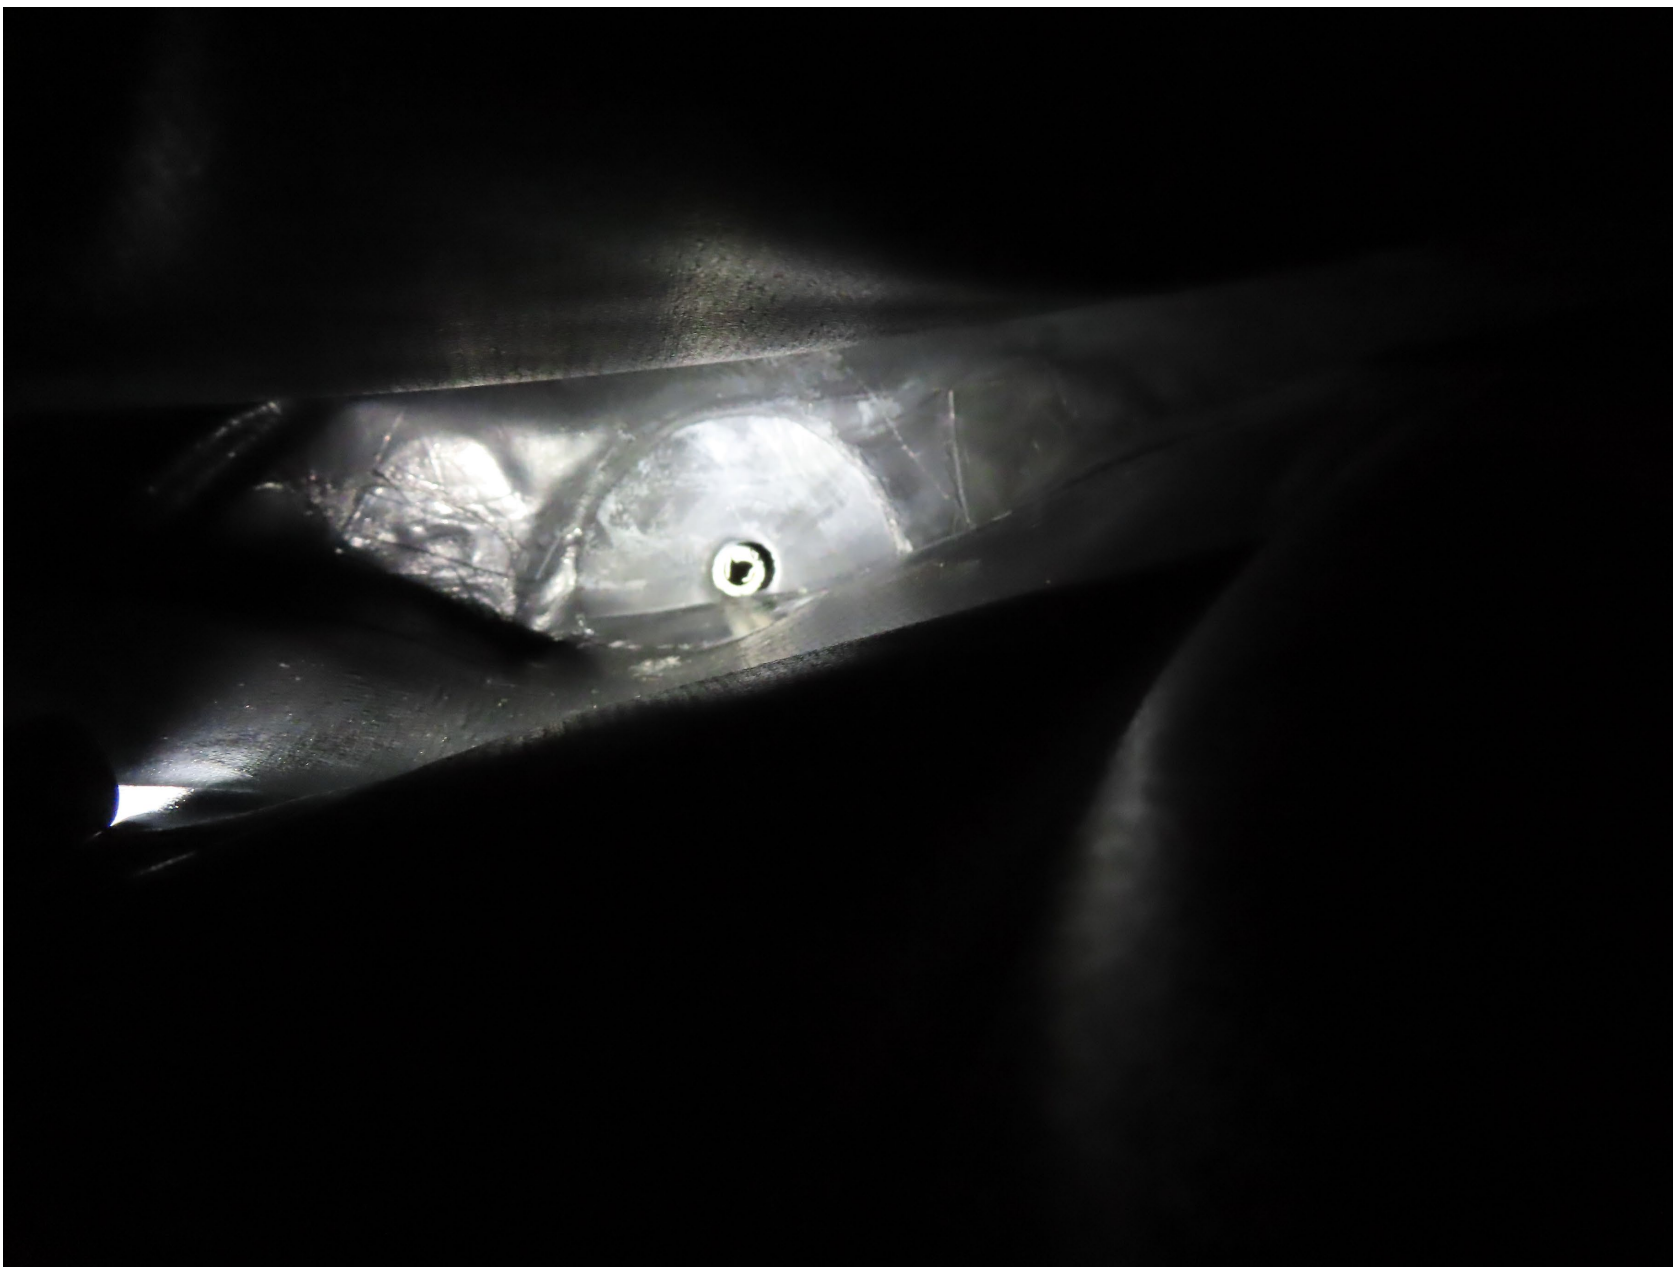
**Photo 10 – Left Inboard Fuel Pick-up with Inlet Screen Not Installed (Piper)**
