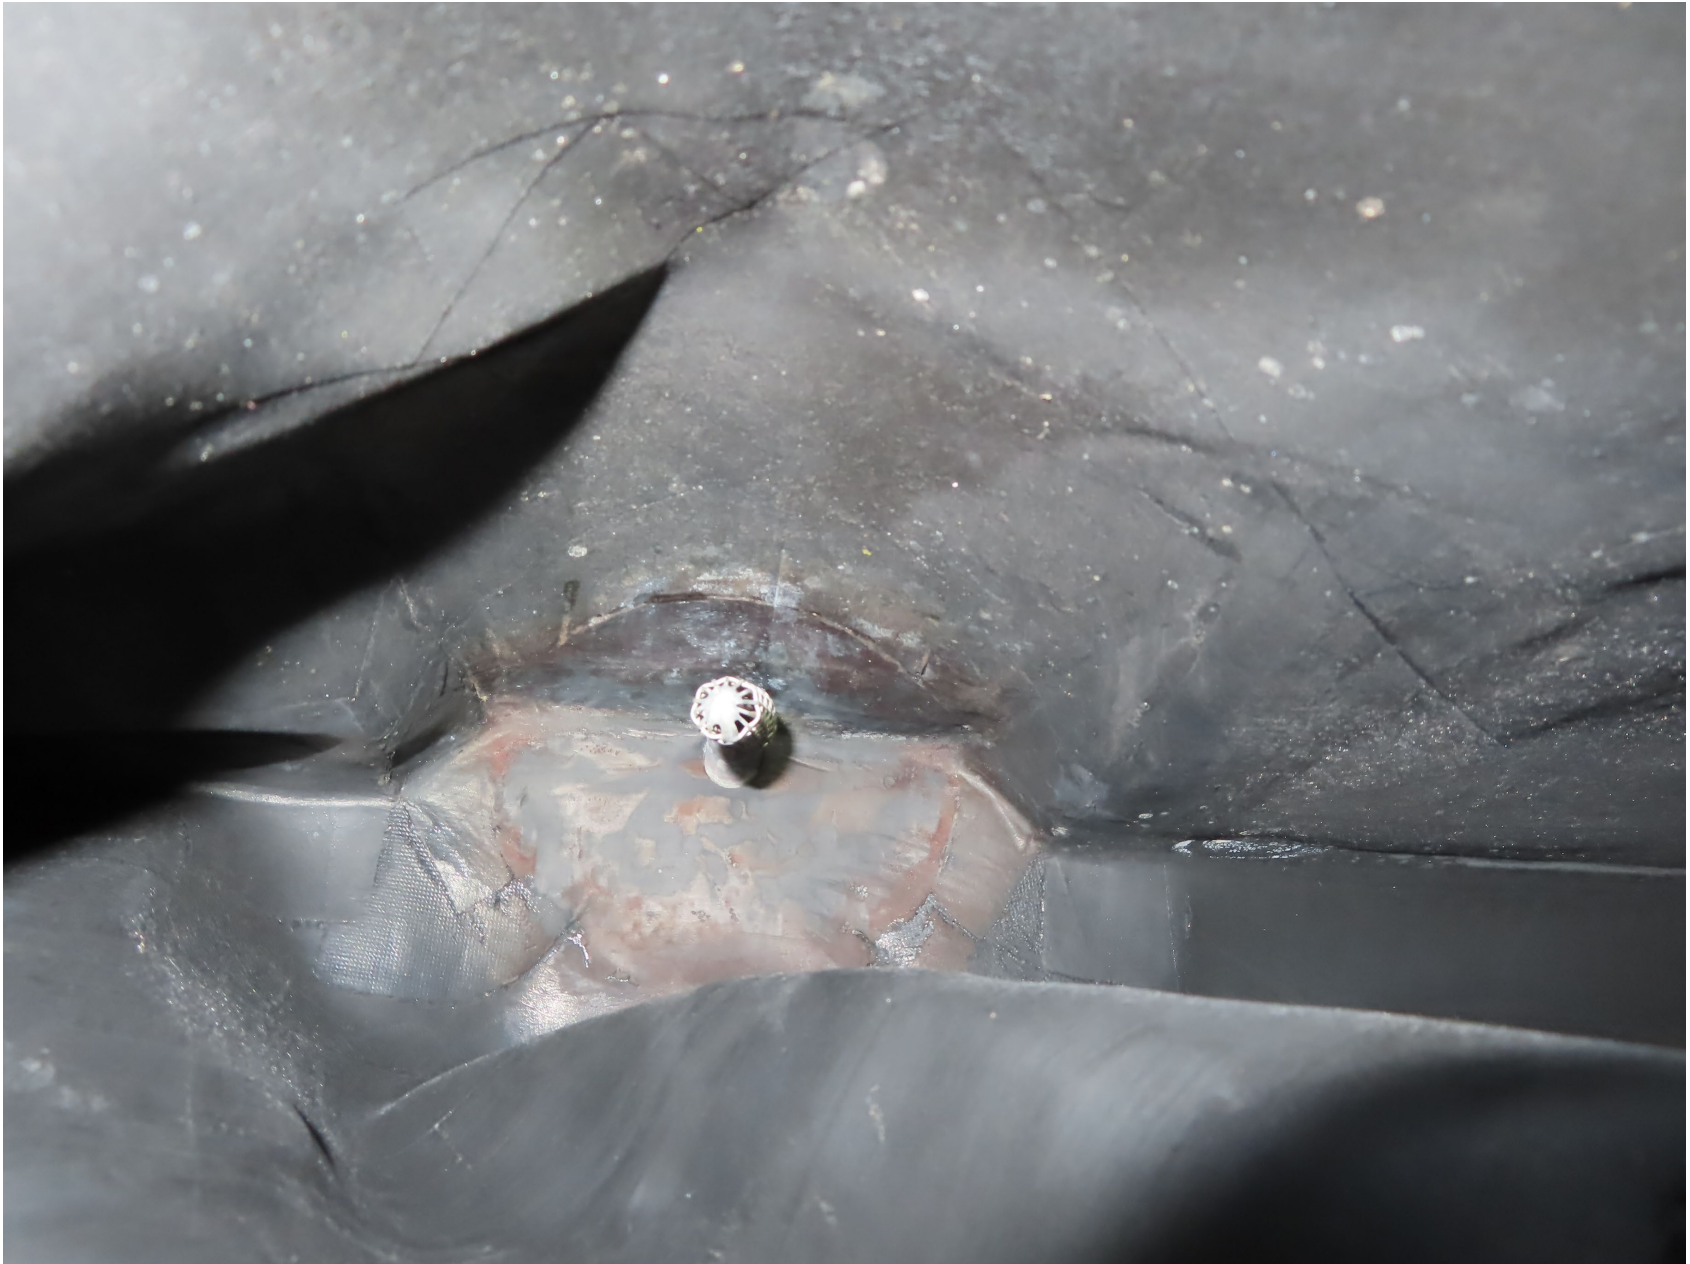
**Photo 11 – Right Wing Inboard Fuel Pick-up with Inlet Screen Installed (Piper)**
