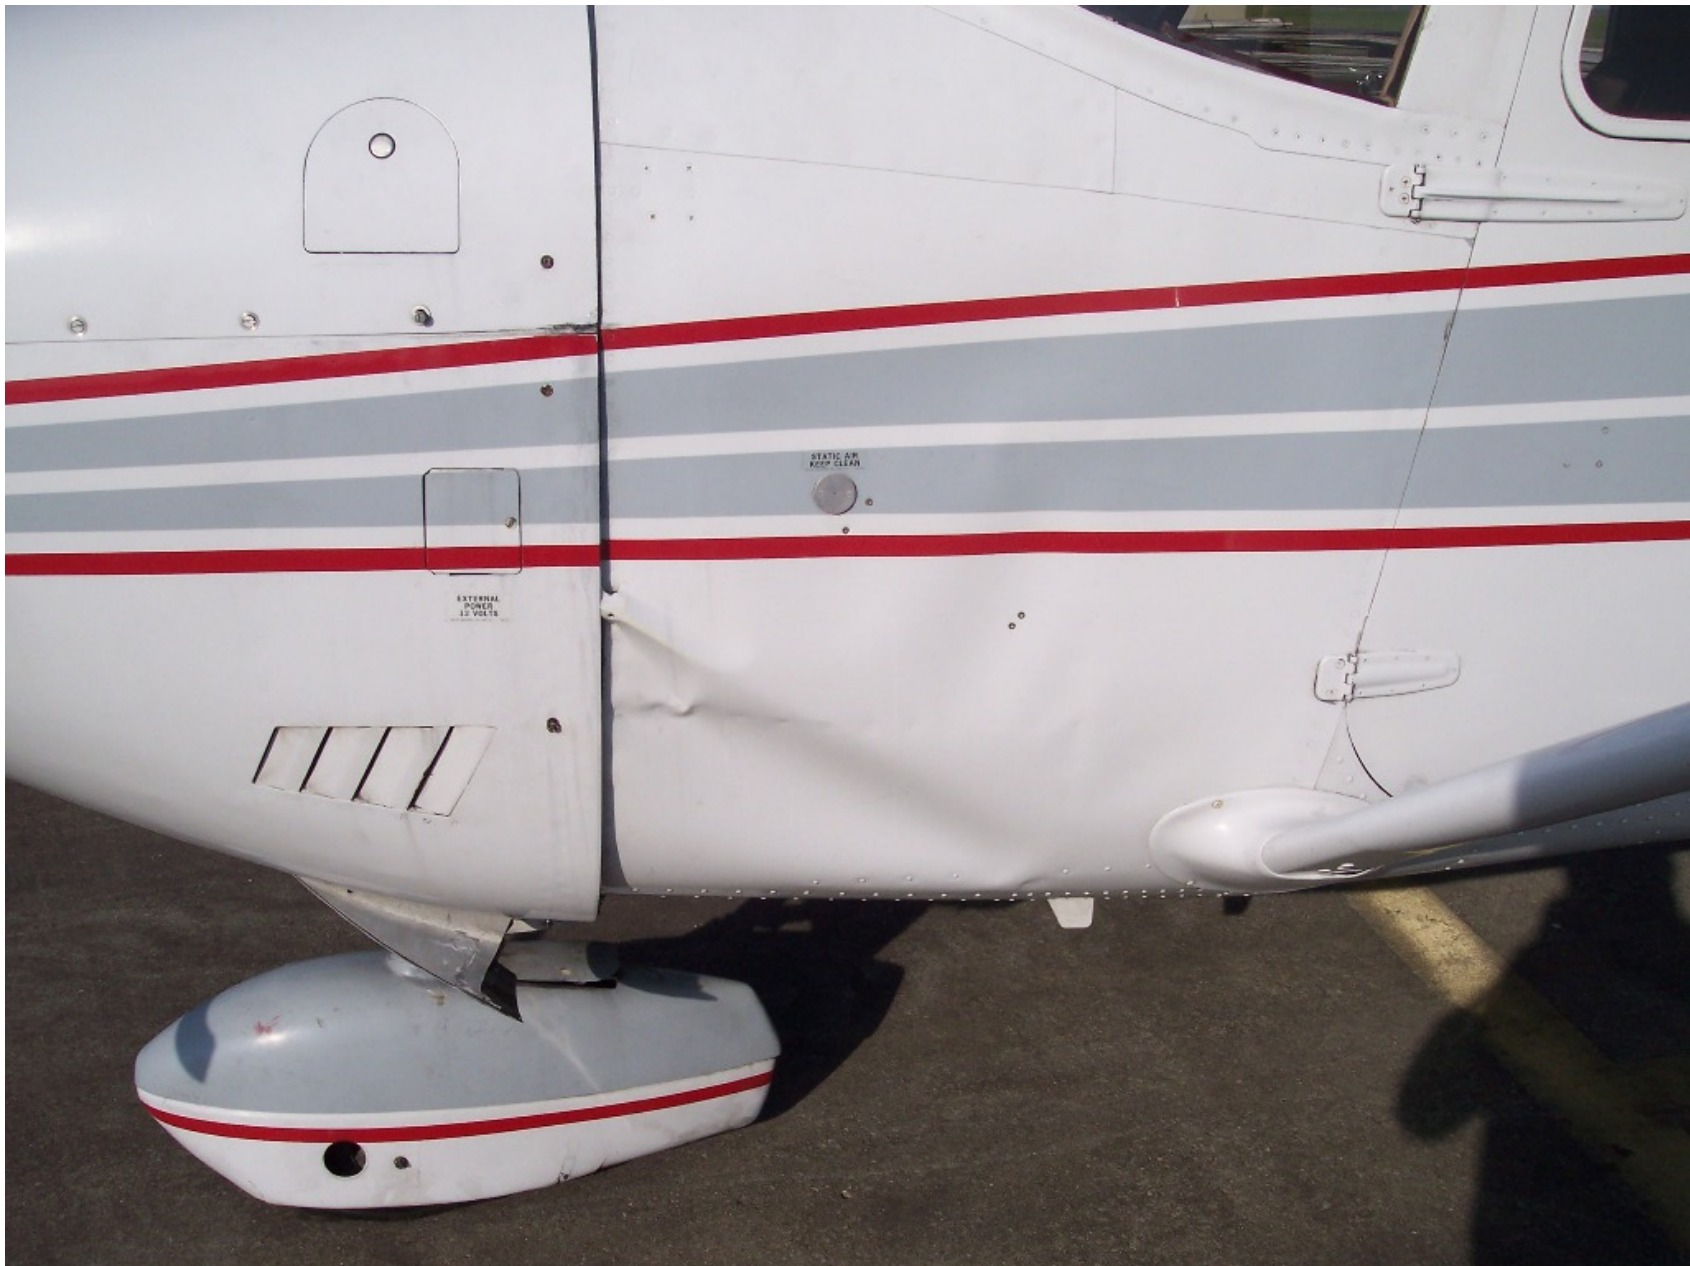
**Photo 1 – FAA Digital Photograph. Left Side View of the Front Fuselage Depicting a Compression Wrinkle in the Lower Fuselage Aft of the Firewall.**

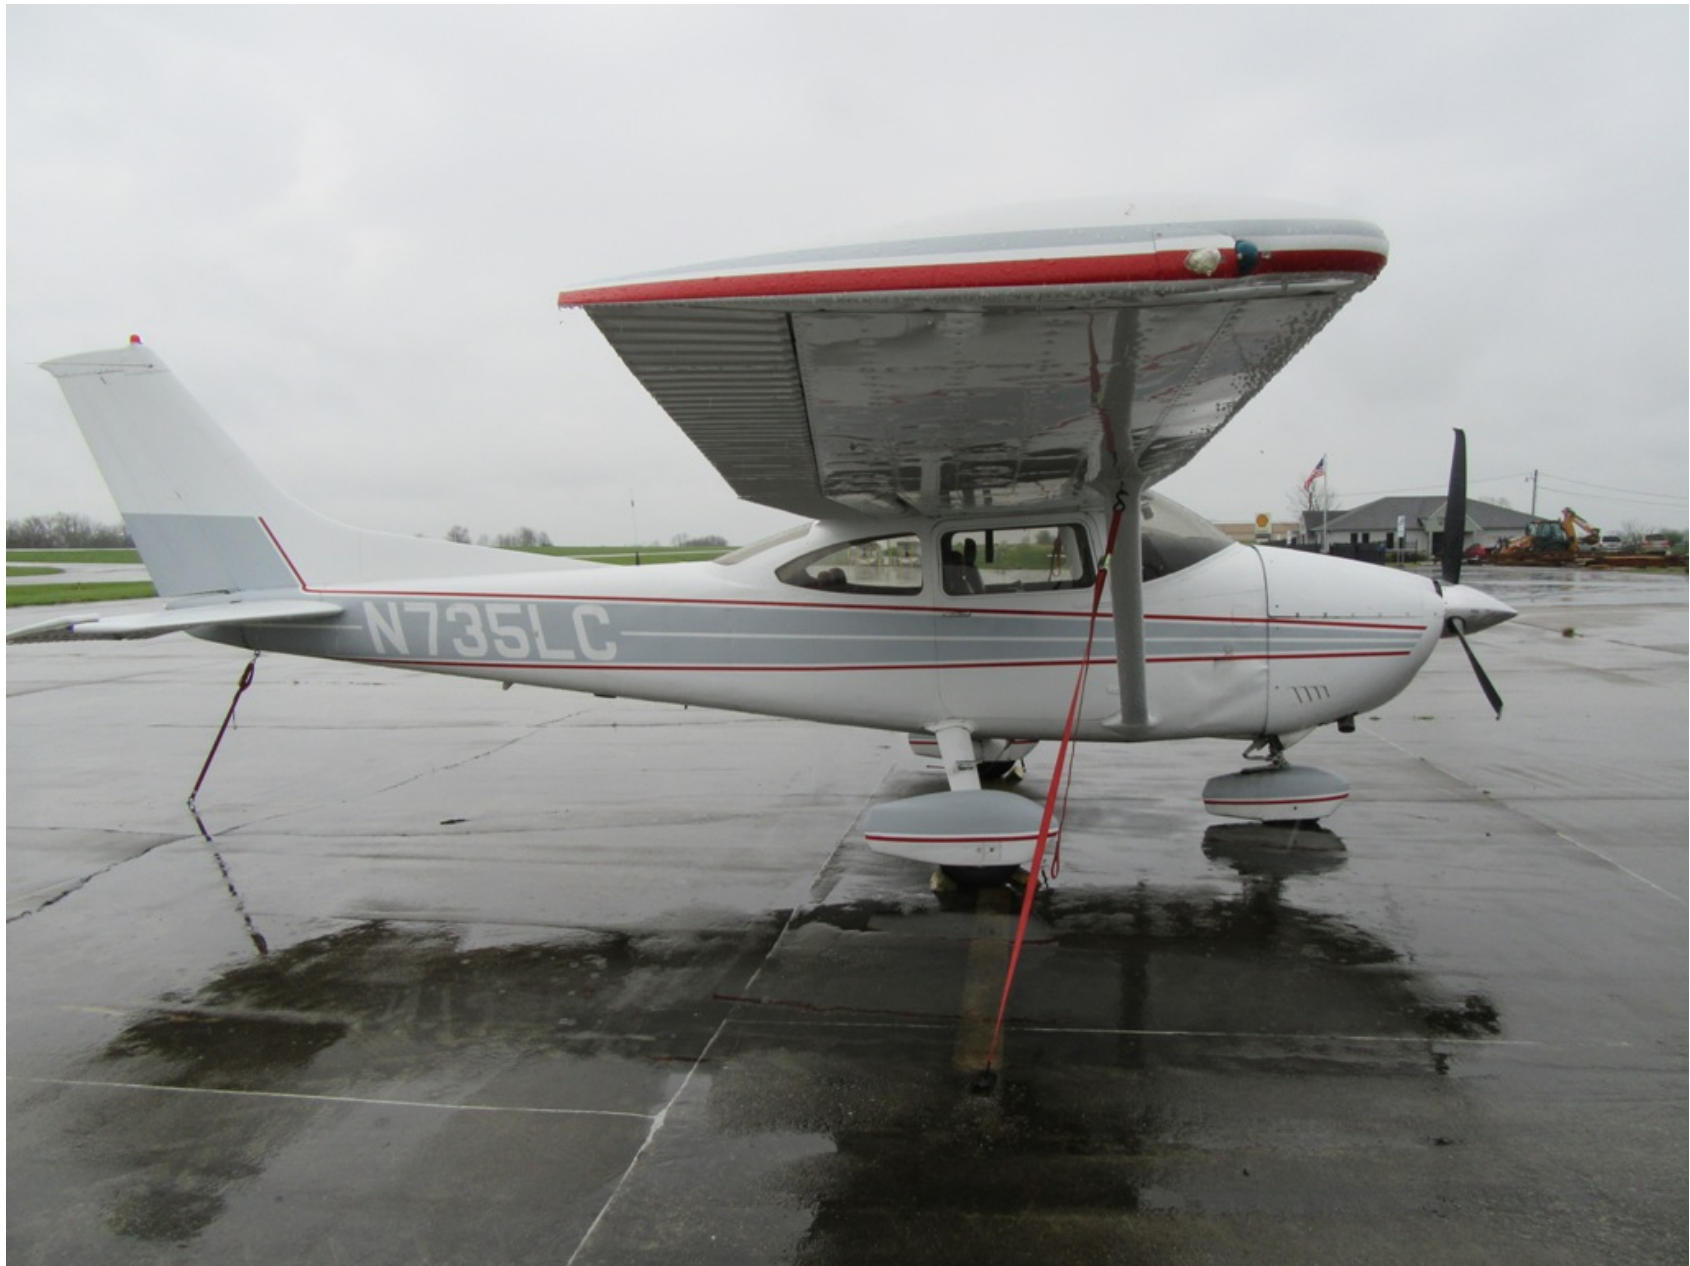
**Photo 2 - FAA Digital Photograph. Right Side View of the Airplane Depicting a Compression Wrinkle in the Lower Fuselage Aft of the Firewall.**

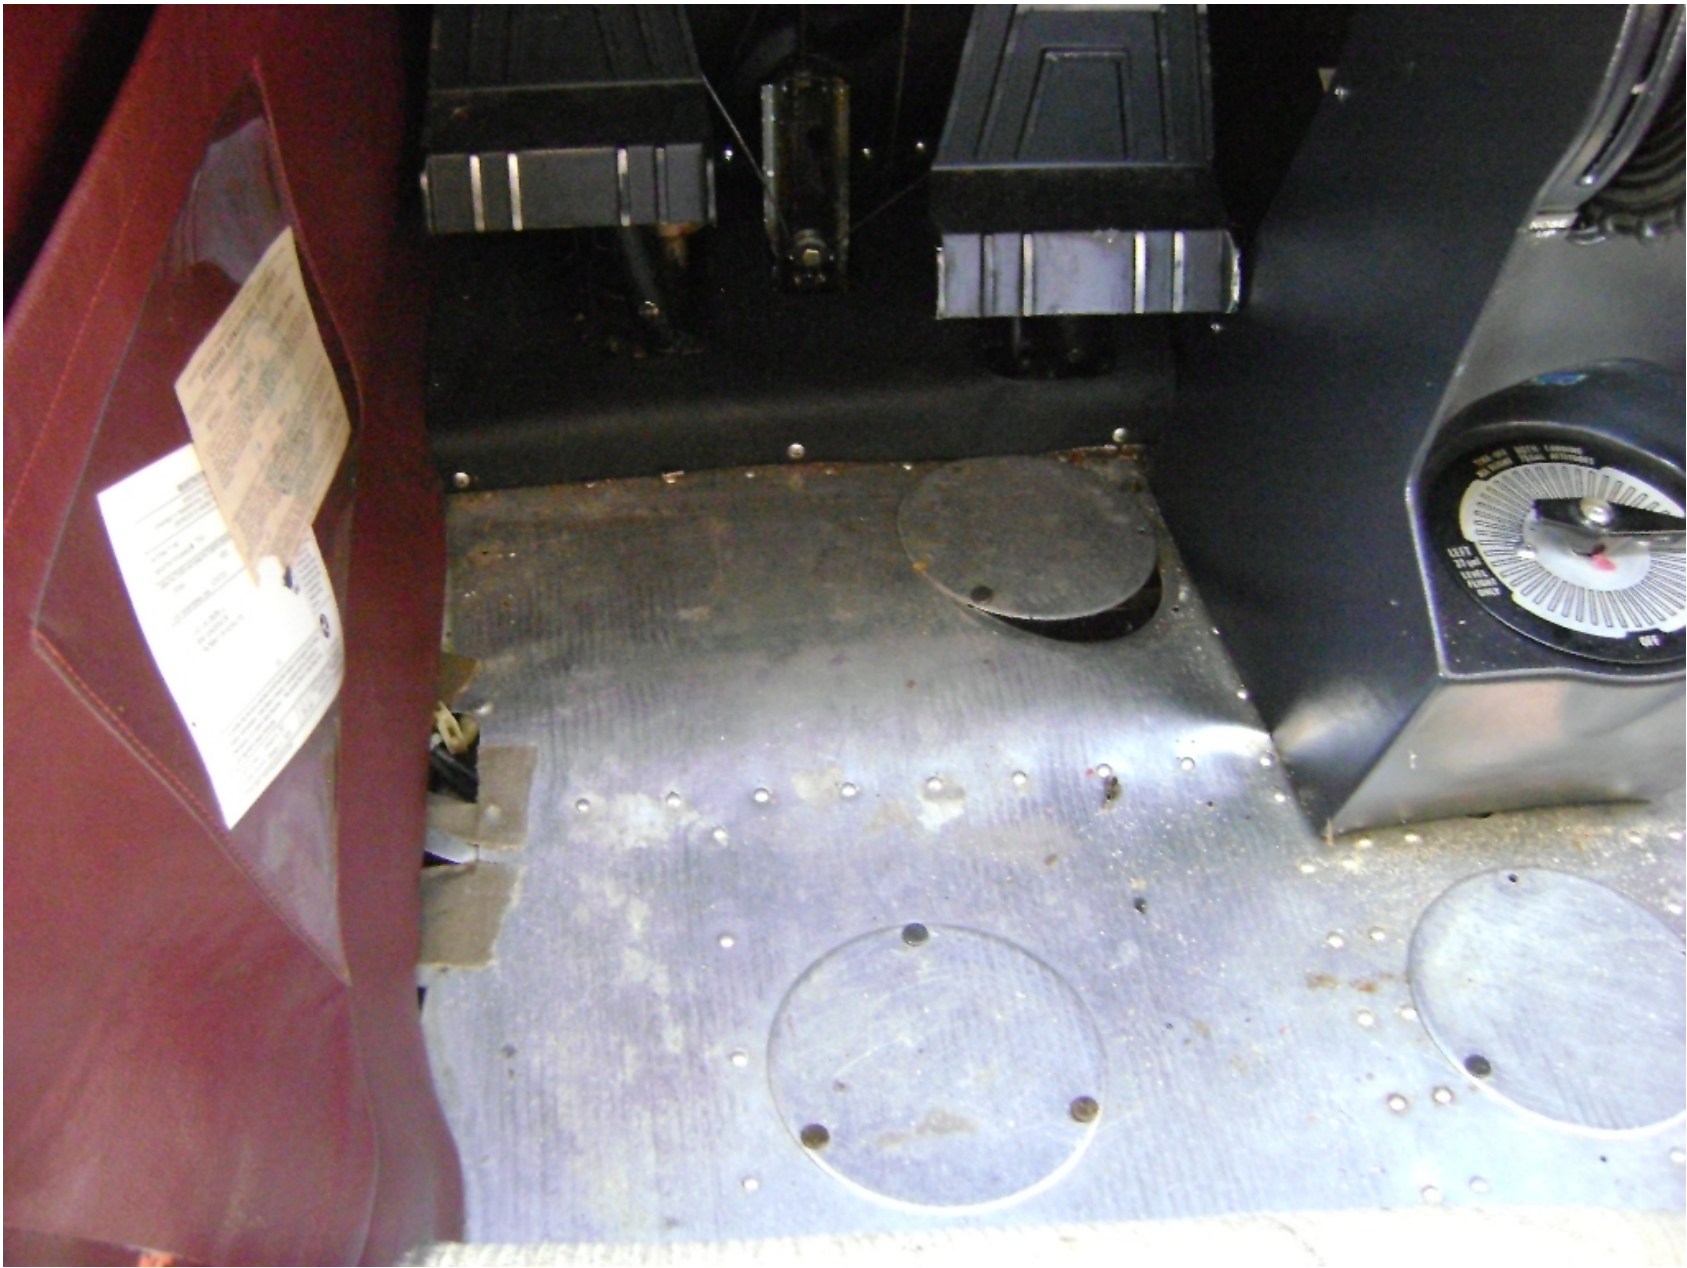
**Photo 3 - FAA Digital Photograph. View Depicting Buckling of the Pilot's Floor.**
