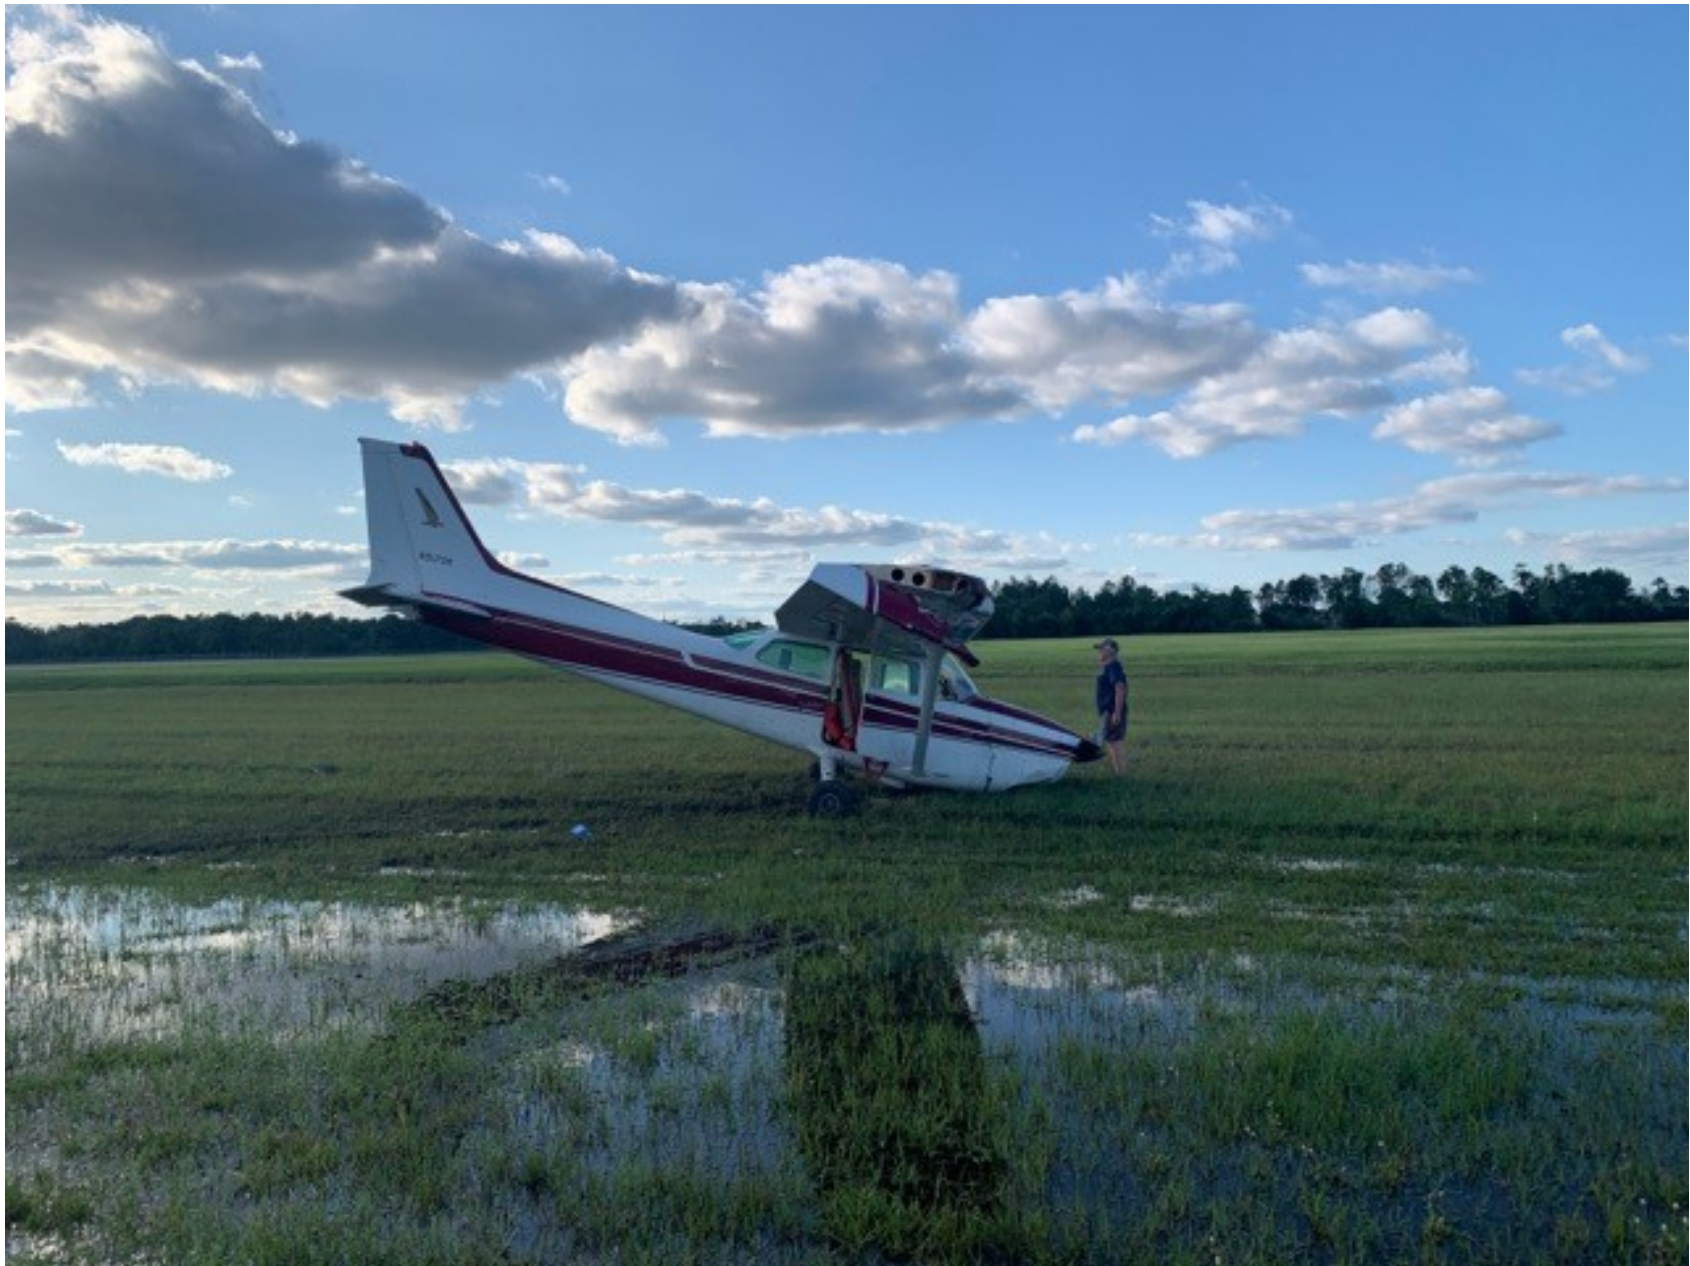
**Photo 1 – Digital Photograph from Operator. Right Side View of the Airplane at the Accident Site.**

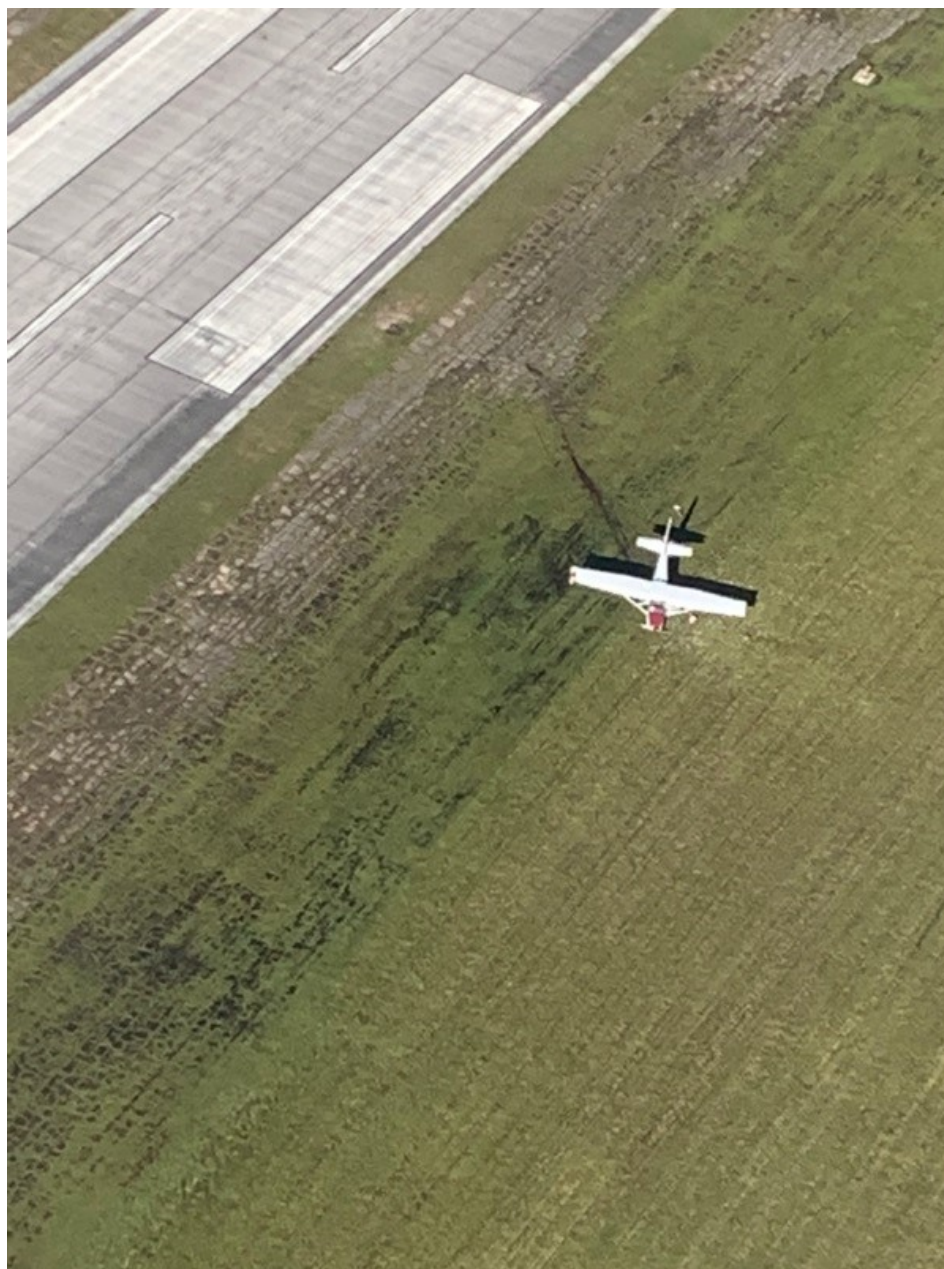
**Photo 2 - Digital Photograph from Operator. Aerial View of the Airplane at the Accident Site.**

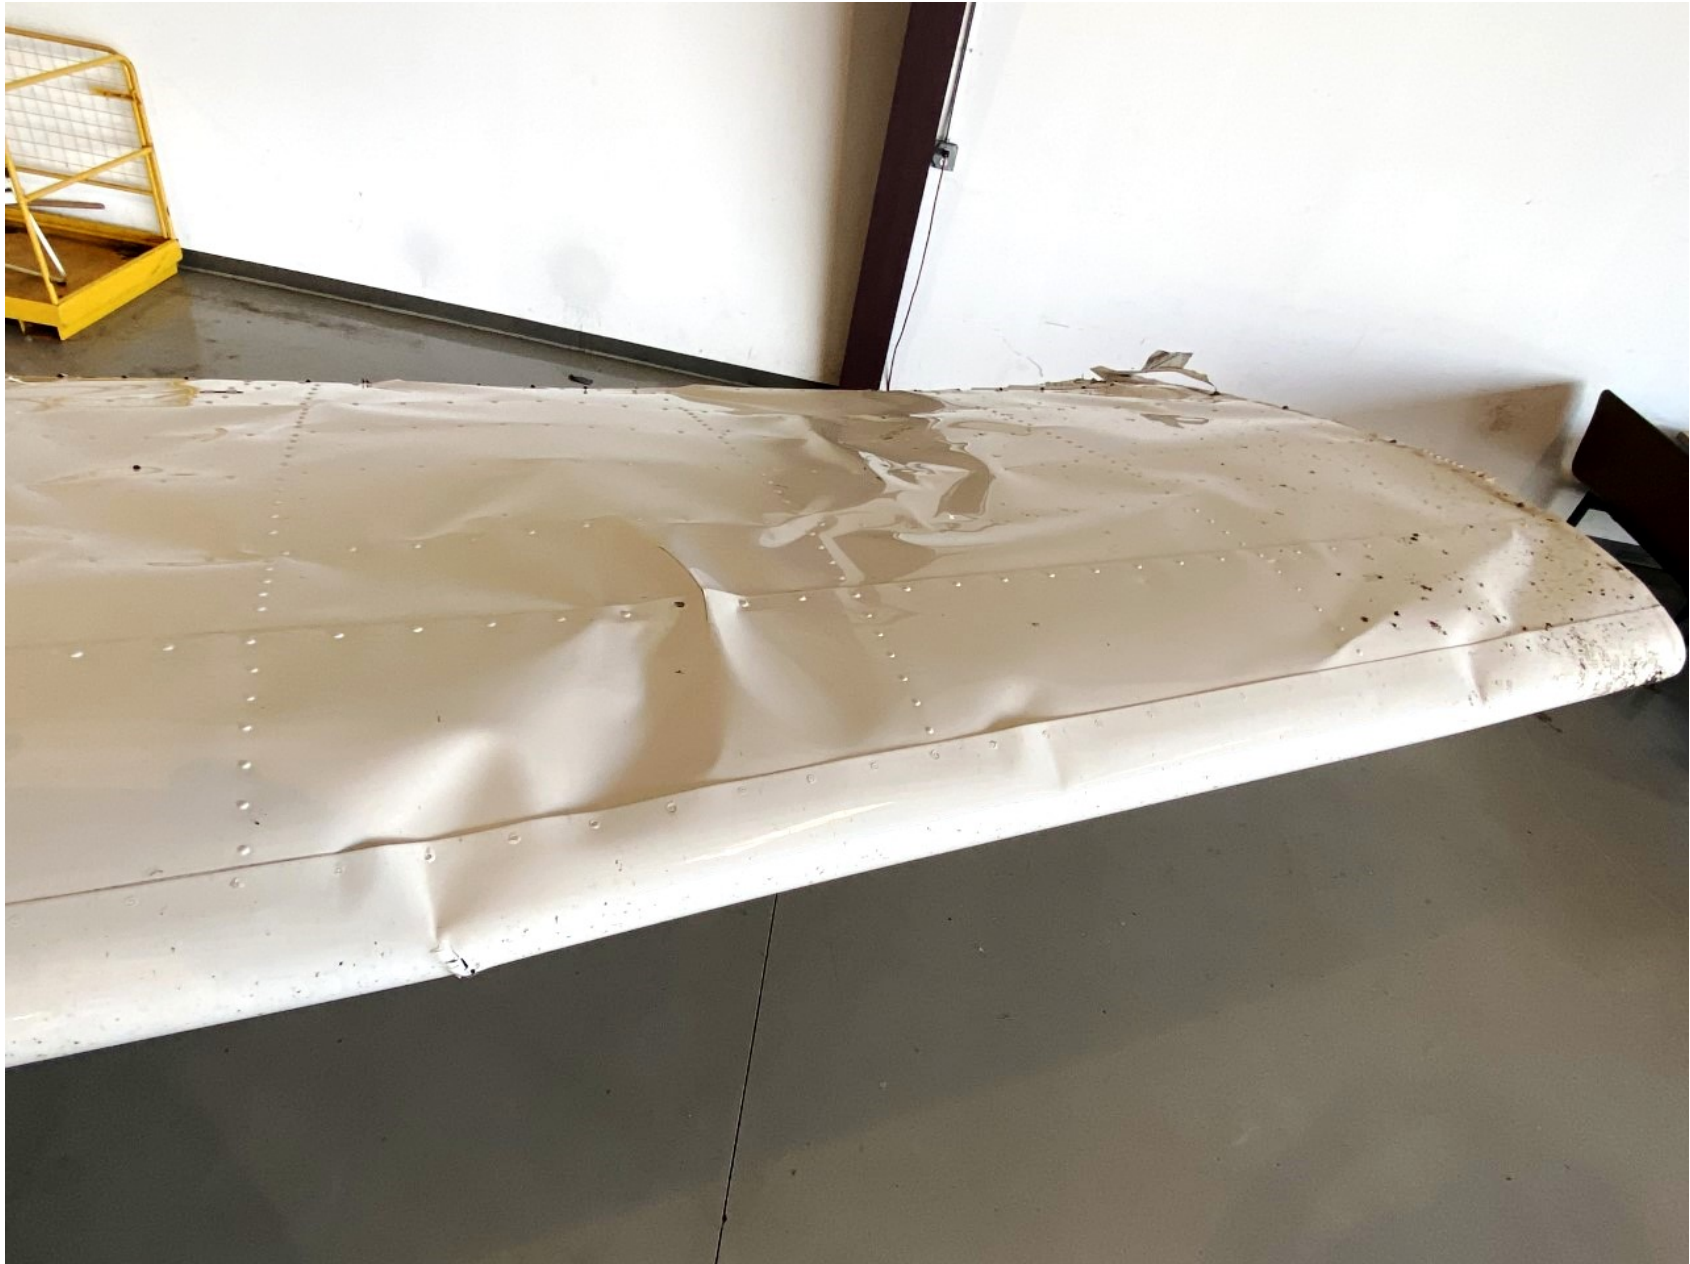
**Photo 3 – Digital Photograph From FAA. View Looking Aft of the Outer Portion of the Left Wing. Note the Damage to the Skin Across the Main Spar, and the Skin Buckling and Wrinkling.**

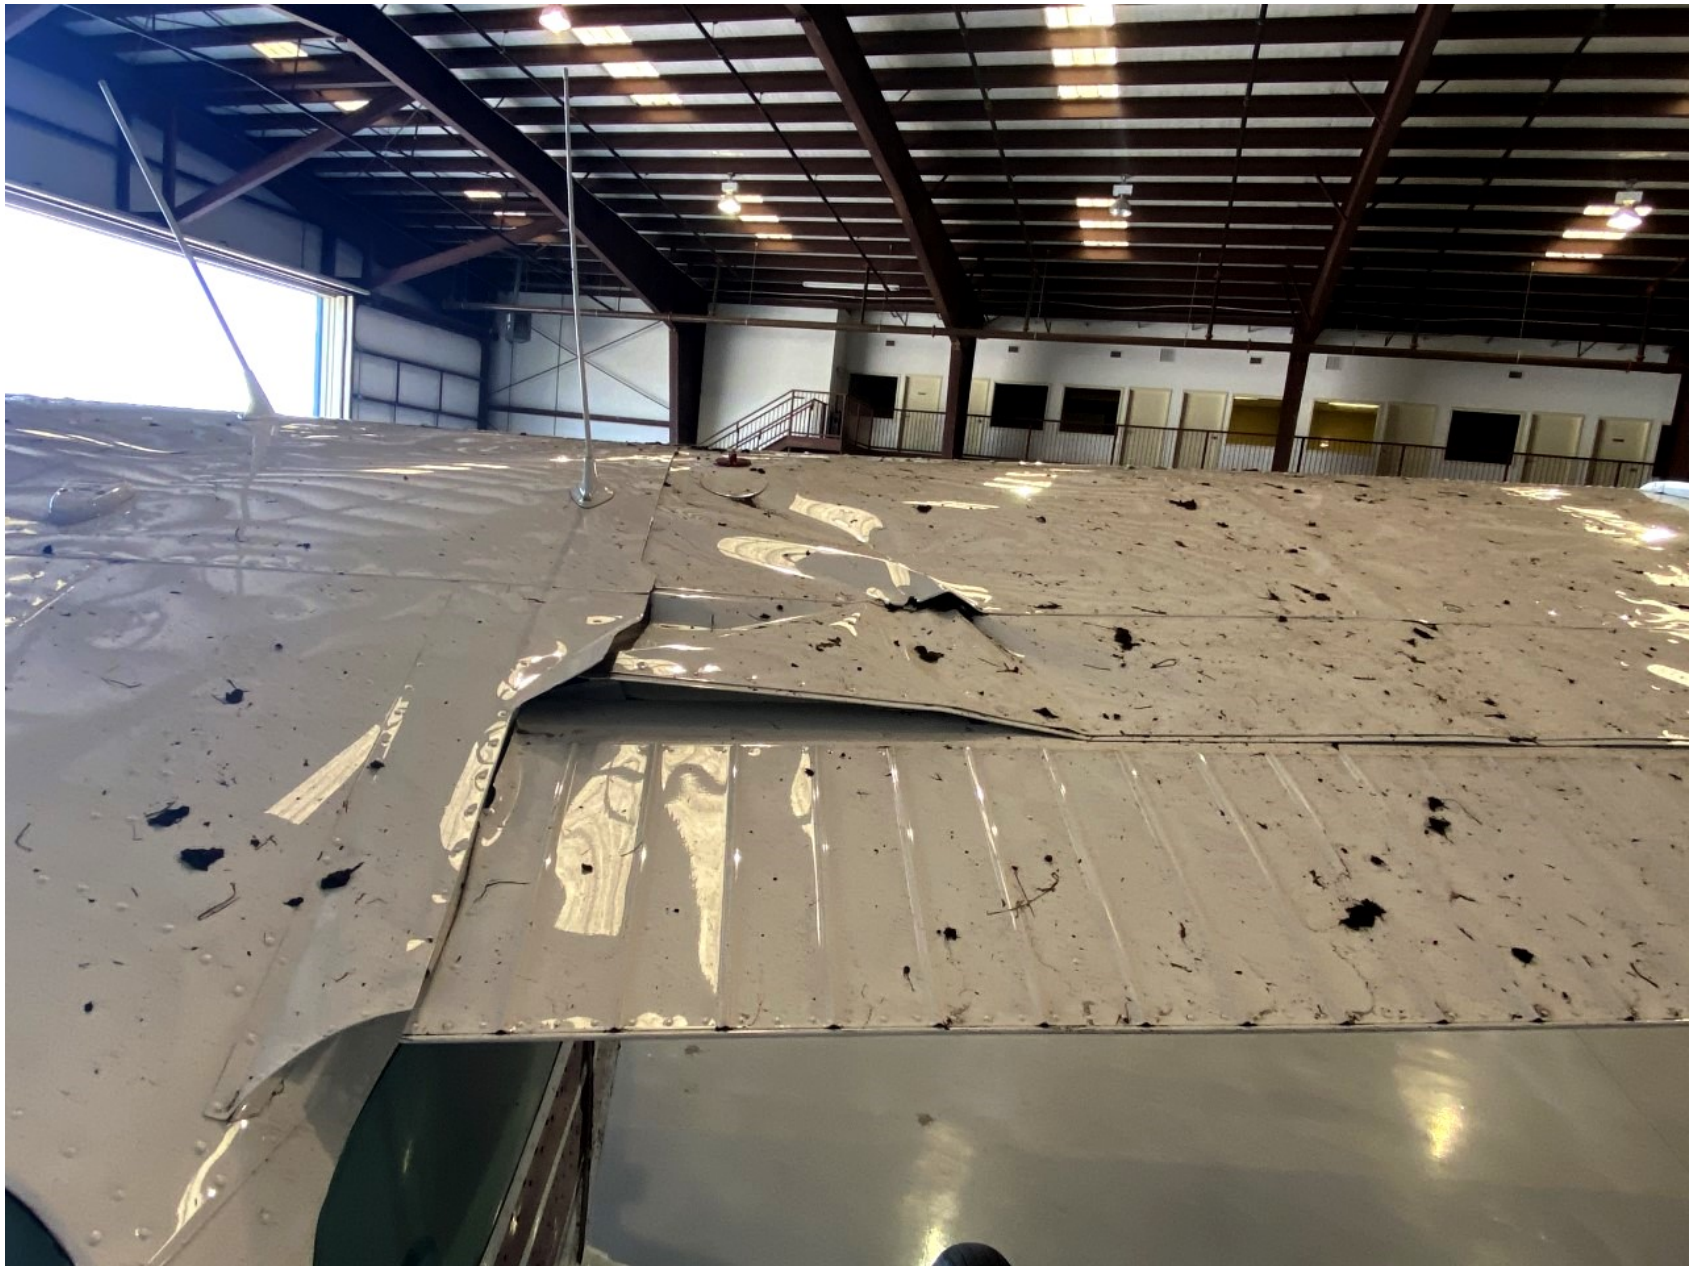
**Photo 4 - Digital Photograph From FAA. View Looking Forward of the Inboard Portion of the Right Wing. Note the Skin Buckling and Wrinkling at the Aft Spar Area.**

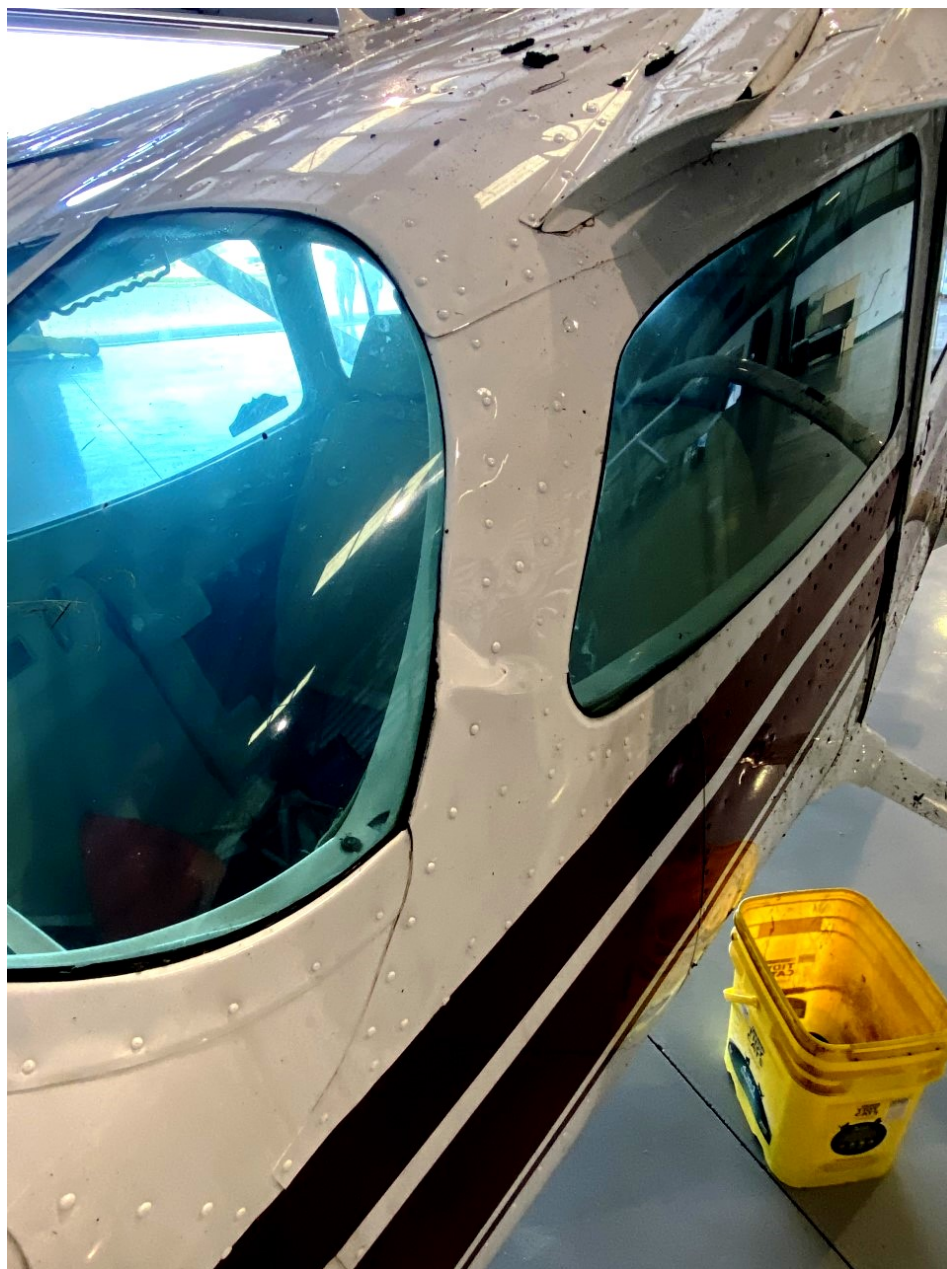
**Photo 5 - Digital Photograph From FAA. View of the Right Side of the Fuselage near the Right Aft Window and the Aft Window. Note the Skin Buckling and Wrinkling.**
