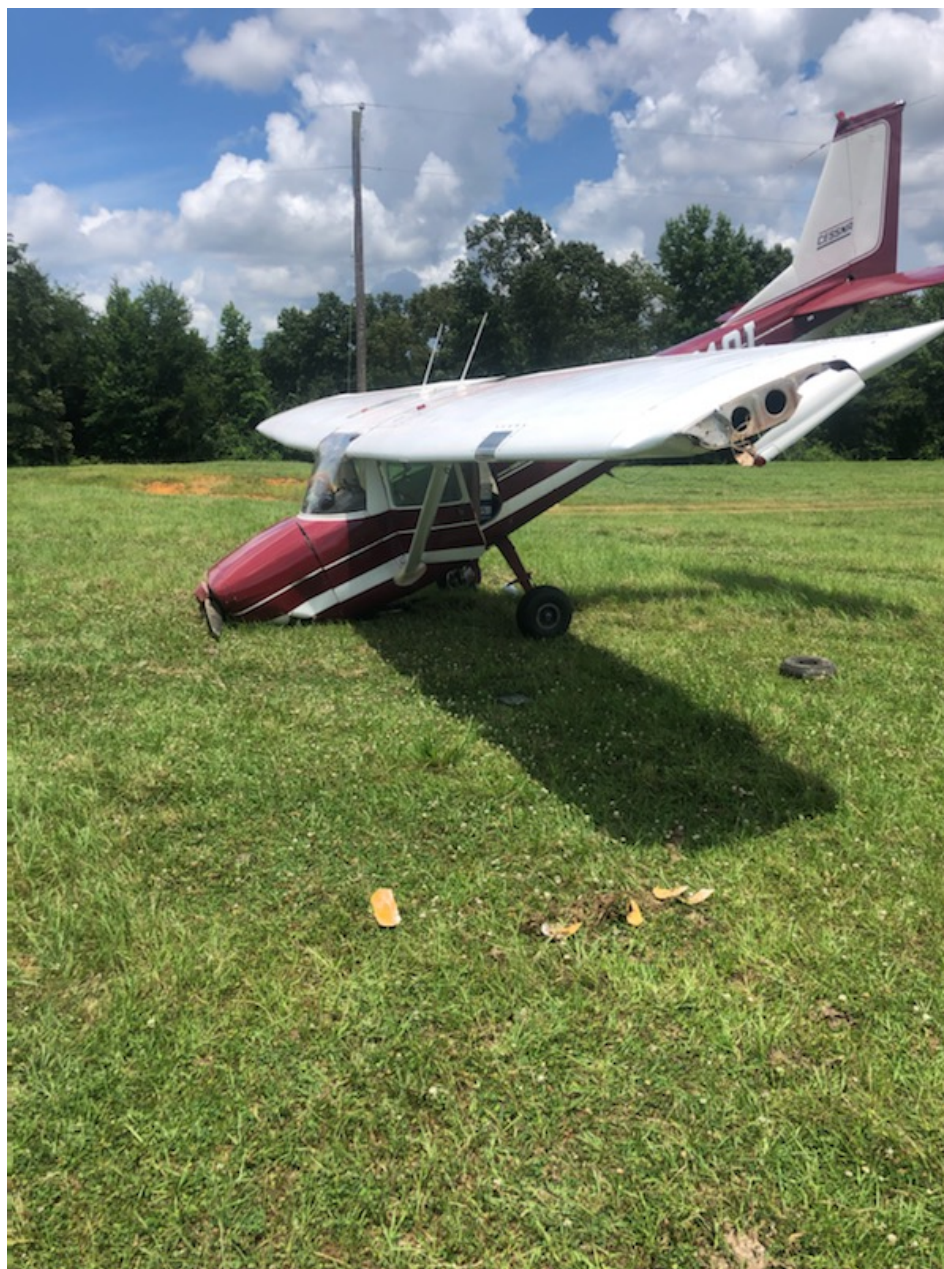
**Photo 1 – Digital Photograph Provided by FAA. Left Side View of the Airplane at the Accident Site.**

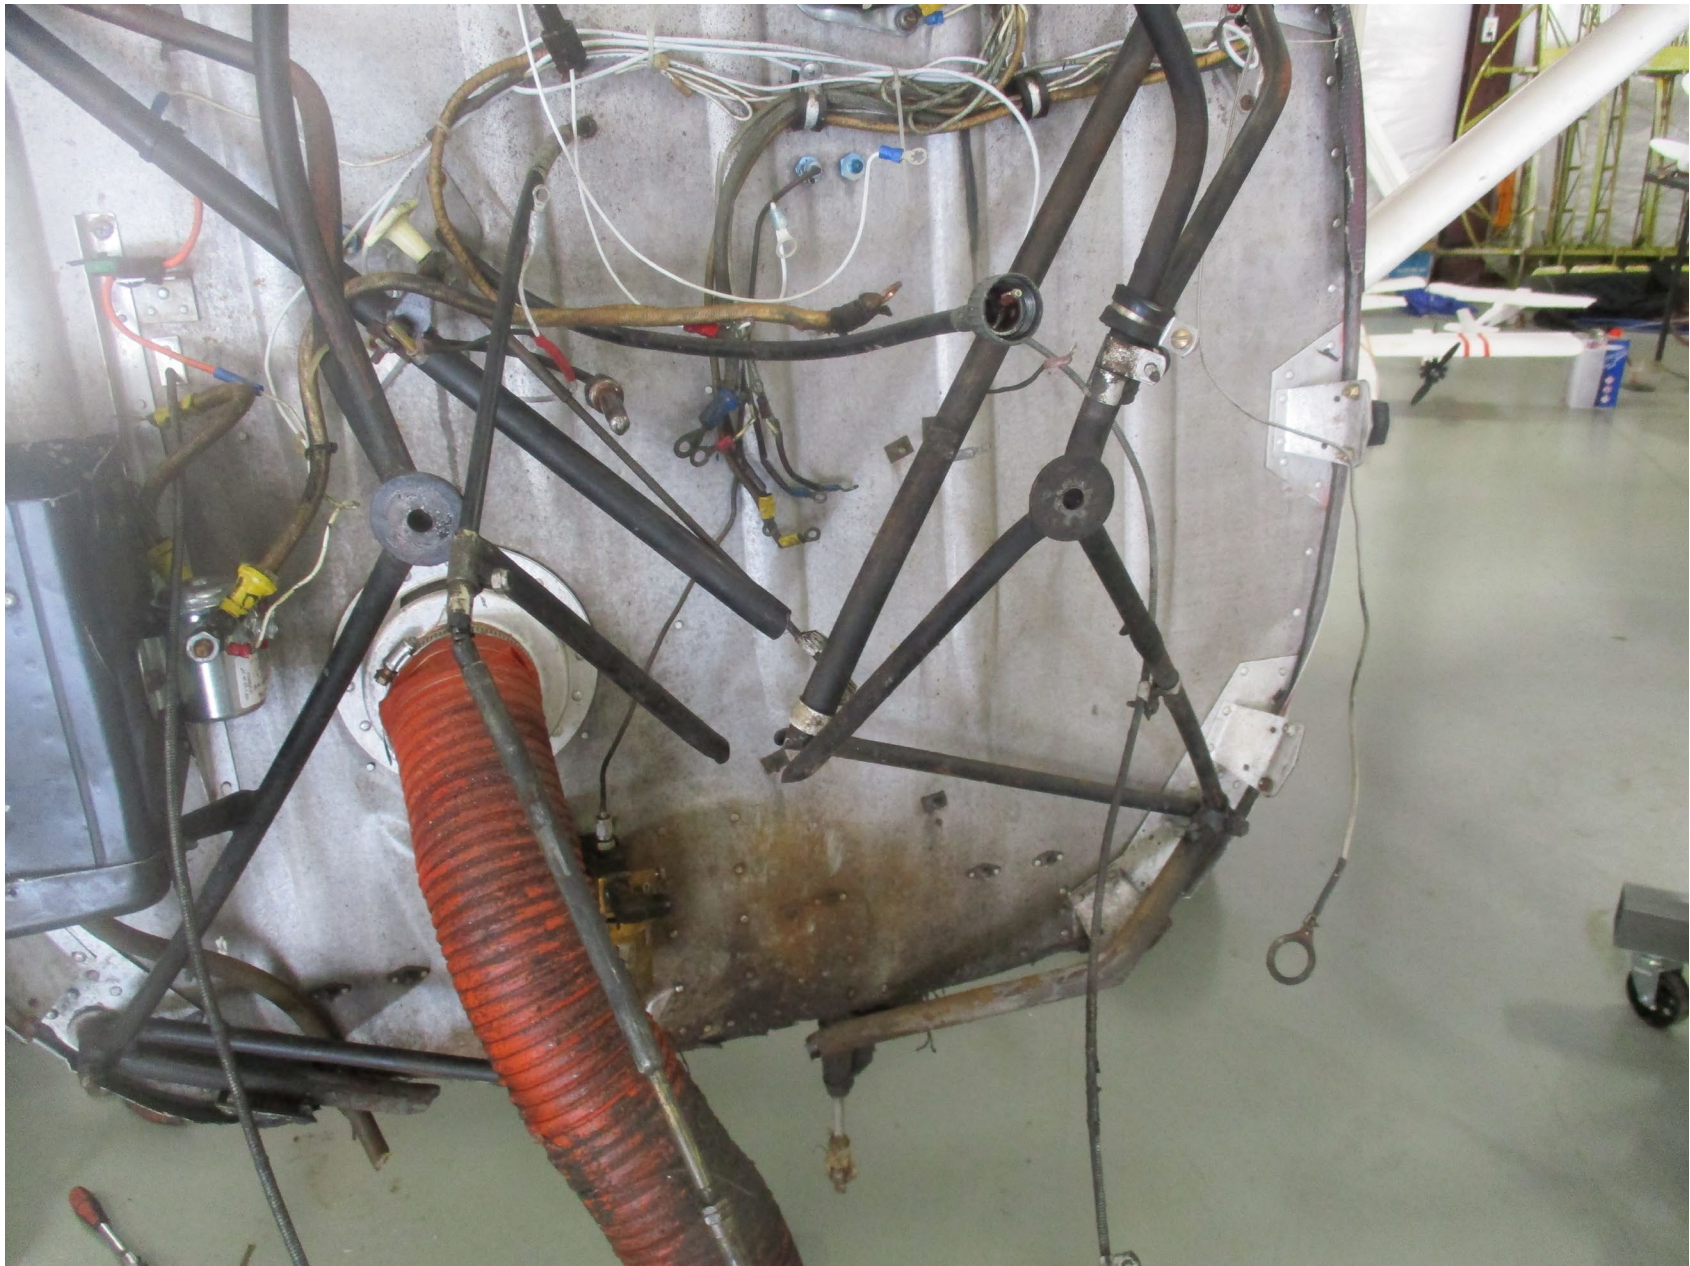
**Photo 2 – FAA Digital Photograph. View of the Firewall and Damaged Engine Mount.**

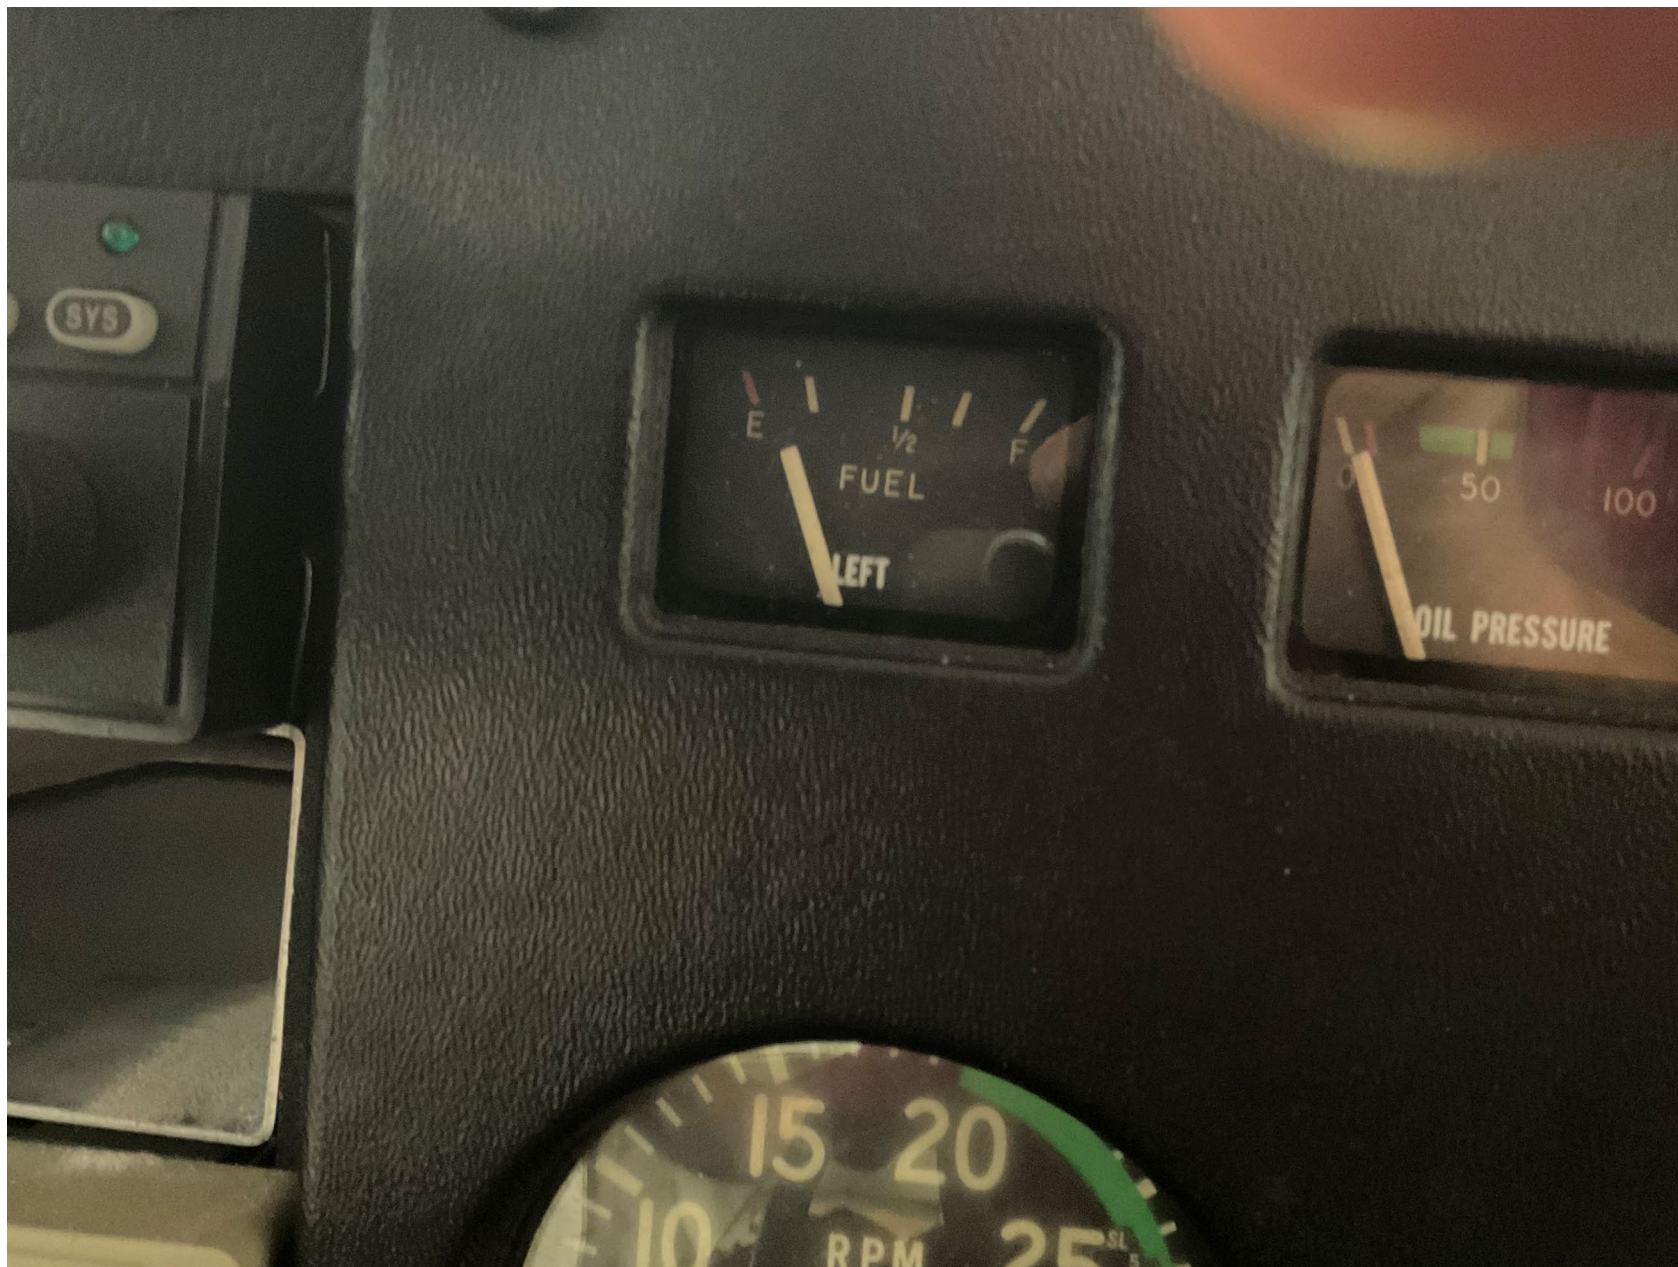
**Photo 3 - FAA Digital Photograph. View of the Left Fuel Gauge with Electrical Power Applied and No Fuel in Left Fuel Tank. Note the Needle Slightly Above Empty.**

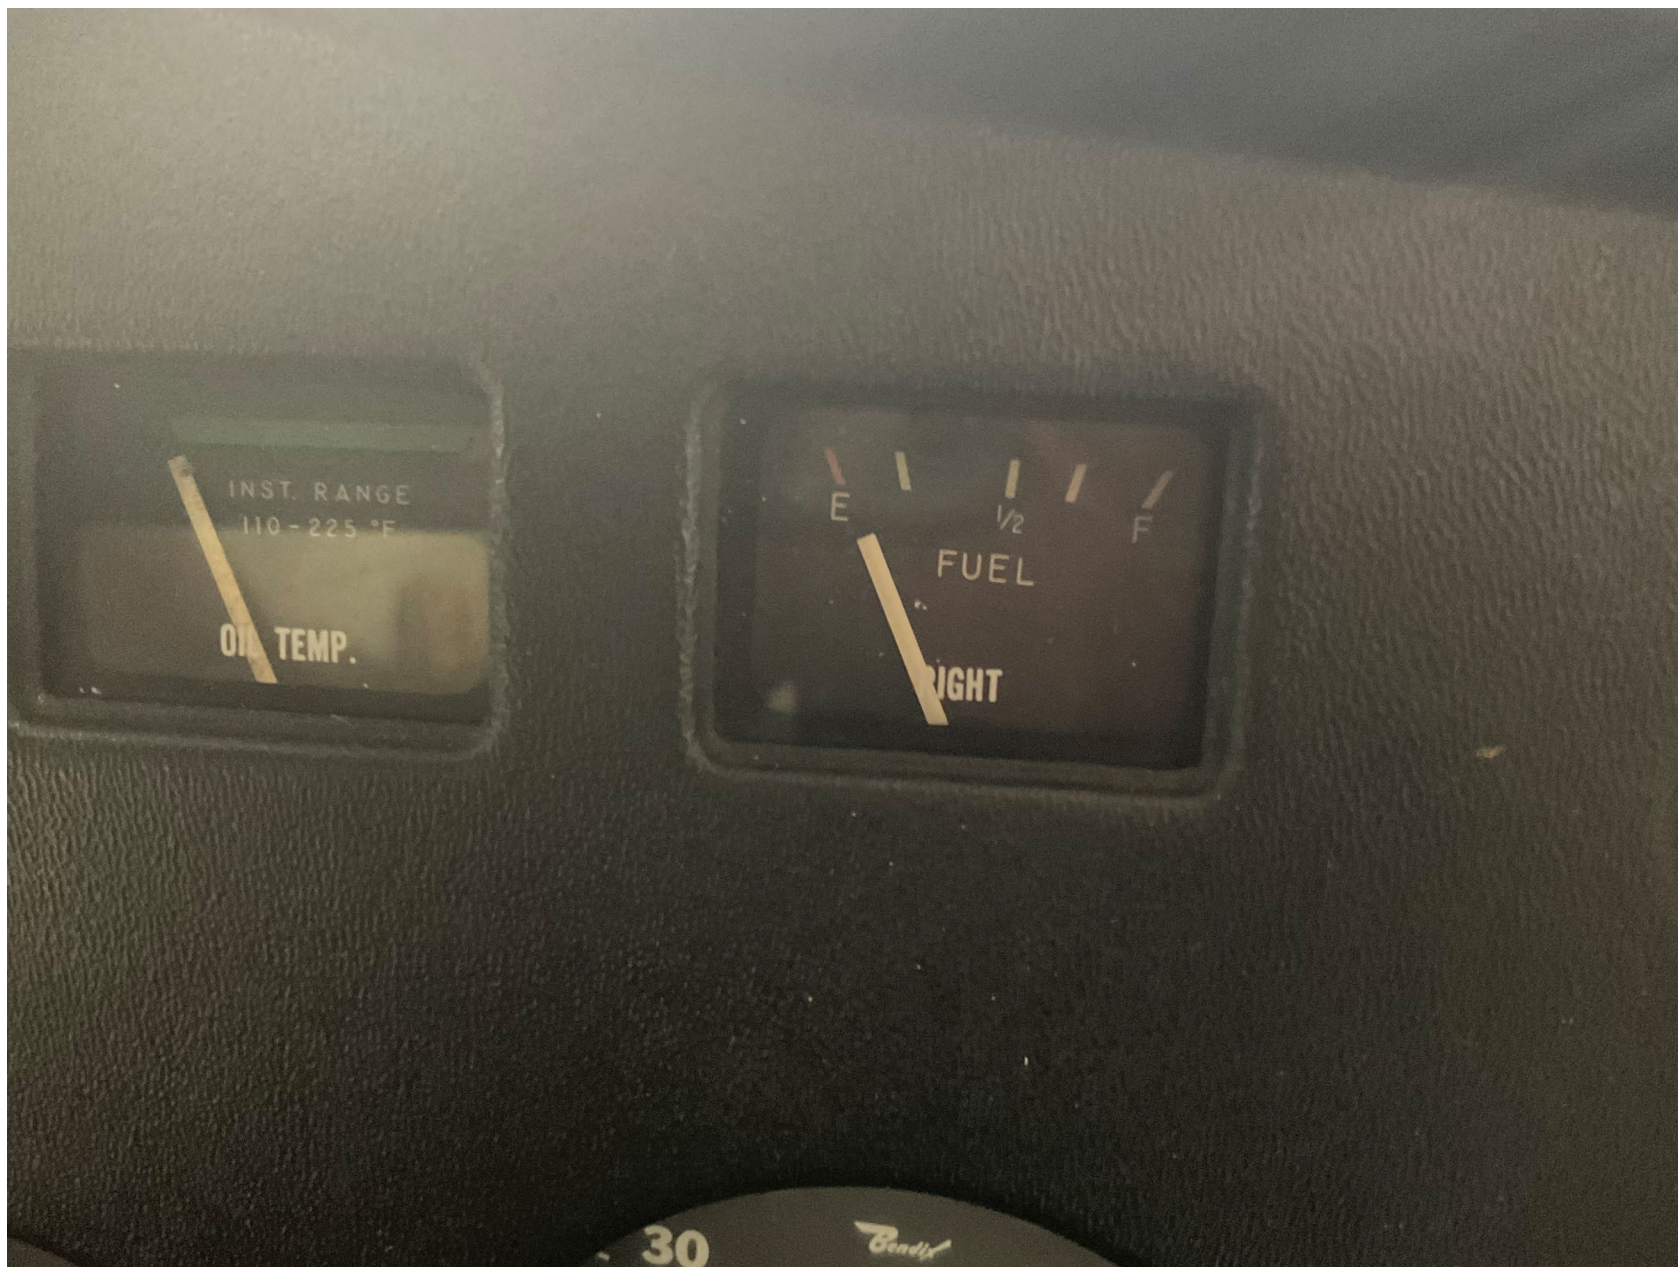
**Photo 4 - FAA Digital Photograph. View of the Right Fuel Gauge with Electrical Power Applied and No Fuel in Right Fuel Tank. Note the Needle at Empty.**
