# NTSB MEMORANDUM FOR RECORD

**Date: 8/30/2021**  
**Person Contacted: David Vandebroek (FAA Inspector)**  
**NTSB Accident Number: ERA21LA322**

## **ELEVATOR SYSTEM EXAMINATION**

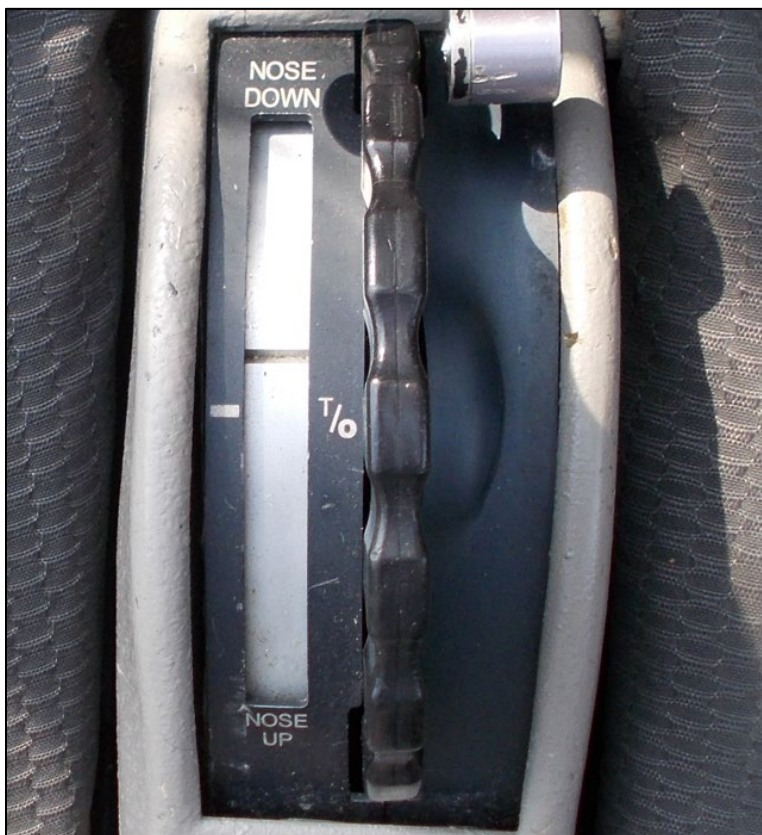
There were no abnormalities discovered in either the elevator control system or the elevator trim system that would account for the inability to properly control the aircraft in pitch as described by the two pilots. The trim wheel was set in a slight nose down position. This was documented in pictures taken by the North Carolina State Police shortly after the accident and before anyone else gained access to the aircraft.

*Figure 1: View of the elevator pitch trim control wheel*

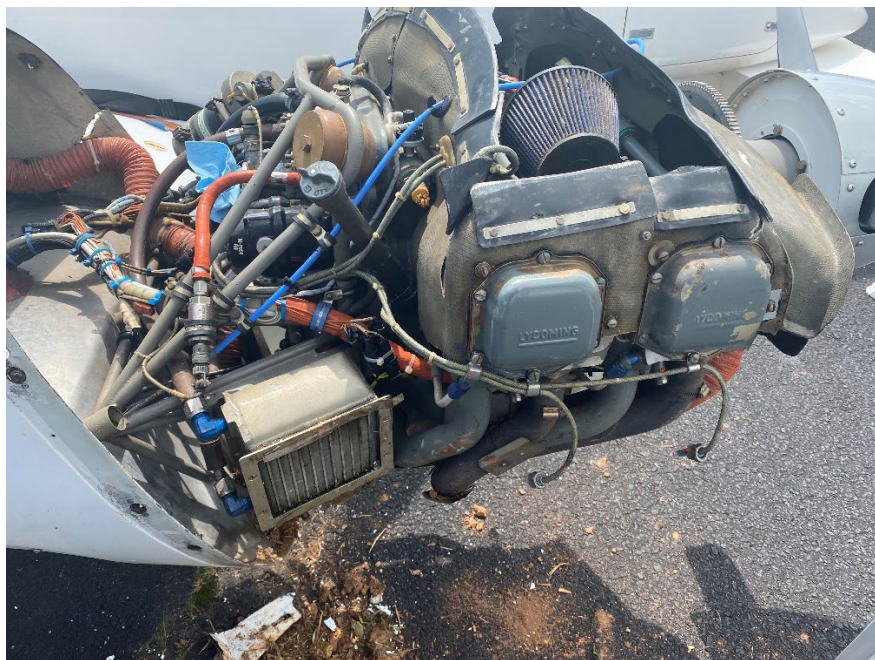
- No damage or defects noted that indicated any pre impact issues with the engine.
- All fuel and oil lines were secure and tight. No leaks noted.
- Dipstick indicated 6.0 quarts of engine oil.
- All spark plug electrodes looked normal.
- Performed borescope. No defects noted.
- Engine rotated freely. Pistons moved freely within the cylinders.
- Performed thumb compression test on all cylinders. All cylinders displayed strong compression.
- Both magnetos were set at 25 degrees before top dead center. Proper timing is 25.
- Air filter was clean, and no obstructions noted in intake.
- No foreign material was noted in engine oil filter.

*Figure 2: View of the right engine*

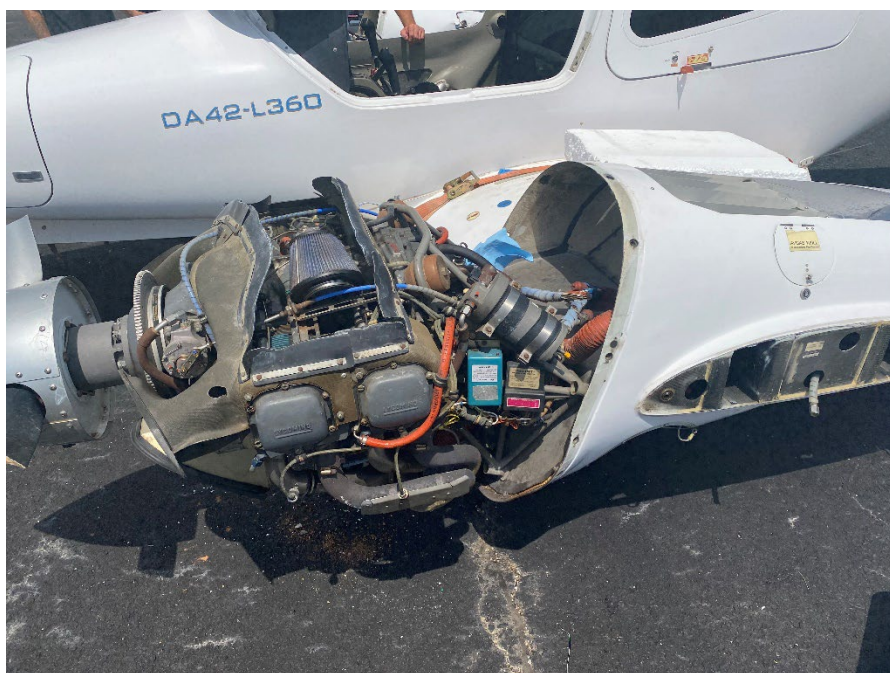
- All fuel and oil lines were secure and tight. No leaks noted.
- Dipstick indicated 6.5 quarts of engine oil.

- All spark plug electrodes looked normal. However, the lower plug on the #1 cylinder was full of engine oil. This was the low point of the engine postaccident.
- Performed borescope. No defects noted.
- Engine rotated freely.
- Pistons moved freely within the cylinders.
- Performed thumb compression test on all cylinders. All cylinders displayed strong compression. This includes #1 which had the oil soaked spark plug.
- Both magnetos were set at 27 degrees before top dead center. Proper timing is 25.
- Air filter was clean, and no obstructions noted in intake.
- No foreign material noted in the engine oil filter.
- There was no indication of the oil being burned onto the plug which would have been likely if the oil existed during combustion.

*Figure 3: View of the left engine*

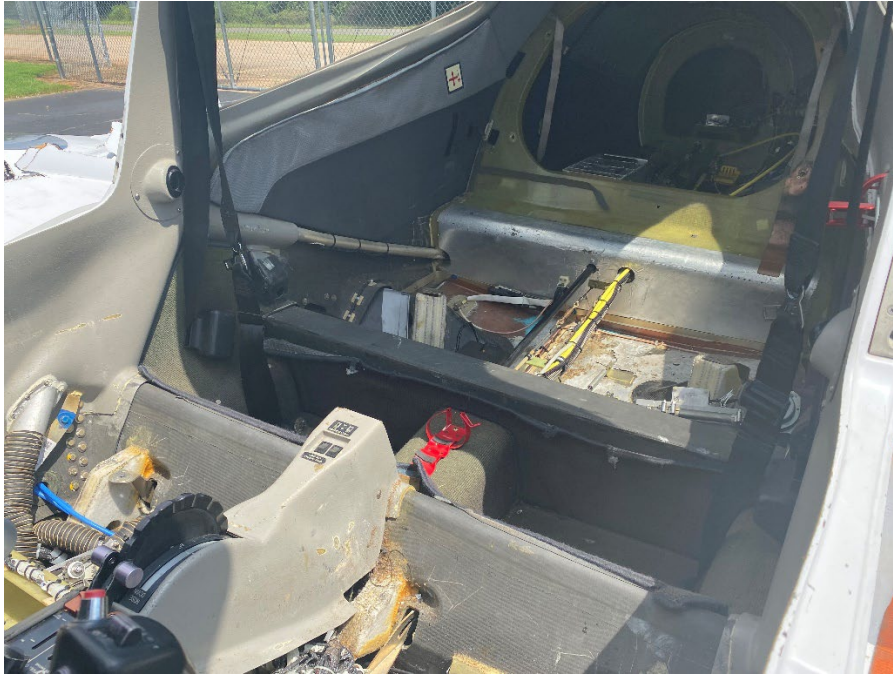
The control stick movement was free and correct. No restrictions or obstructions noted. There was full travel of the elevator.

No defects noted.

*Figure 4: View of the elevator control linkages*
