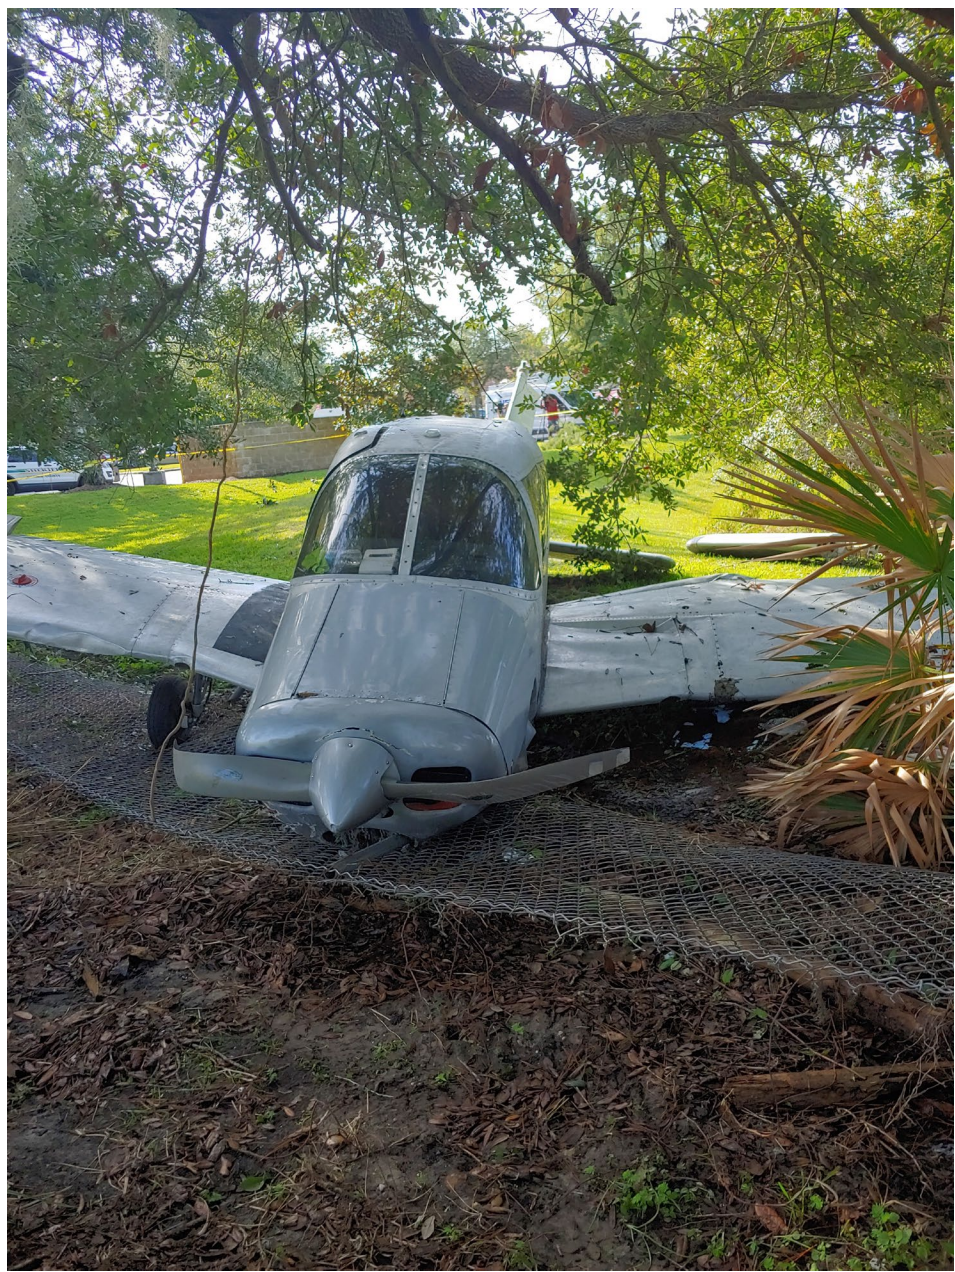
**Photo 1 – Front View of Main Wreckage – Courtesy of FAA**

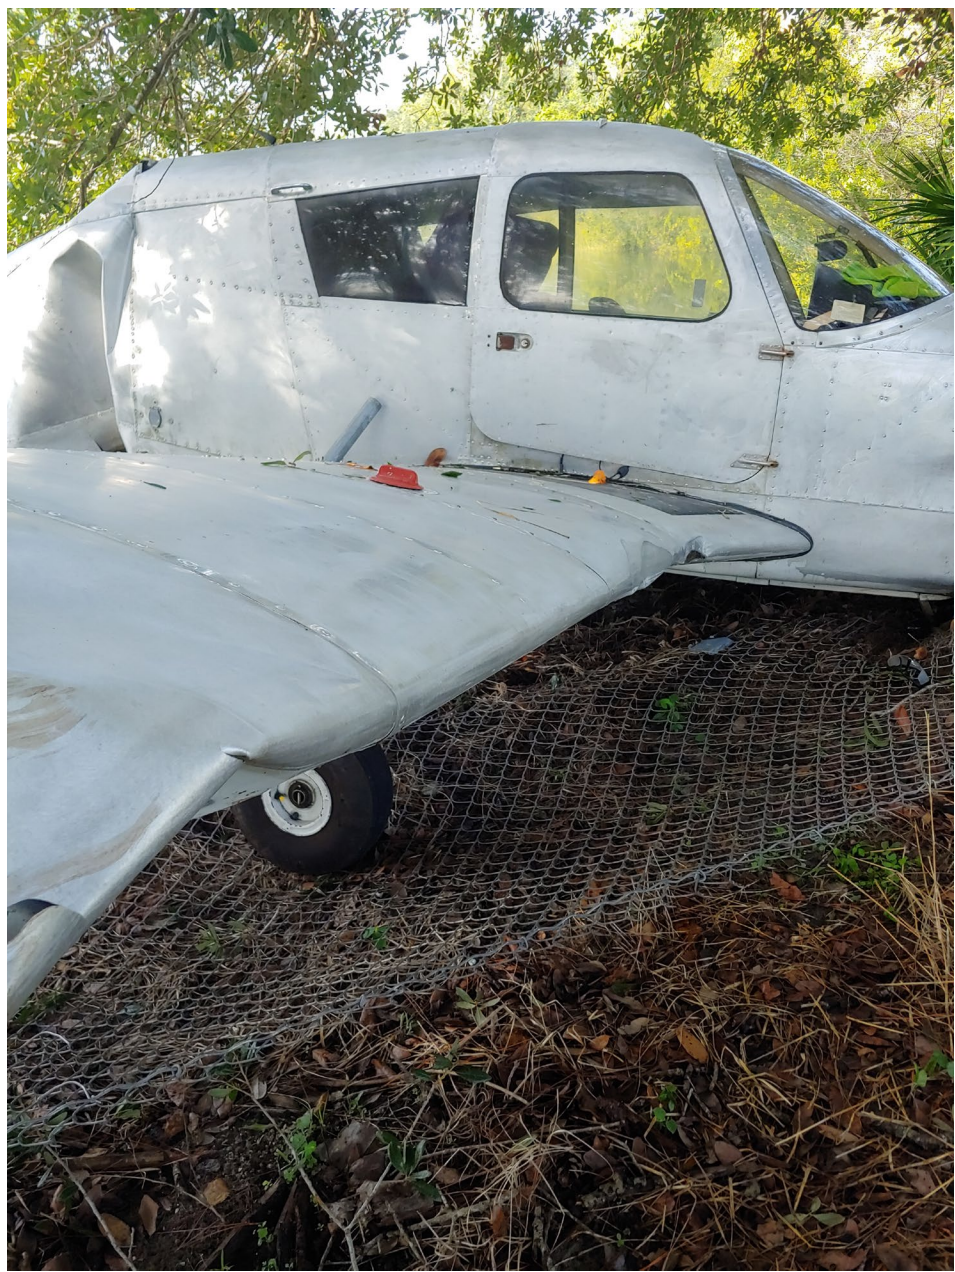
**Photo 2 -Right Side of Main Wreckage – Courtesy of FAA**

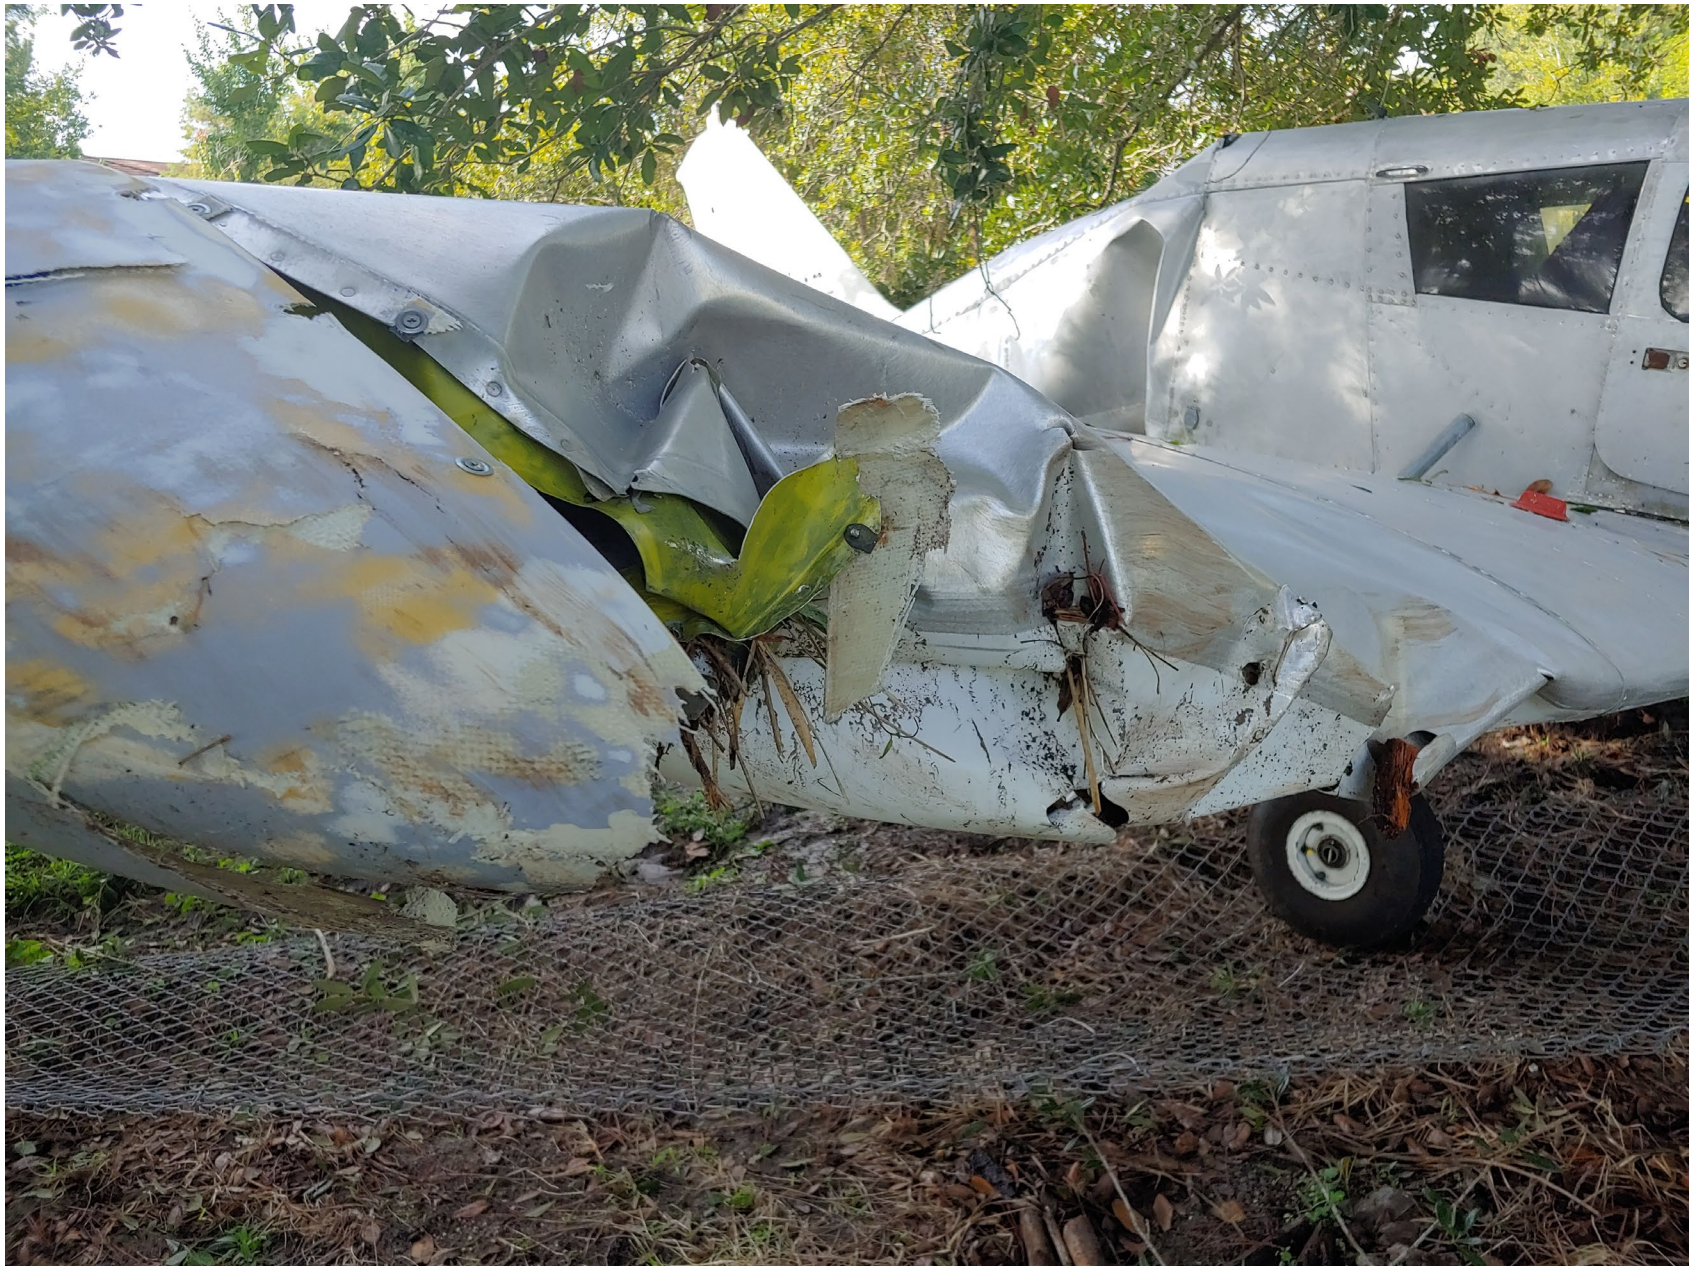
**Photo 3 – Right Wing – Courtesy of FAA**

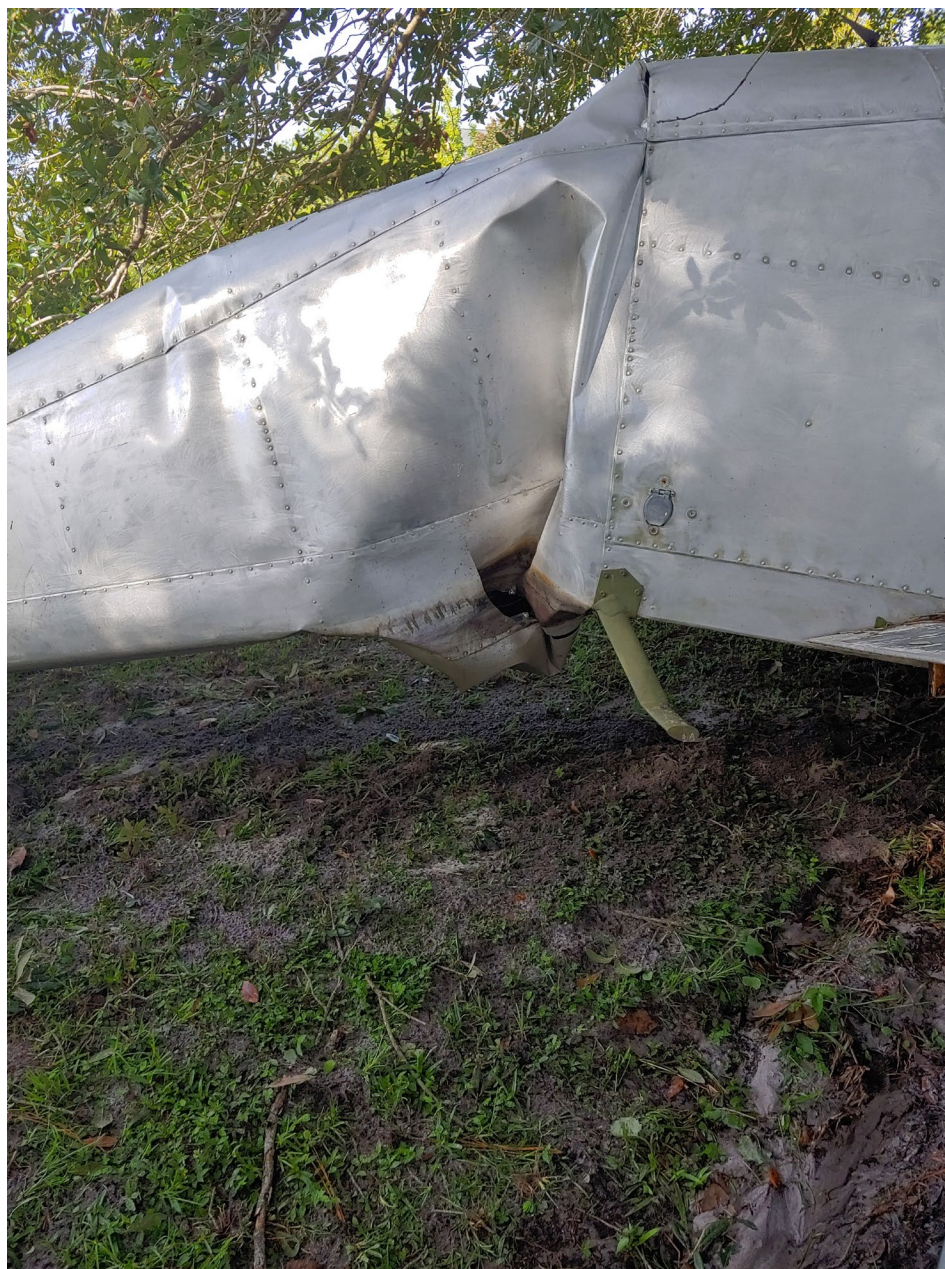
**Photo 4 – Aft Fuselage – Courtesy of FAA**

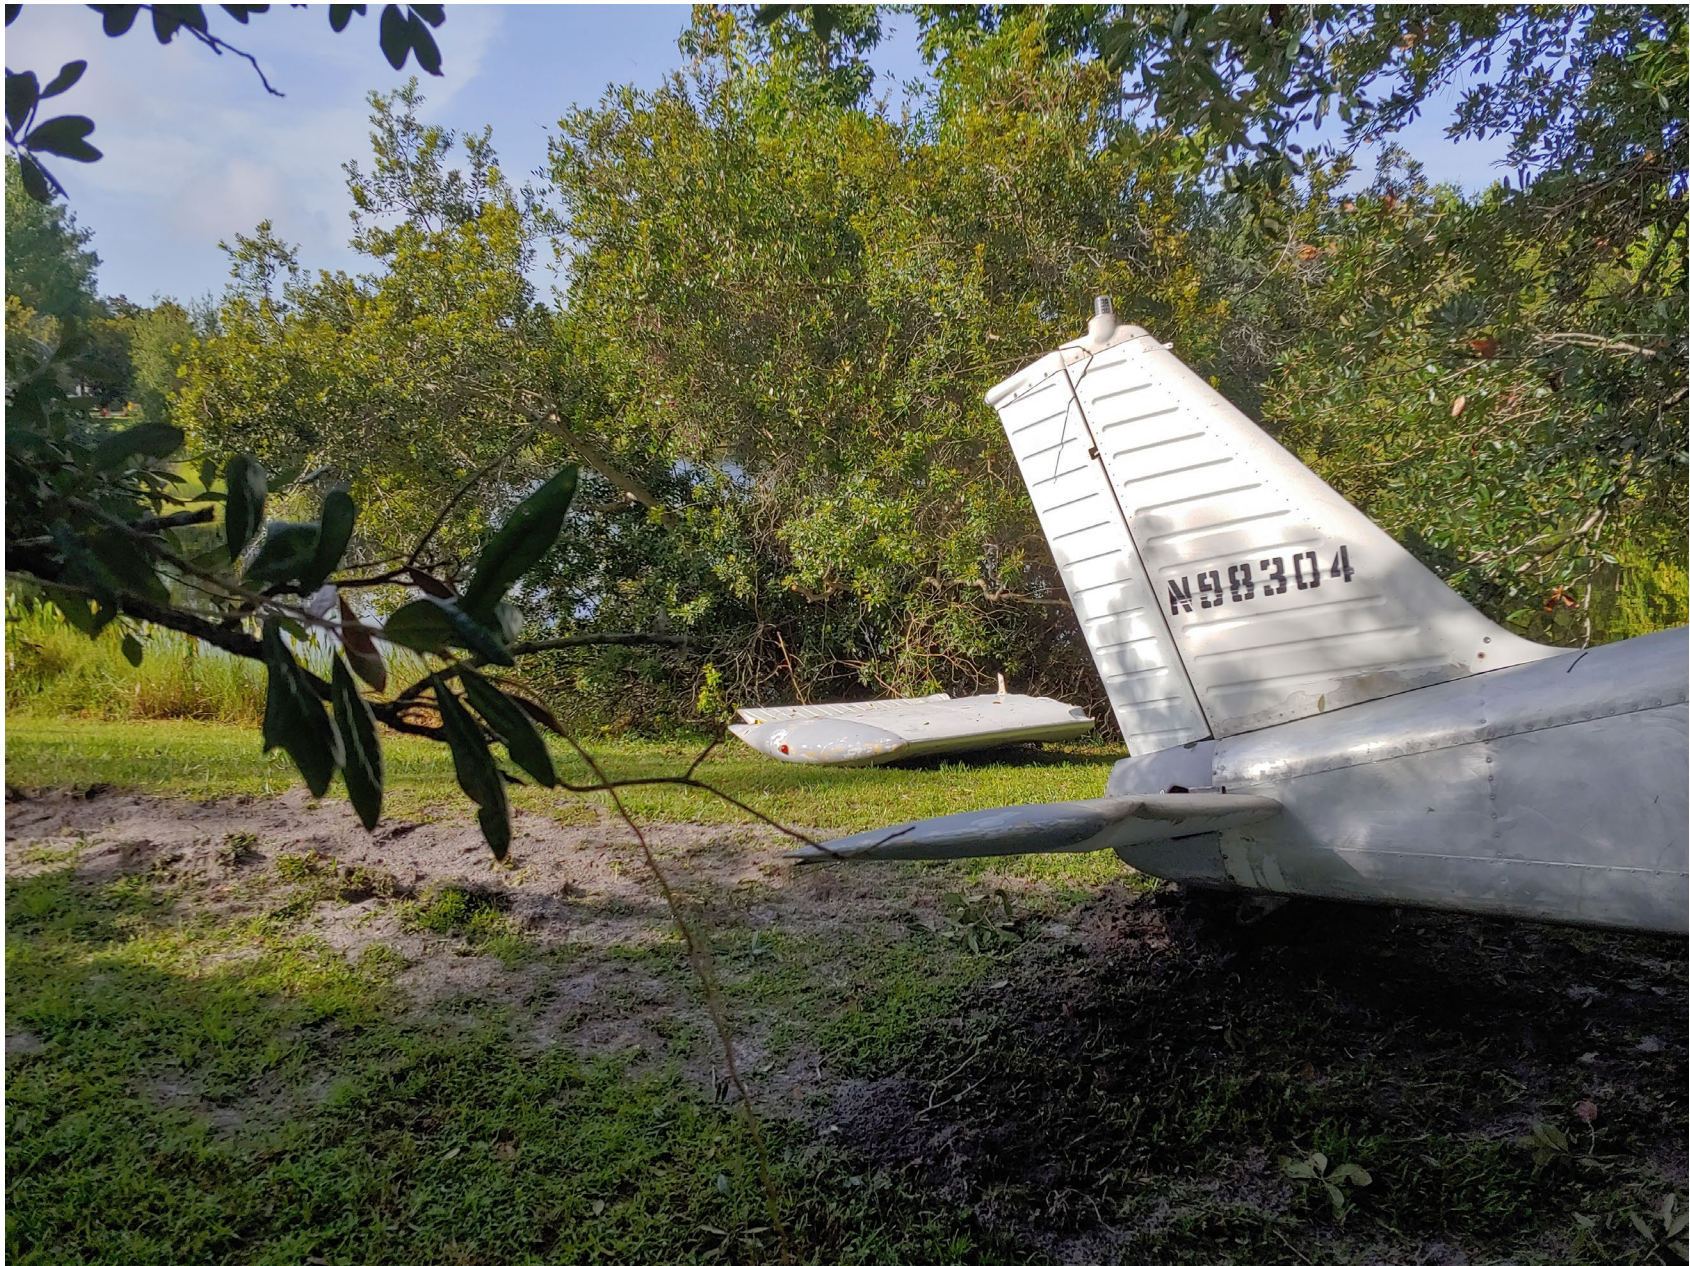
**Photo 5 – Empennage and Left Wing – Courtesy of FAA**

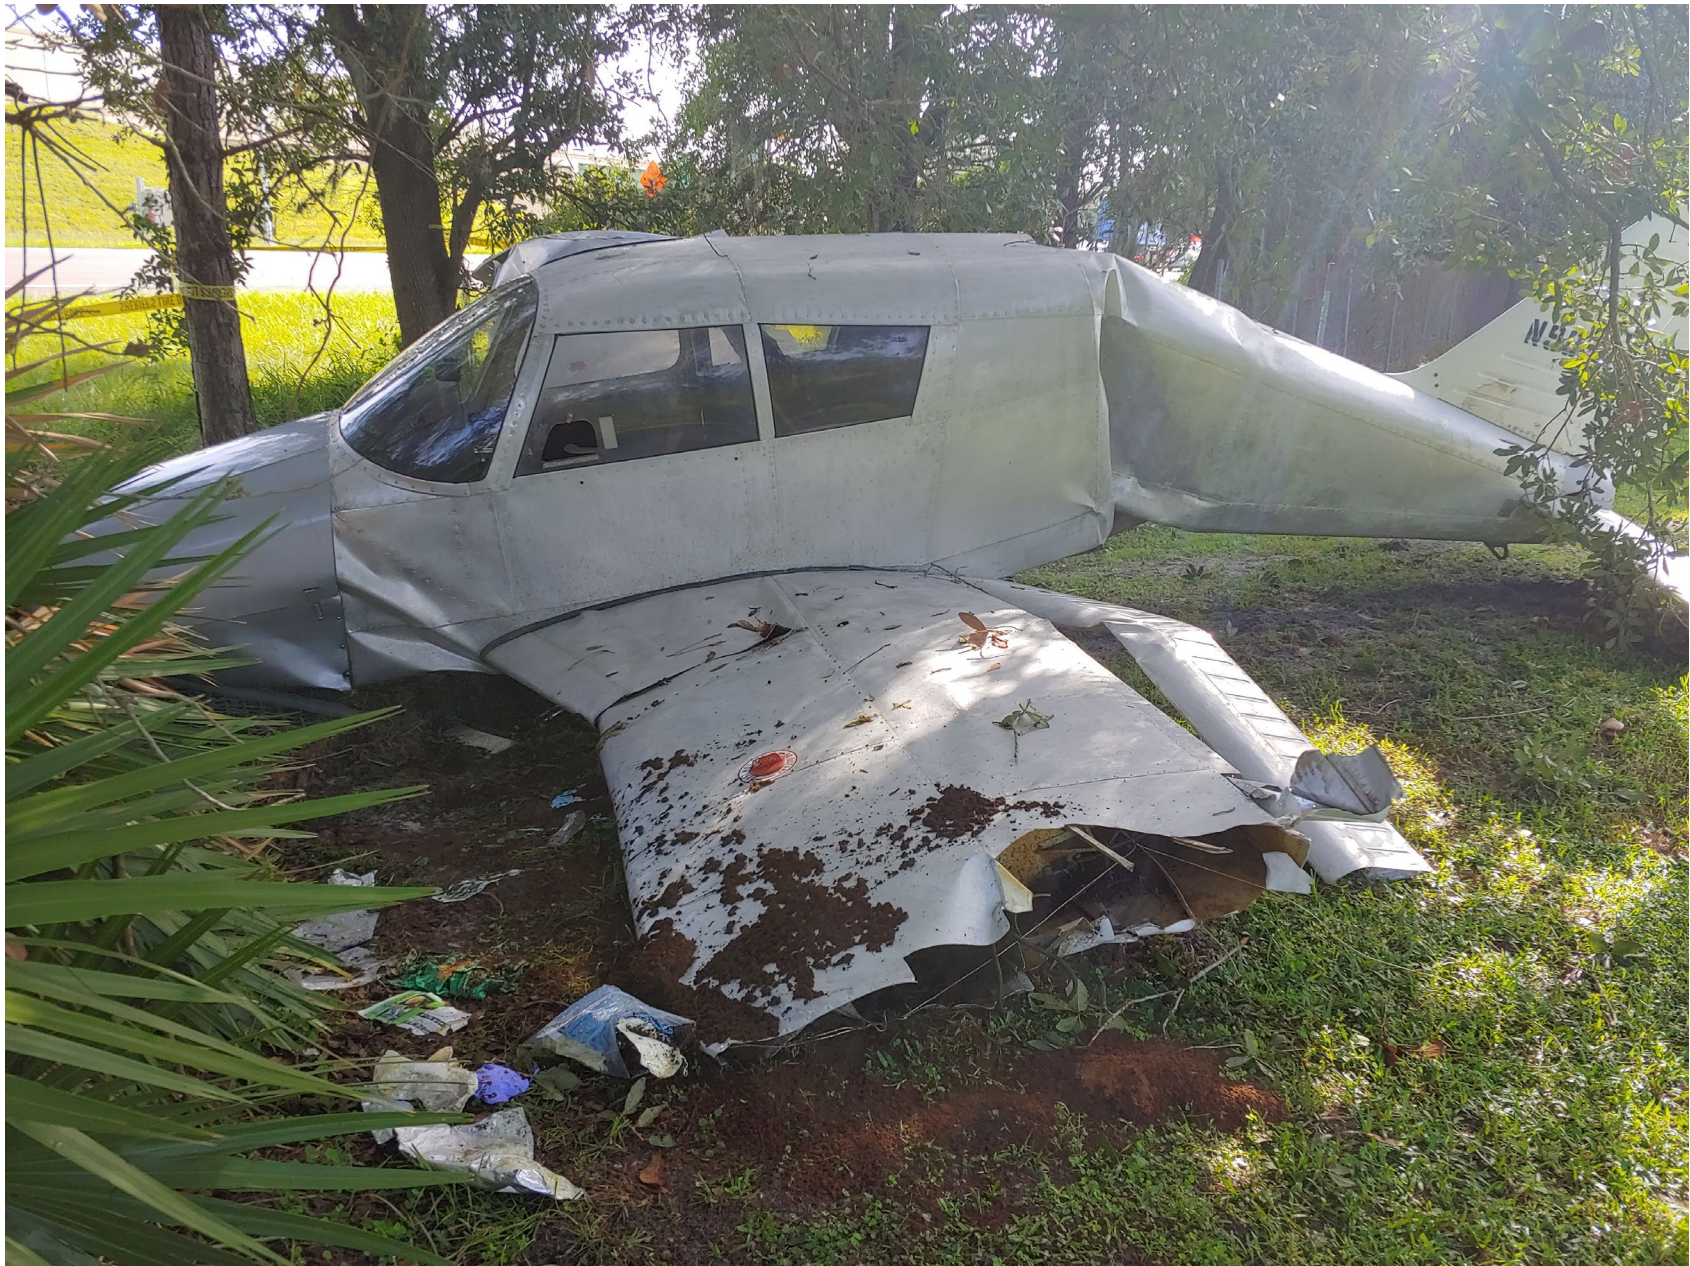
**Photo 6 – Left Side View of Main Wreckage – Courtesy of FAA**

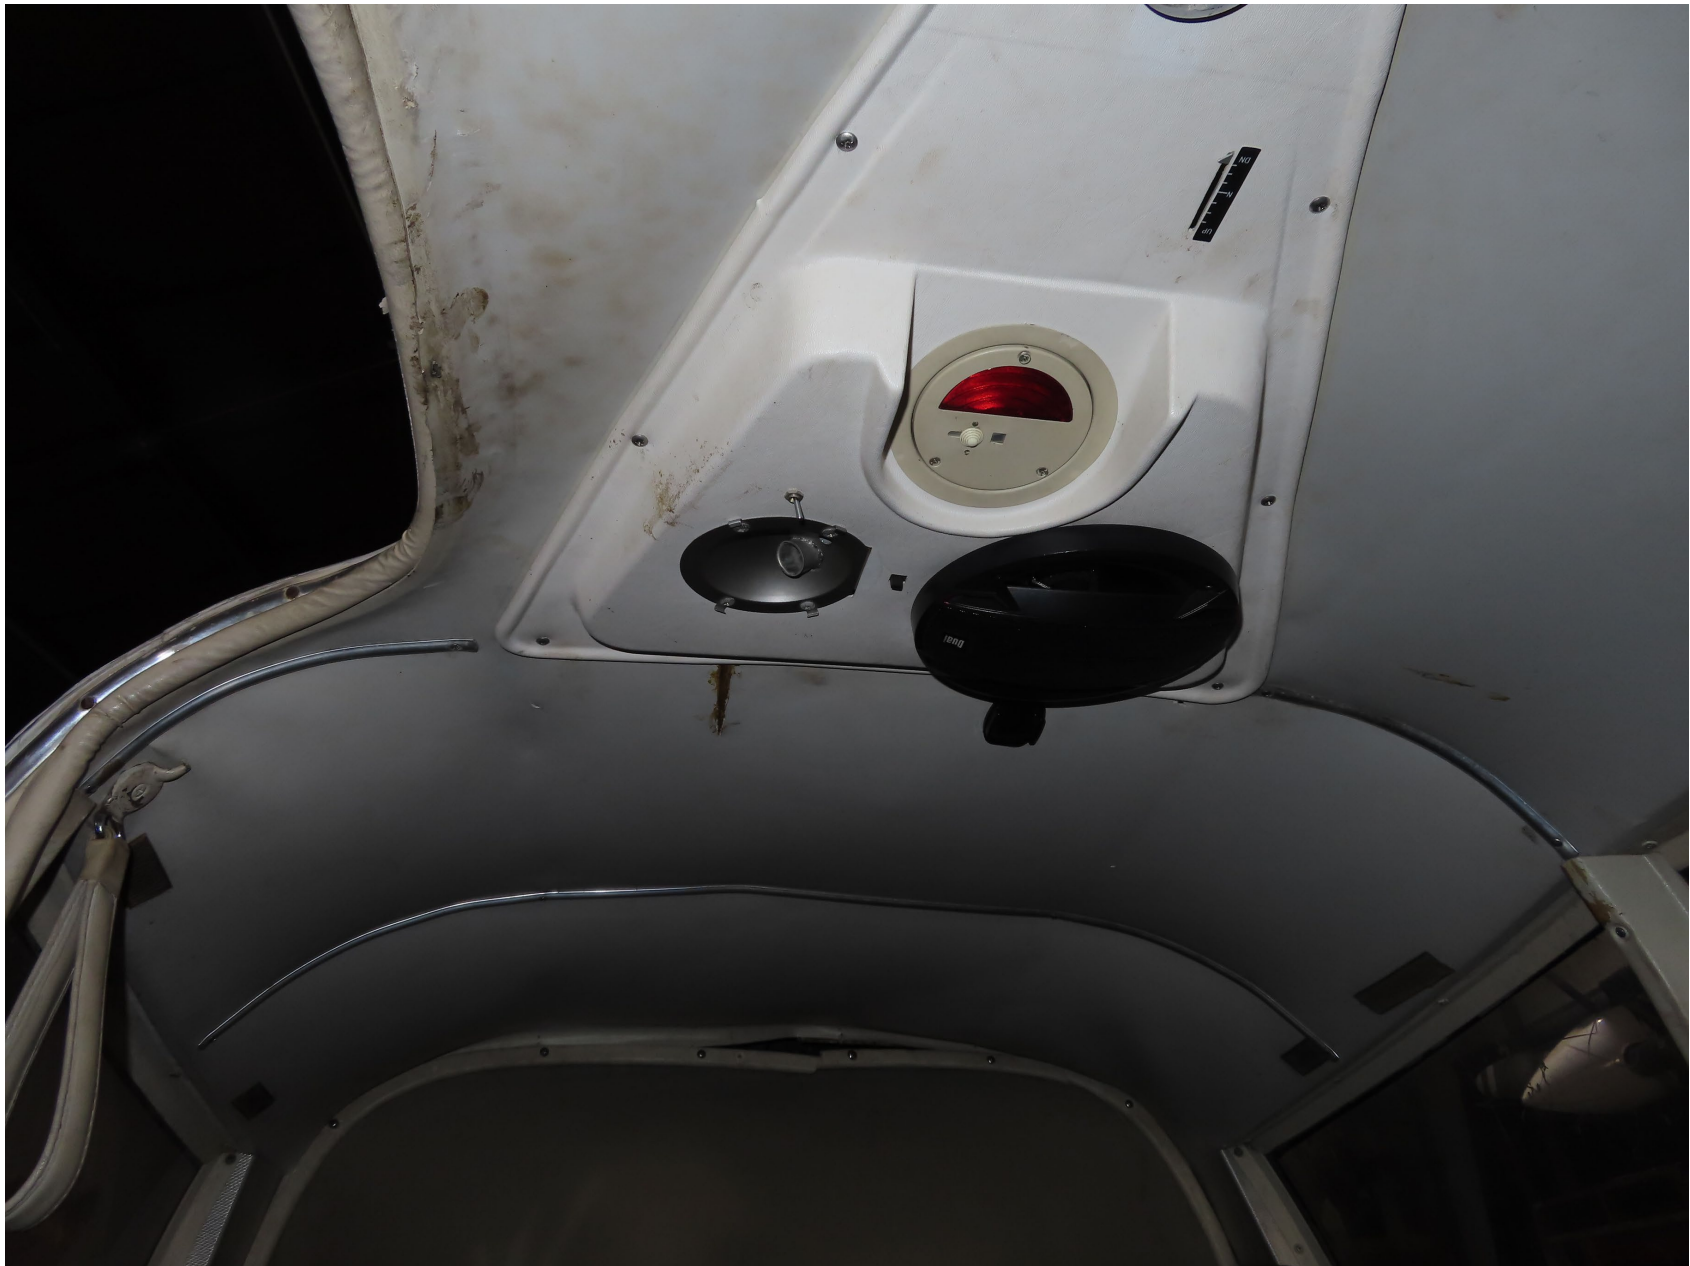
**Photo 7 – Missing Light and Lense – Courtesy of Piper Aircraft**

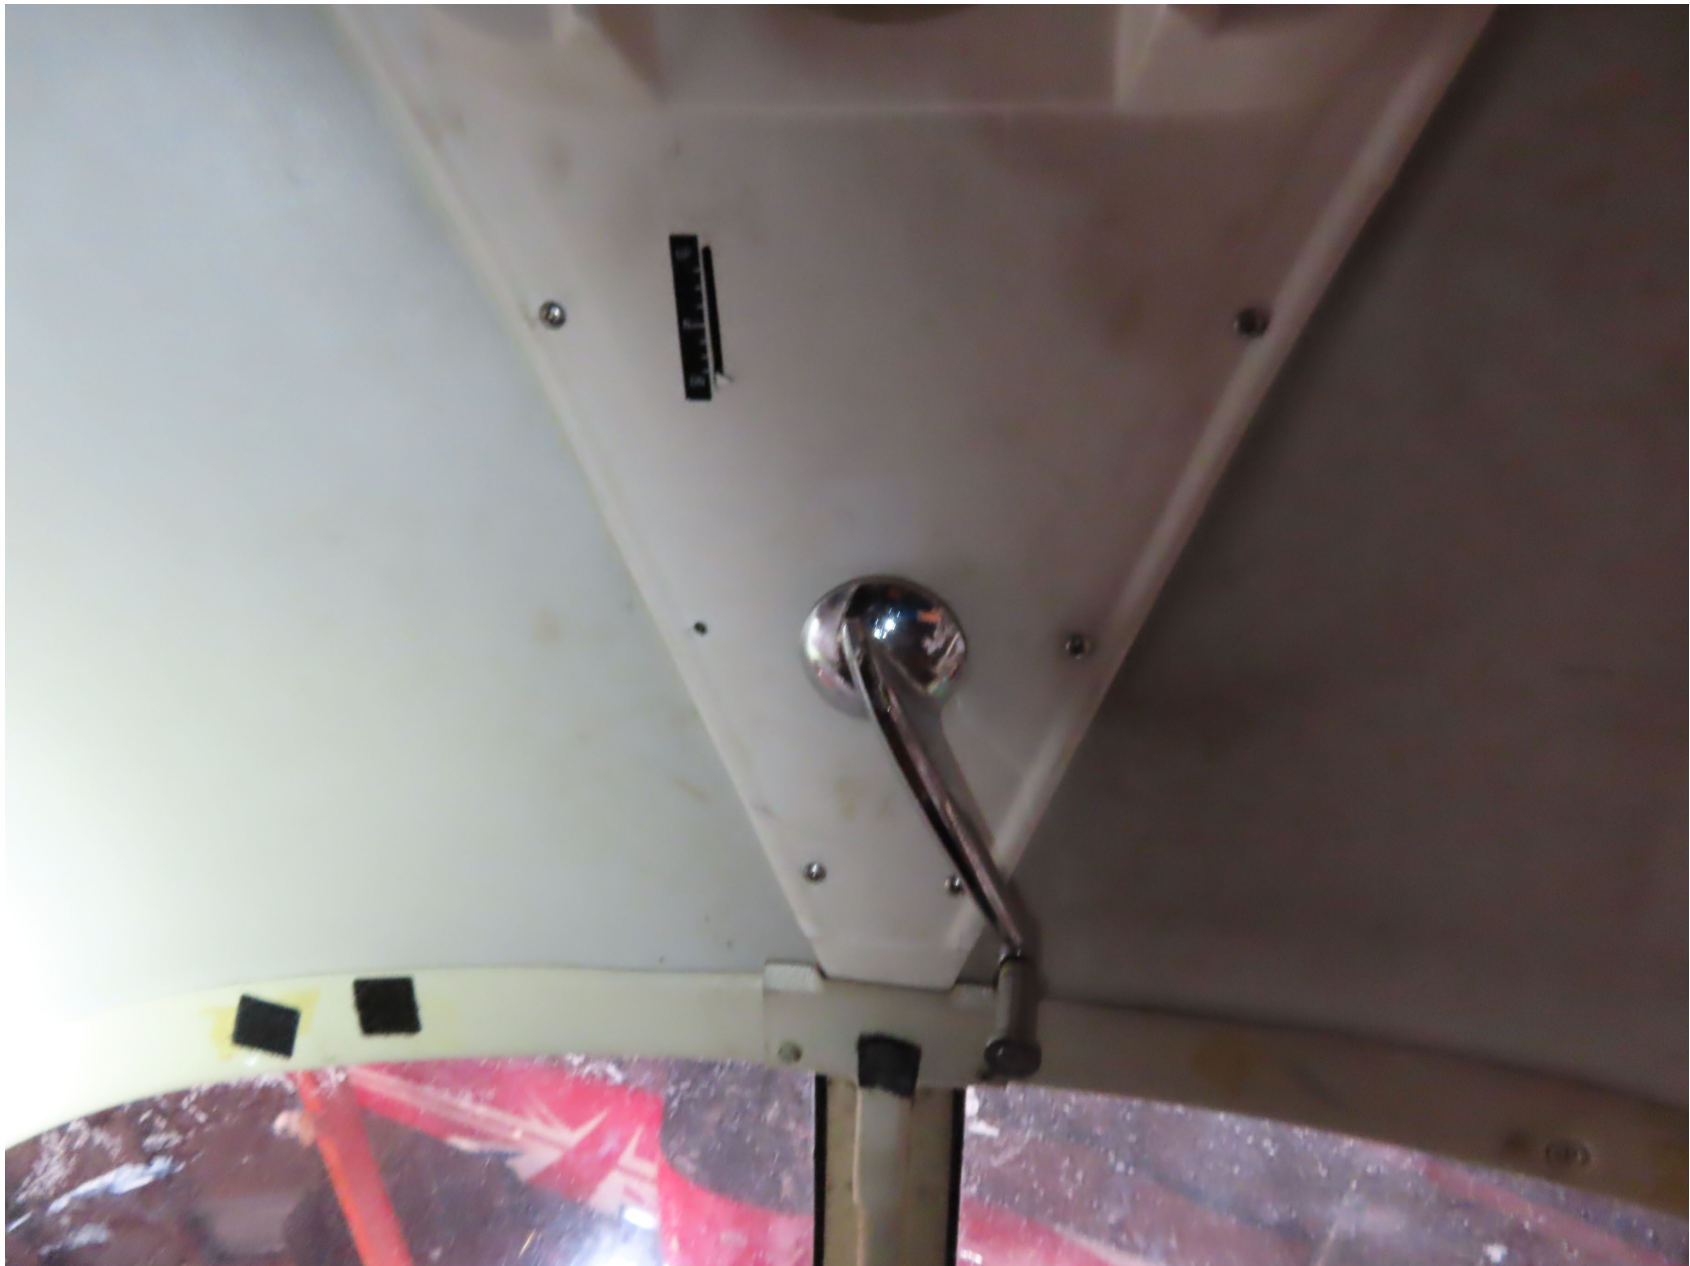
**Photo 8 – Pitch Trim Handle – Courtesy of Piper Aircraft**

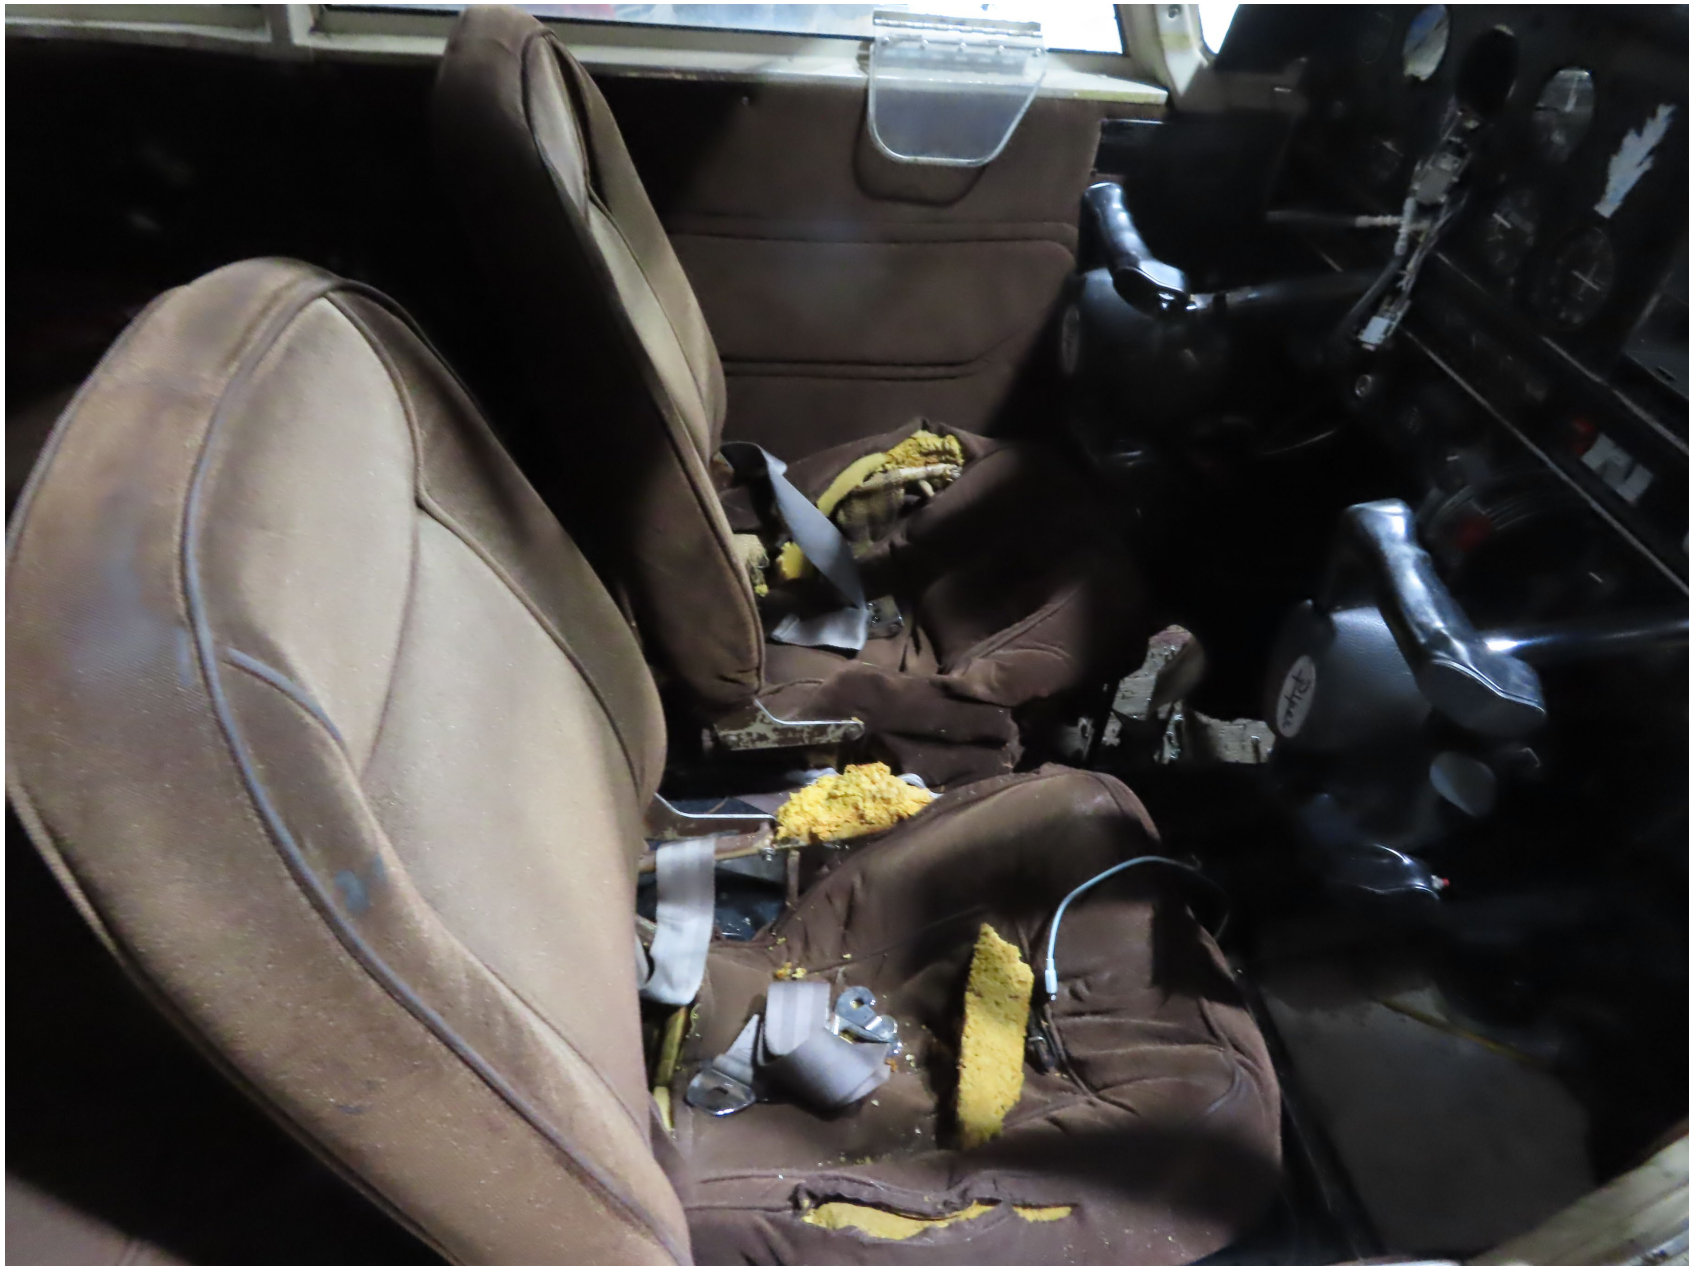
**Photo 9 – Front Seats – Courtesy of Piper Aircraft**

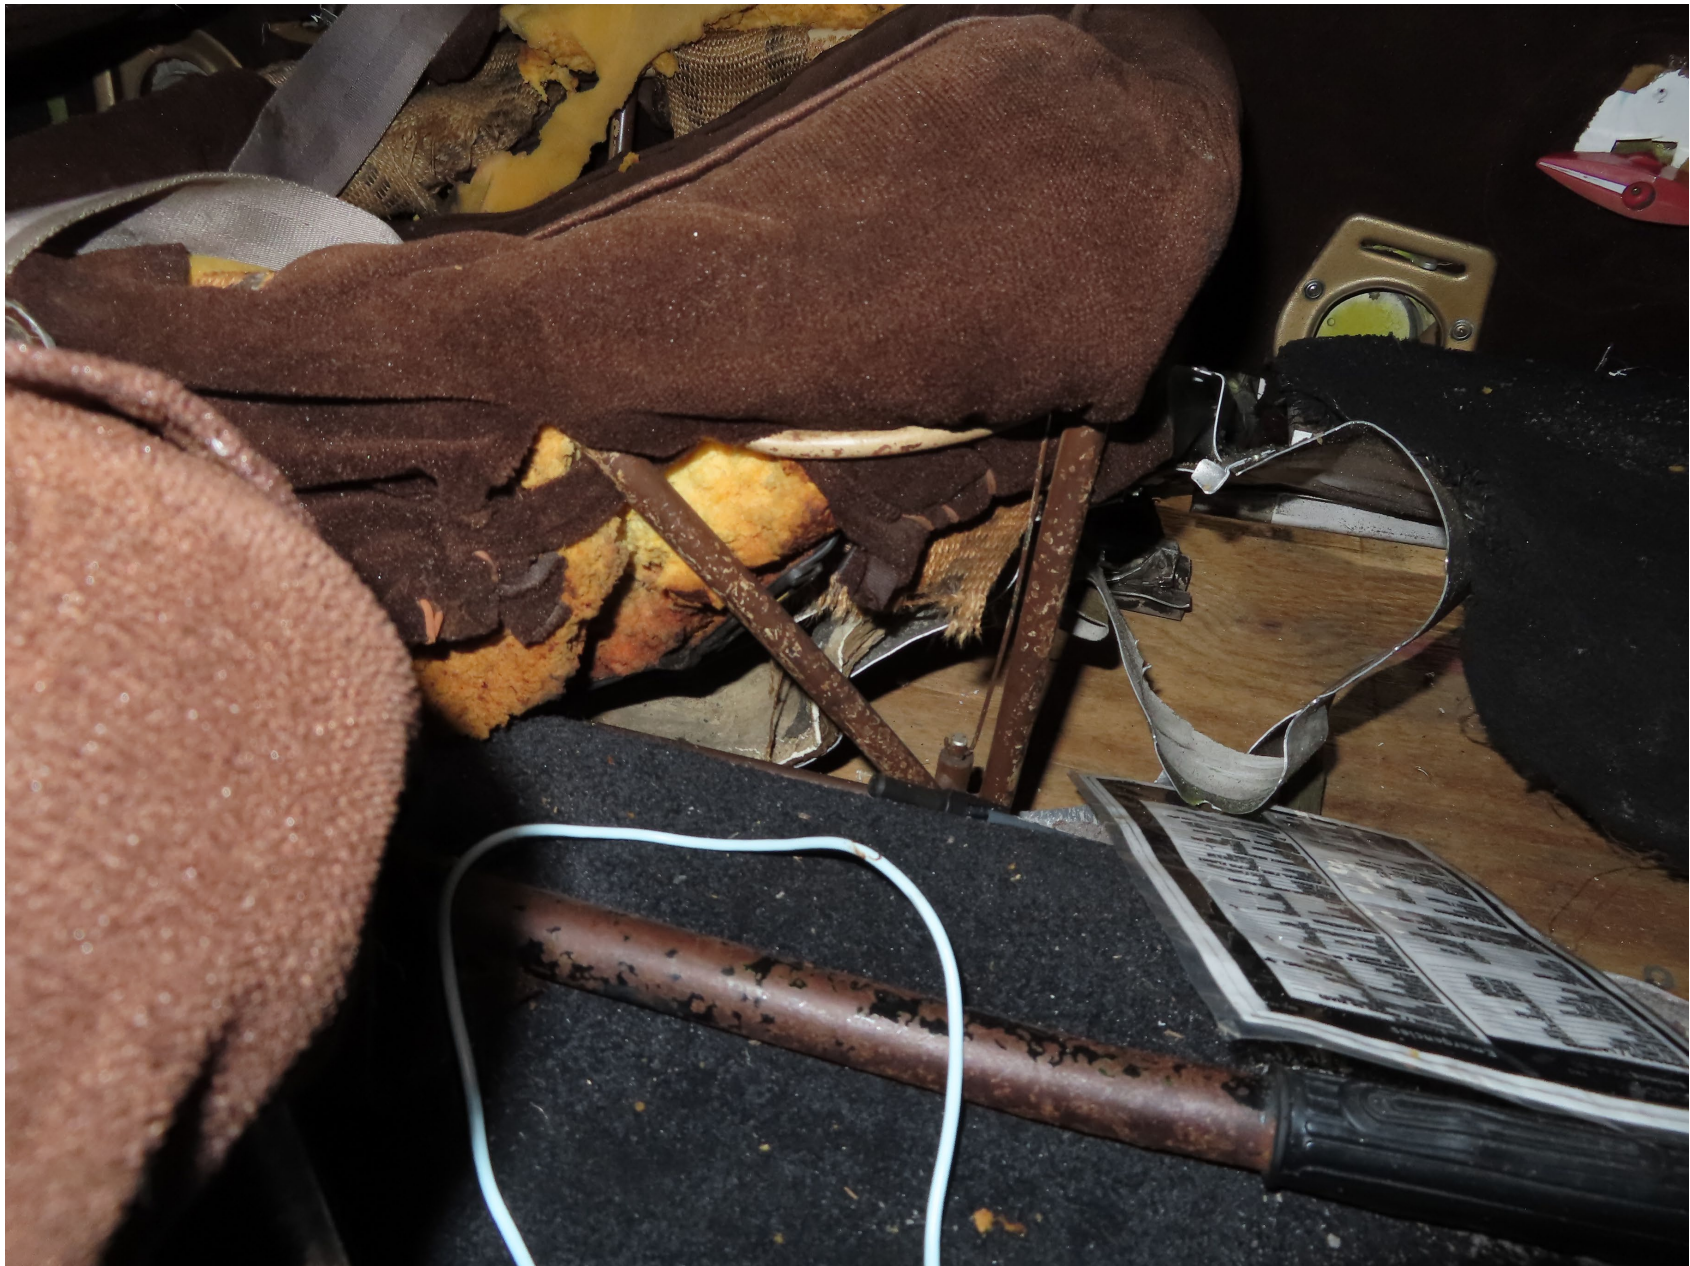
**Photo 10 – Underside of Seat – Courtesy of Piper Aircraft**

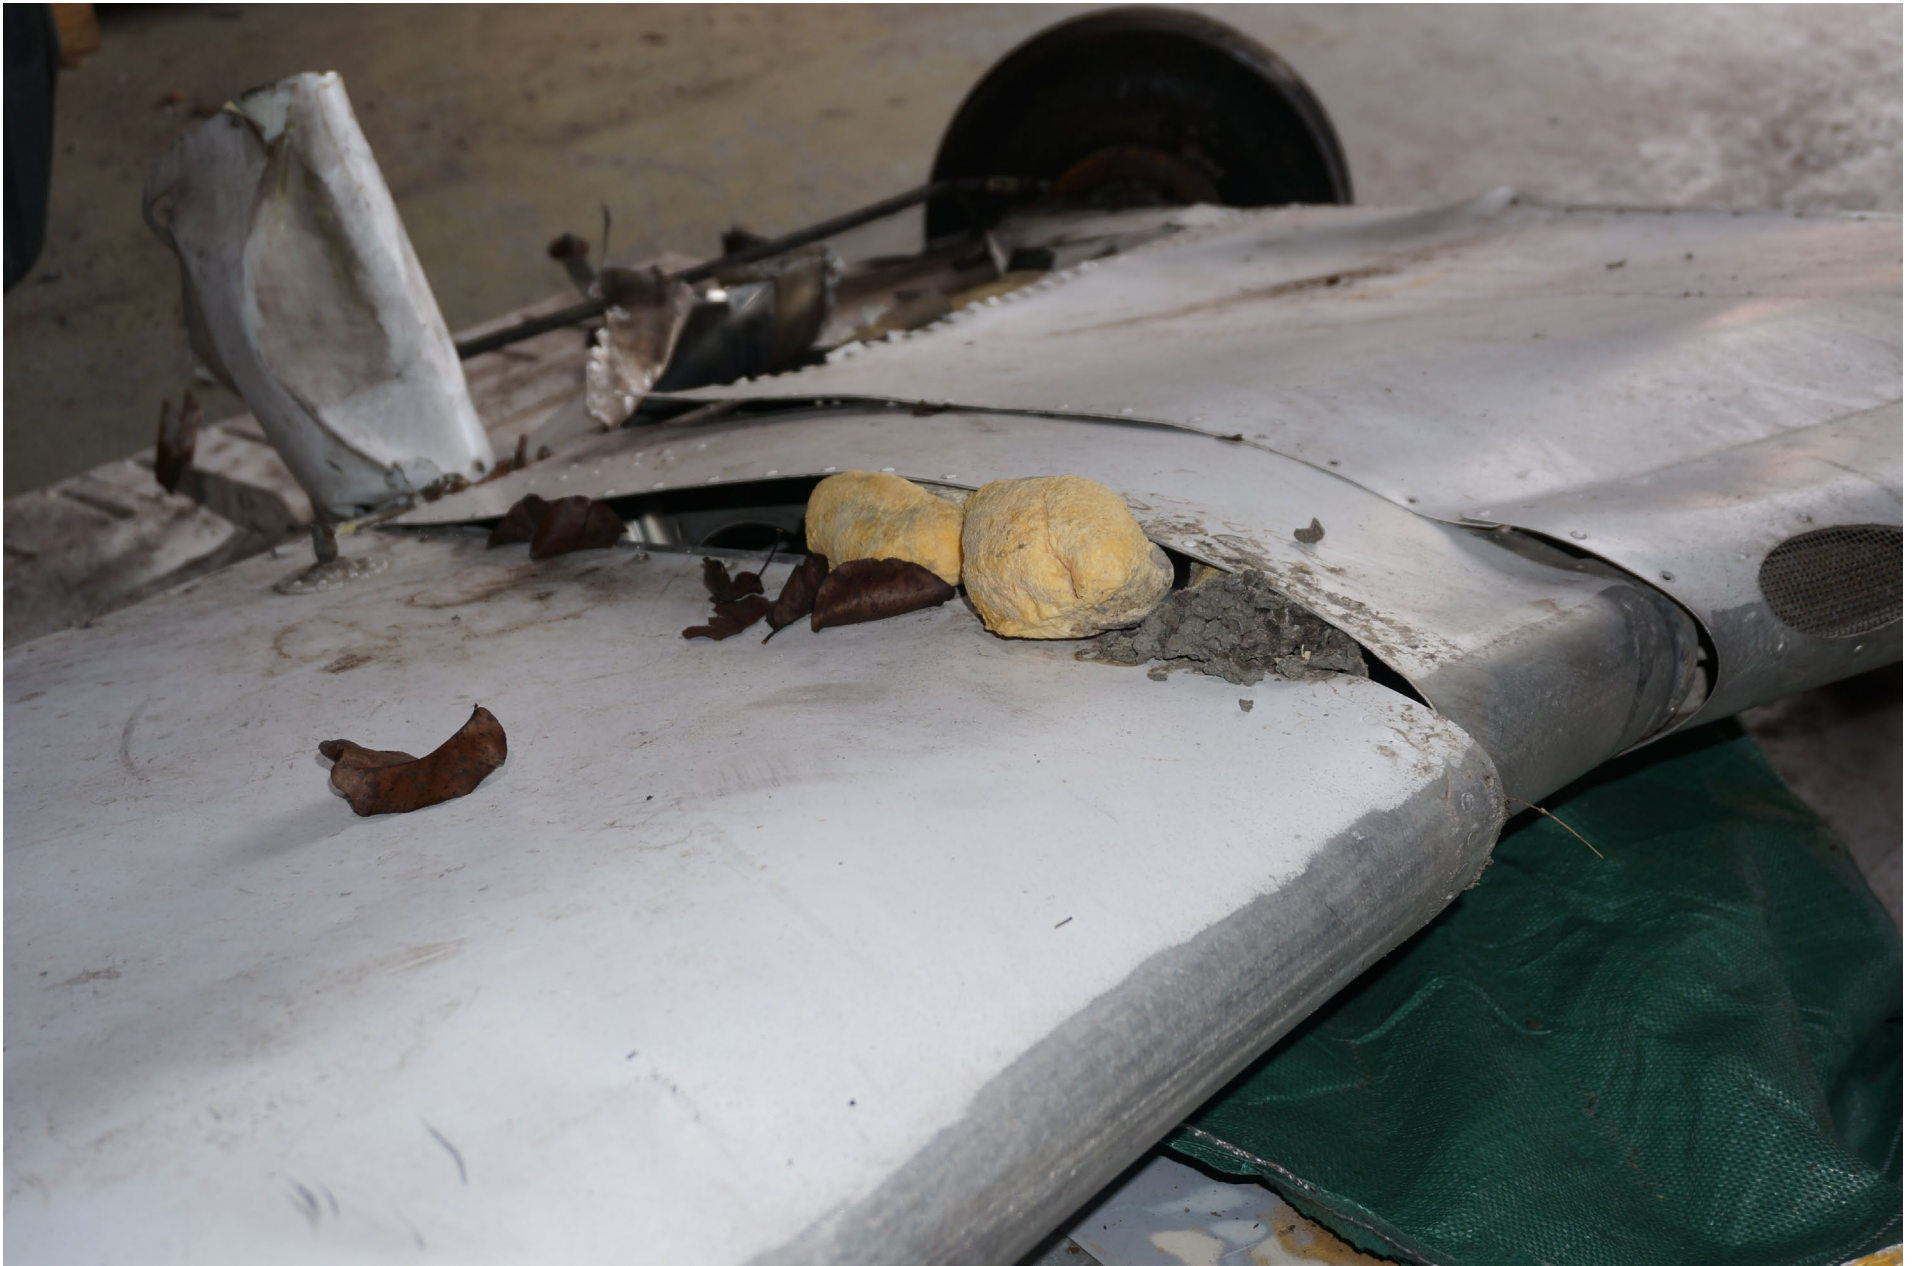
**Photo 11 - High Expansion Foam**

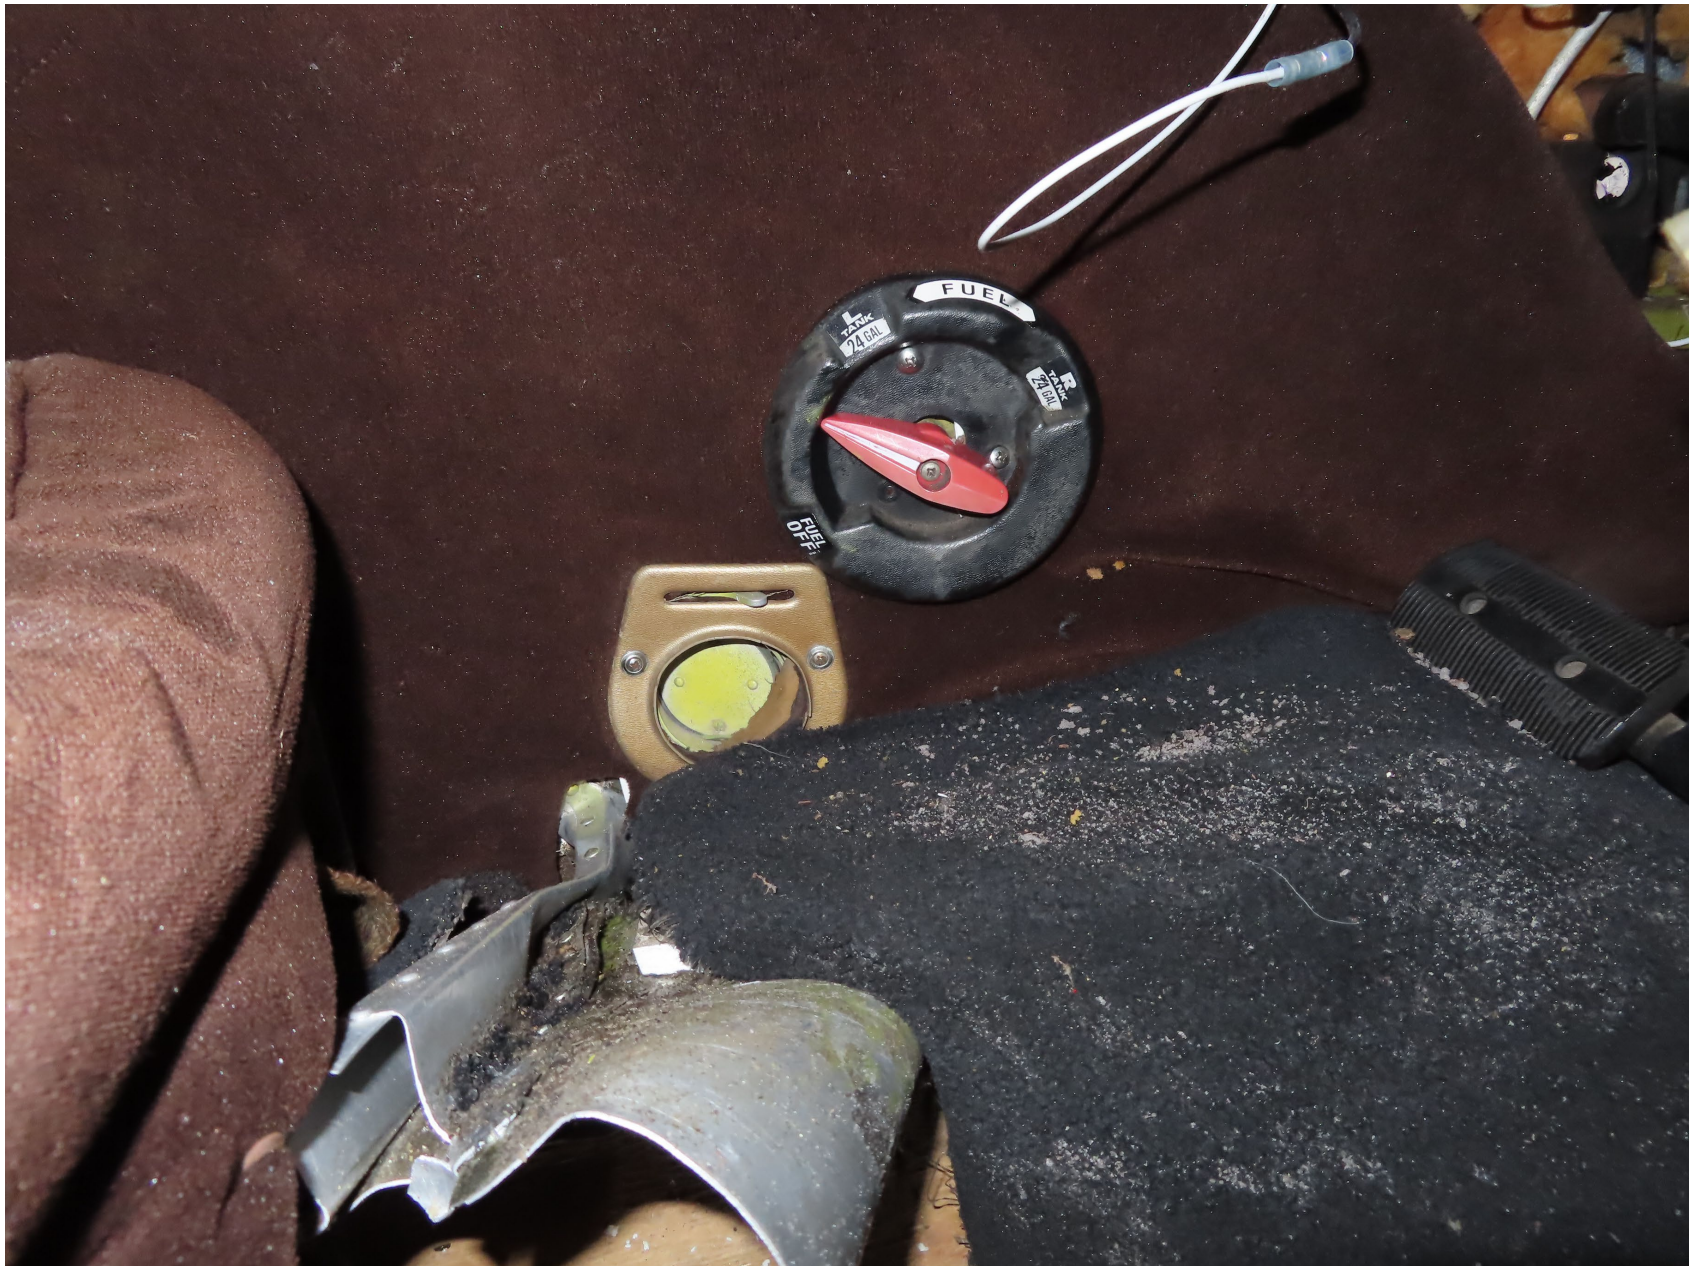
**Photo 12 – Fuel Selector**
