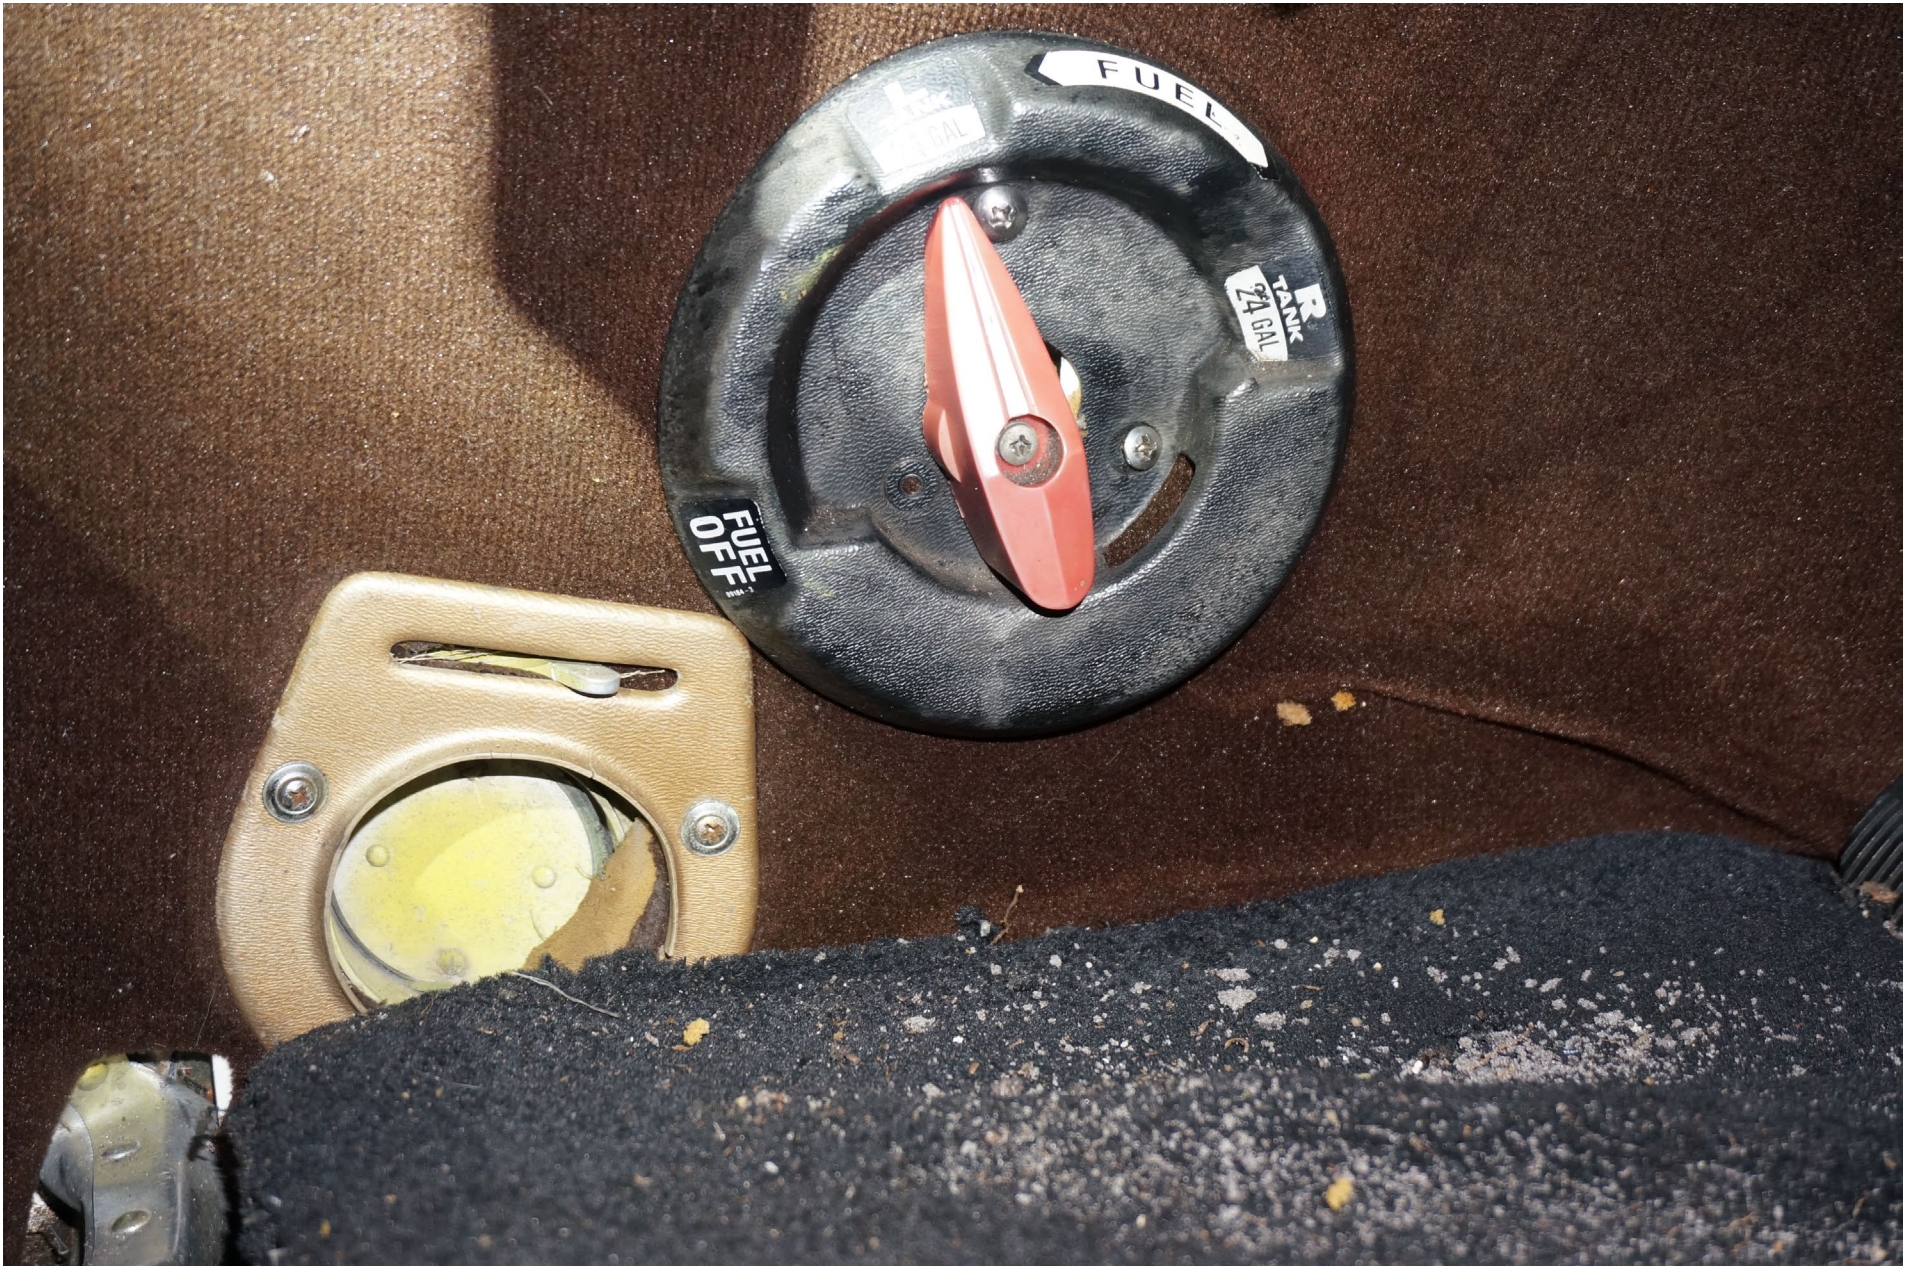
**Photo 13 – Close Up of Fuel Selector**

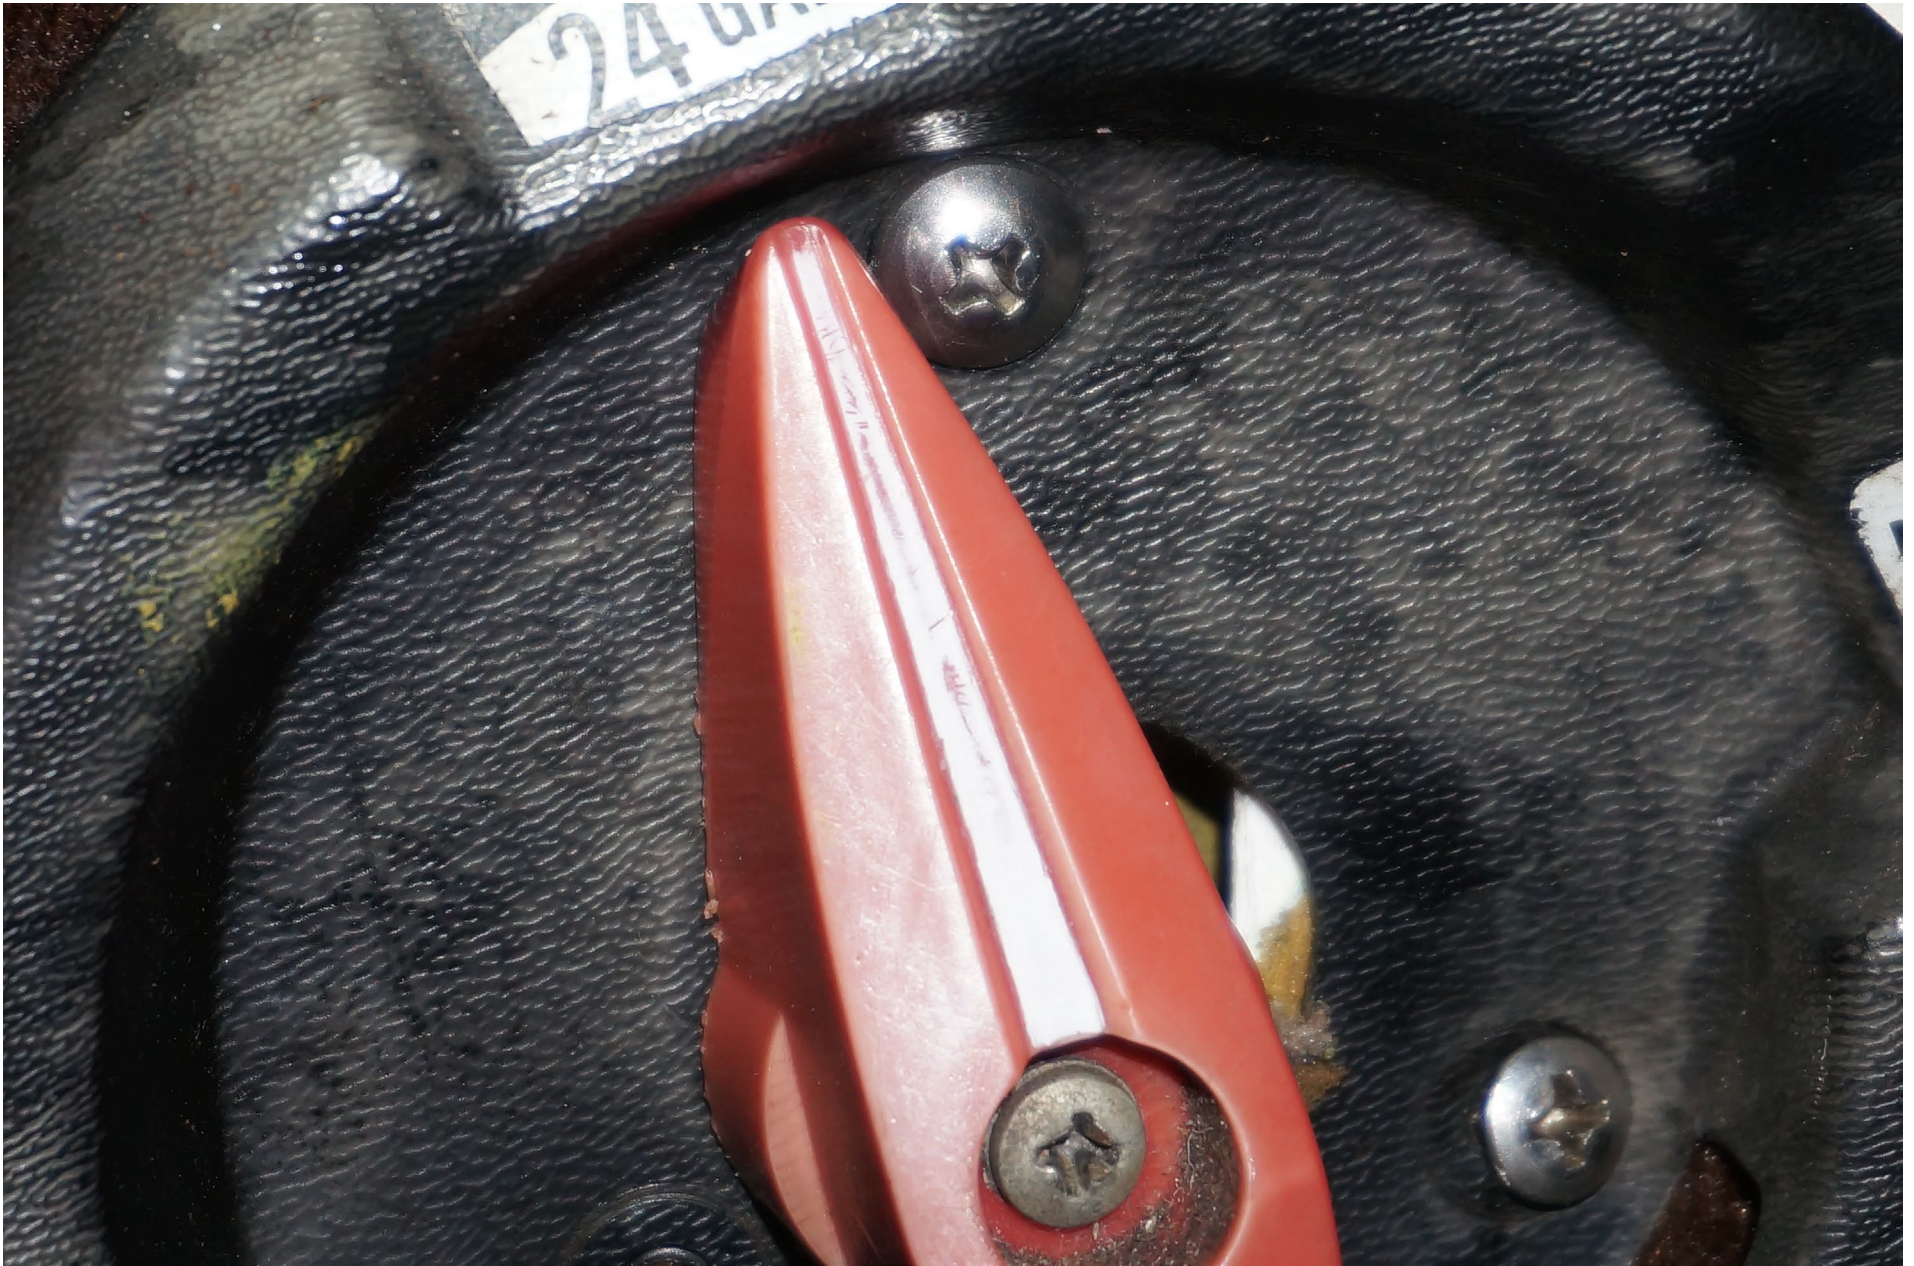
**Photo 14 – Screw Interfering with Fuel Selector Handle**

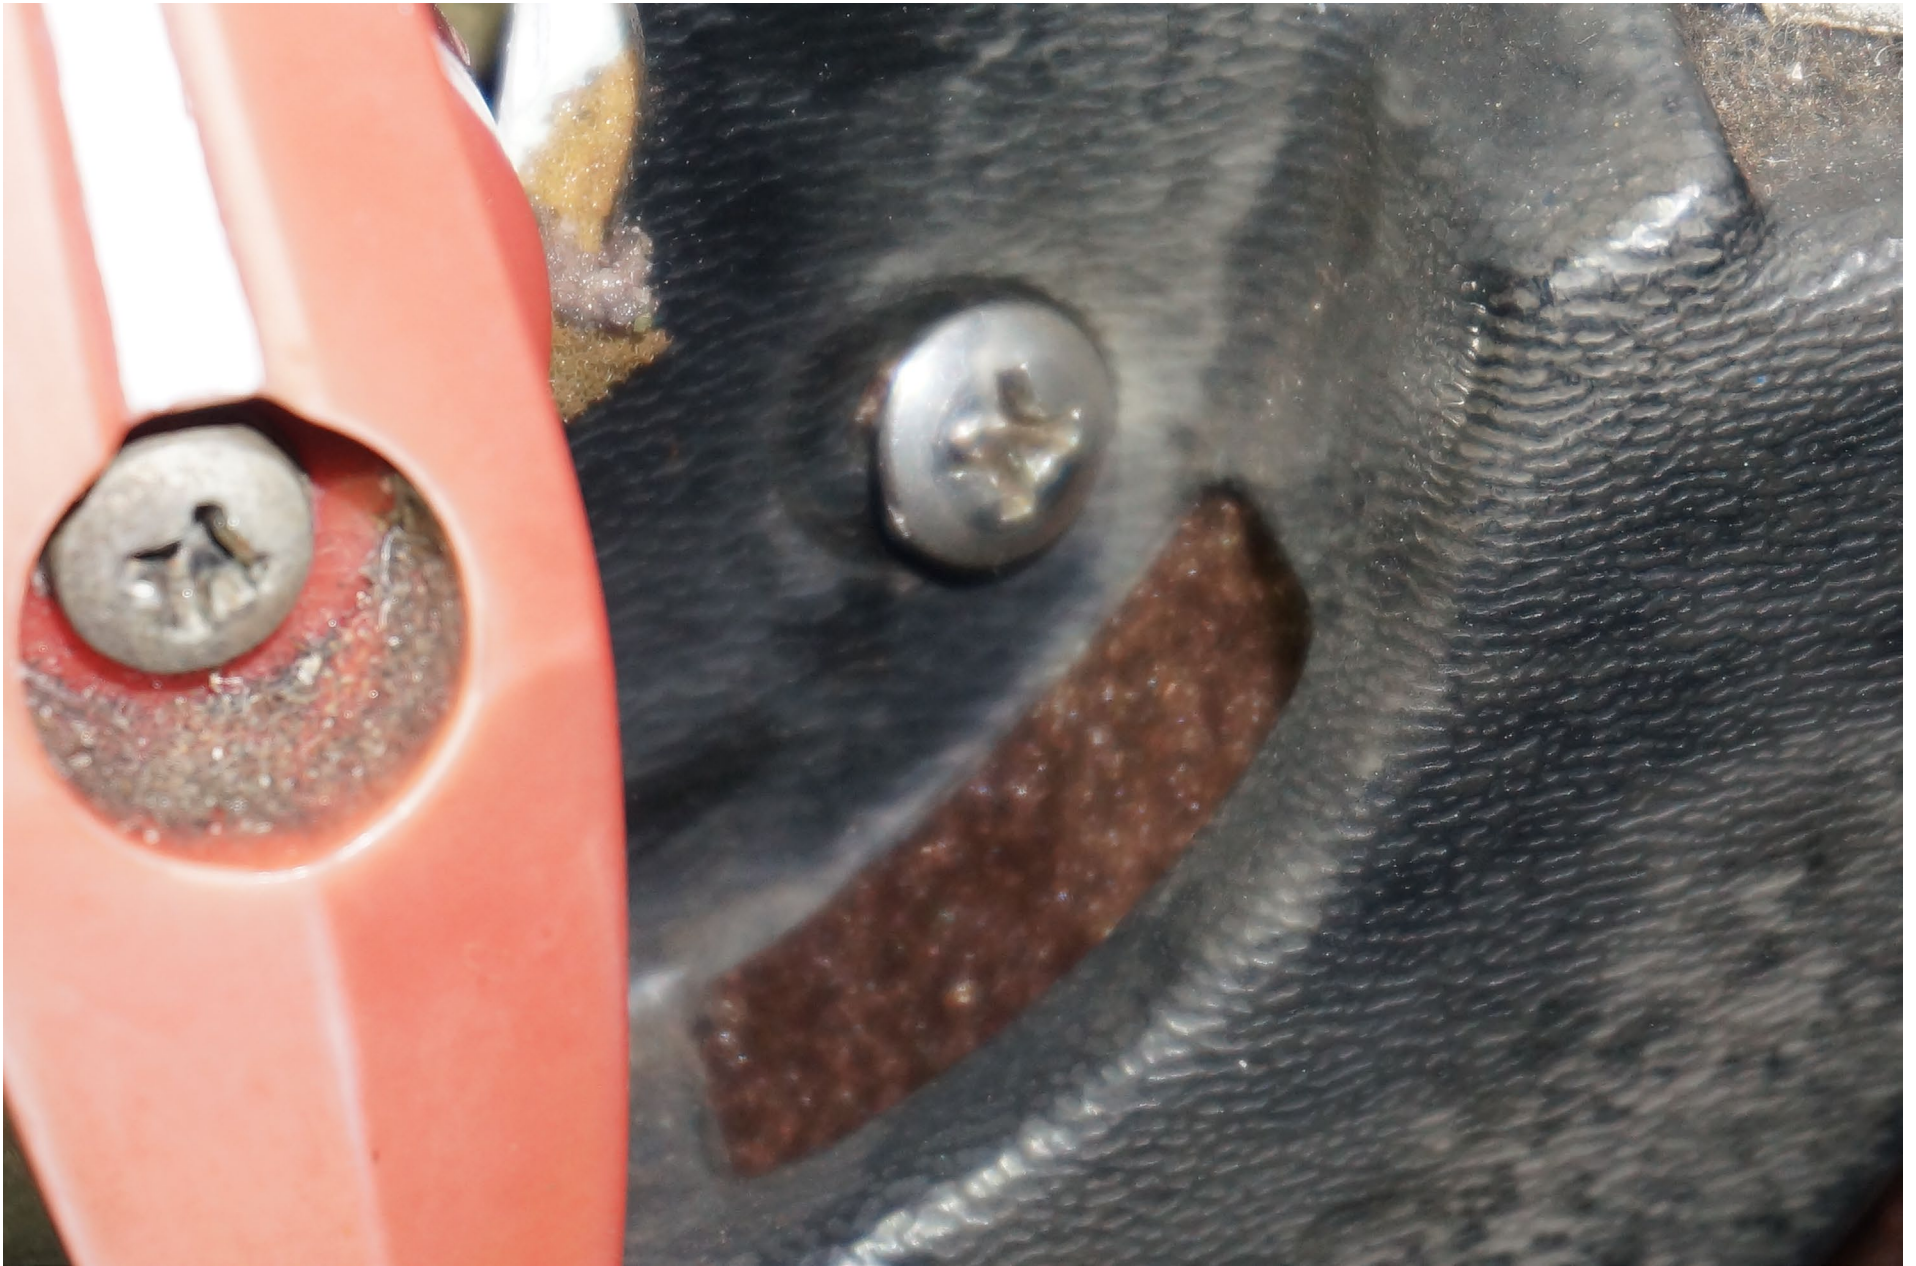
**Photo 15 – Missing Spring Loaded Metal Stop**

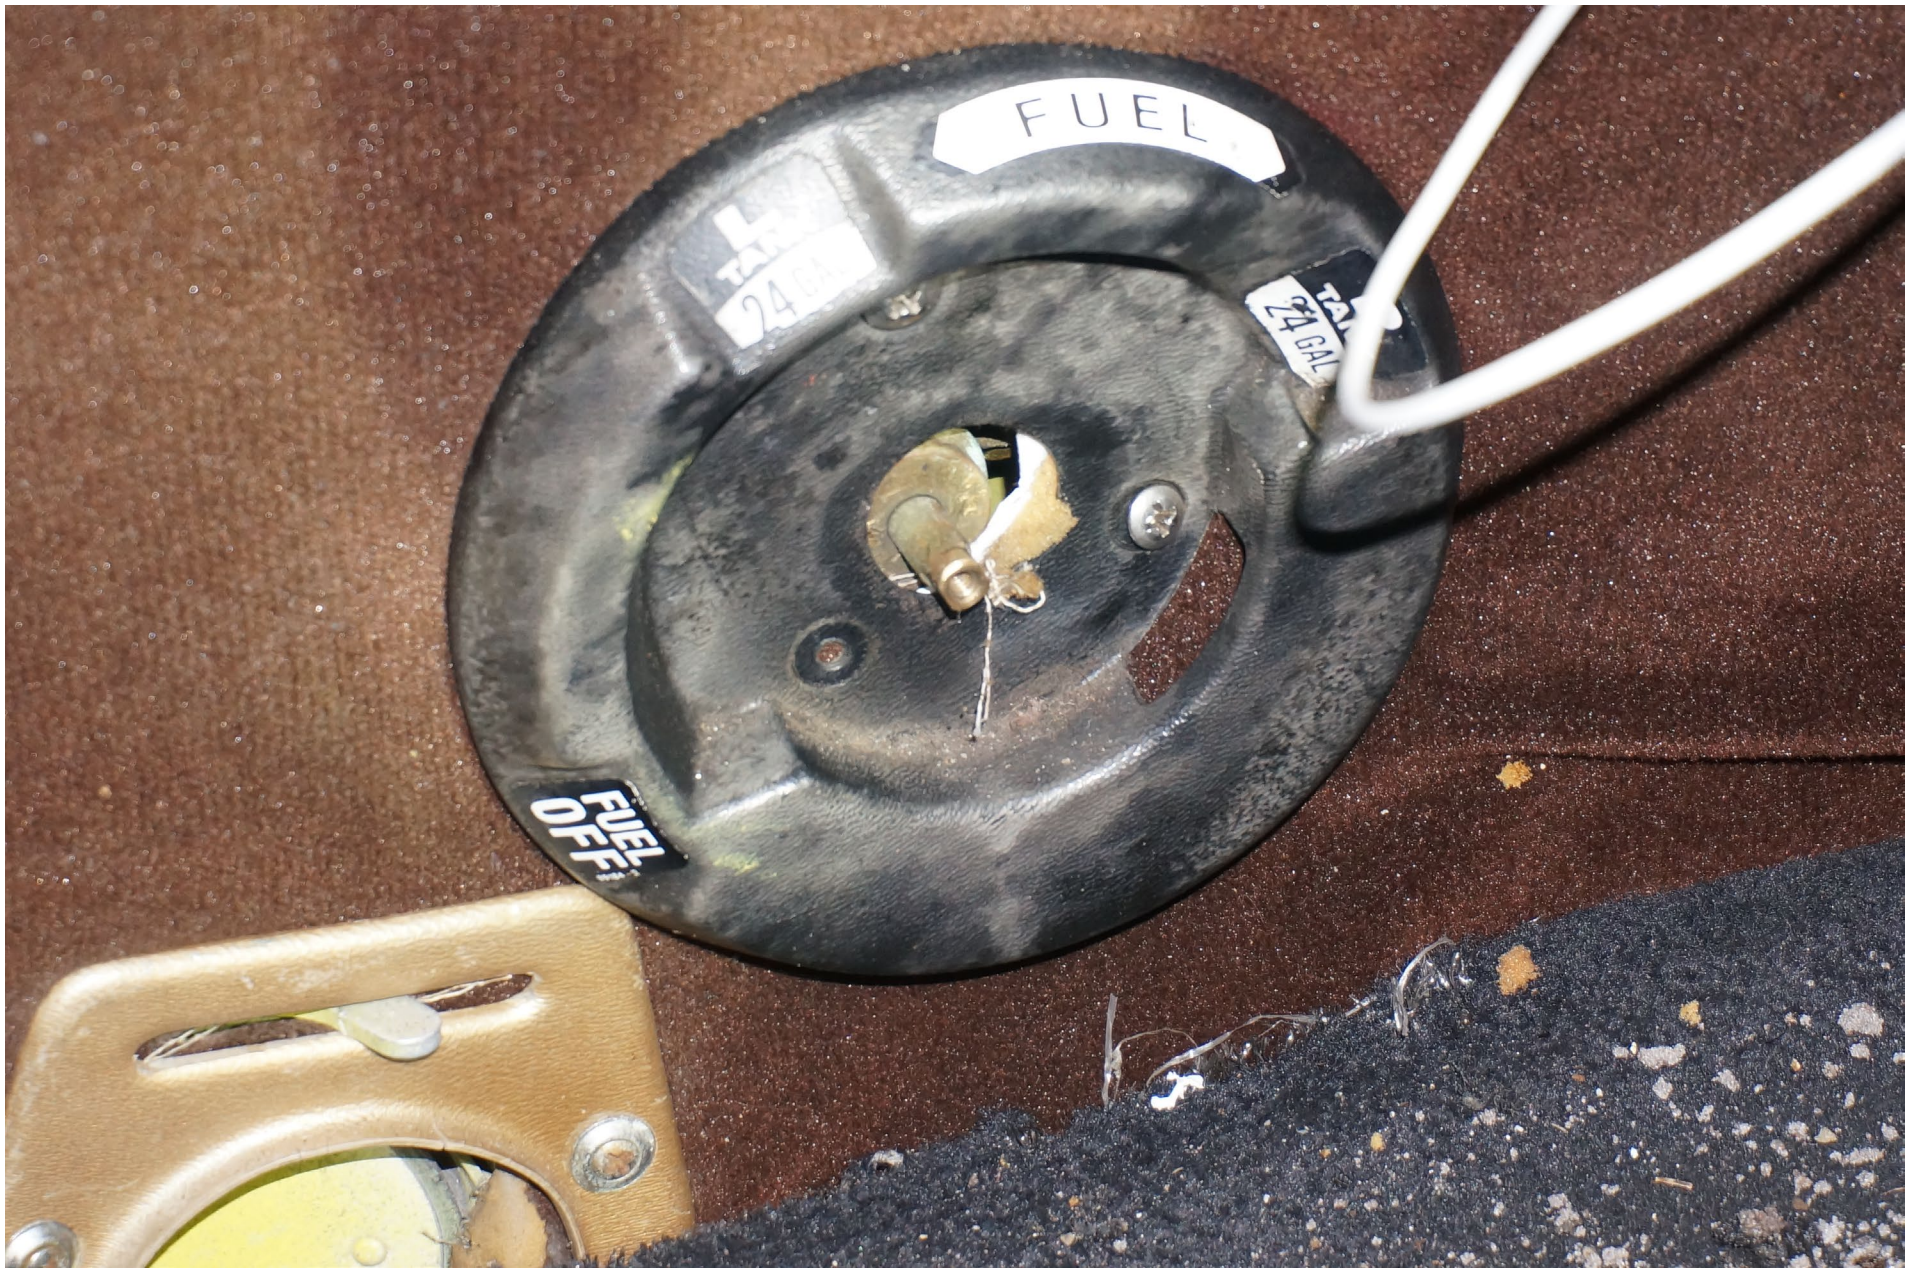
**Photo 16 – Fuel Selector Valve Cover Mounted Off Center and not Clocked / Indexed**
