# Query made at 11/05/2021 03:50:59 UTC

**KSUA, Stuart, Witham Field Airport (United States).**  
WMO index: ----- . Latitude 27-10-54N. Longitude 080-13-16W. Altitude 6 m.

Carburetor Icing Chart from FAA Special Airworthiness Information Bulletin CD-09-35

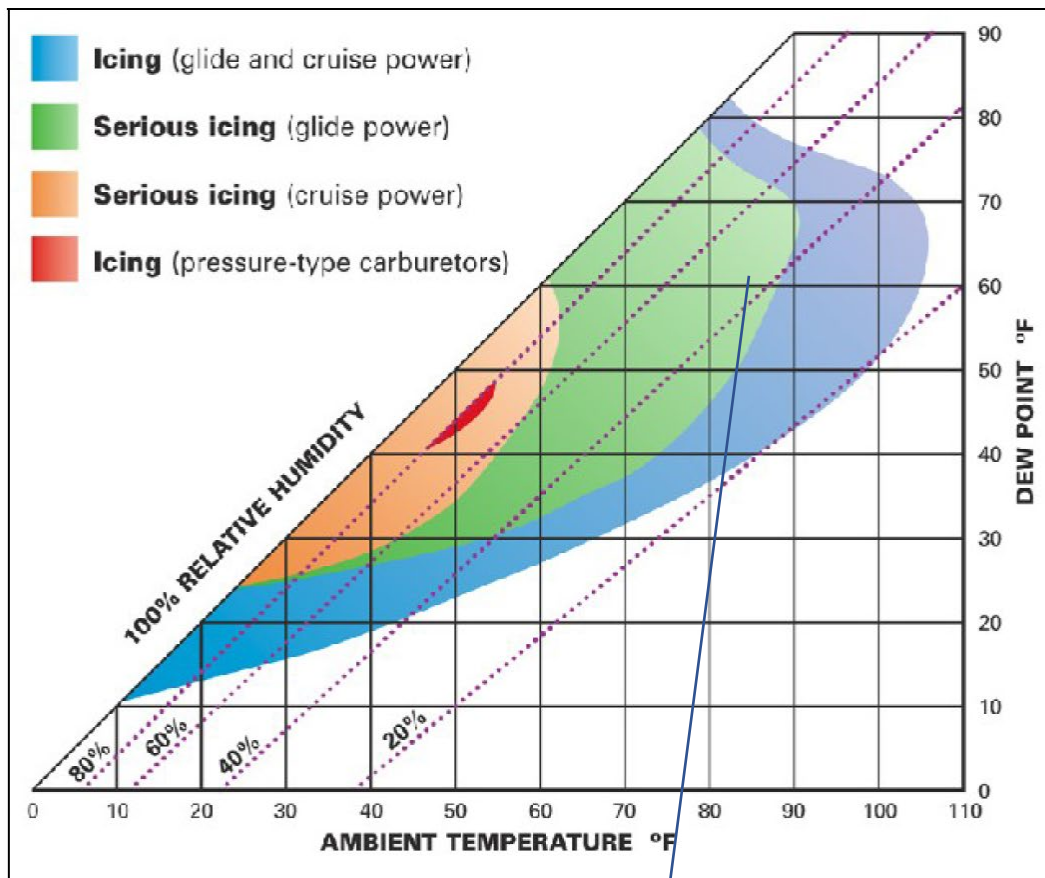
SUA 1458 (LCL) observation

Temperature 84.2F

Dew Point 6038F
