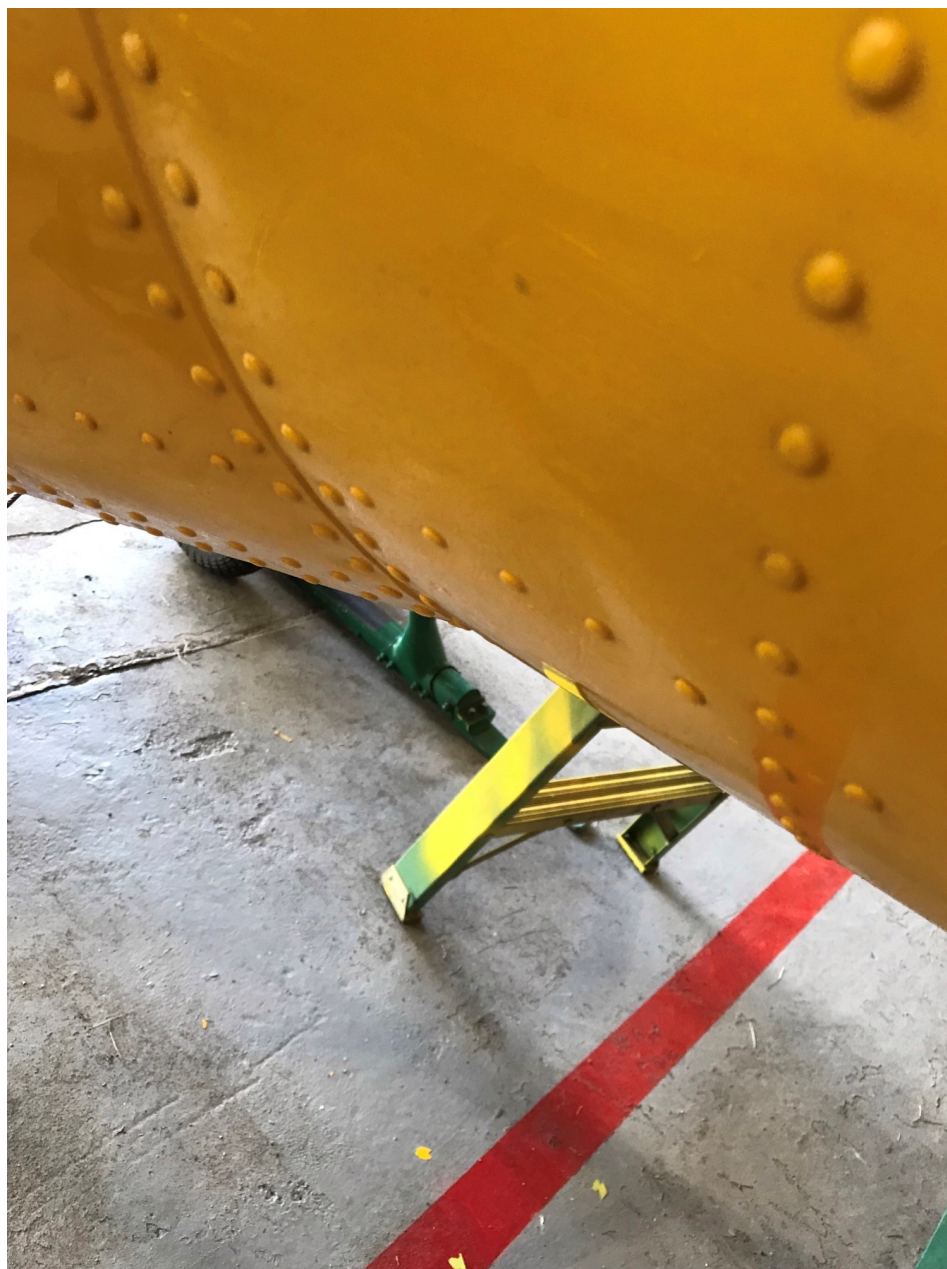
**Photo 1 – View of left side of tail boom showing buckling (Airbus Photo)**

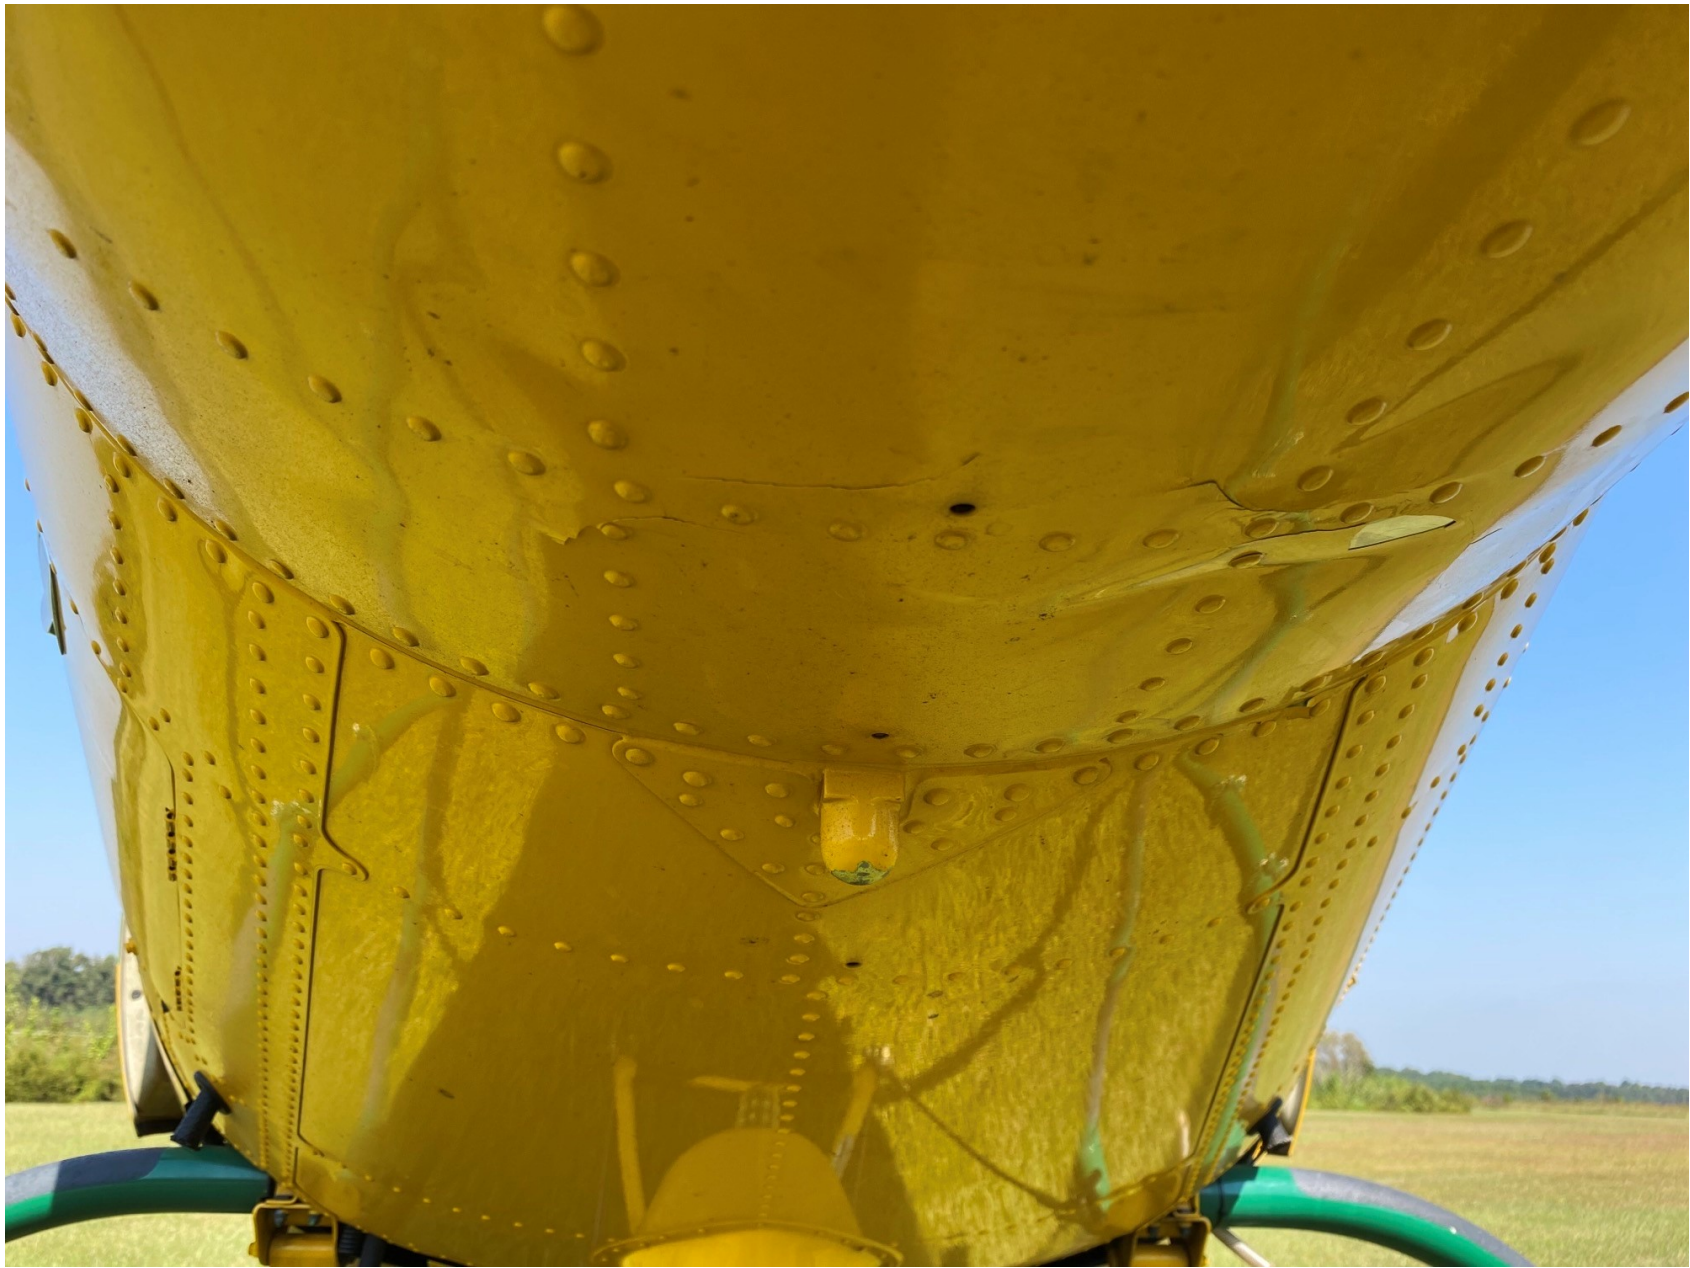
**Photo 2 – View of bottom of tail boom showing buckling and cracked paint (Airbus Photo)**

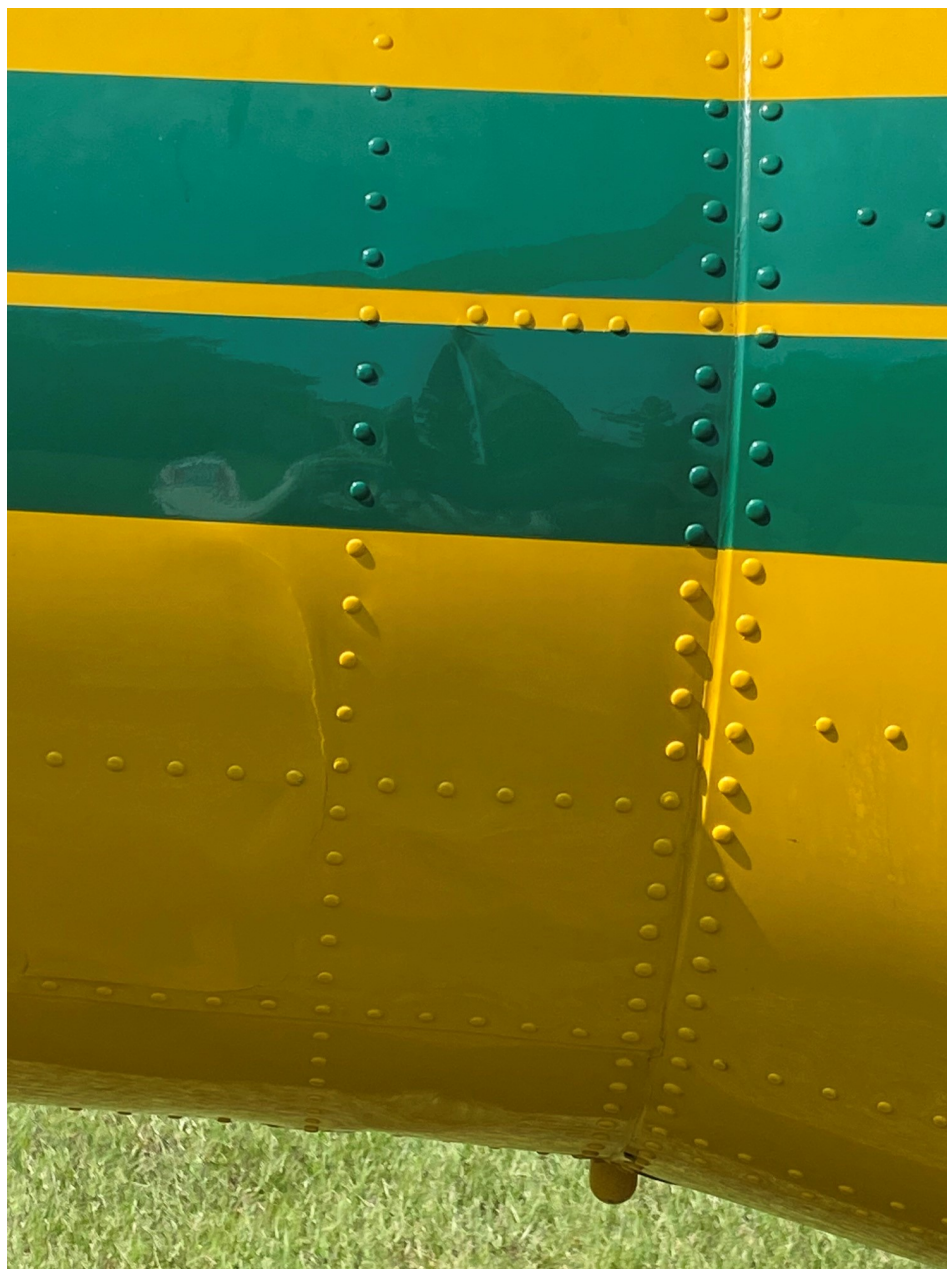
**Photo 3 – View of right side showing buckling and cracked paint. (Airbus Photo)**
