## **NATIONAL TRANSPORTATION SAFETY BOARD**

### **Specialist's Factual Report**

# **METEOROLOGY**

ERA22FA010

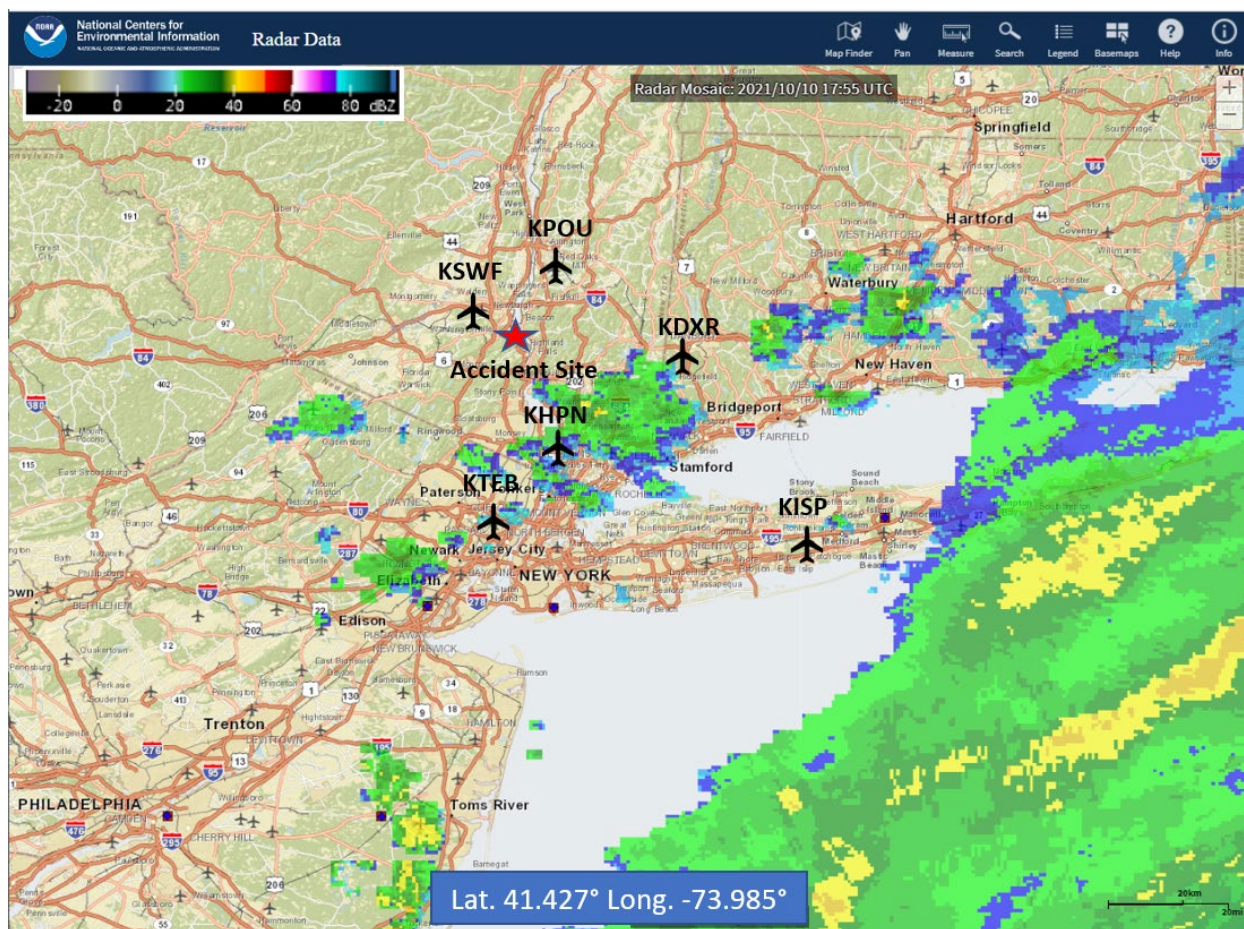
The regional view of the National Composite Radar Mosaic for 1355 EDT is included as figure 2 with the approximate accident site marked by the red star. Several of the closest weather reporting sites have been added that will be documented in section 2.0 below. The image depicts a large band of precipitation extending across eastern Long Island into southern New Jersey, with another area of scattered light to moderate echoes associated with rain showers extending from

northeast New Jersey, southern New York, into Connecticut immediately south of the accident site. Based on the potential for echoes in the vicinity of the accident site the closest weather surveillance radar will be further documented in section 5.0 of this report.

Figure 2 - National Composite Radar Mosaic for 1355 EDT with the approximate accident site marked.
