## **Memorandum For Record**

**Date: 2/29/2024**  
**NTSB Accident Number: ERA22FA126**

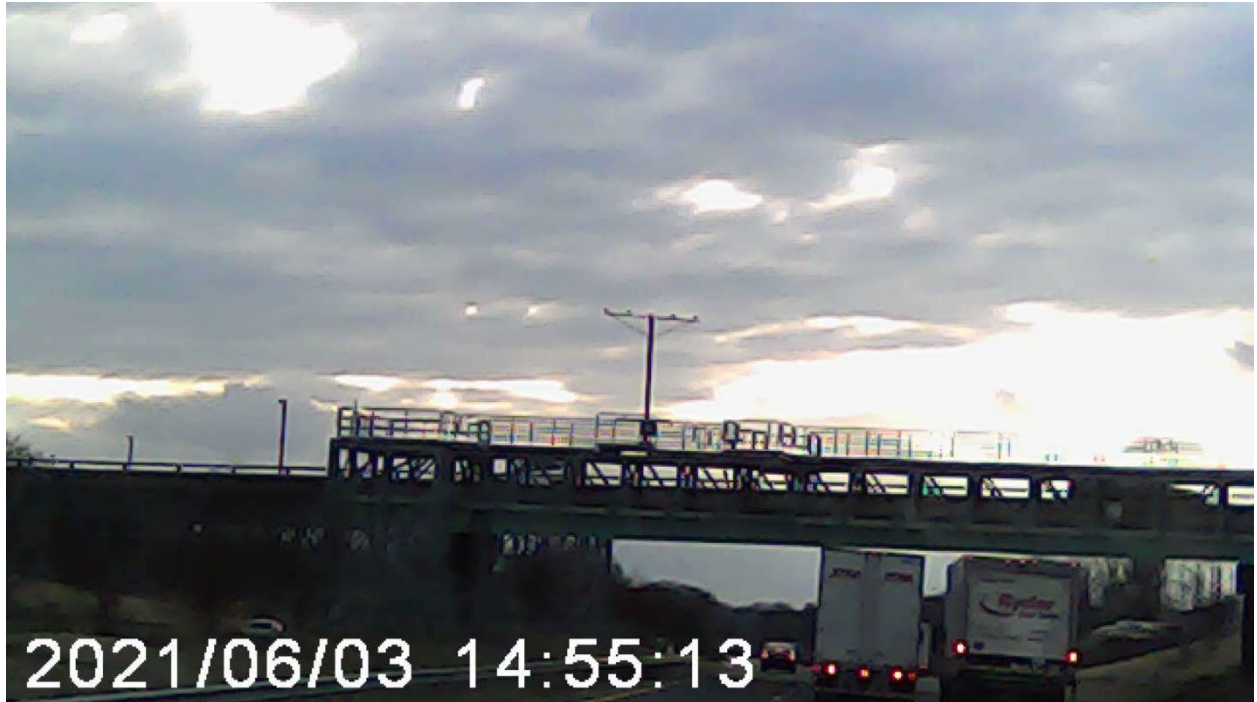
As part of the investigation, a 3 minutes 0 seconds long video from a tractor trailer that was driving on the highway behind the impacted truck was provided to NTSB. The video with sound from the cab depicted the occupants talking with a view looking forward as the truck proceeded along the highway. At about 1 minutes 30 seconds elapsed time, with several vehicles in all 3 lanes of the highway, the airplane appeared (left side view) to the right of the lanes in a slight nose up attitude (Figure 1). The video did not depict the collision with the truck but there was nothing unusual observed about the left wing or left side of the fuselage. A large fireball covering all 3 lanes began about 1 minute 32 seconds elapsed time and the video depicted vehicles moving to the left to avoid the fire. The truck taking the video stopped behind another tractor trailer and the video depicted the impacted tractor trailer rolling onto its side and coming to rest. The fire continued to the end of the video recording.

Figure 1: Screen Shot From Video Depicting a Left Side View of the Airplane in a Slight Nose-Up Attitude Immediately Before Impact.
