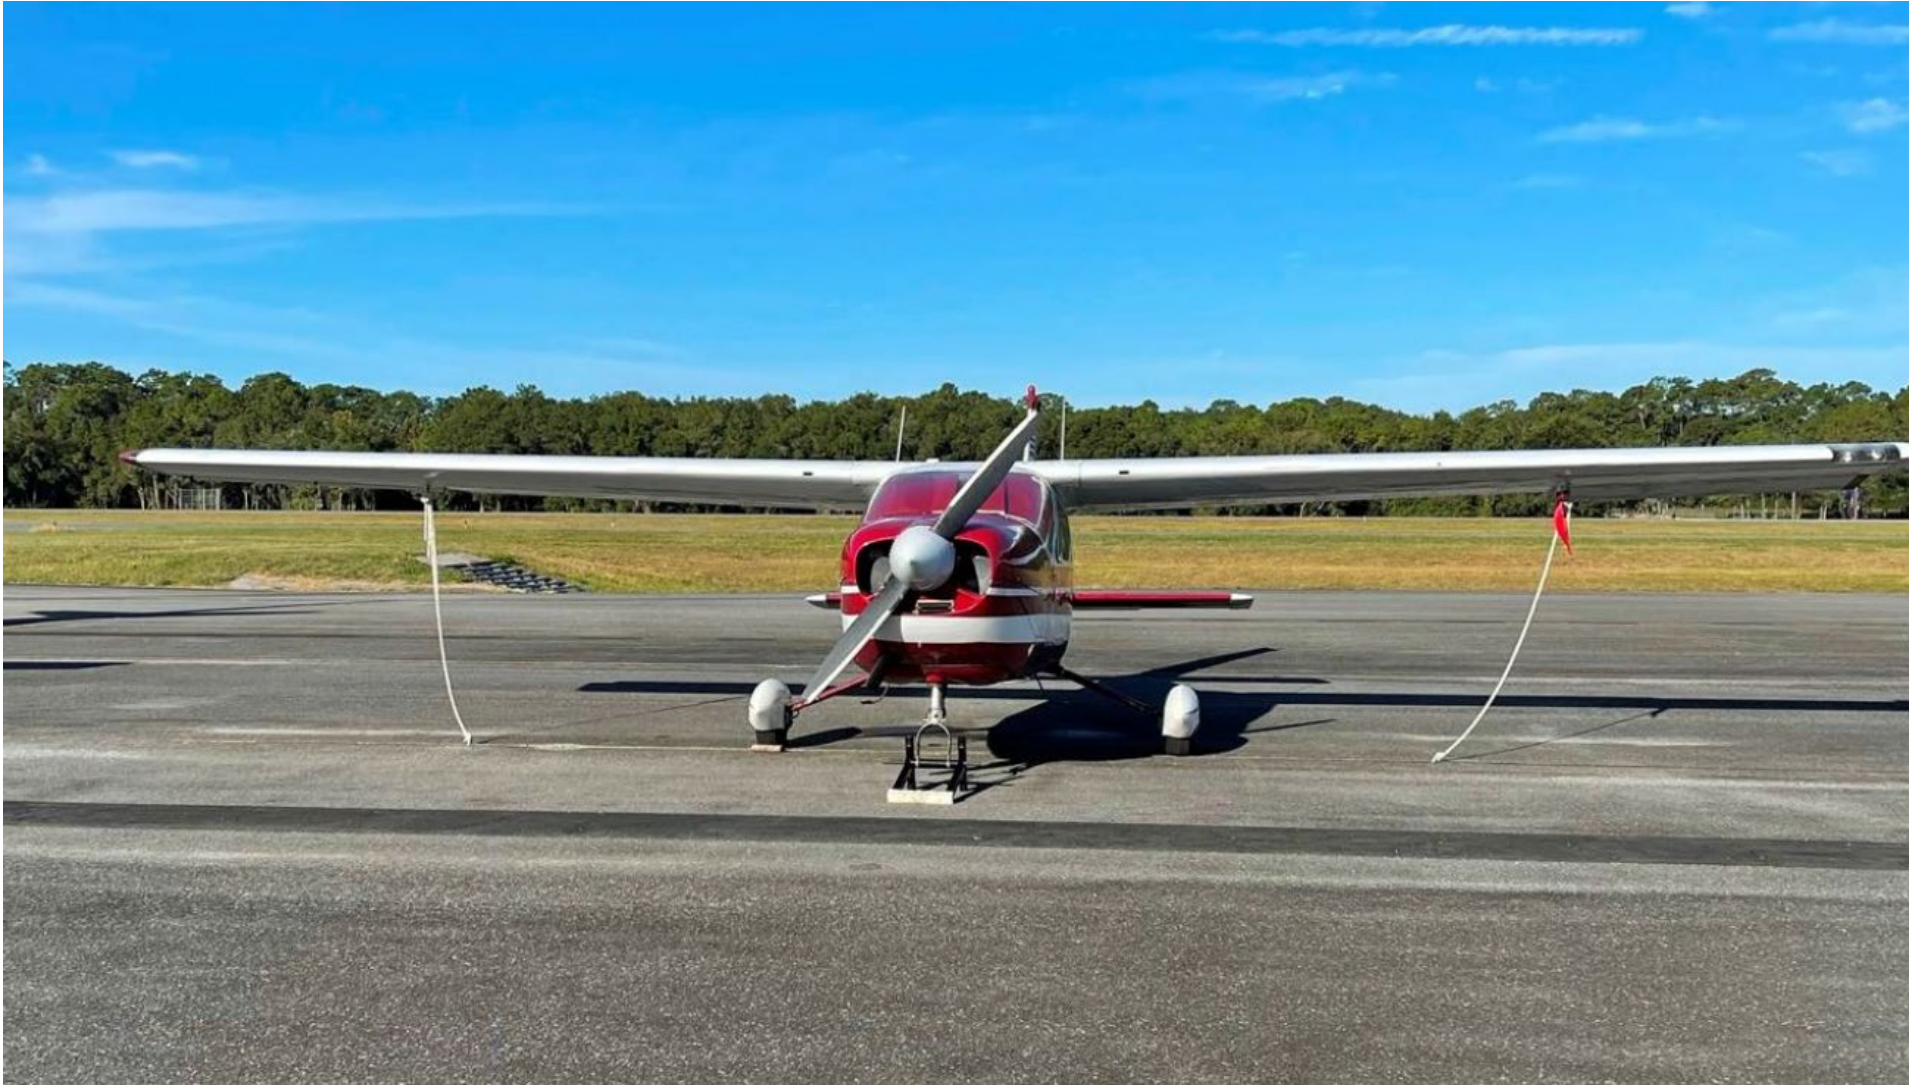
**Photo 1 – Insurance Adjuster Digital Photograph. View in Front of the Airplane Looking Aft.**

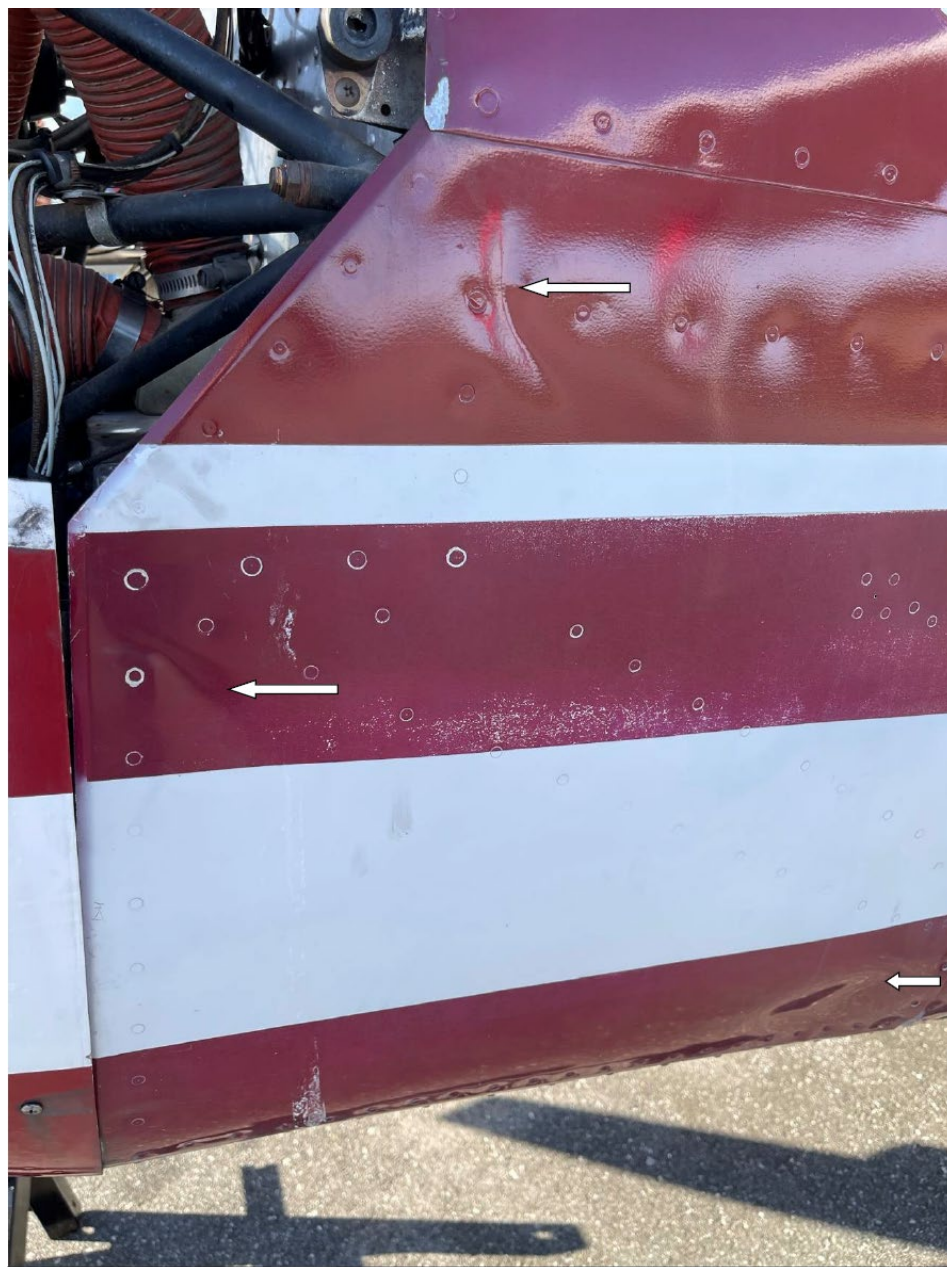
**Photo 2 - Insurance Adjuster Digital Photograph. View of The Left Side of the Fuselage Between the Firewall and Front Portion of the Door. White Arrows denote Locations of Compression Wrinkles.**

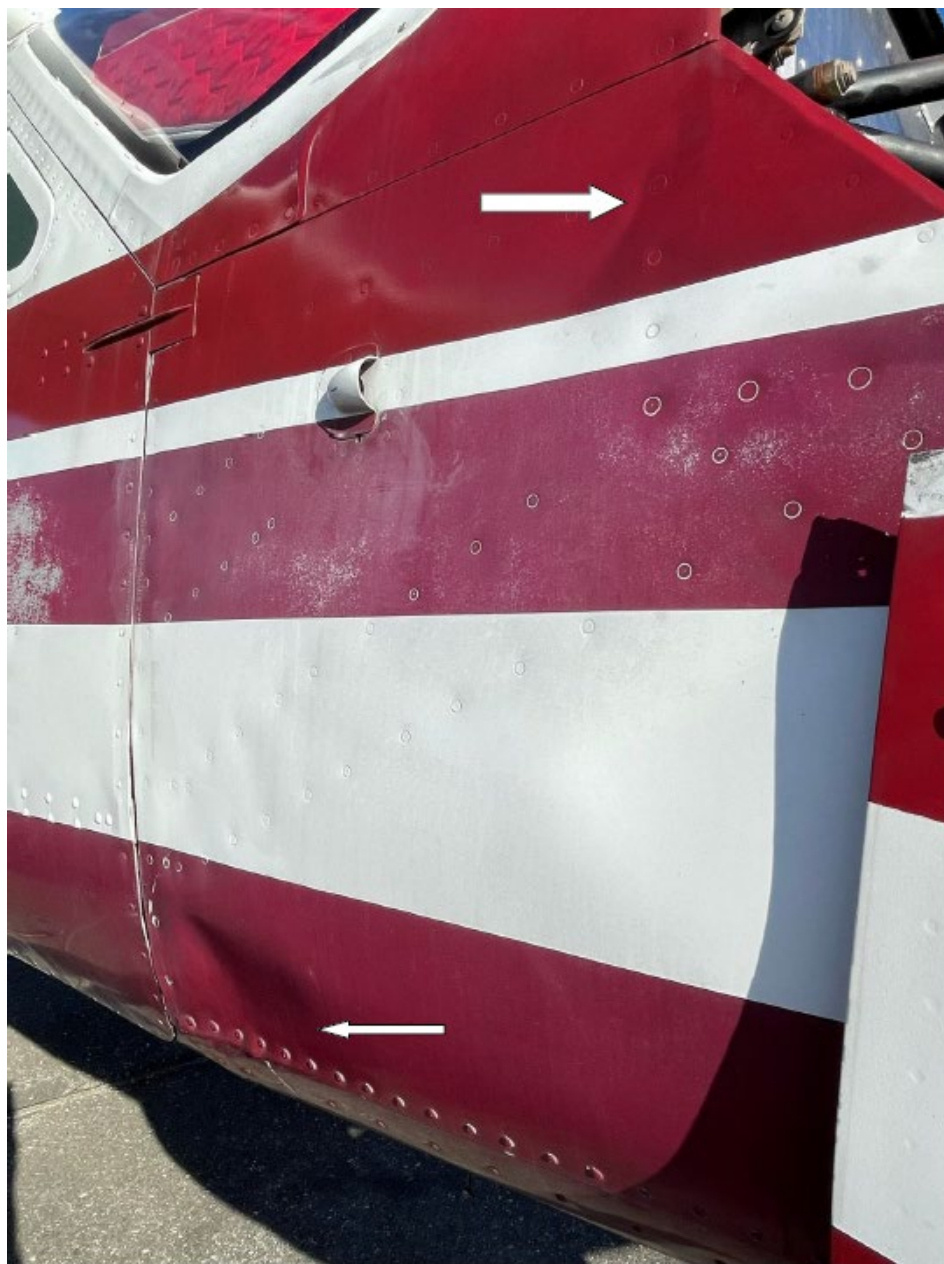
**Photo 3 - Insurance Adjuster Digital Photograph. View of The Right Side of the Fuselage Between the Firewall and Front Portion of the Door. White Arrows denote Locations of Compression Wrinkles.**

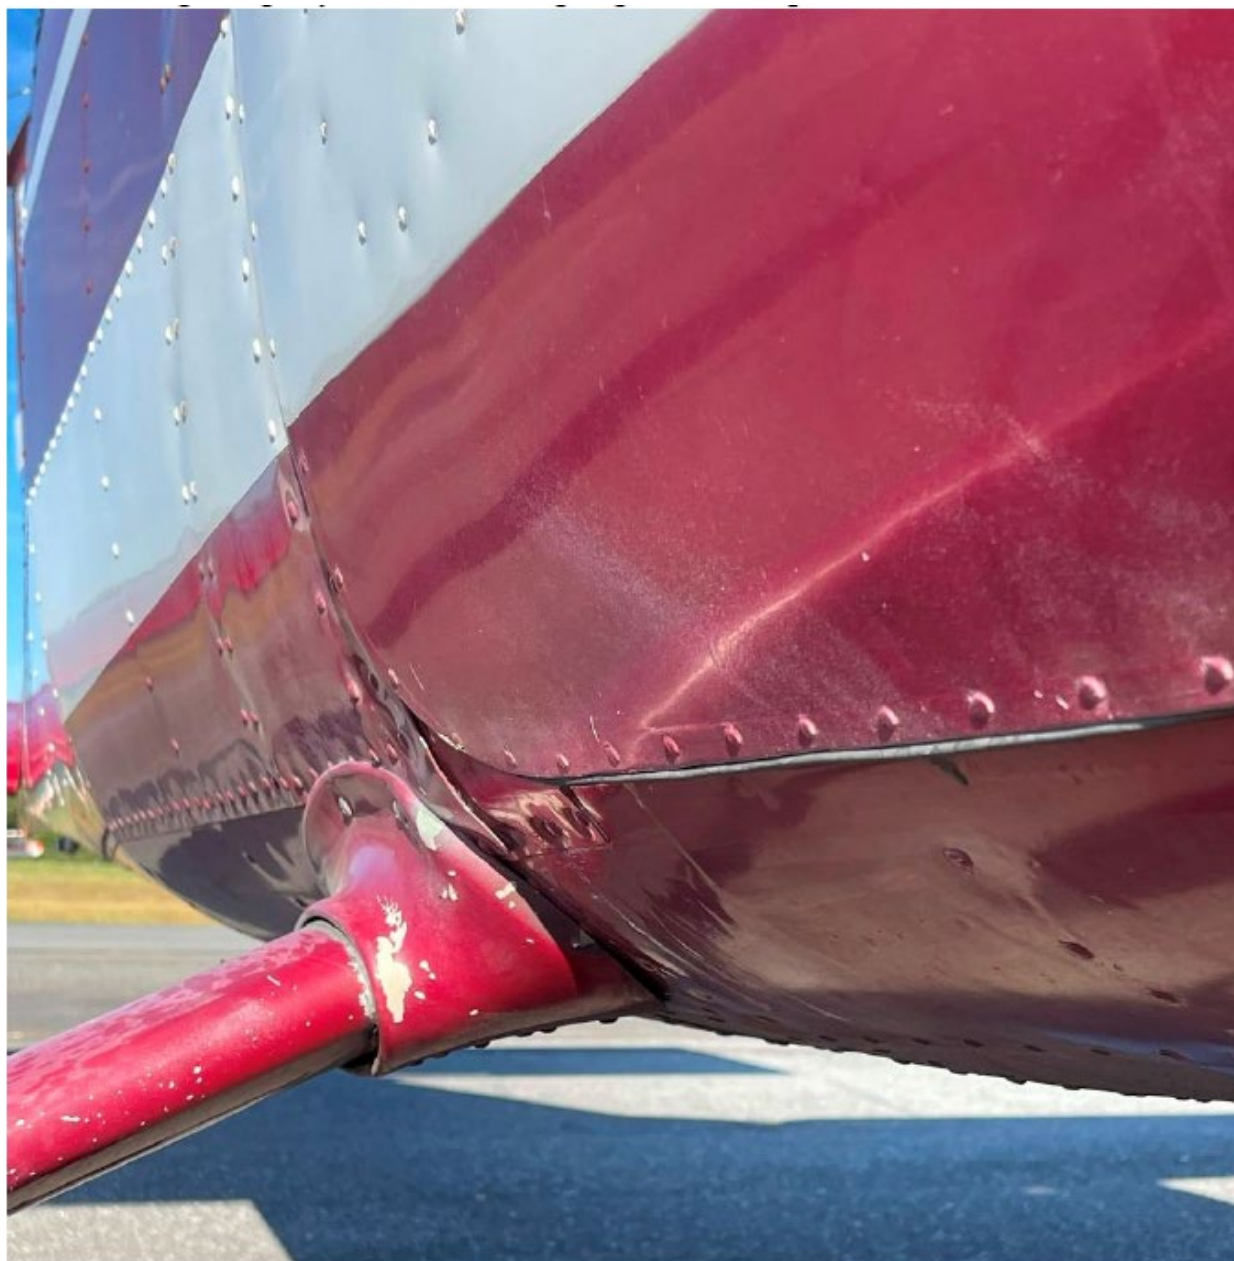
**Photo 4 - Insurance Adjuster Digital Photograph. View of The Right Side of the Fuselage At the Main Landing Gear Attach. Note the Slight Deformation.**

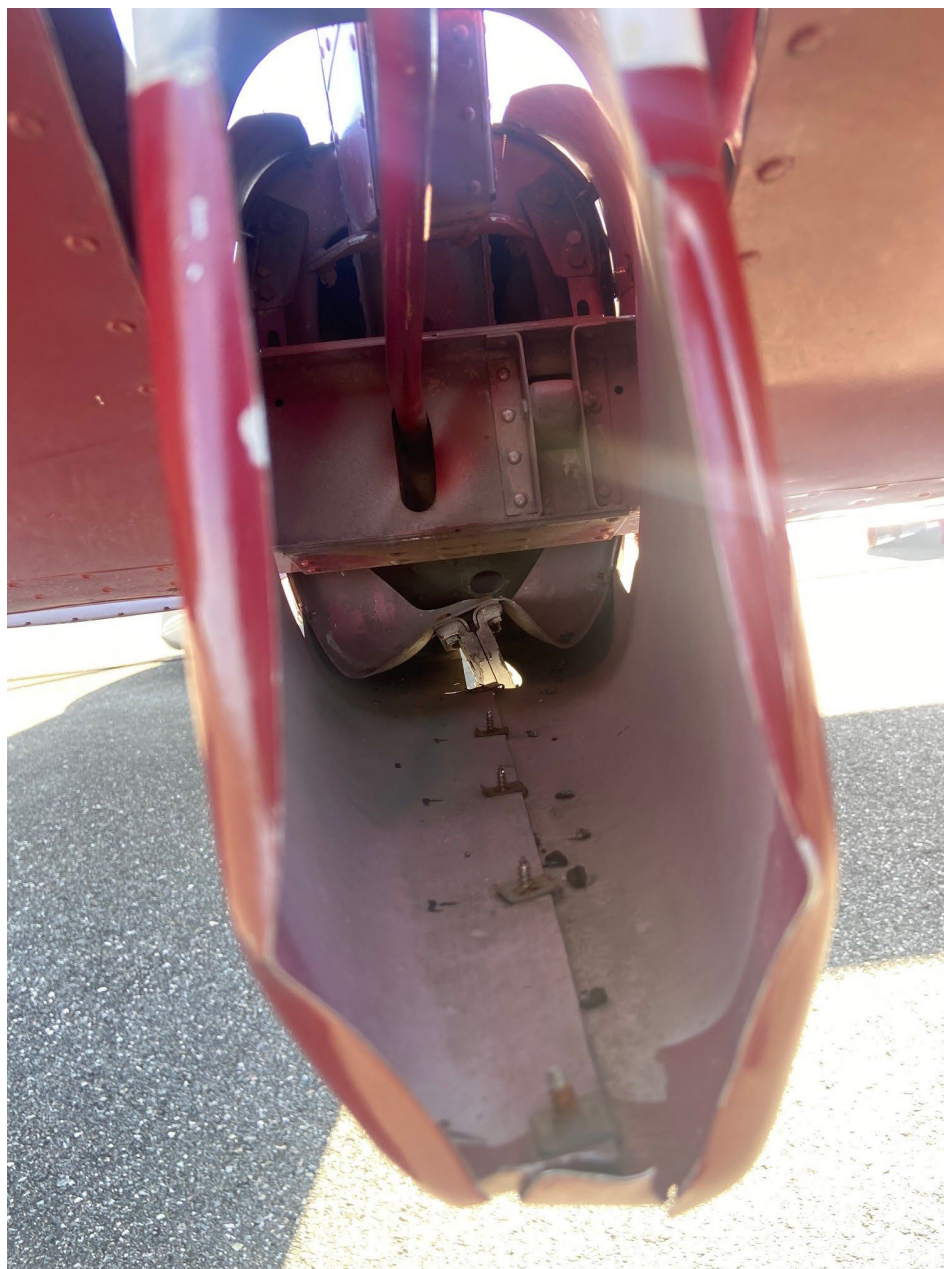
**Photo 5 – Digital Photograph From Flight Instructor. View From Aft Looking Forward Showing Damage to Lower portion of Bulkhead Assembly Part Number 1712105-1 at Fuselage Station 281.48**
